# **Kanata West Development Area Meander Belt Width Assessment and Erosion Analysis**

## **Feedmill Creek**

### **Draft Report**

Report Title: Kanata West Development Area Meander Belt  
Assessment and Erosion Analysis, Feedmill Creek

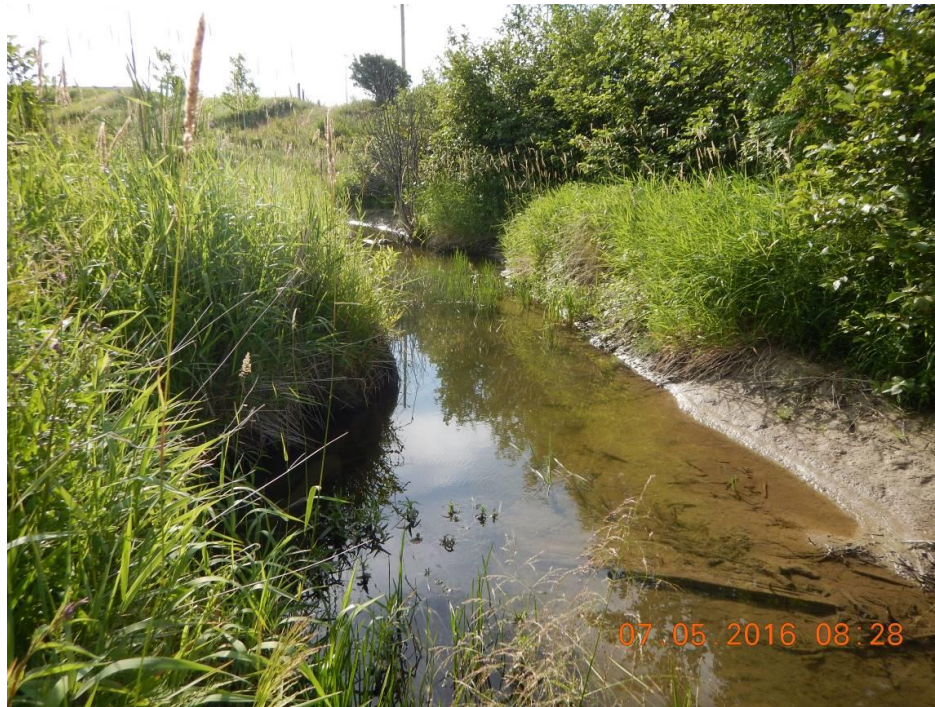
Photo  
1

Reach 1 – upstream facing to run feature; grassy banks, partial confinement, undercutting on inner bank, sandy deposit out outer bank

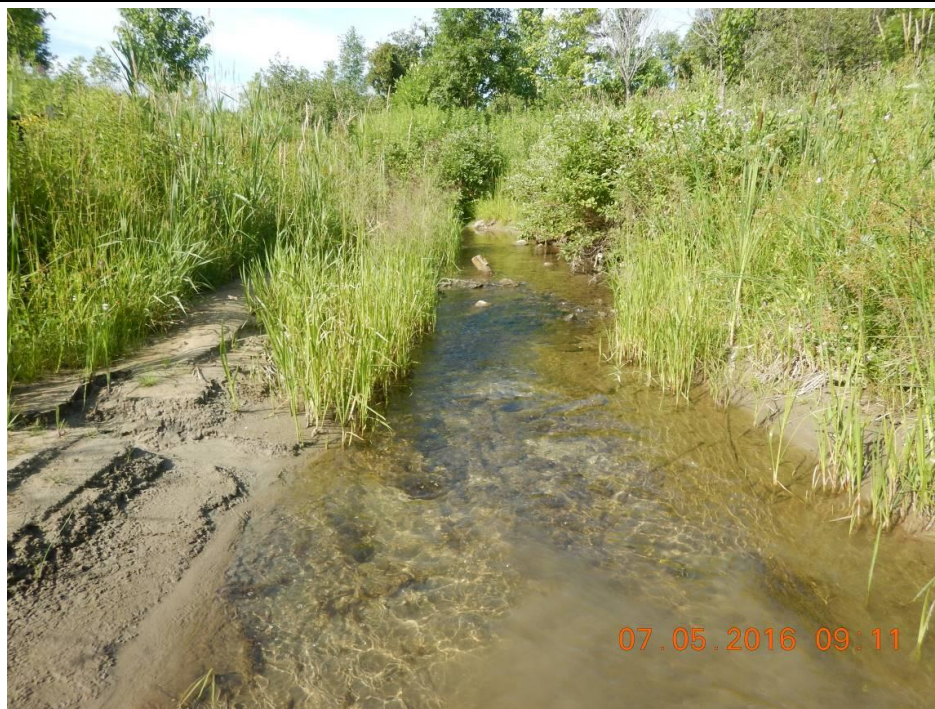
Photo  
2

Reach 1 – upstream facing upstream of new crossing; large sandy deposit with cut face on bank

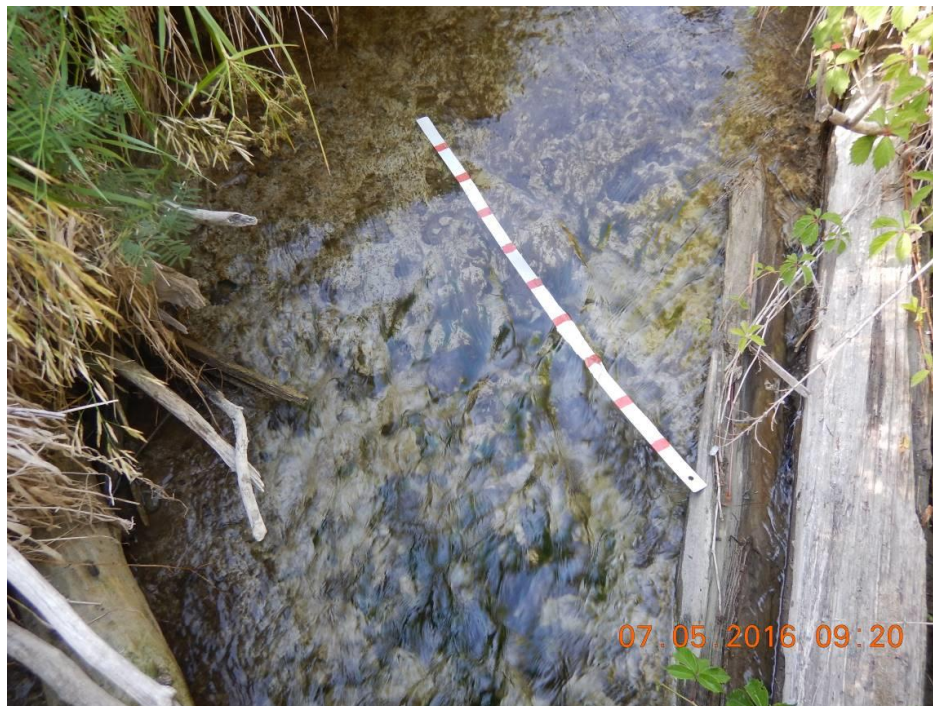
Photo  
3

Reach 2 – till on stream bed

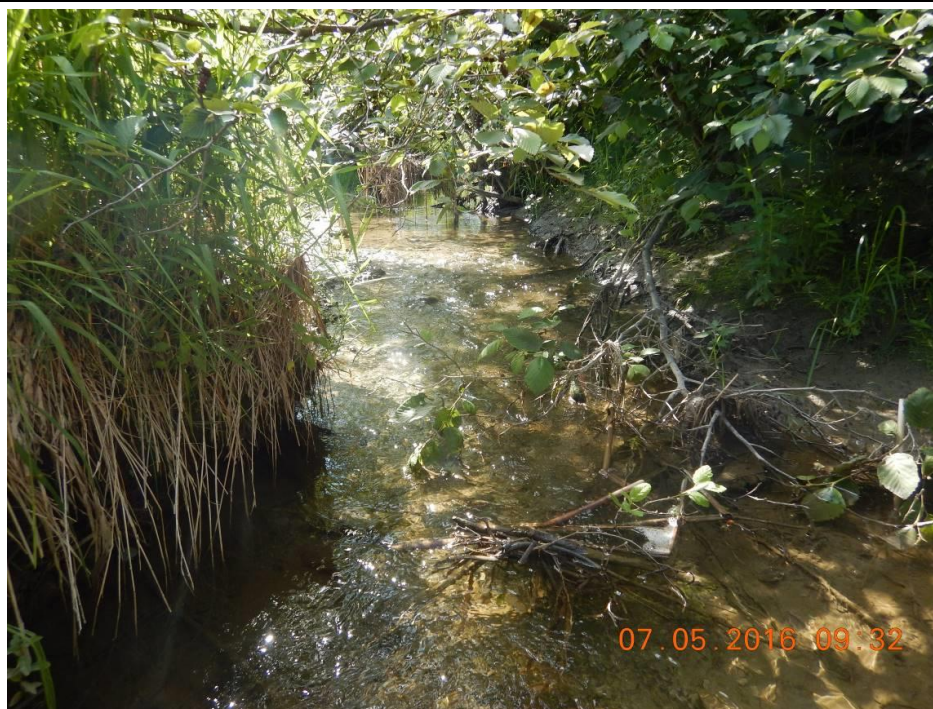
Photo  
4

Reach 2 – upstream facing – wooded section of reach; undercut banks, woody debris; riffle feature with cobbles; embedded cobbles at downstream end; sand on bank

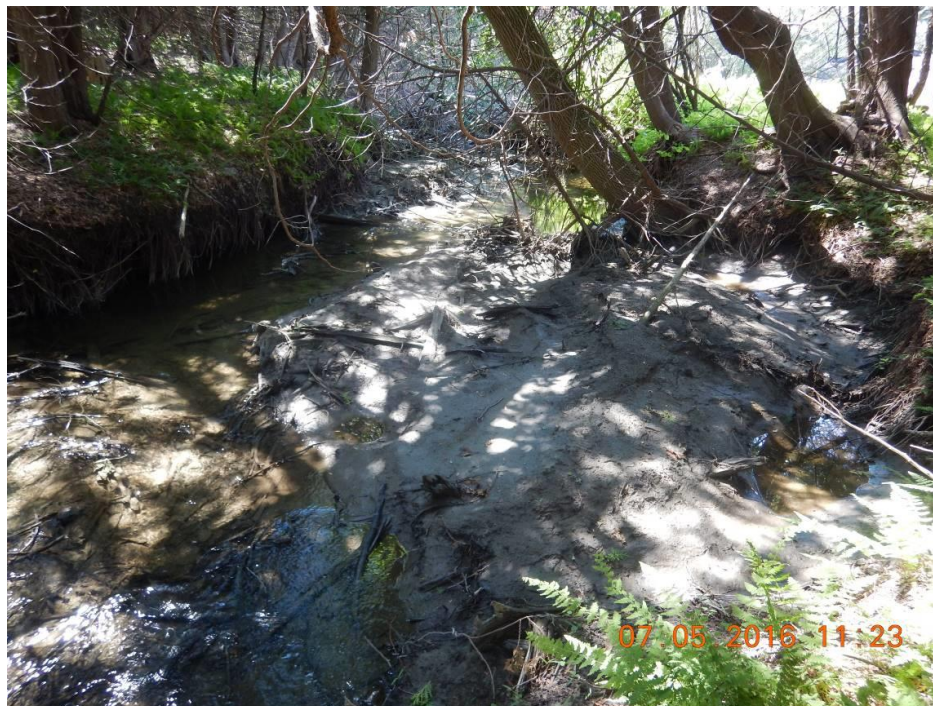
Photo  
5

Reach 3 – upstream facing downstream end of reach; large undercut, large sandy deposit, exposed tree roots and woody debris

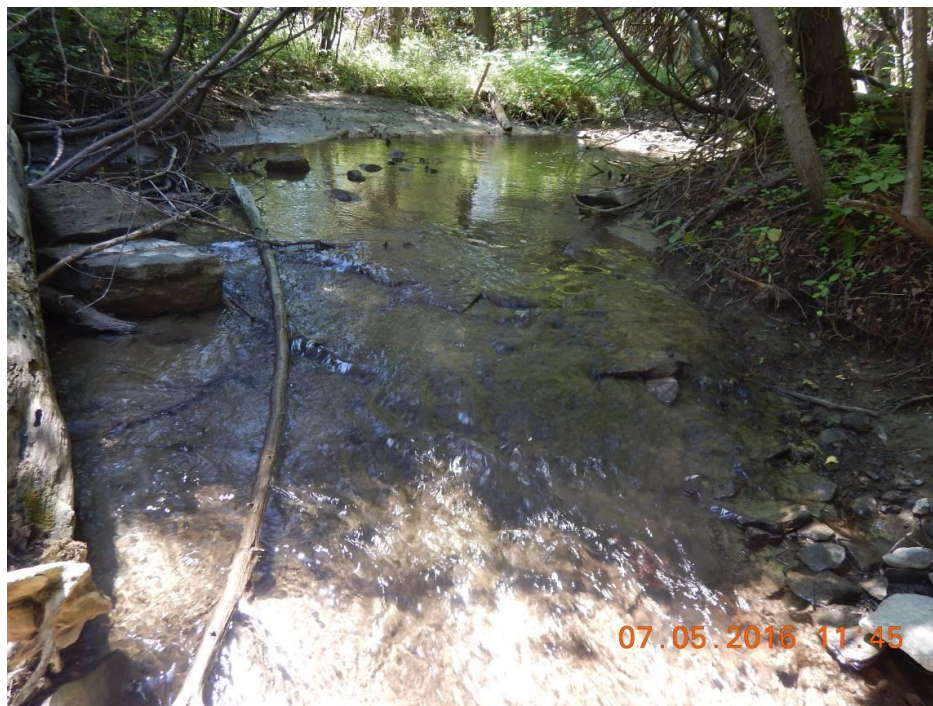
Photo  
6

Reach 3 – upstream facing at downstream end of reach; riffle over exposed bedrock on bed

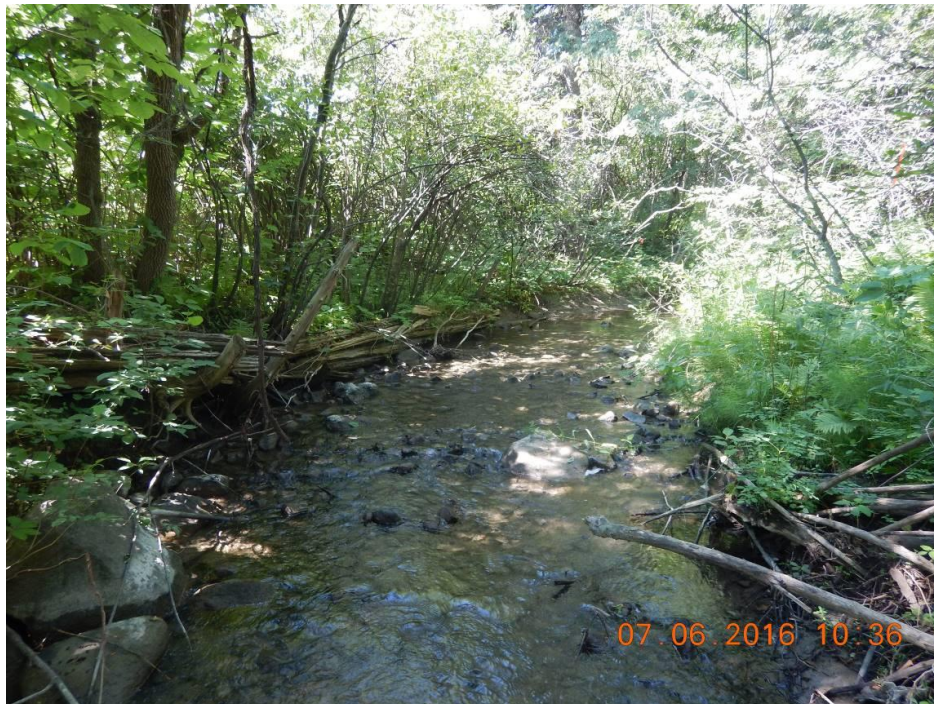
Photo  
7

Reach 3 – upstream facing at surveyed cross section 3 (mid-reach) - riffle feature; bed material mainly cobbles

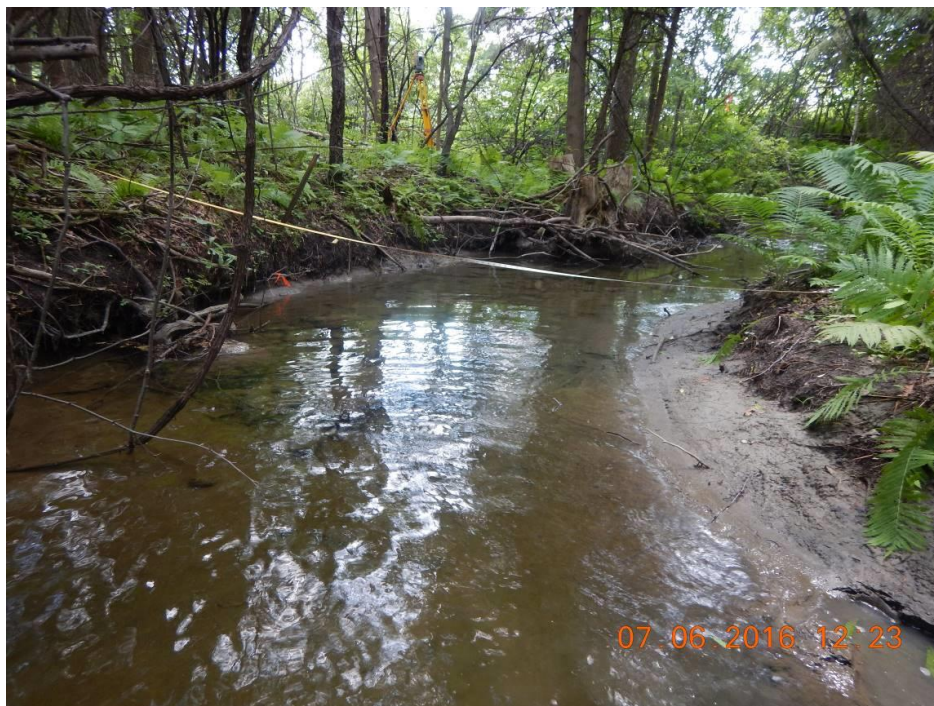
Photo  
8

Reach 3 – downstream facing at surveyed cross-section 5 (mid-reach) – pool feature; bed material clay to sand with embedded cobbles; sand on inner bank, undercut outer bank

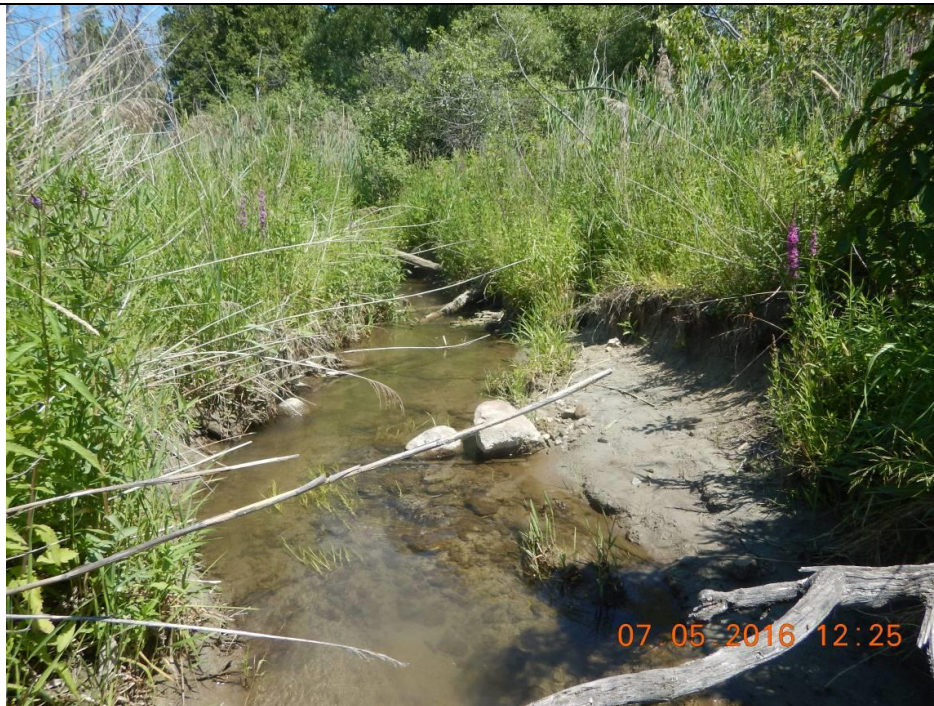
Photo  
9

Reach 4 - upstream facing; grassy undercut banks; silt to cobbles on bed

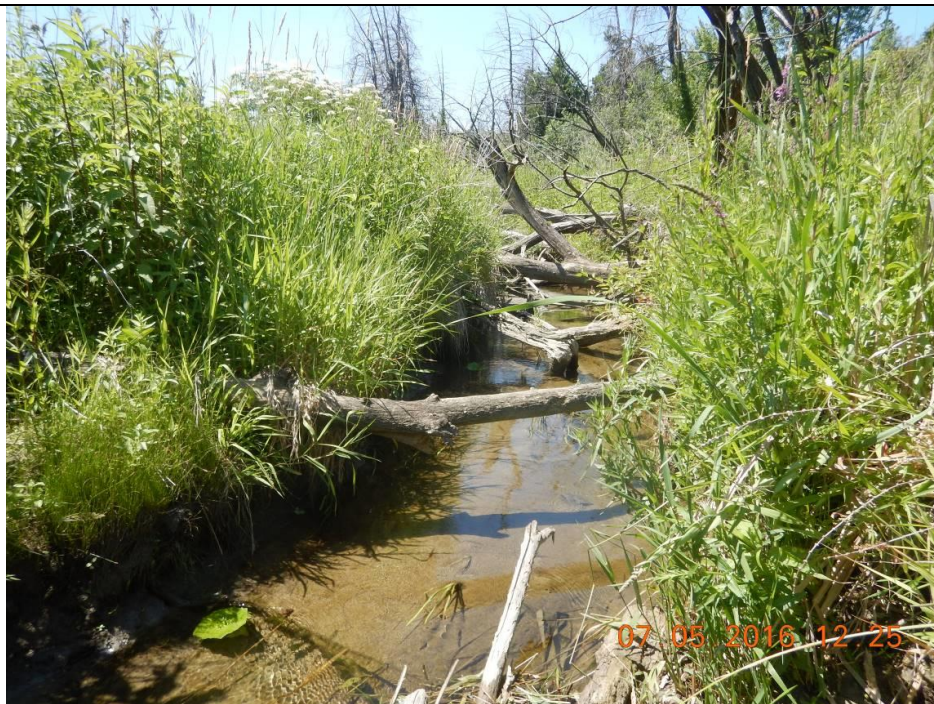
Photo  
10

Reach 4 - upstream facing; run feature with undercut banks and large woody debris; dead trees throughout floodplain

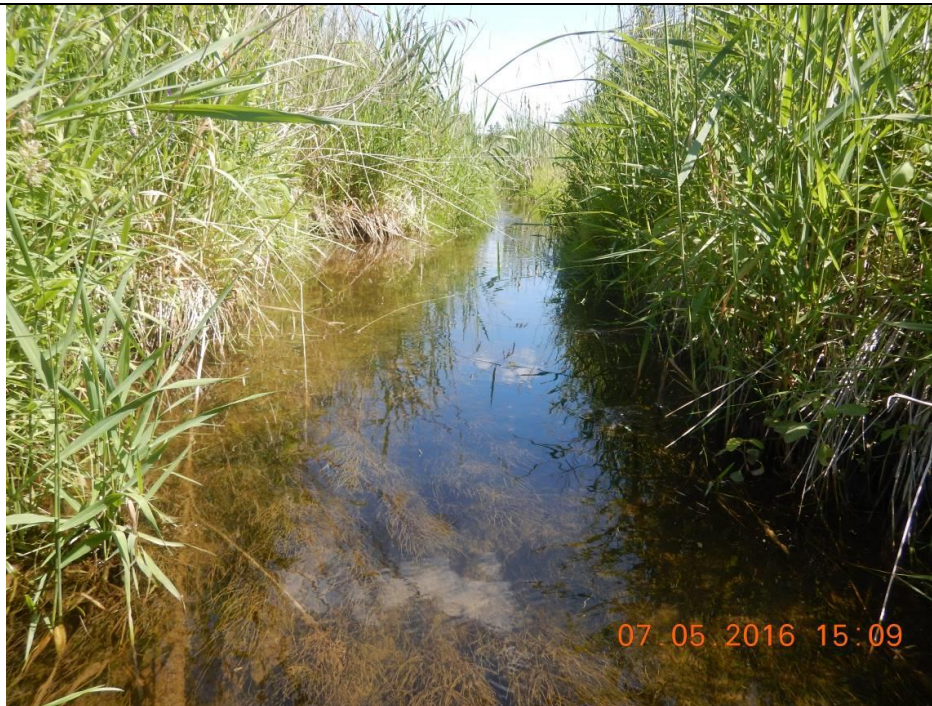
Photo  
11

Reach 5 - upstream facing; grassy undercut banks; run feature; clay to silt bed with rooted submergent vegetation

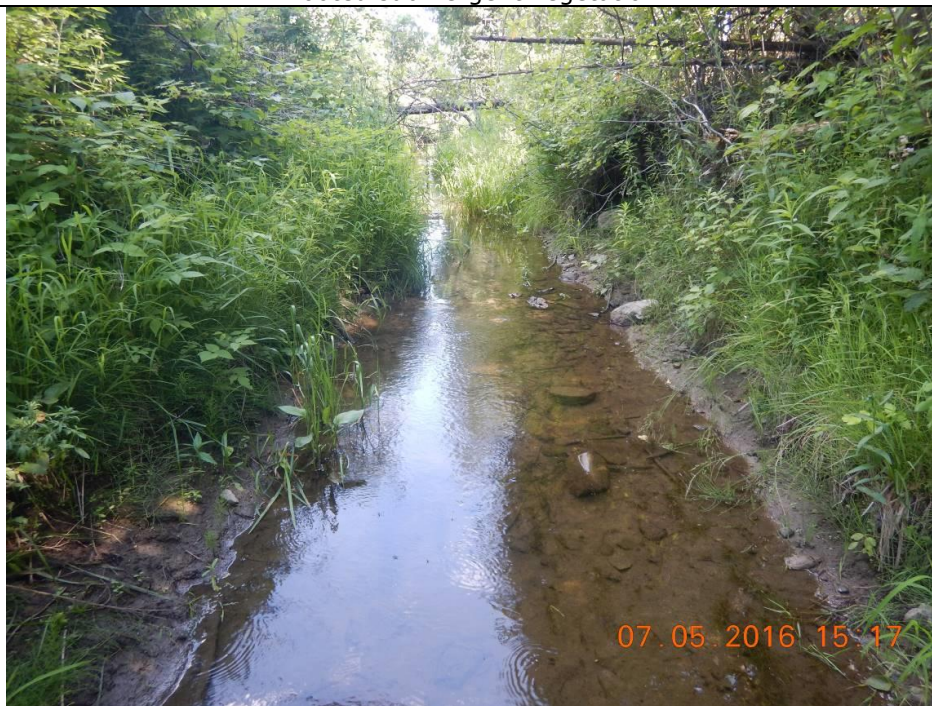
Photo  
12

Reach 5 - upstream facing in scrubby wooded section of reach showing bankfull dimensions and straight nature of reach; clay to cobble bed material, embeddedness

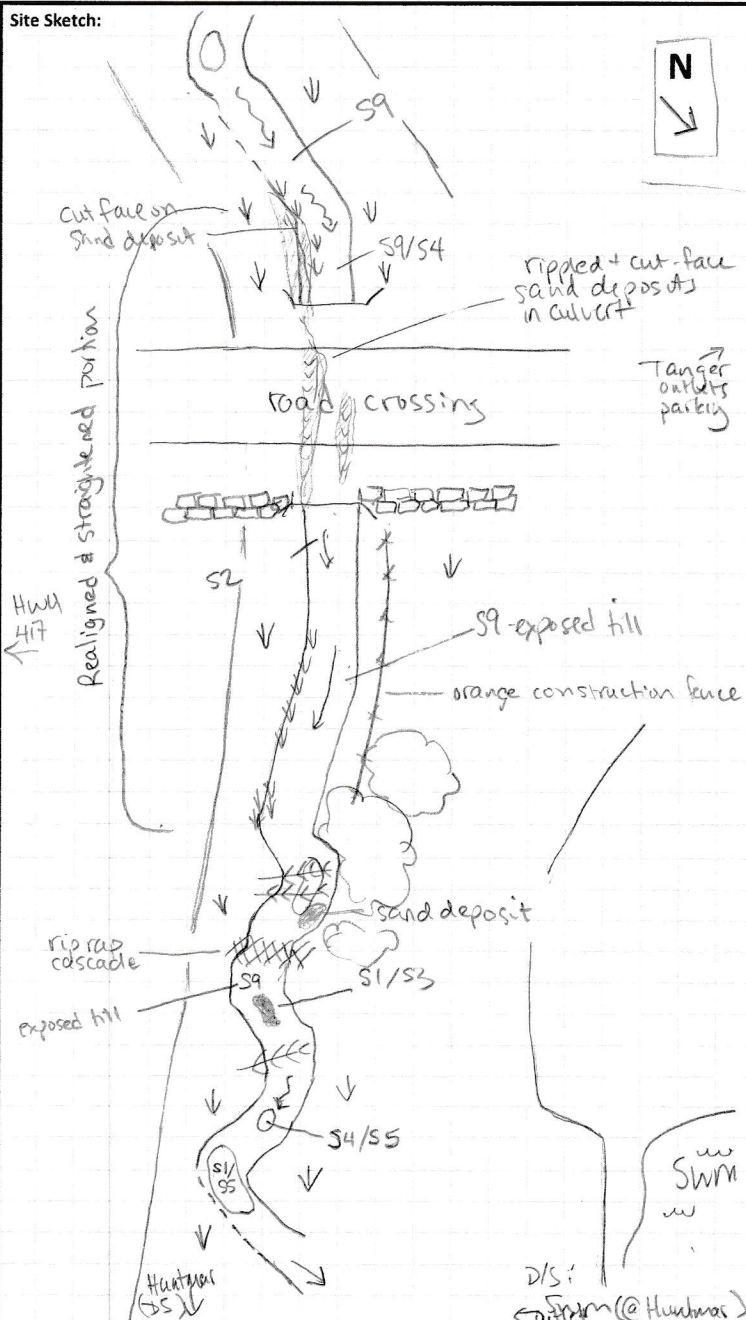
Additional notes: beaver cut wood in creek · Siltation in pools

Overbank sand deposits common

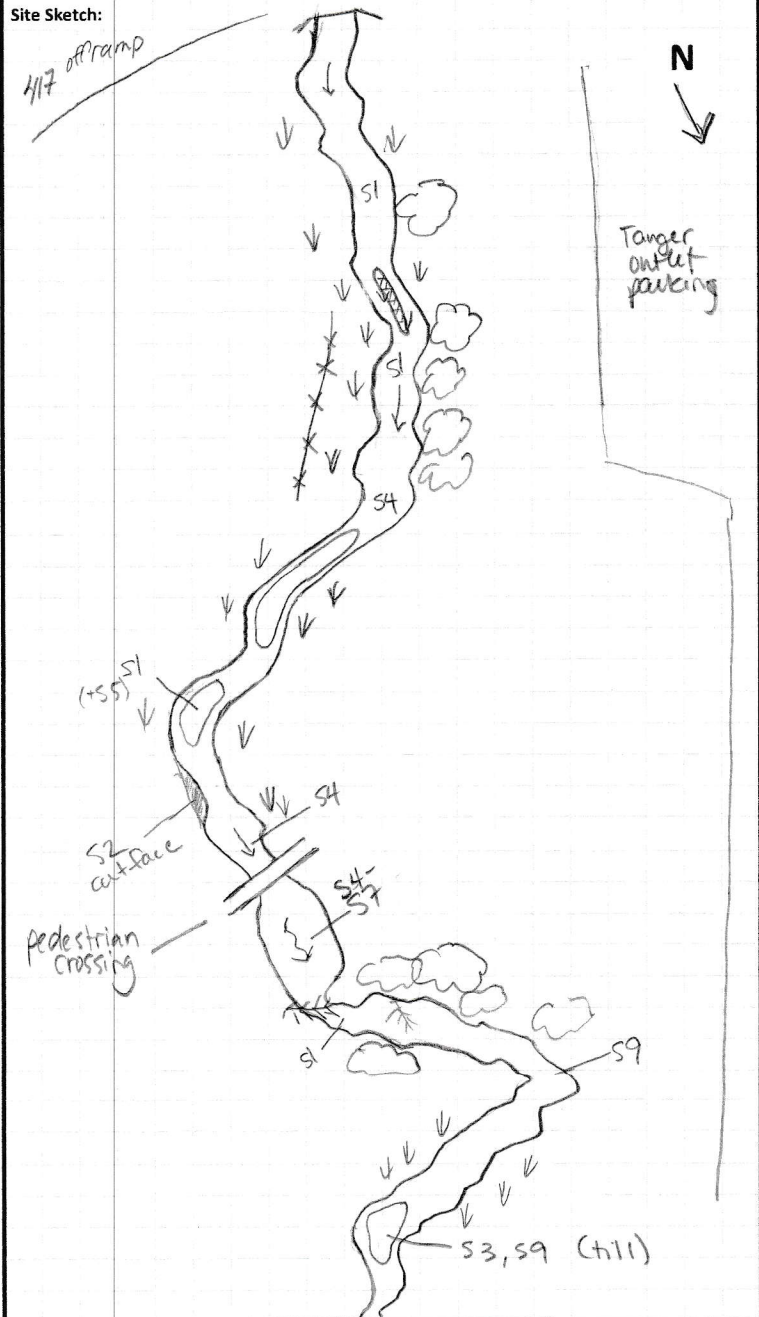
undercut along entire reach  
till exposed on bed extensively, esp through d/s end of reach

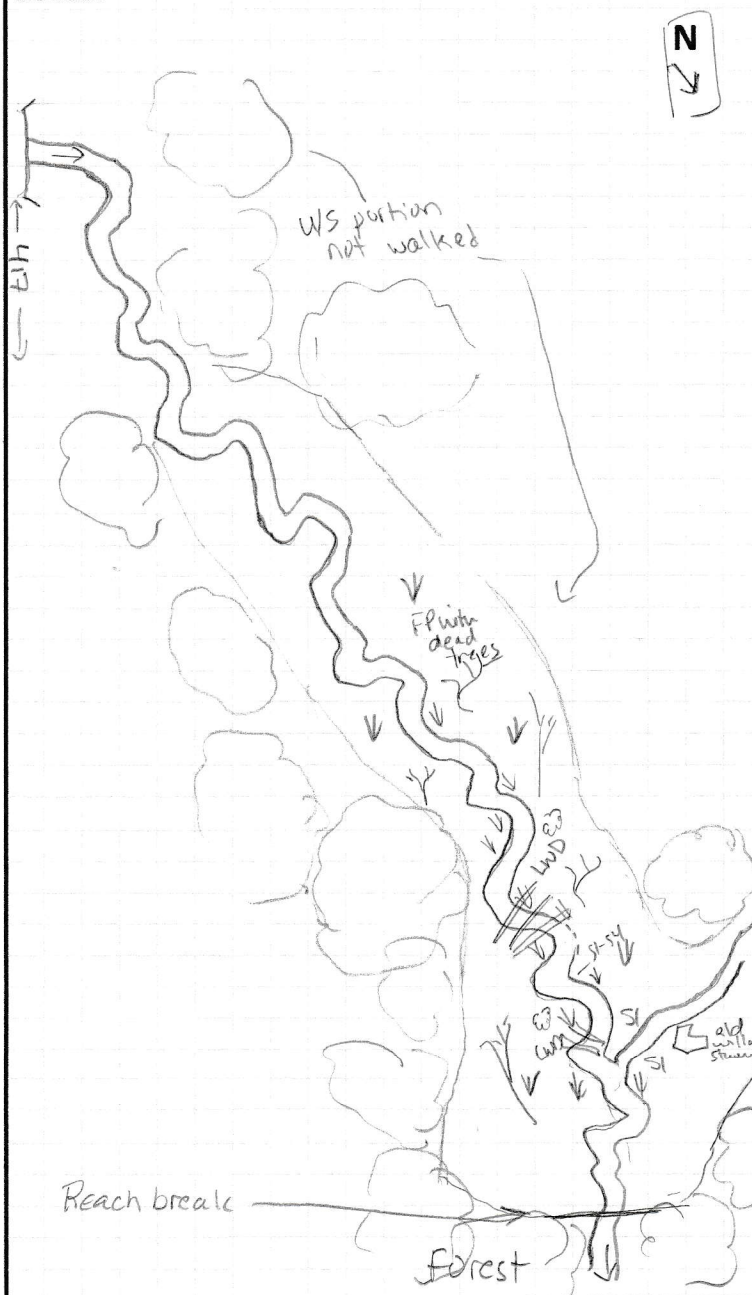
Additional notes: Tributary almost dry (source cut off)

Floodplain occupied by grasses, few shrubs and dead trees - Former Beaver dam @ d/s end of reach likely cause. Cedar forest d/s of reach and outside FP. WS extent not observed.

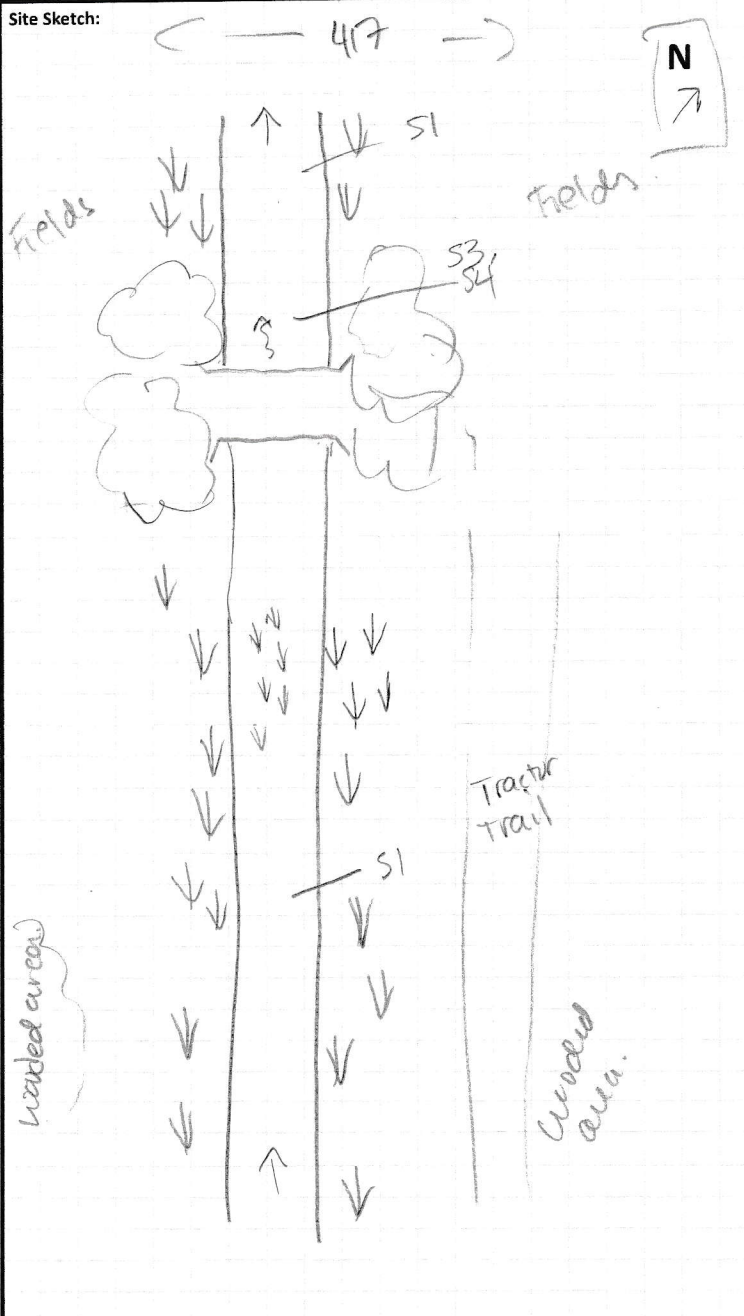
straightened channel  
more encroachment than d/s reaches
