January 26, 2010  
File: PG1887-LET.01R

Subject: **Slope Stability Analysis**  
**2175 Prince of Wales Drive**  
**Ottawa, Ontario**

NOVATECH ENGINEERING CONSULTANTS LTD.  
 SITE PLAN  
 DWG. NO. PG1887-1

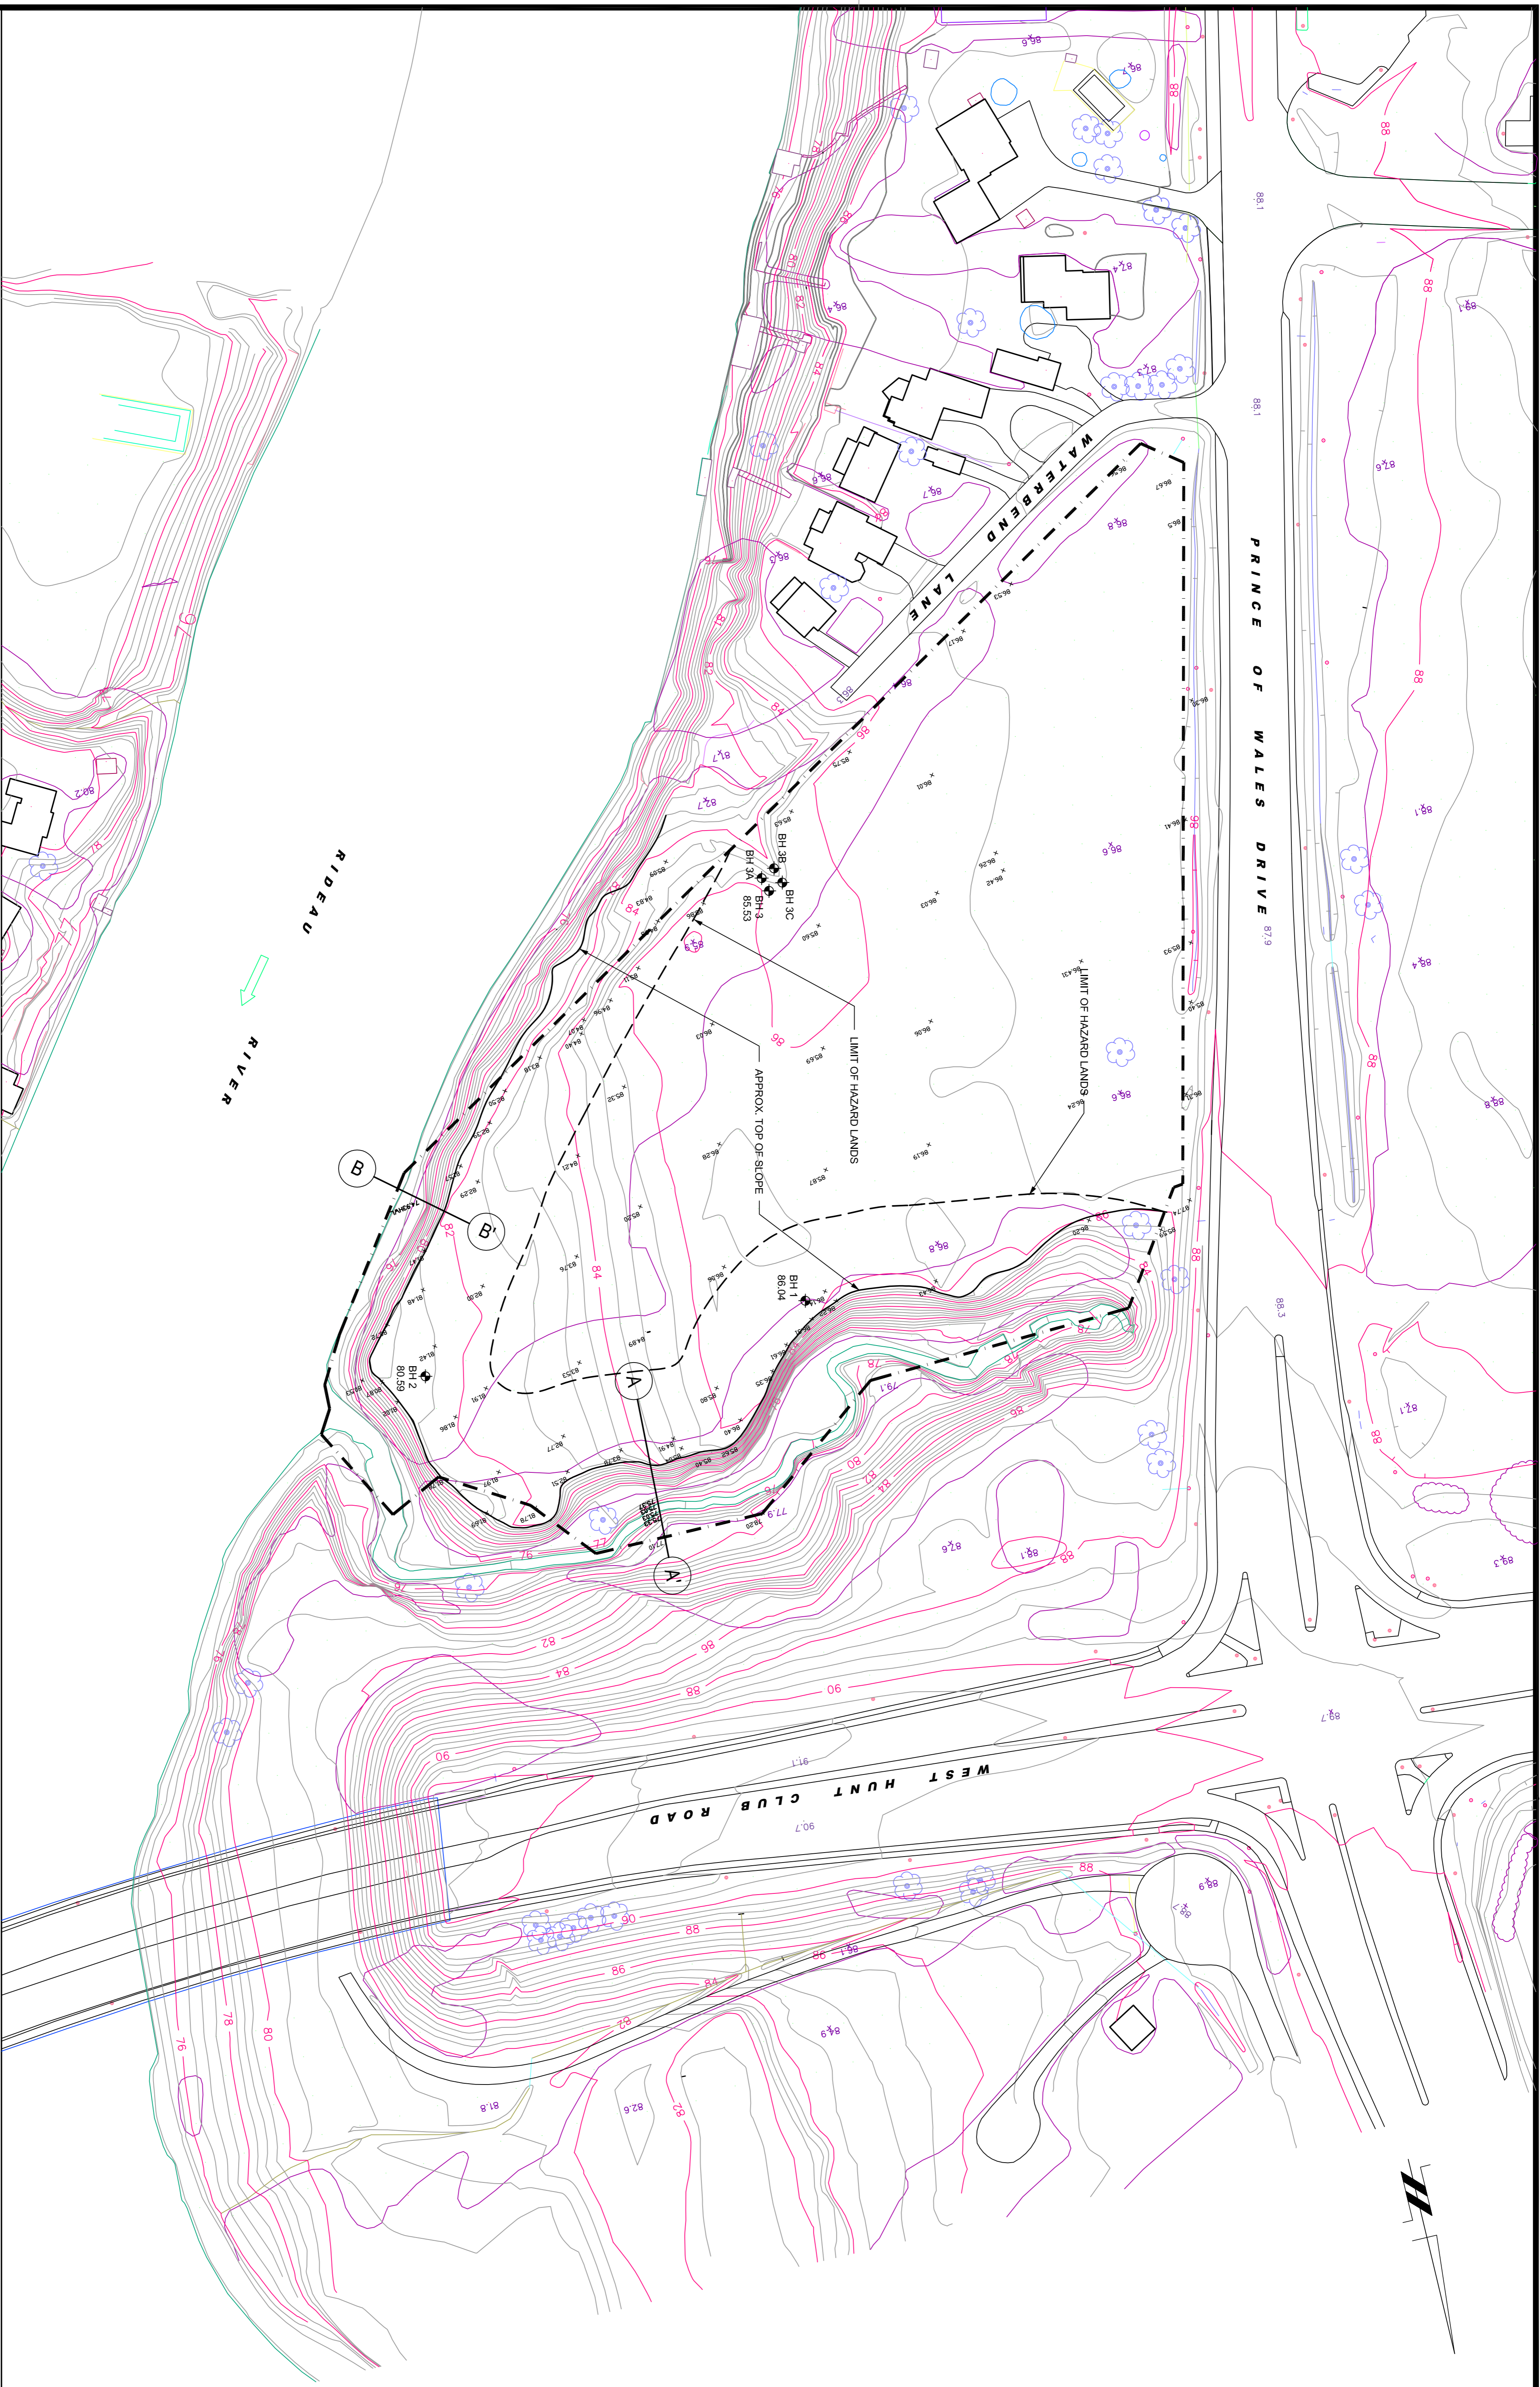
The limit of hazard lands includes a stable slope allowance taken from top of slope. The limit of hazard lands also includes a toe erosion and a 6 m erosion access allowance. The various allowances and the overall limit of hazard lands for the subject site are indicated on Drawing PG1887-1 - Site plan attached to the present letter.

The toe erosion allowance for the slopes was based on the nature of the soils, the observed current erosional activities and the width and location of the current watercourse. Signs of erosion were noted in areas where the existing watercourse has meandered in close proximity to the toe of the corridor wall of the north neighbouring tributary watercourse. It is considered that a toe erosion allowance of 5 m is appropriate for the tributary watercourse.

Some erosional activities were noted along the toe of the subject valley corridor wall for the Rideau River. It is considered that a toe erosion allowance of 8 m is appropriate for the subject slope along the Rideau River.

The existing vegetation on the slope face should not be removed as it contributes to the stability of the slope and reduces erosion. If the existing vegetation needs to be removed, it is recommended that 100 to 150 mm of topsoil mixed with a hardy seed or an erosional control blanket be placed across the exposed slope face.
