Our File Ref.: 160796

Subject: Slope Stability Analysis
6909 Notre Dame Street
Ottawa, Ontario

Project: Slope Stability – Proposed House

Site Location: 6909 Notre Dame Street, Ottawa ON

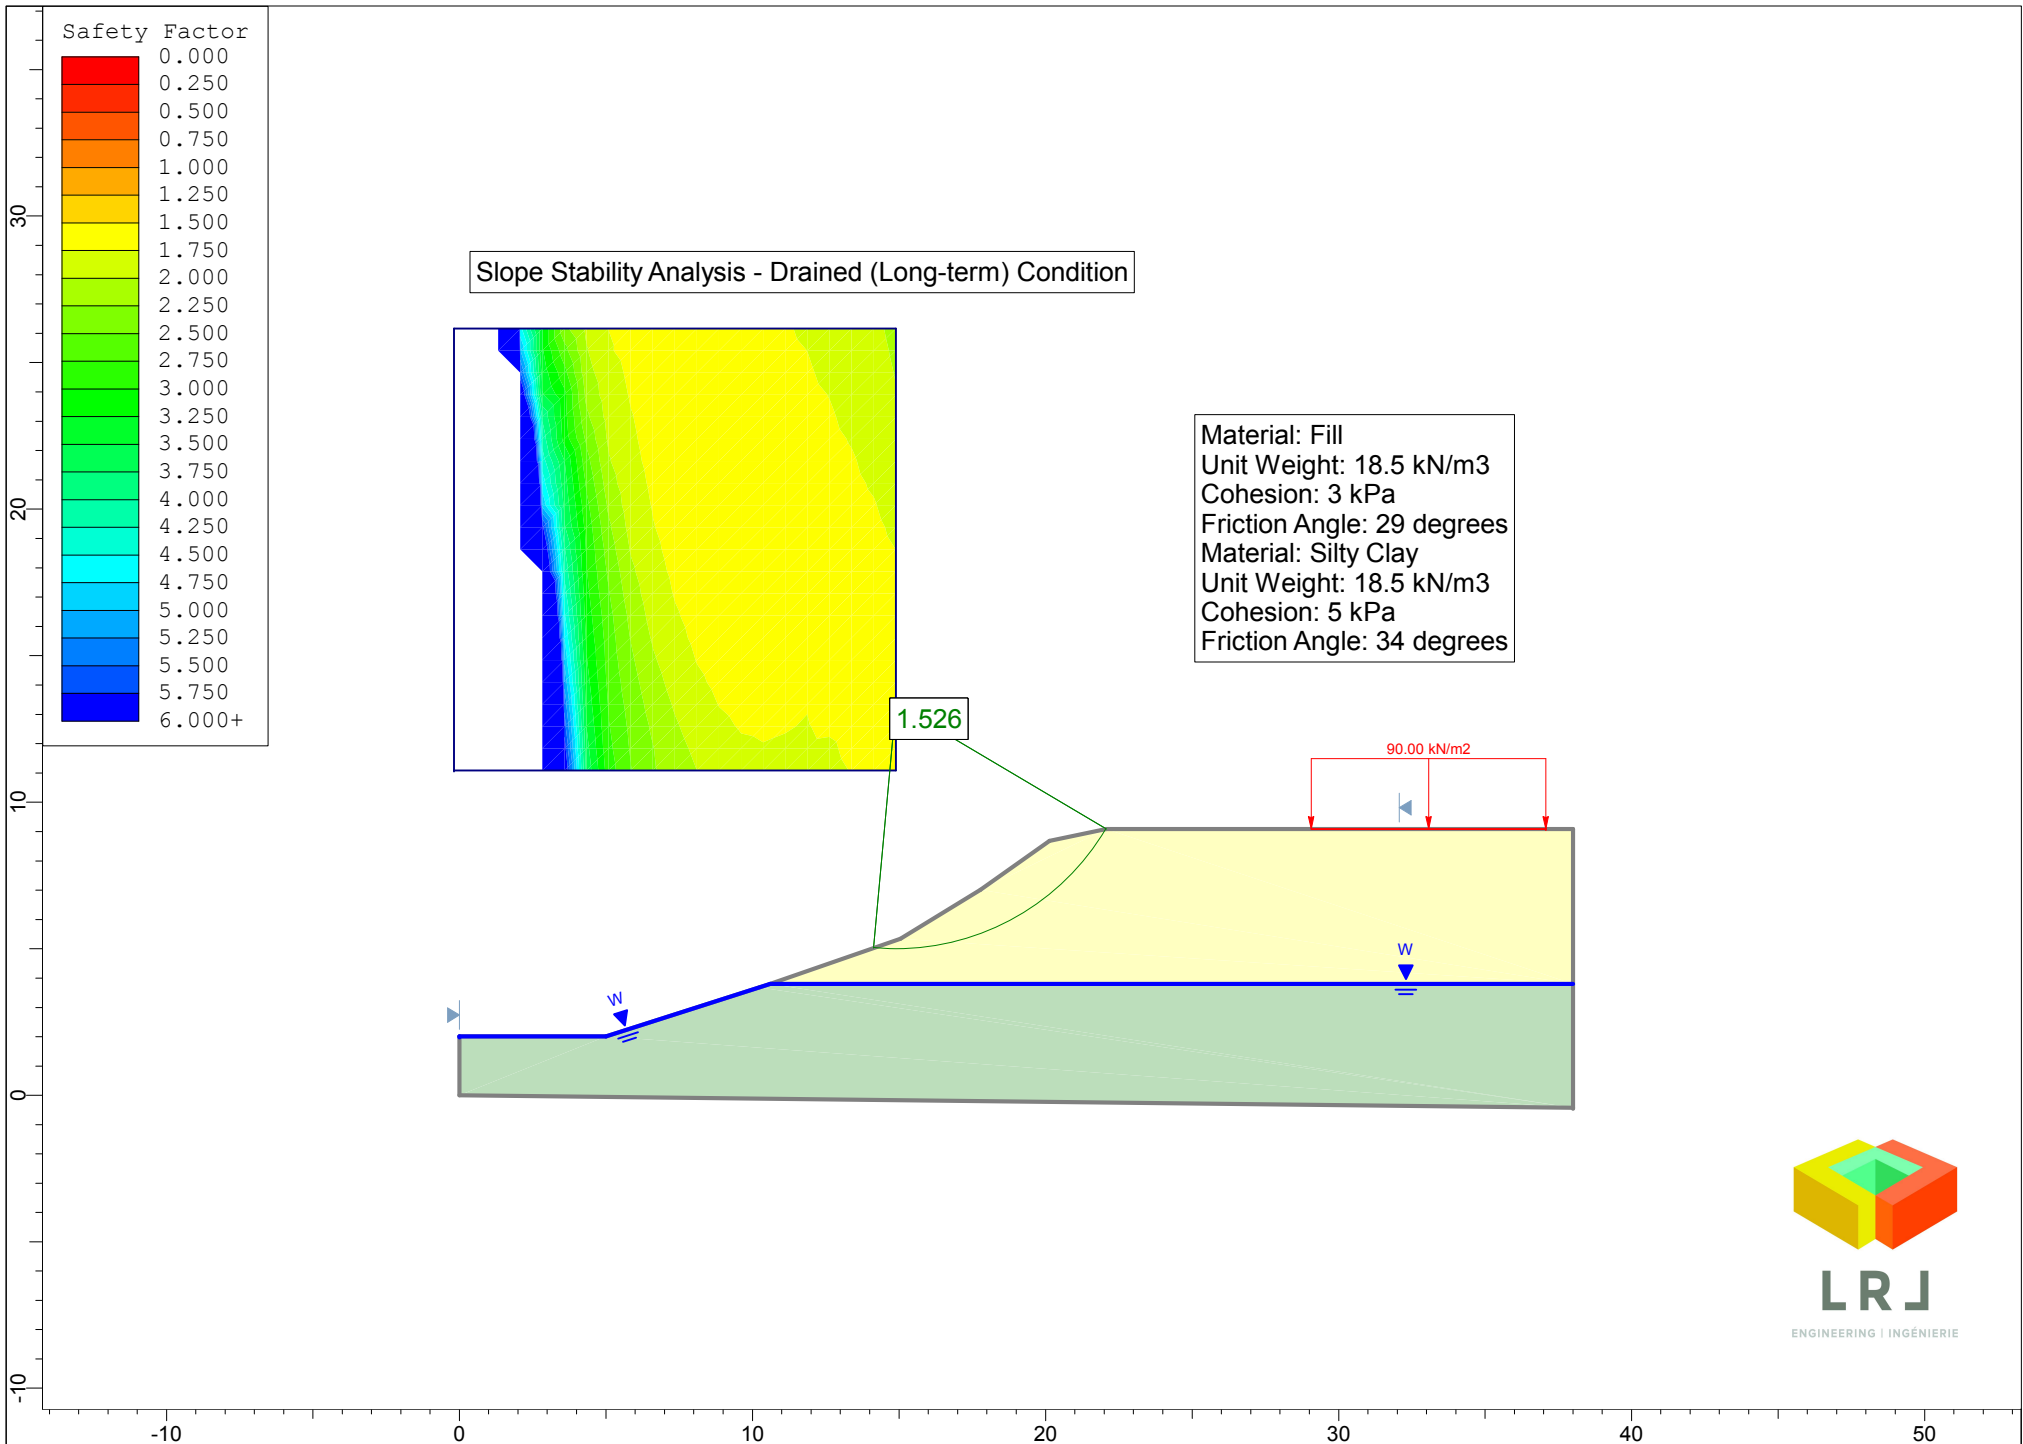
The factor of safety (FoS) against slope failure was ran for the undrained and drained condition. The FoS values obtained were 1.72 and 1.53 respectively. A FoS of 1.5 or greater is considered to be safe with regard to slope stability. The designed house load was not provided (design bearing pressure at serviceability limit state) during our field investigation. However a typical value assumed to be 90 kPa for similar type of residential construction was included within the model.

These results indicate that the current condition of the slope will remain stable for both the undrained condition (short-term) and drained condition (long-term).
