TREE CONSERVATION REPORT— 373 PRINCETON AVENUE

October 20, 2016

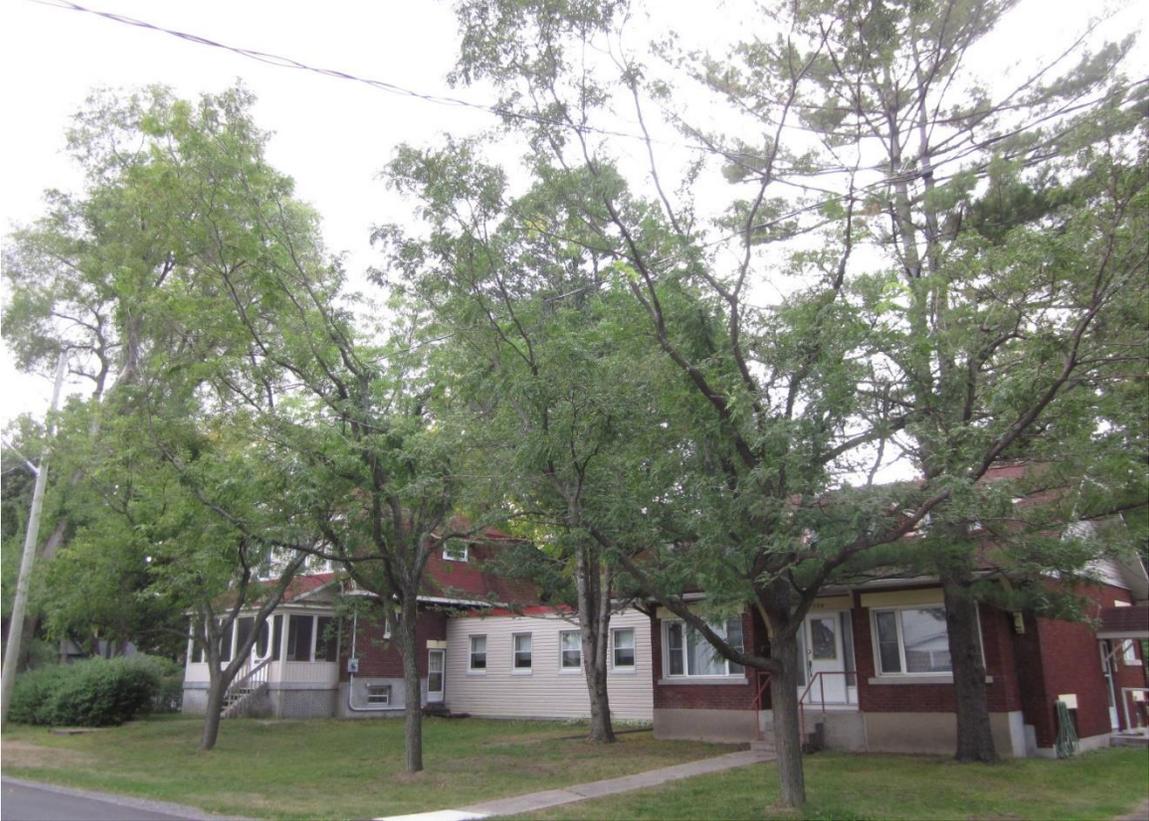
Tree No.	Tree Species	D.B.H (cm)	Ownership	Tree Condition Notes and Status (to be removed or retained)
1	Honey-locust (<i>Gleditsia triacanthos</i>)	30.6	City	Fair; heavily pruned from overhead wires by Hydro; to be retained and protected
2	White pine (<i>Pinus strobus</i>)	52.1	Private	Fair; co-dominant stems at 4.25m from grade - parallel; poor crown density and needle colour, fair growth increment; to be removed due to conflicts with development
3	Douglas-fir (<i>Pseudotsuga menziesii</i>)	41.2	Private	Fair; tri-stemmed at 2-2.25m from grade; both stems split again at 4-4.25m; broad crown; fair density, increment and colour; to be removed due to conflicts with development
4	Honey-locust	27.4	City	Fair; heavily pruned from overhead wires by Hydro; to be retained and protected
5	Honey-locust	31.0	City	Fair; heavily pruned from overhead wires by Hydro; to be retained and protected
6	Siberian elm (<i>Ulmus pumila</i>)	58.0	Private	Poor; crown heavily asymmetrical due to Hydro pruning; weak-wooded, invasive species; recommended for removal

Picture 1. Trees 1 through 5 at 373 Princeton Ave.

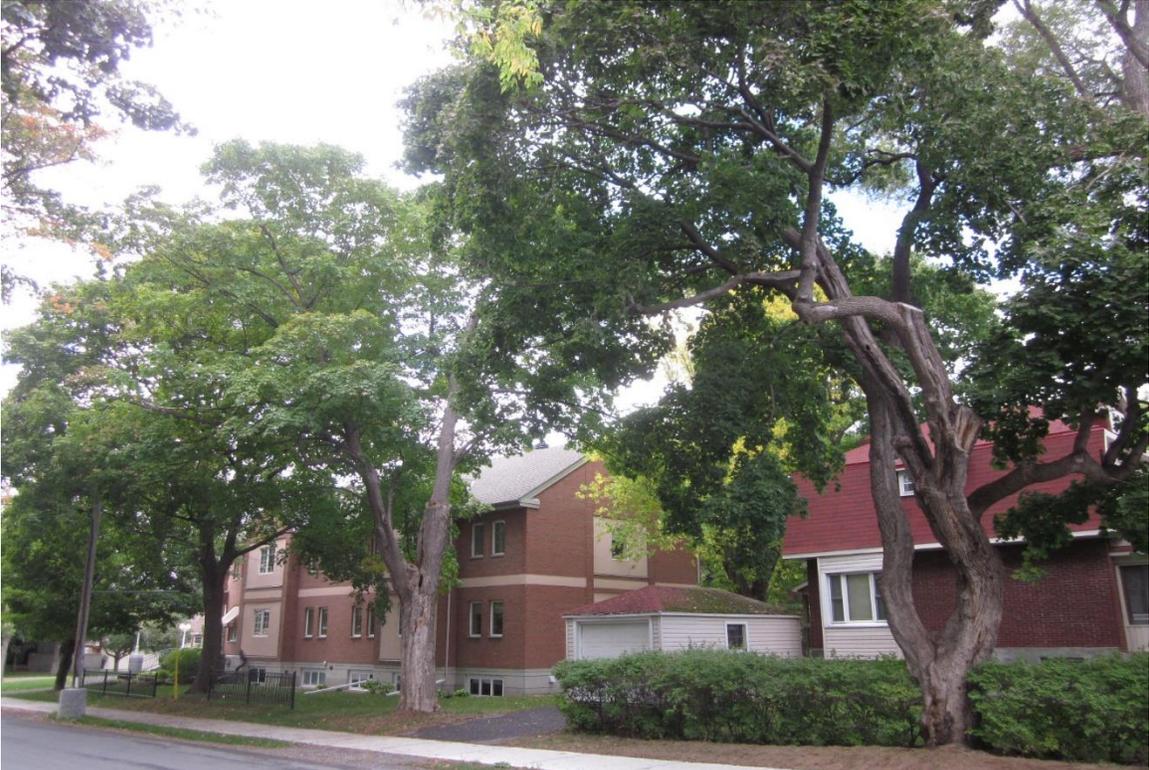
7	Siberian elm	80.5	Private	Very poor; crown heavily asymmetrical due to Hydro pruning; weak-wooded, invasive species; root plate partially lifted out of ground – potentially hazardous; recommended for removal
8	Norway maple (<i>Acer platanoides</i>)	81.6	Private	Poor; very mature (senescent); co-dominant stems at 1.75m; ribs of reaction wood and cavities in both stems; invasive species; to be removed due to pre-existing poor condition
9	Sugar maple (<i>Acer saccharum</i>)	79.4	Private	Very poor; co-dominant stems at 3.5m with major cavity at union (expanding foam present); basal decay due to past root damage/death – hazardous; to be removed due to pre-existing poor condition

Tree No.	Tree Species	D.B.H (cm)	Ownership	Tree Condition Notes and Status (to be removed or retained)
10	Norway maple	62.0	Private	Good; co-dominant stems at 4m with strong union; early Eutypella canker (<i>Eutypella parasitica</i>) present on north side of main stem at 4m; good root collar-binding roots present; invasive species; not affected by construction
11	Sugar maple	40.5	Private	Very good; central stem; dense crown; raised grade at base; moderate mower damage; not affected by construction
12	Manitoba maple (<i>Acer negundo</i>)	56.2	City	Poor; co-dominant stems at 4m – both leaning heavily over intersection; pockets of decay in both stems – potentially hazardous; not affected by construction
13	Siberian elm	44.5	City	Poor; crown completely asymmetrical due to previous tree to east; weak-wooded, invasive species; slime flux present in old pruning wounds; not affected by construction
14	Emerald cedars (<i>Thuja</i> spp.)	24.7 (avg.)	Private	Fair; four trees planted in a line; three are suffering from basal wounds due to root damage; not affected by construction

Picture 2. Trees 8, 9 and 10 at 373 Princeton Ave.

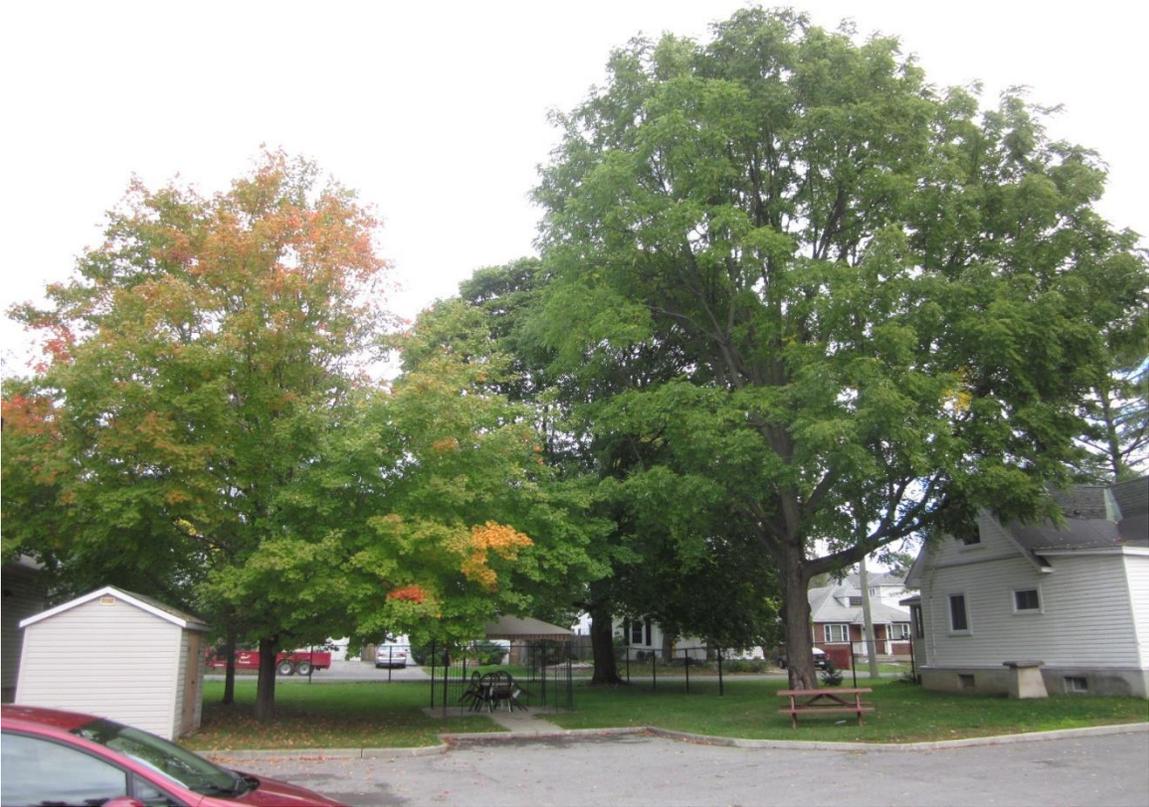
33	Sugar maple	35.6	Private	Good; central stem with multiple competing laterals; broad crown; to be removed due to conflicts with development
34	Black walnut (<i>Juglans nigra</i>)	74.8	Private	Poor; primary union at 1.5m; major stem wound on north side at and below primary union - future entry point for decay; basal cavity with decay now present; multiple wounds in lateral stem towards west; to be removed due to pre-existing poor condition
35	Norway spruce	46.3	Private	Fair; mature tree; fair density, increment and colour; to be retained and protected
36	Norway spruce	43.4	Private	Fair; mature tree; fair density, increment and colour; to be retained and protected

Picture 3. Trees 31 (background), 33 and 34 at 373 Princeton Ave.

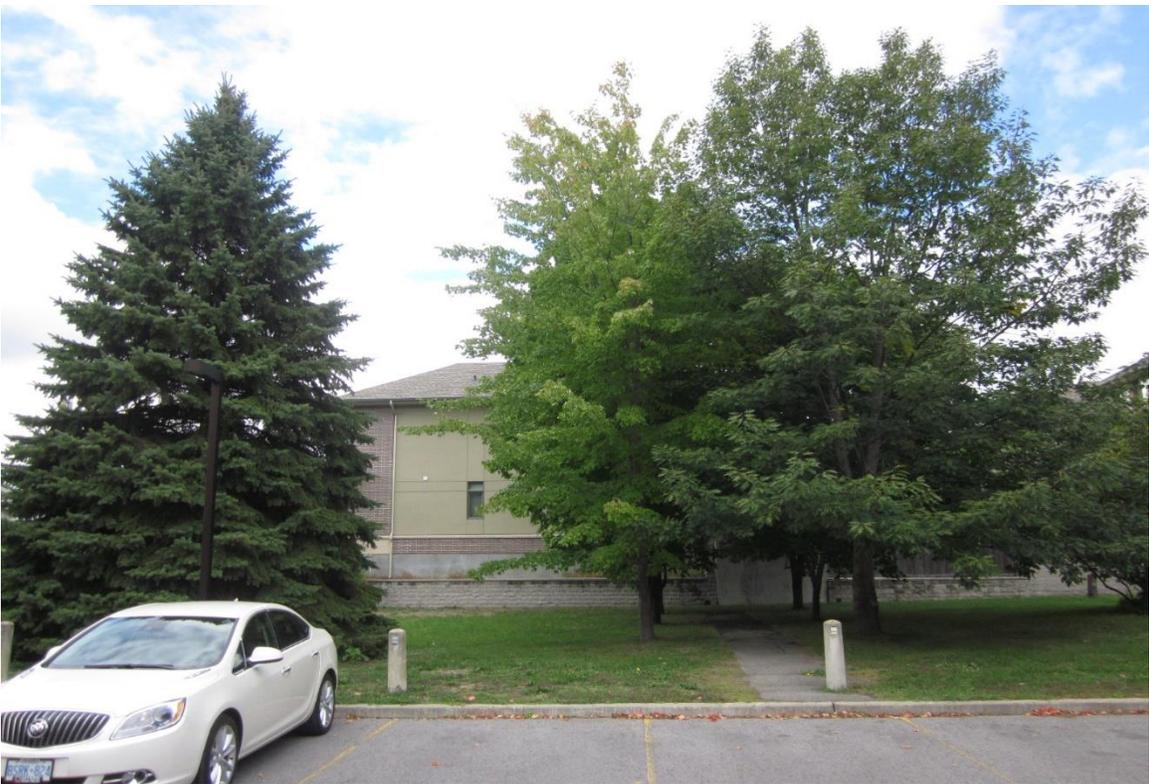
24	Freeman maple (<i>Acer x freemanii</i>)	23.8	Private	Good; co-dominant stems at 0.6m with moderately weak union; to be removed due to conflicts with development
25	Sugar maple	29.2	Private	Good; co-dominant stems at 0.75m, larger stem splits again at 1.75m – both with weak unions (reaction wood present); to be removed due to conflicts with development
26	Sugar maple	25.3	Private	Very good; central, dominant stem; to be removed due to conflicts with development
27	Red oak (<i>Quercus rubra</i>)	37.7	Private	Good; co-dominant stems at 2.5m with weak union (included bark); frost crack on southeast side of main stem - grade to 2.25m; to be removed due to conflicts with development

Picture 4. Trees 23, 24 and 27 at 373 Princeton Ave.

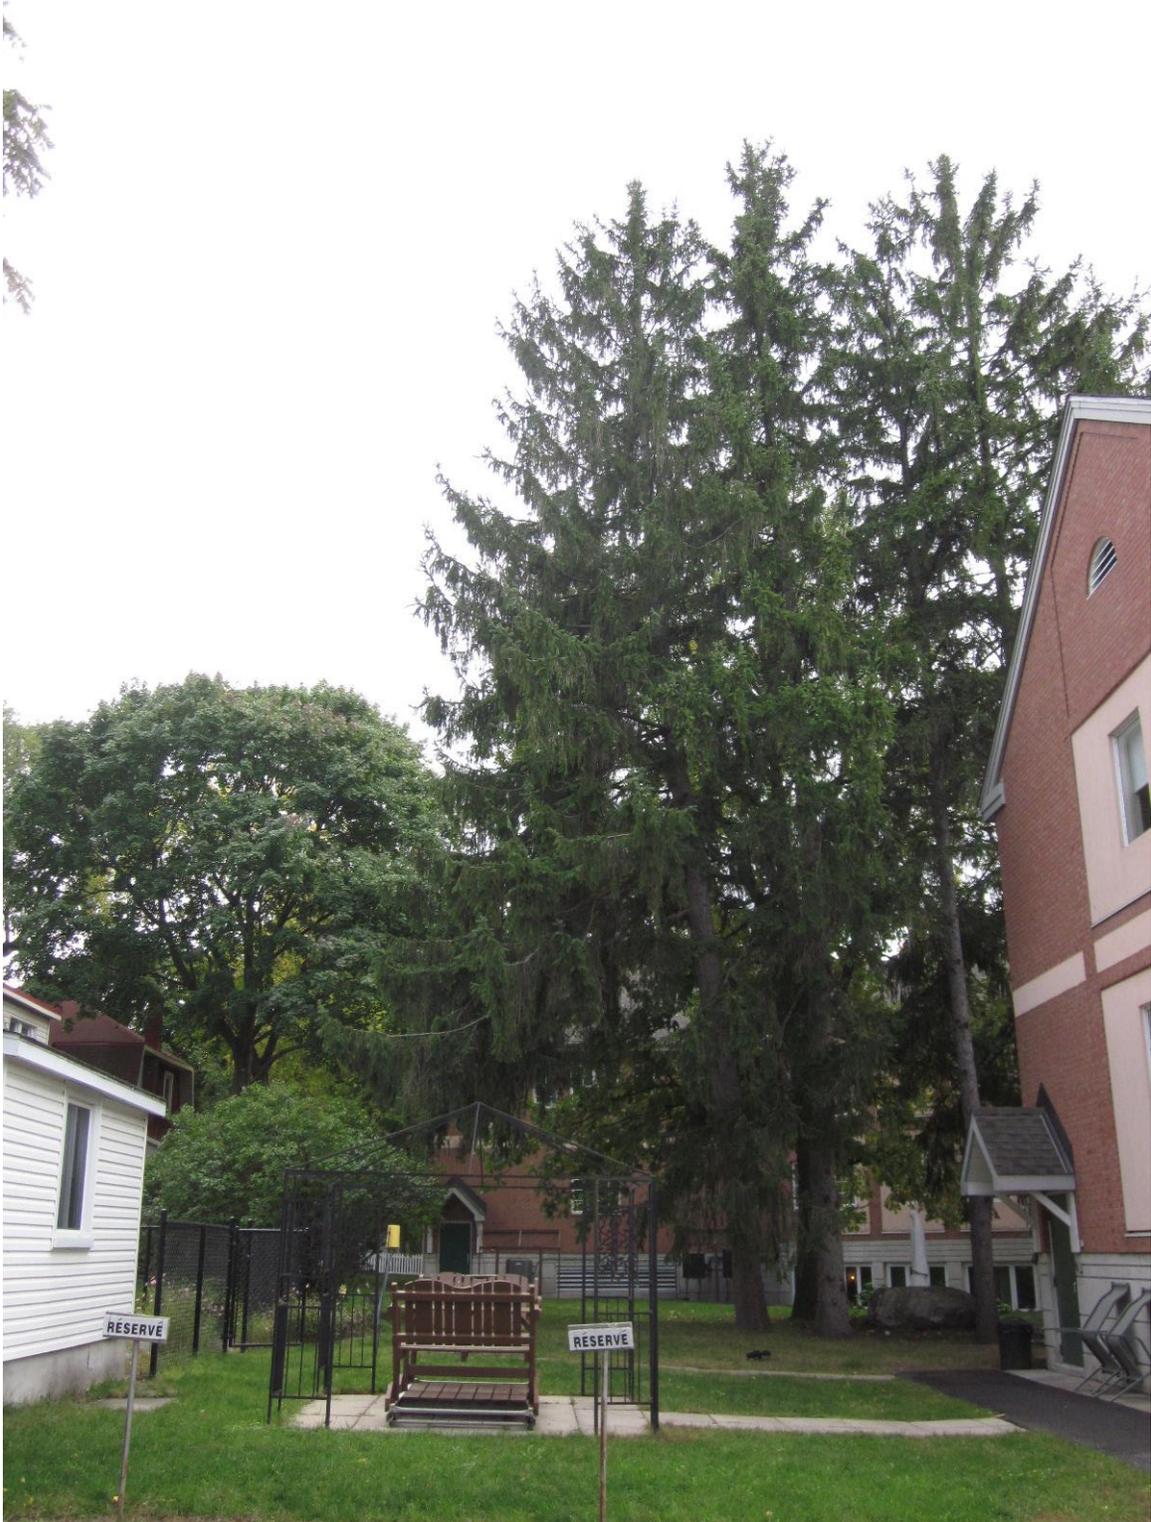
Tree No.	Tree Species	D.B.H (cm)	Ownership	Tree Condition Notes and Status (to be removed or retained)
37	Norway spruce	32.5	Private	Fair; mature tree; fair density, increment and colour; to be retained and protected
38	Norway spruce	40.2	Private	Fair; mature tree; fair density, increment and colour; to be retained and protected
39	Norway spruce	44.2	Private	Fair; mature tree; fair density, increment and colour; to be retained and protected
40	Bur oak (<i>Quercus macrocarpa</i>)	61.0	Private	Good; crown asymmetrical due to competition with line of spruce trees towards north; to be retained and protected
41	Norway maple	59.5	Private	Good; central dominant stem; generally symmetrical crown; invasive species; to be retained and protected
42	Manitoba maple	66.1	Private	Very poor; co-dominant stems at 3.25m – divergent; one stem topped to create clearance from roof, other stem growing towards tree #41; fair root collar; to be removed due to pre-existing poor condition

Picture 5. Trees 41 (far left) and 35 through 38 (top half only showing) at 373 Princeton Ave.
