**WILSON COWAN DRAIN FLUVIAL GEOMORPHIC EXISTING CONDITIONS
MINTO MAHOGANY, MANOTICK**

156380-25016-504

Report Prepared for:
MINTO COMMUNITIES INC.

Prepared by:
MATRIX SOLUTIONS INC.

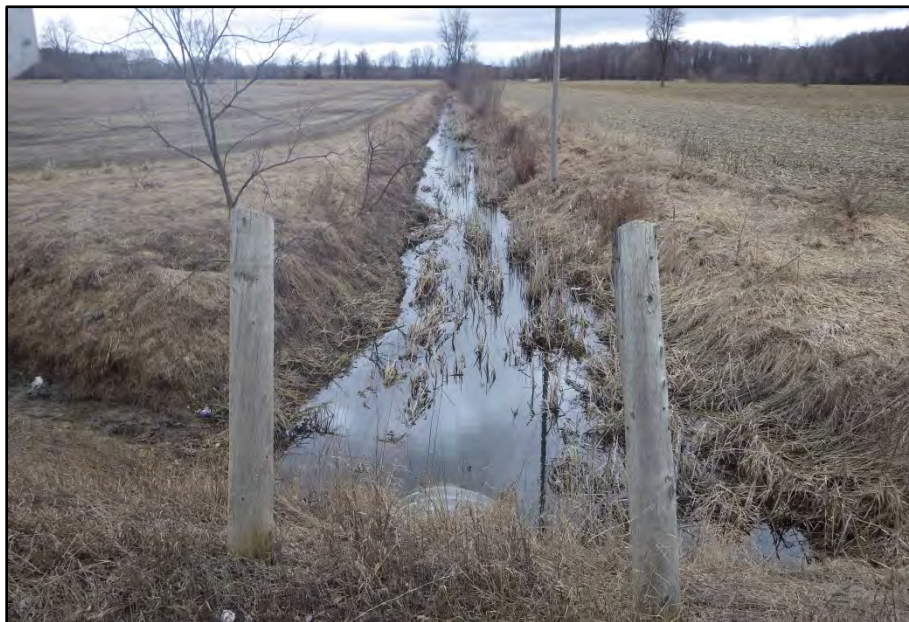
1. WCD-R1: View looking downstream from Century Road. Agricultural fields on both sides of drain. Note presence of instream vegetation.

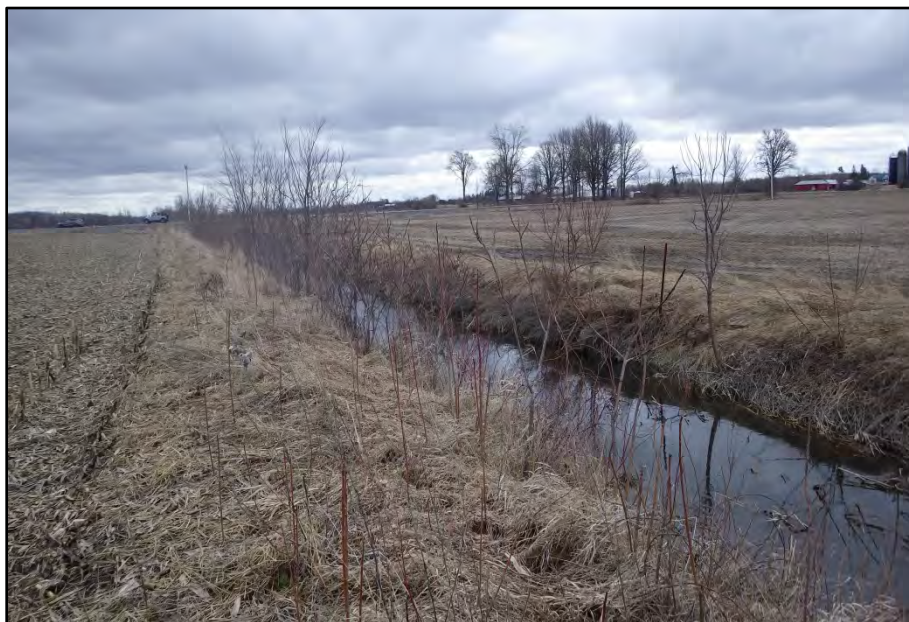
2. WCD-R1: View looking upstream towards Century Road. Riparian zone consists of tall grasses and intermittent shrubs.

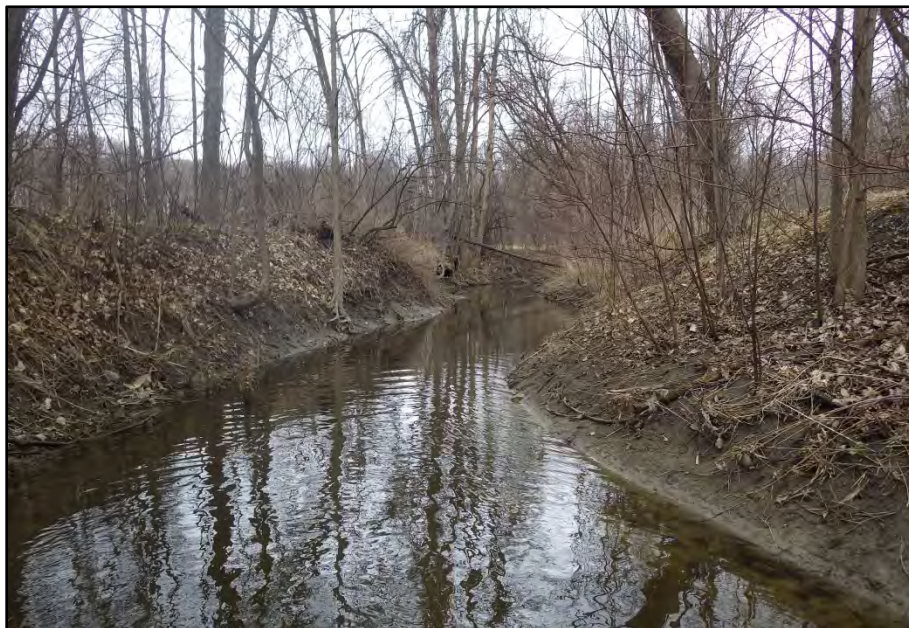
3. WCD-R2: View looking downstream. Riparian zone consists of deciduous trees and grasses. Note the lack of vegetation along both bank toes.

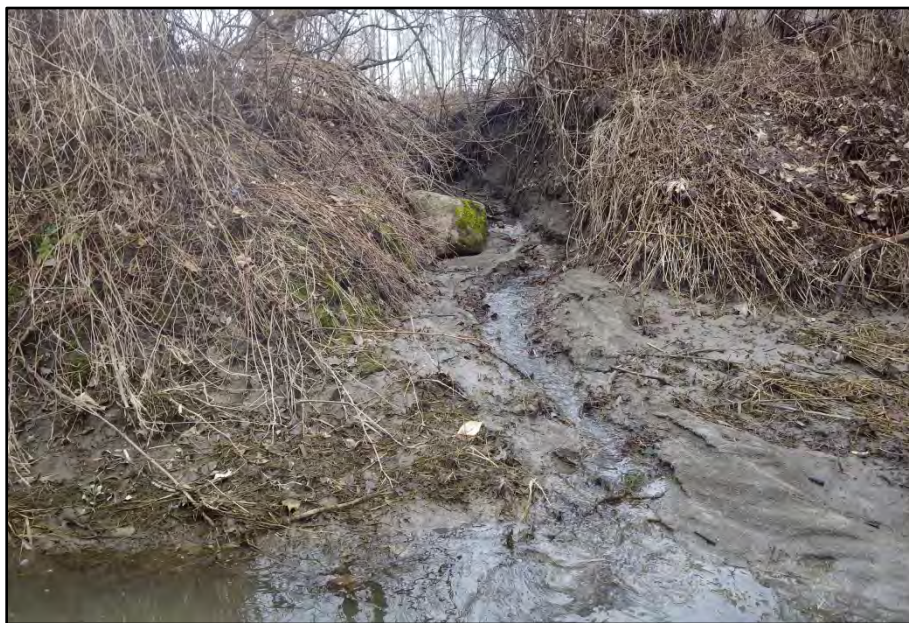
Field observations of channel process noted that both channels exhibited depositional characteristics, with significant sediment inputs from surrounding agricultural lands. In low lying areas, gullying was present along channel banks where sediment heavy surface runoff from agricultural fields has caused the slope failures. These gullies provide significant sediment sources that make up the majority of the bed material through the site, especially in the main branch of the Wilson Cowan Drain. The channel showed no signs of active erosion.

4. WCD-R2: Gully formation originating from agricultural field resulting in sandy depositional feature.

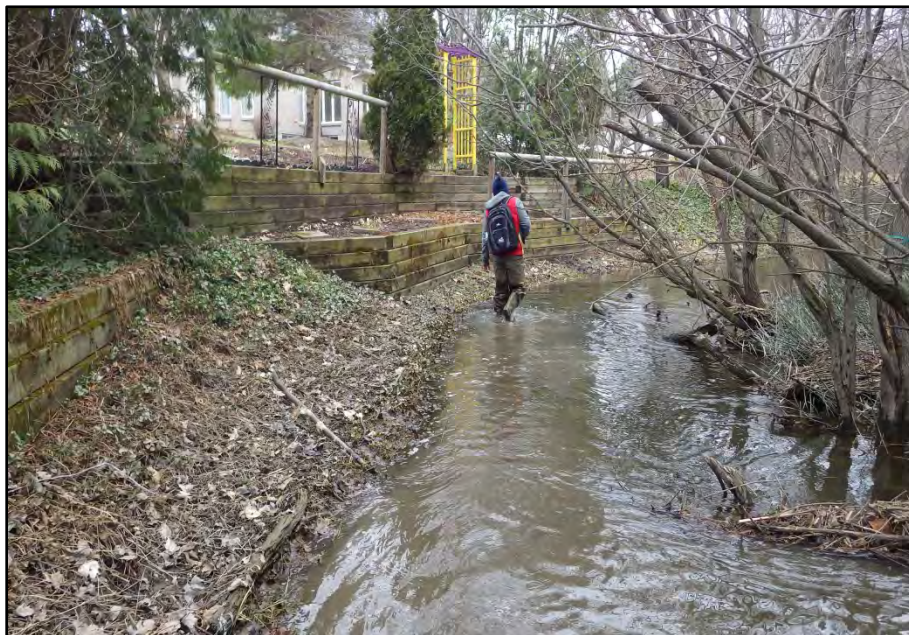
5. WCD-R2: Wooden retaining wall behind houses along Watterson St. No active erosion observed.

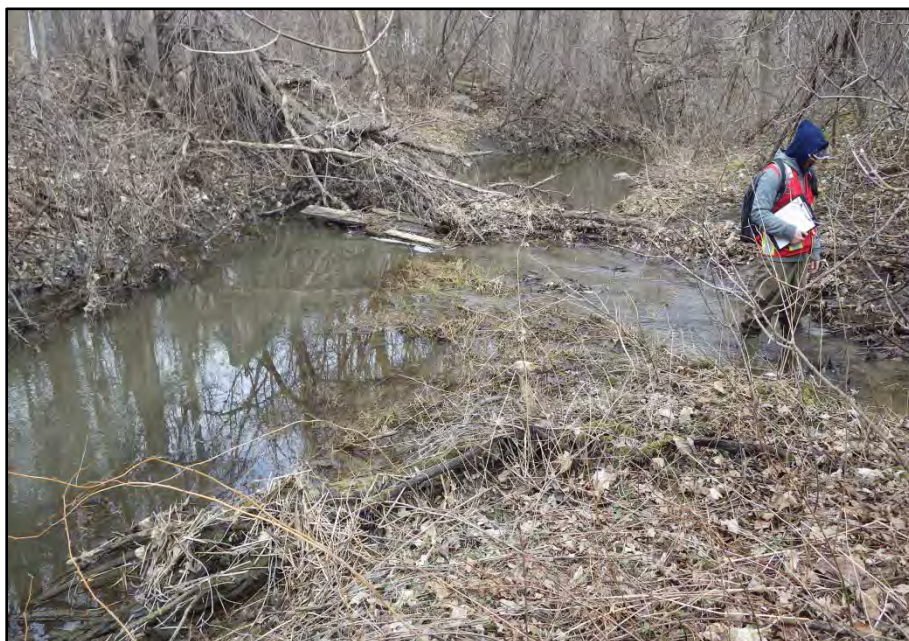
6. WCD-R2: Confluence of tributary (right side of photo) with the main channel of Wilson Cowan Drain.

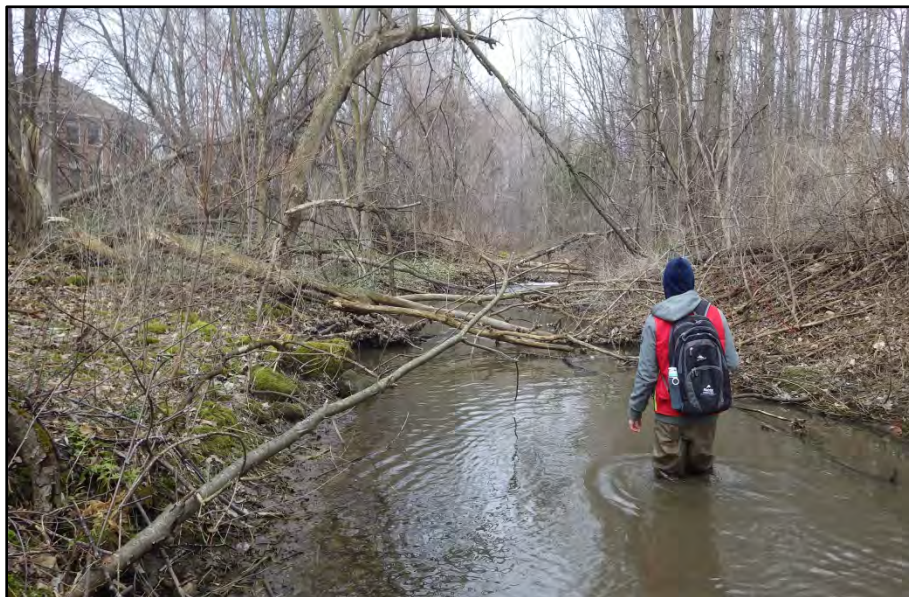
7. WCD-R1: View looking downstream. Some fallen trees, not due to erosion.

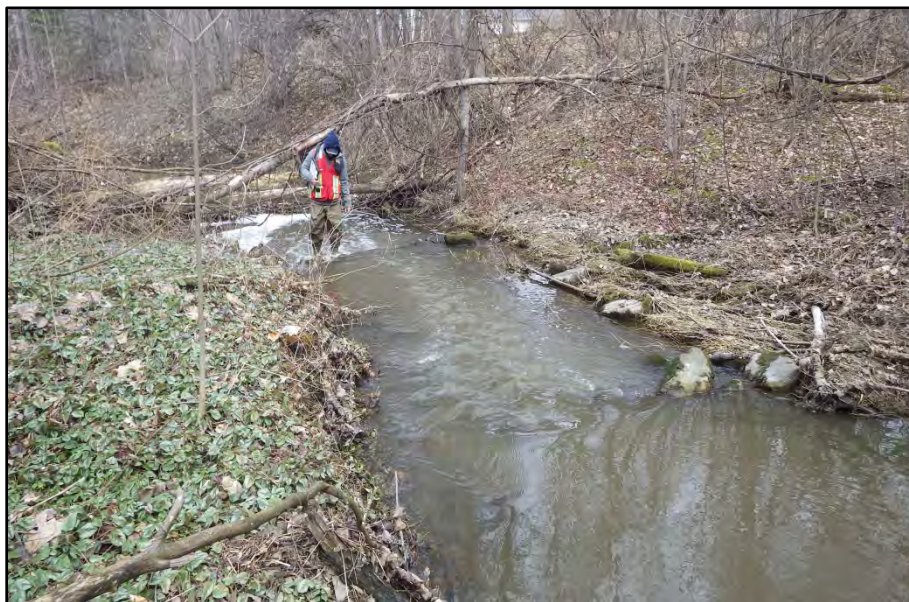
8. WCD-R1: View looking downstream at step-pool formation. Large stones (potentially placed) across channel creating small drop.

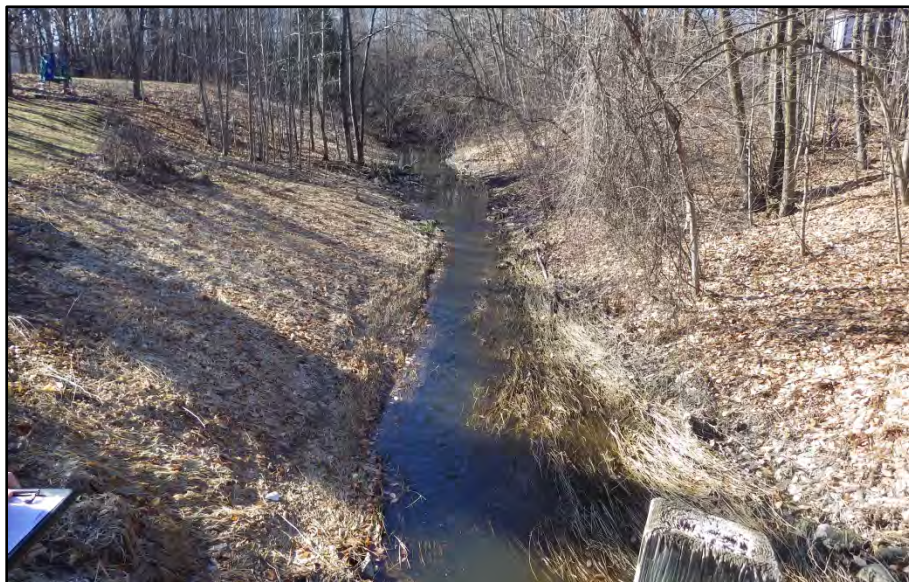
9. WCD-R1: View looking upstream from Watterson St. Large quantities of instream vegetation.

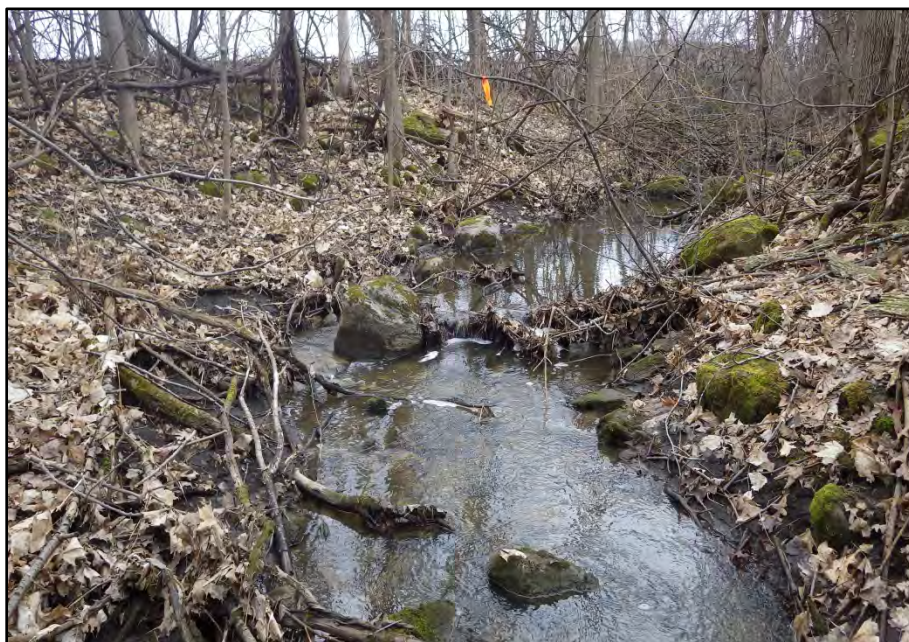
10. WCDT-R1: View looking upstream. Substrate consists of small-large cobble within a riffle-pool sequence.

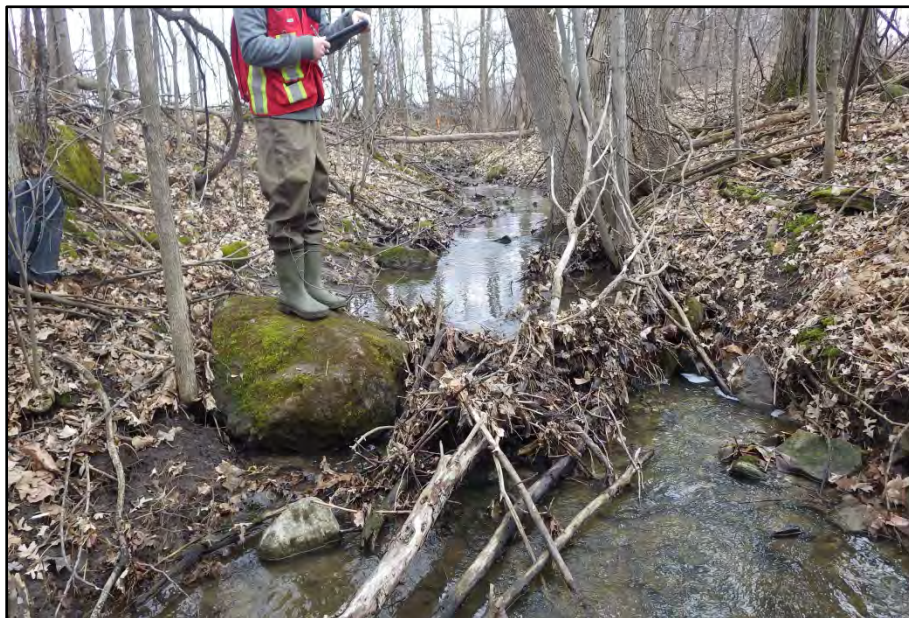
11. WCDT-R1: Woody debris build up in channel.

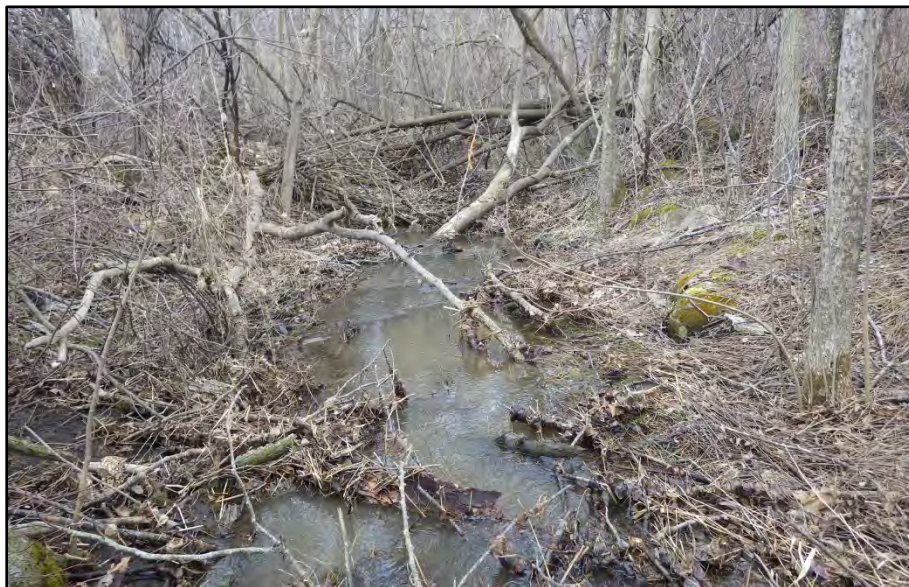
12. WCDT-R1: Tributary within wooded buffer with agricultural fields on both sides.

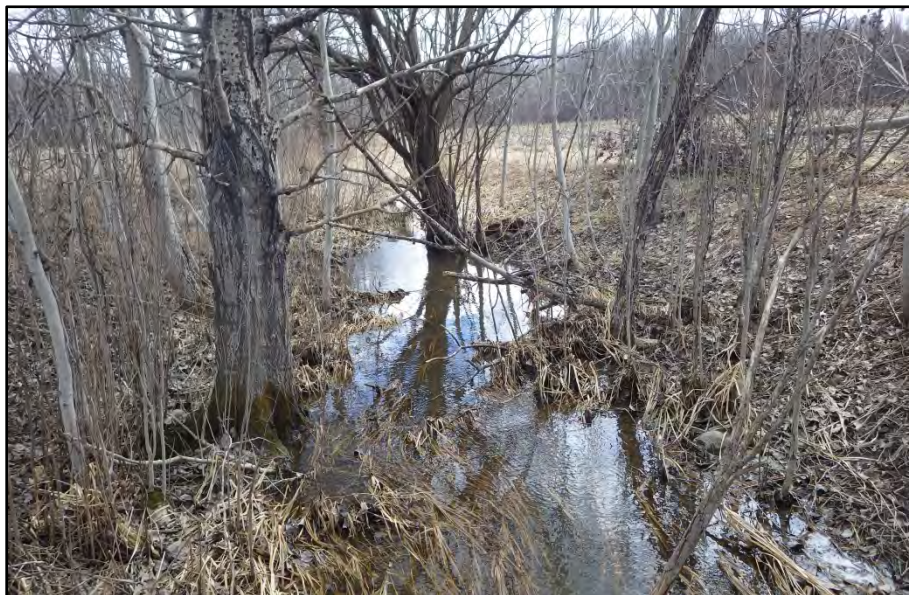
13. WCDT-R2: View looking upstream. Shows transition from agricultural field to beginning of wooded buffer.

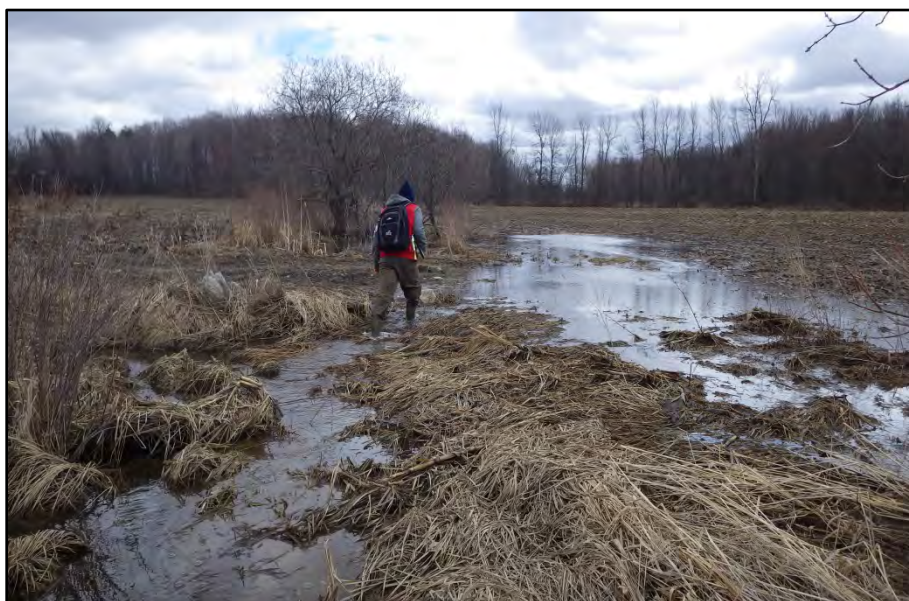
14. WCDT-R2: Channel has lost definition and has much lower grade.

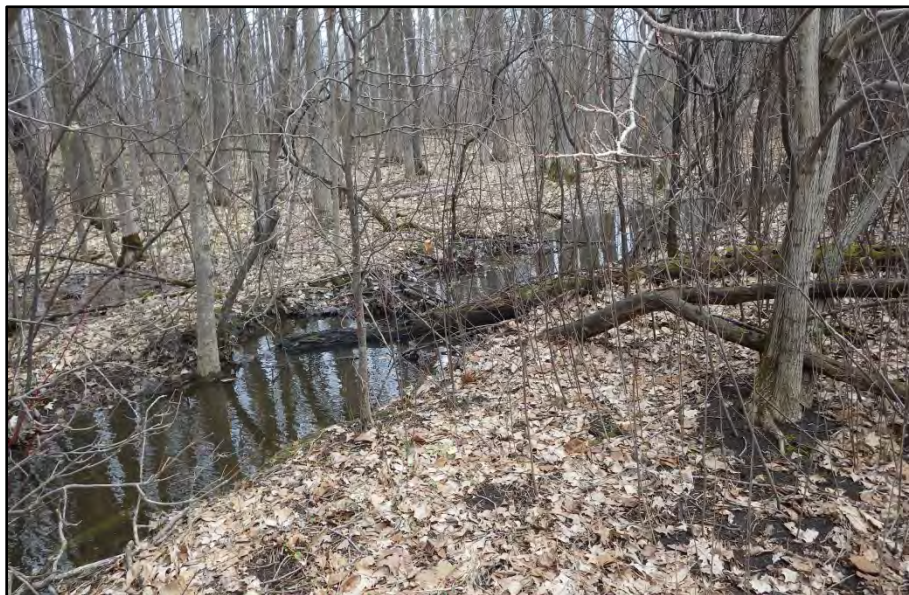
15. WCDT-R3: Where channel enters wooded area it regains some definition.

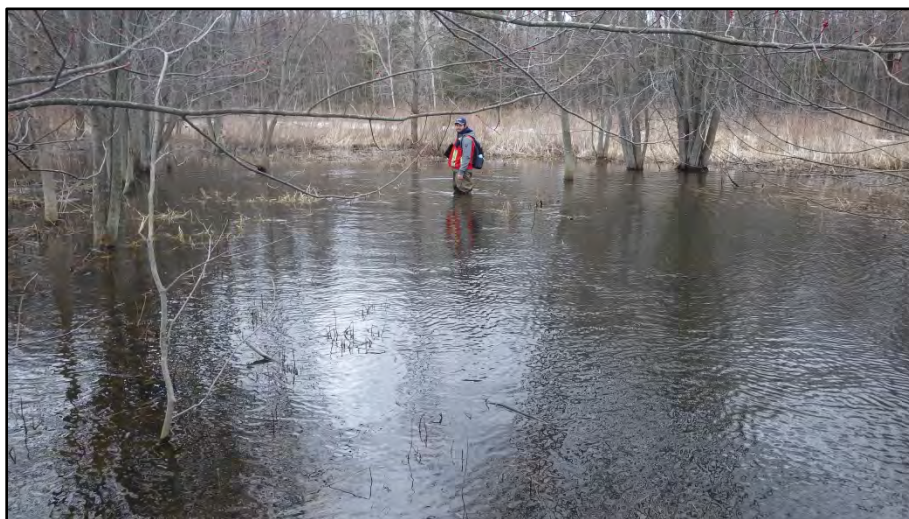
16. WCDT-R3: Water spreads out and creates small pond.

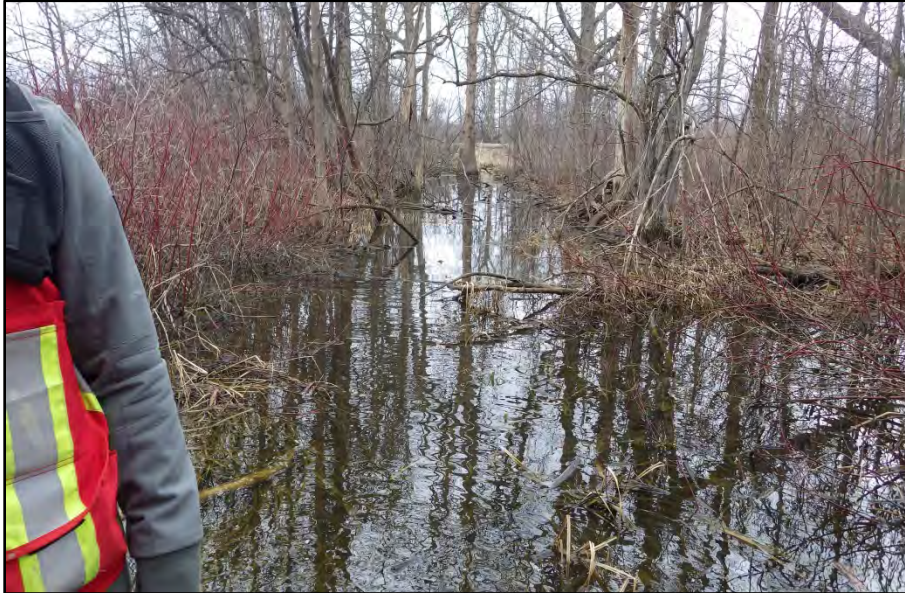
17. WCDT-R3: Channel remains undefined and flooded up to culvert under Century Rd.
