Urban Forestry & Forest Management Consulting

April 7, 2017

Re: Tree Conservation Report – Kingston Avenue

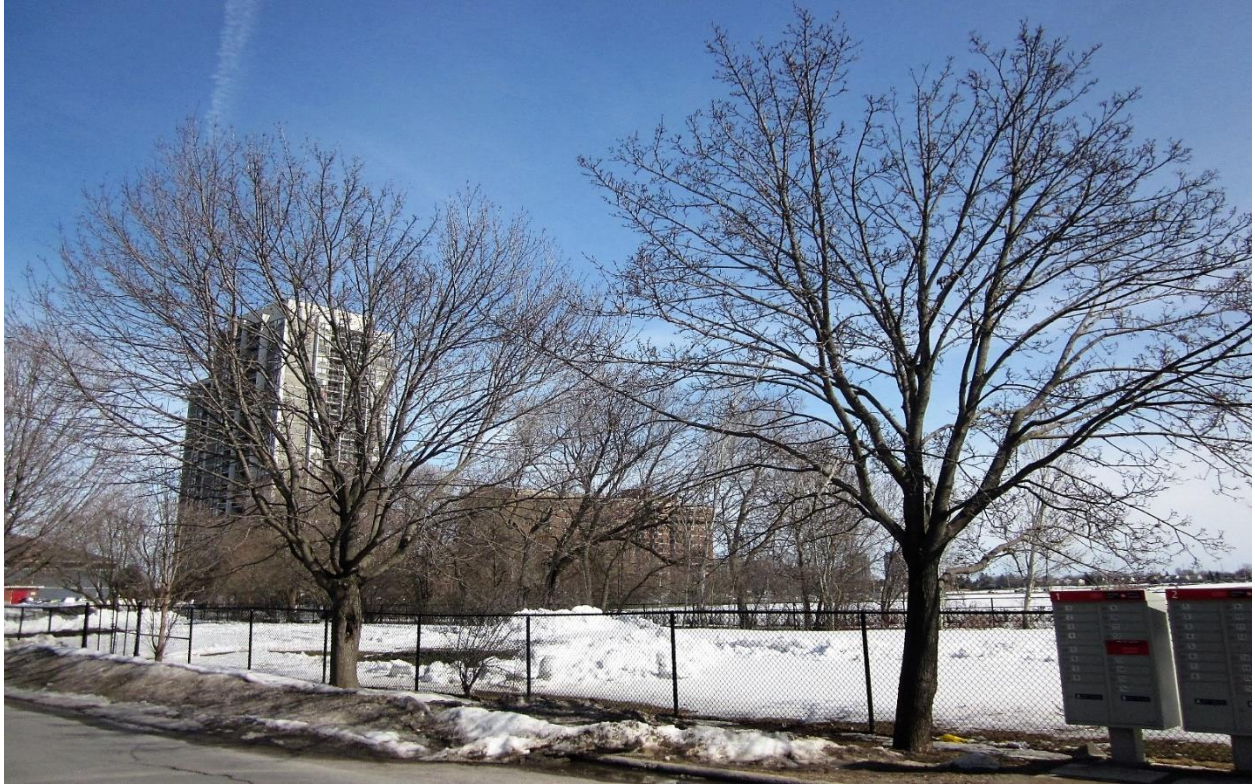
Picture 1. Trees # 1 and 2 on Kingston Avenue.

Tree No.	Tree Species	Condition (VP→E)	D.B.H (cm)	Tree Condition Notes & <b>Status</b> (to be removed or retained)
1	Norway maple ( <i>Acer platanoides</i> )	Poor	34.3	Mature; co-dominant stems at 2.5m-parallel with weak union; symmetrical crown; trunk infected with Eutypella canker ( <i>Eutypella parasitica</i> ) 0.25-0.75m on south side-incipient decay now present (will become hazardous); seam on north side of trunk grade to 2m-healed; good annual increment (vigour); root collar lacking flares-likely due to girdling roots; undesirable, invasive species; <b>to be retained</b>
2	Norway maple	Very poor	41.9	Mature; central stem with multiple competing laterals – broad, symmetrical crown; cluster of branches at 2m constricting growth above; trunk infected with Eutypella canker ( <i>Eutypella parasitica</i> ) 1-1.5m on southwest side - advanced decay now present (potentially hazardous); good annual increment; good flaring at root collar; undesirable, invasive species; <b>to be removed with agreement of City</b>

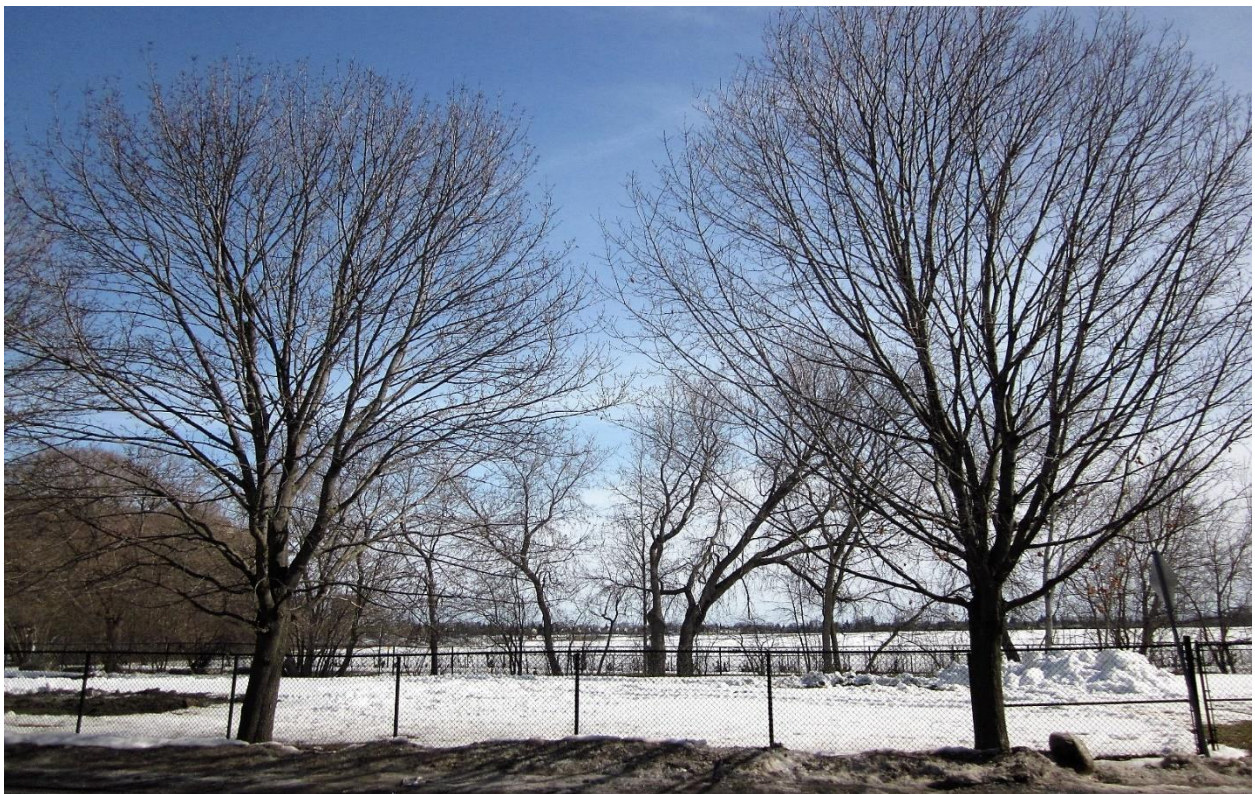
Picture 2. Trees #4 and 5 on Kingston Avenue.

3	Ash ( <i>Fraxinus</i> spp.)	Dead	10.1	Immature; coppice growth arising from stump cut at 0.3m; dead due to Emerald ash borer ( <i>Agrilus planipennis</i> ); <b>to be removed with agreement of City</b>
4	Sugar maple ( <i>Acer saccharum</i> )	Good	36.6	Mature; co-dominant stems at 3m with strong union; broad, dense & symmetrical crown; good annual increment; fair flaring at root collar; desirable species; <b>to be retained</b>
5	Norway maple	Fair	42.6.	Mature; central stem with multiple competing laterals starting at 2m-most with weak unions; broad, symmetrical crown; root collar with multiple girdling and binding roots; fair annual increment; undesirable, invasive species; <b>to be removed with agreement of City</b>

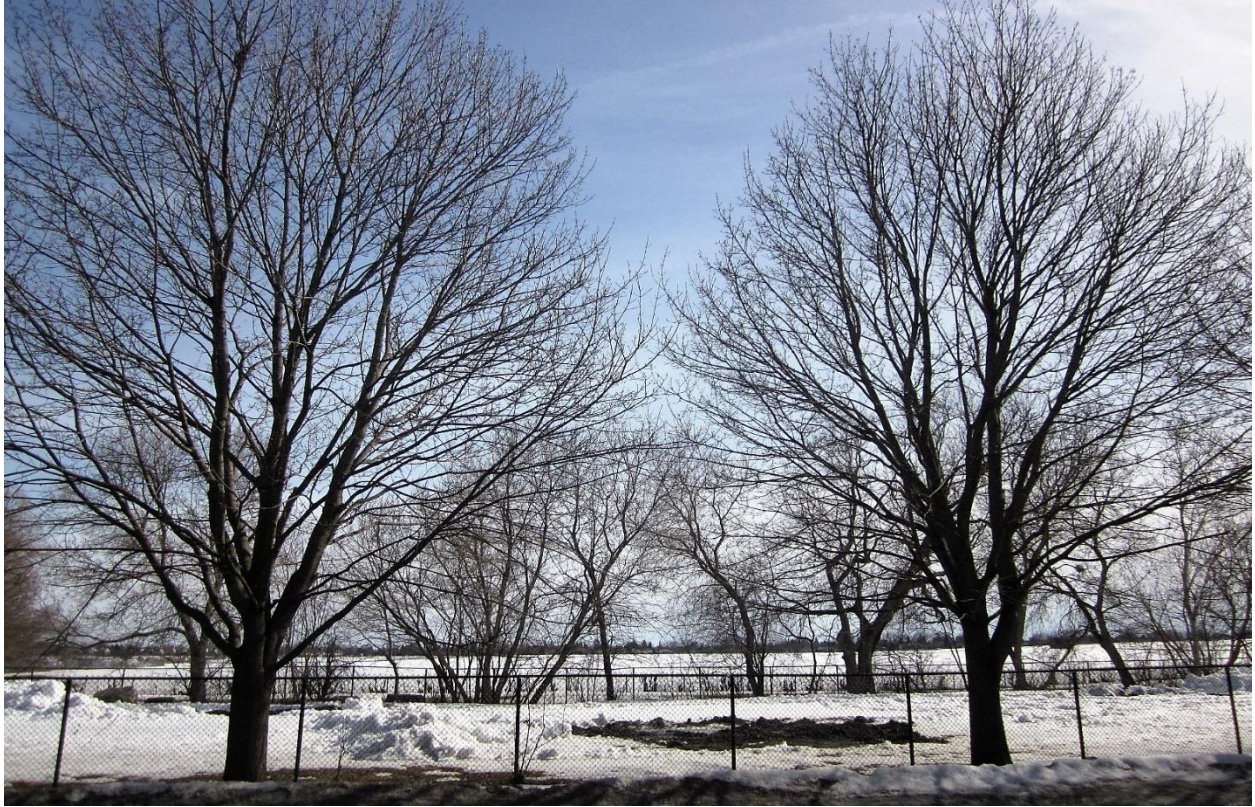
Picture 3. Trees #6 and 7 on Kingston Avenue.

6	Norway maple	Fair	44.9	Mature; co-dominant stems at 1.75m with very weak union (previously rod braced); secondary union at 2.5m also weak; broad, symmetrical crown; good annual increment; fair flaring at root collar – girdling roots for 1/3 of circumference; undesirable, invasive species; <b>to be removed with agreement of City</b>
7	Norway maple	Fair	45.8	Mature; co-dominant stems at 1.75m with weak union, secondary union at 1.5m very weak; neither union rod braced-potentially hazardous if not addressed; broad, symmetrical crown; good annual increment; fair flaring at root collar – girdling roots for 1/3 of circumference; surface roots damaged by mowers; undesirable, invasive species; <b>to be retained</b>
8	Manitoba maple ( <i>Acer negundo</i> )	Very poor	38.4	Mature; likely originated from seed; primary union at 2.5m with co-dominant stems and two competing laterals; union weak due to fissure and missing bark; located on slope by drain – root plate undermined by erosion; root collar one-sided with missing bark (likely due to root death making tree potentially hazardous); fair annual increment; undesirable, naturalized species; <b>to be retained</b>

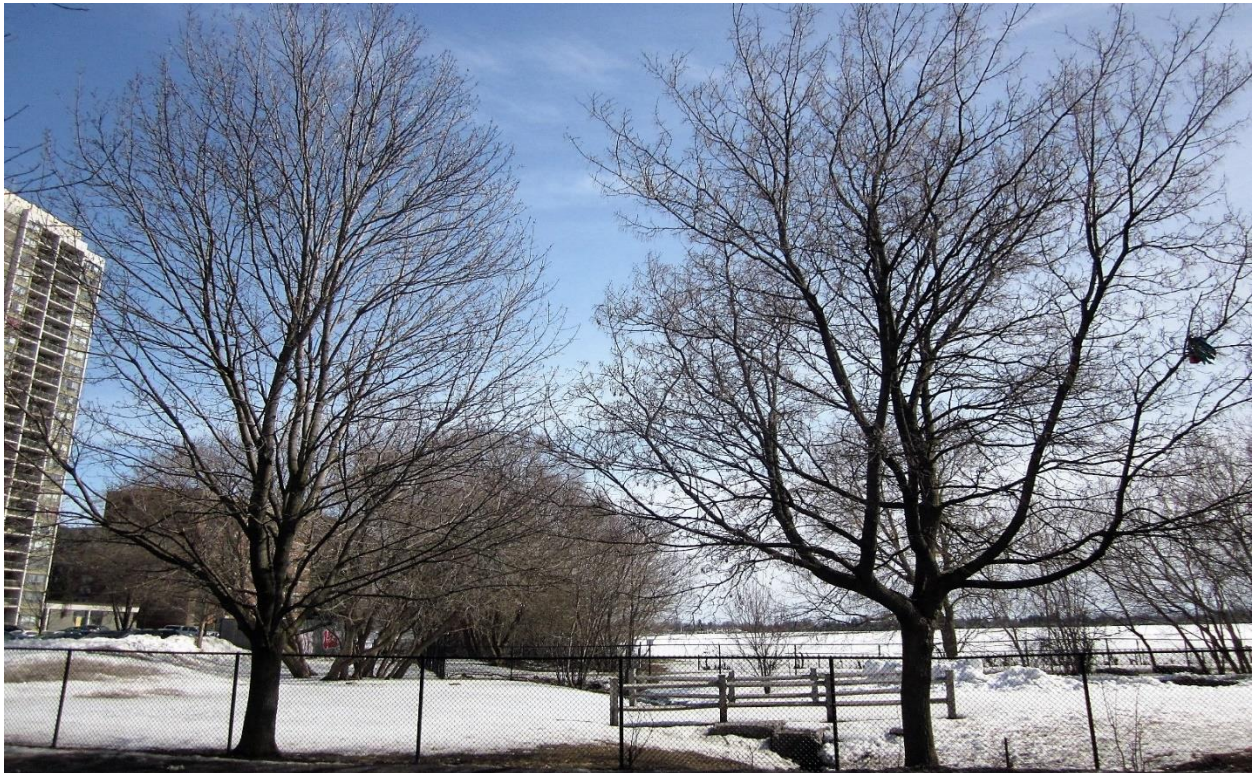
Picture 4. Trees #8 and 9 on Kingston Avenue.

The two maples close to the subject property, trees #8 and 9, are not anticipated to be impacted by construction. All other trees on adjacent properties can be retained as they do not conflict with the proposed construction. Lastly, none of the existing trees are of suitable species, health condition and/or size which would allow them to be successfully transplanted out of the way of construction.

9	Norway maple	Fair	39.5	Mature; primary union at 3m with co-dominant stems-strong union; secondary union at 2.5m is very weak (included bark and reaction wood present); flaring at root collar for 1/2 of circumference-girdling roots likely suppressing rest; surface roots damaged by mowers; fair annual increment; undesirable, invasive species; <b>to be retained</b>
