Geotechnical Investigation

Proposed Multi-Storey Building St. Joseph Boulevard and Duford Drive Ottawa, Ontario

January 18, 2018

Report: PG4083-1 Revision 2

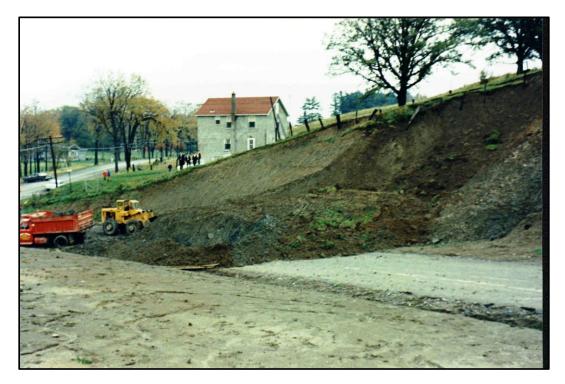
Section C was located within a former slope failure area. It is understood that a slope failure occurred along the east side of Duford Drive in the 1960s. Photographs of the slope failure were provided to Paterson for this response. Photographs 1 and 2 presented in Appendix 2 show a shallow slope failure across a limited section of overall slope face. Based on slope features noted in the photographs, such as lack of vegetation across the slope face and the soil surface in the area of Duford Drive, it appears that the slope failure occurred across a section of the slope, which had been recently re-shaped as part of the construction of Duford Drive.

The natural grade of the slope face was drastically changed during the construction of Duford Drive. It is expected that the slope failure can be directly contributed to the steepness of excavated slope face along with exposure to precipitation events before a vegetative layer could establish. It should be further noted that a vegetative layer across a slope face promotes surficial run-off during precipitation events and limits infiltration of rainwater into the slope soil. Infiltration of water from precipitation events into a slope reduces overall slope stability.

Photo 1: Localized slope failure occurring in the mid 1960s adjacent to Duford Drive. Subject site is located within the foreground of the photograph. St. Joseph Boulevard is in the background. Ground surface adjacent to Duford Drive is noted to be free of vegetation, which is indicative that construction of the subject roadway section and cutting of the subject slope was recently completed. It is suspected that the exposed slope was re-shaped to an unstable slope angle as part of the construction work at that time.

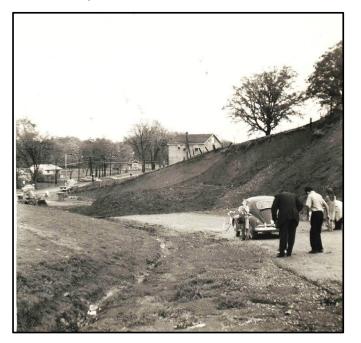
Photo 2: Same localized slope failure, which occurred in mid 1960s.

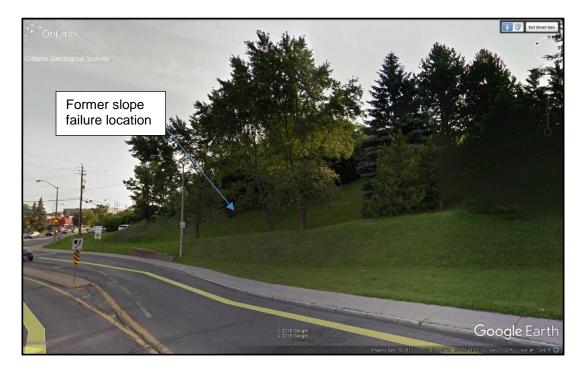
The current slope face was noted to include a terraced area along the base of the slope face in the area of the former slope failure (see Photos 3, 4 and 5 in Appendix 2). It is suspected that the terraced area was introduced after the initial slope failure to stabilize the reinstated slope. Currently, the slope face was noted to be grass covered with mature trees. No signs of slope instability were noted.

Photo 3: Street view image from Google Earth of former slope failure area (presented in Photos 1 and 2) adjacent to Duford Drive. Ground noted to be re-shaped with a terraced slope in front of reinstated slope.

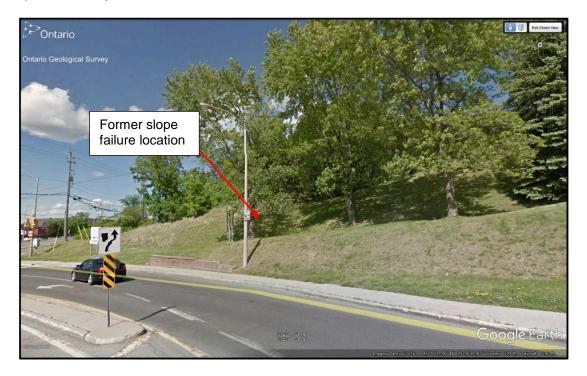
Photo 4: Street view image from Google Earth of the same former slope failure area presented in Photos 1 and 2. The ground surface is noted to be stable with no signs of slope instability.

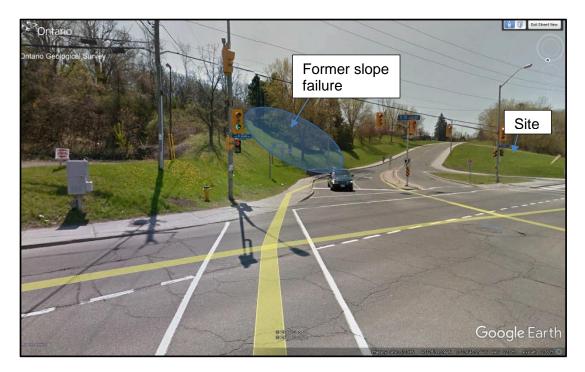
Photo 5: Area of former slope failure noted in Photos 1 and 2. Subject site is property along the right side of the photograph.
