**Phase One Environmental Site Assessment
Proposed School Development
2405 and 2419 Mer Bleue Road
Ottawa, Ontario**

May 28, 2018
Project: 62721.07

**Re: Phase One Environmental Site Assessment
2405 and 2419 Mer Bleue Road, Ottawa, Ontario**

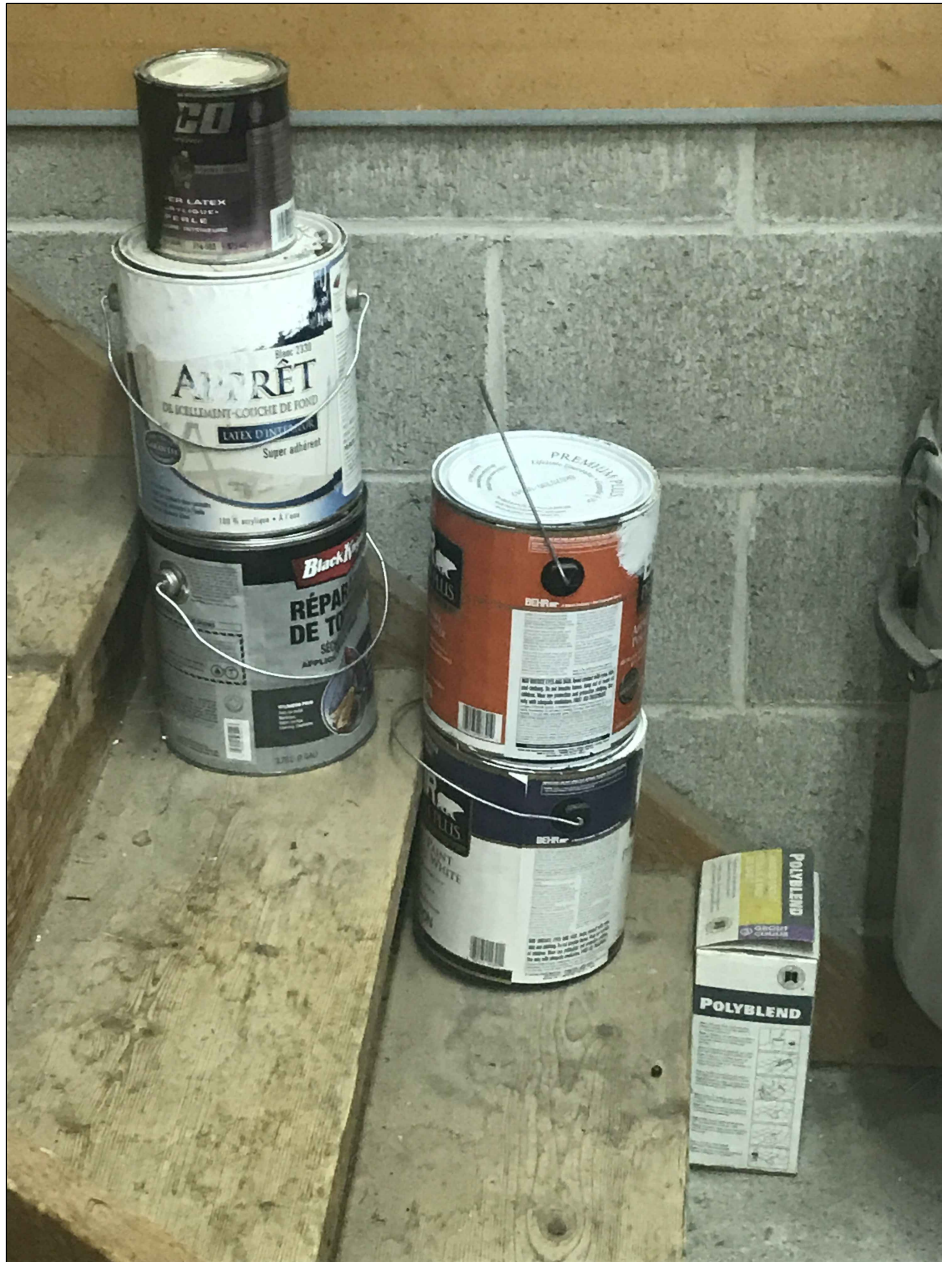
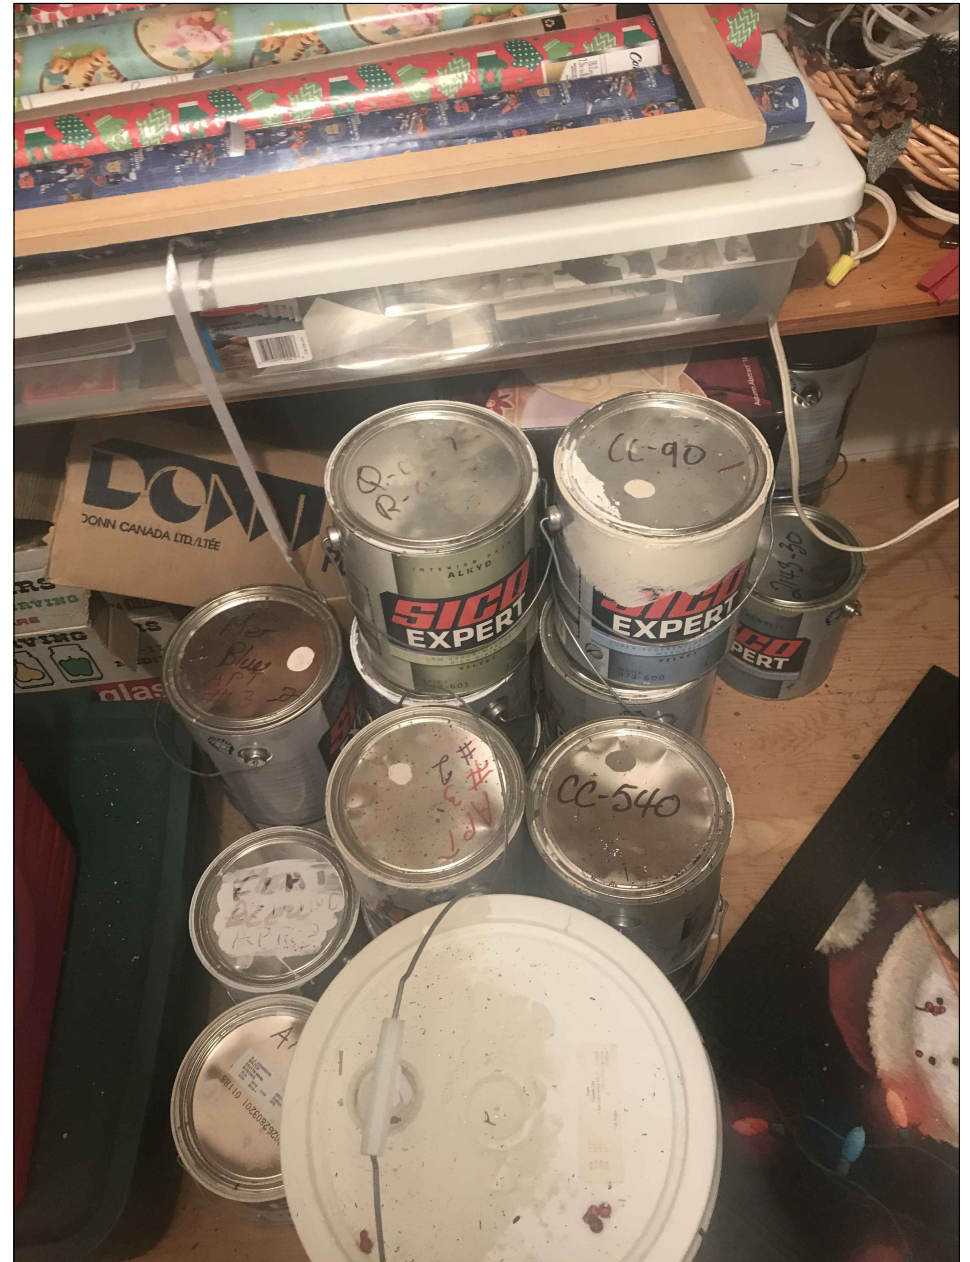
SITE PHOTO
PAINTS STORED ON
THE SUBJECT PROPERTY

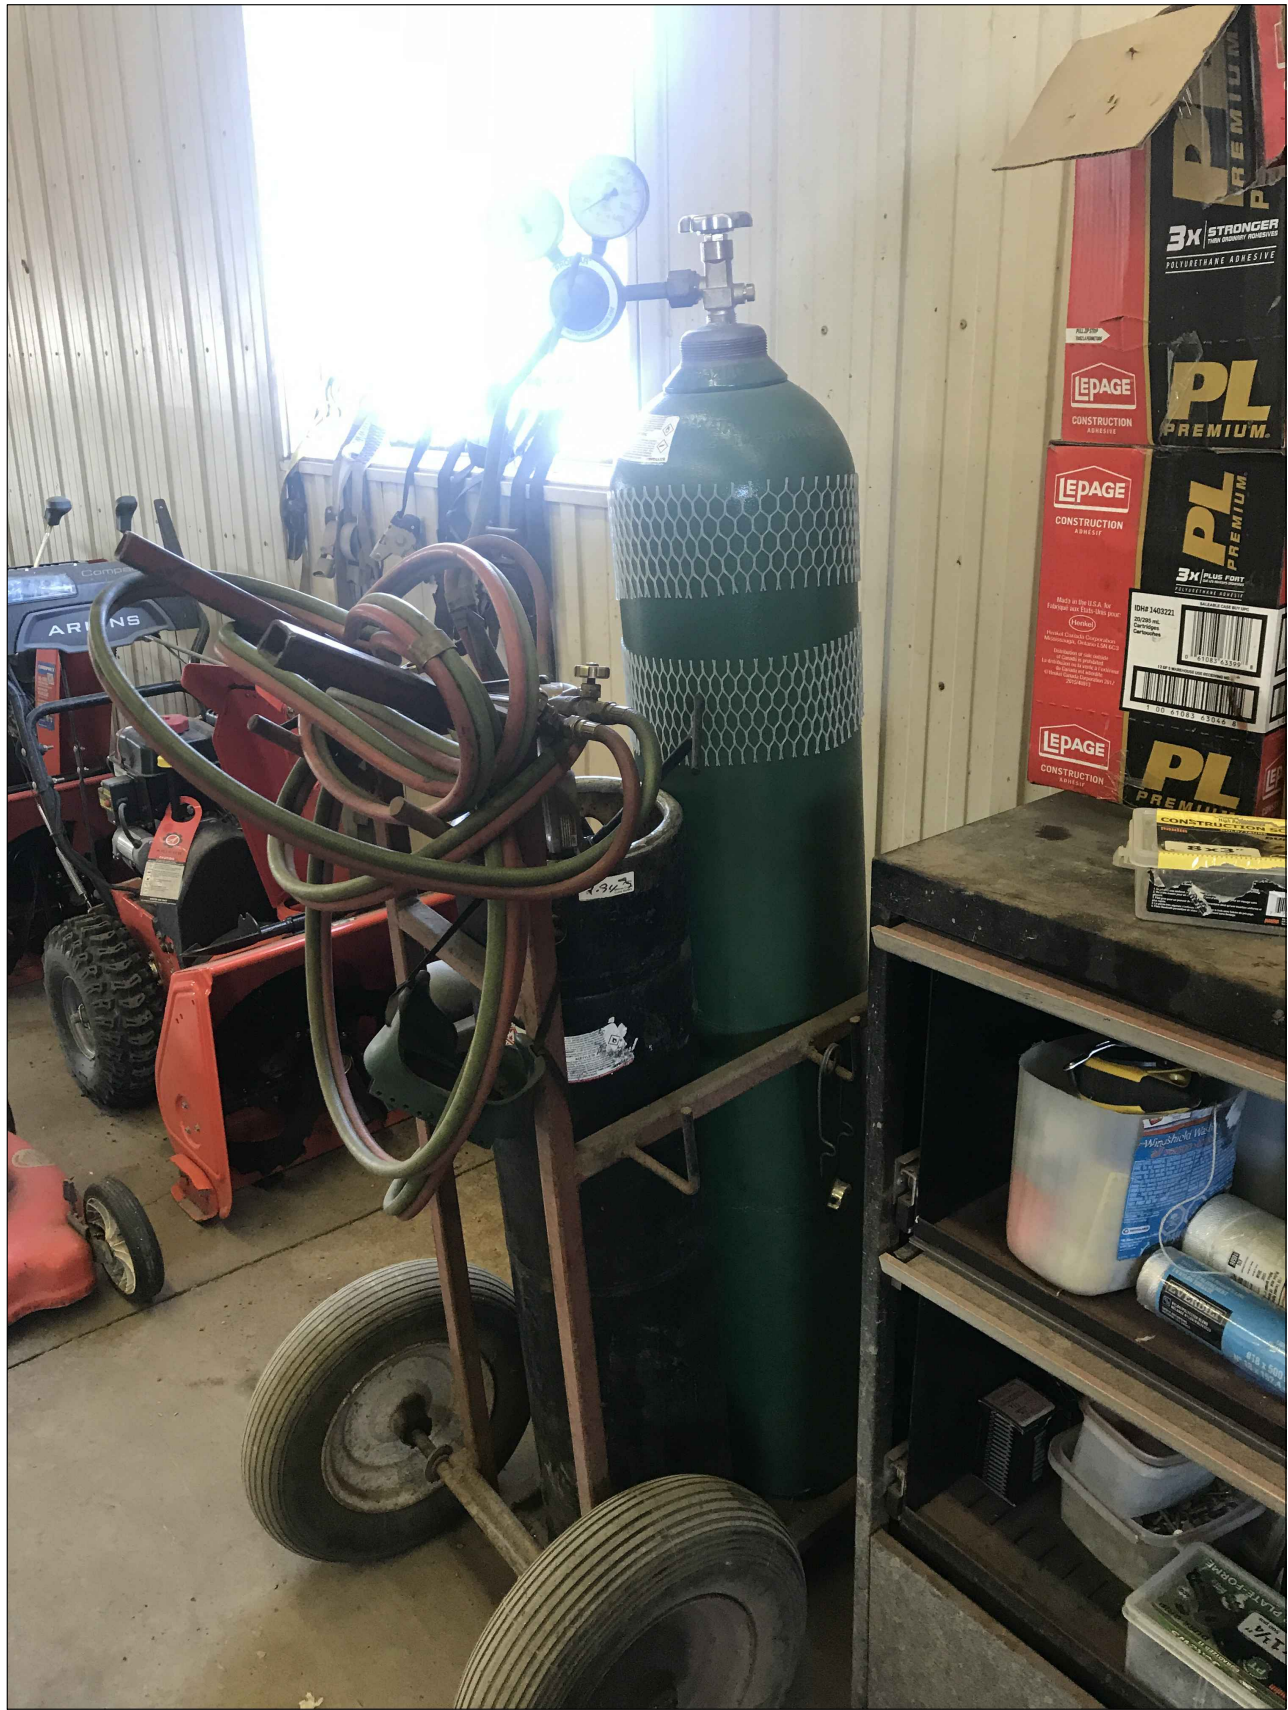
Project No.	Revision No.	FIGURE H4
62421.07	0

Drawing **SITE PHOTO
COMPRESSED GAS USED FOR
WELDING IN THE SHOP AT
2419 MER BLEUE ROAD**

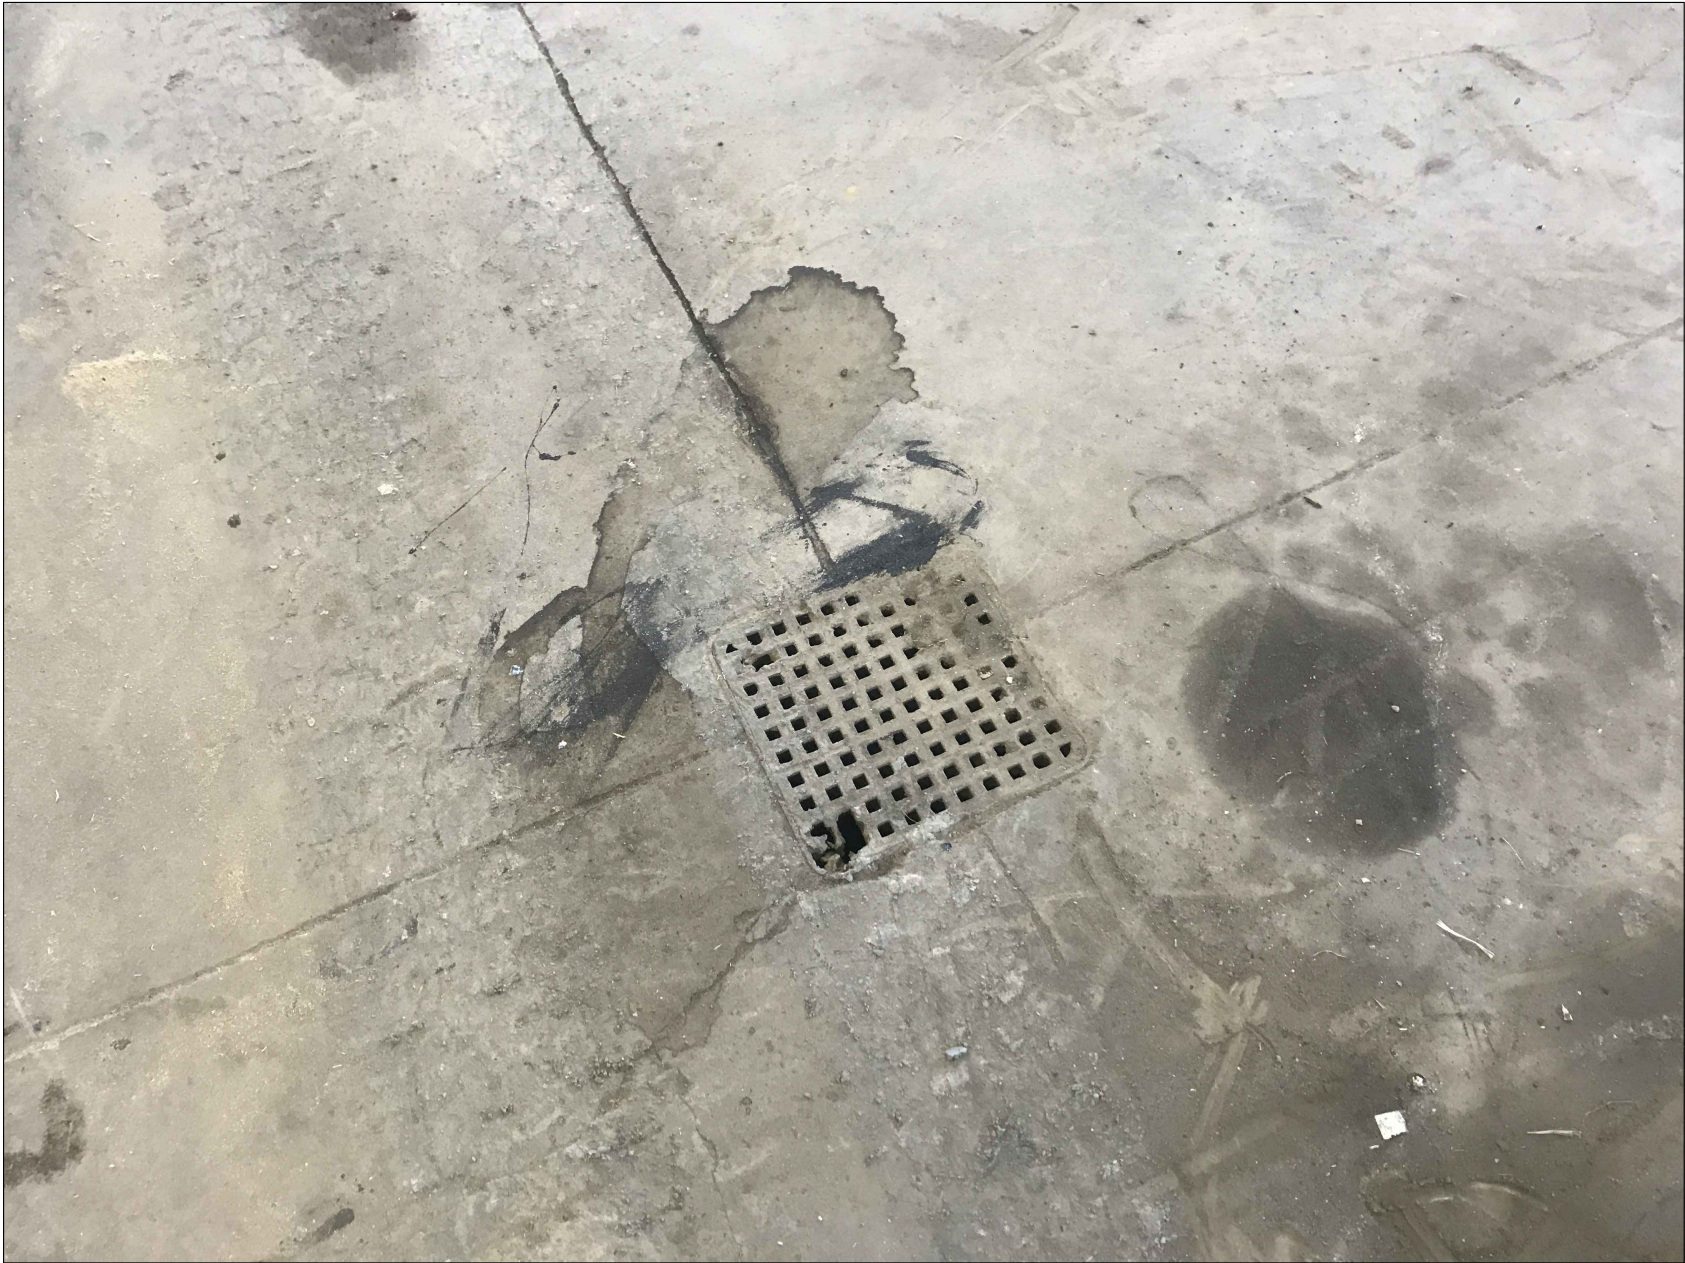
SITE PHOTO
FRENCH DRAIN IN THE SHOP AT
2419 MER BLEUE ROAD

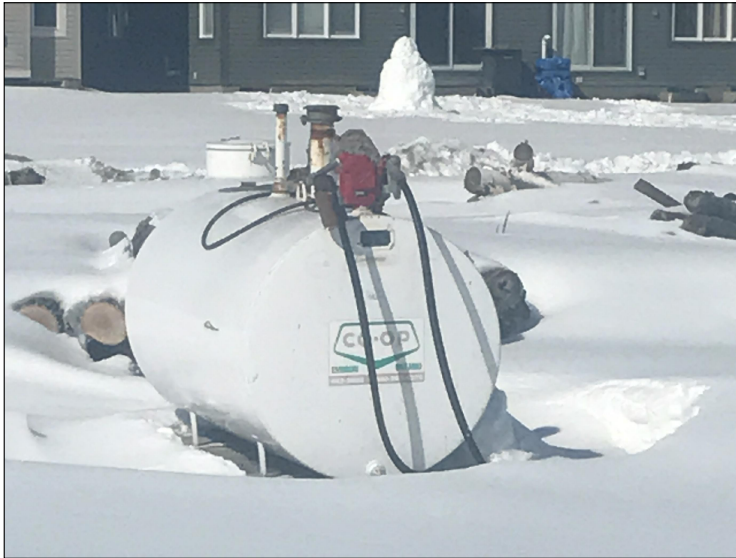
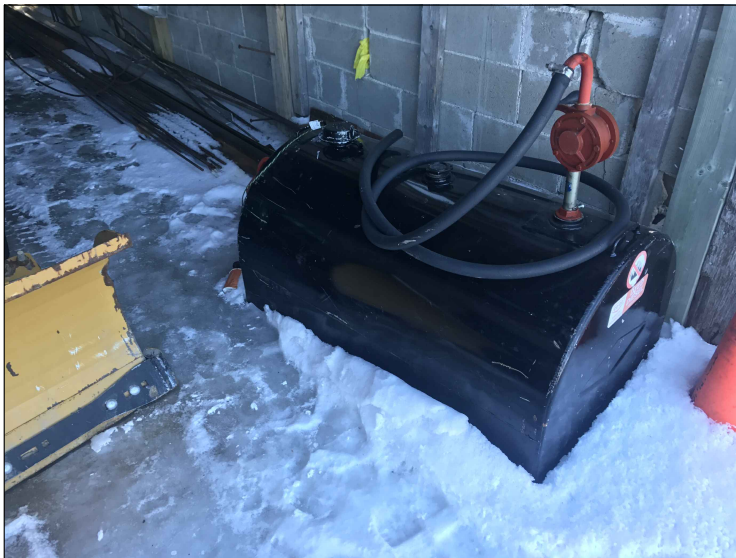
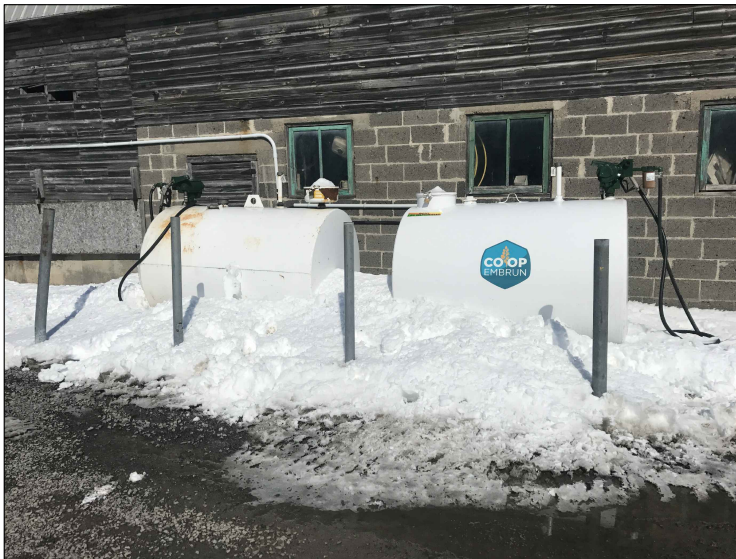
Project No. 62421.07	Revision No. 0	FIGURE H6
--------------------------------	--------------------------	------------------

Four (4) aboveground fuel storage tanks are located on the subject property and are used for equipment refueling. The tanks contain clear and coloured diesel, and one (1) of the tanks is empty. No staining was observed in the vicinity of the storage tanks. Due to the nature of the hydrocarbon products stored, the associated contaminants of concern are petroleum hydrocarbons (PHCs), benzene, toluene, ethylbenzene and xylene (BTEX), volatile organic compounds (VOCs), and polycyclic aromatic hydrocarbons (PAHs).

Drawing **SITE PHOTO
ABOVEGROUND STORAGE TANKS
AT 2419 AND 2405 MER BLEUE ROAD**
