## Phase I - Environmental Site Assessment

2070 Scott Street  
Ottawa, Ontario

July 30, 2019

Report: PE4435-1

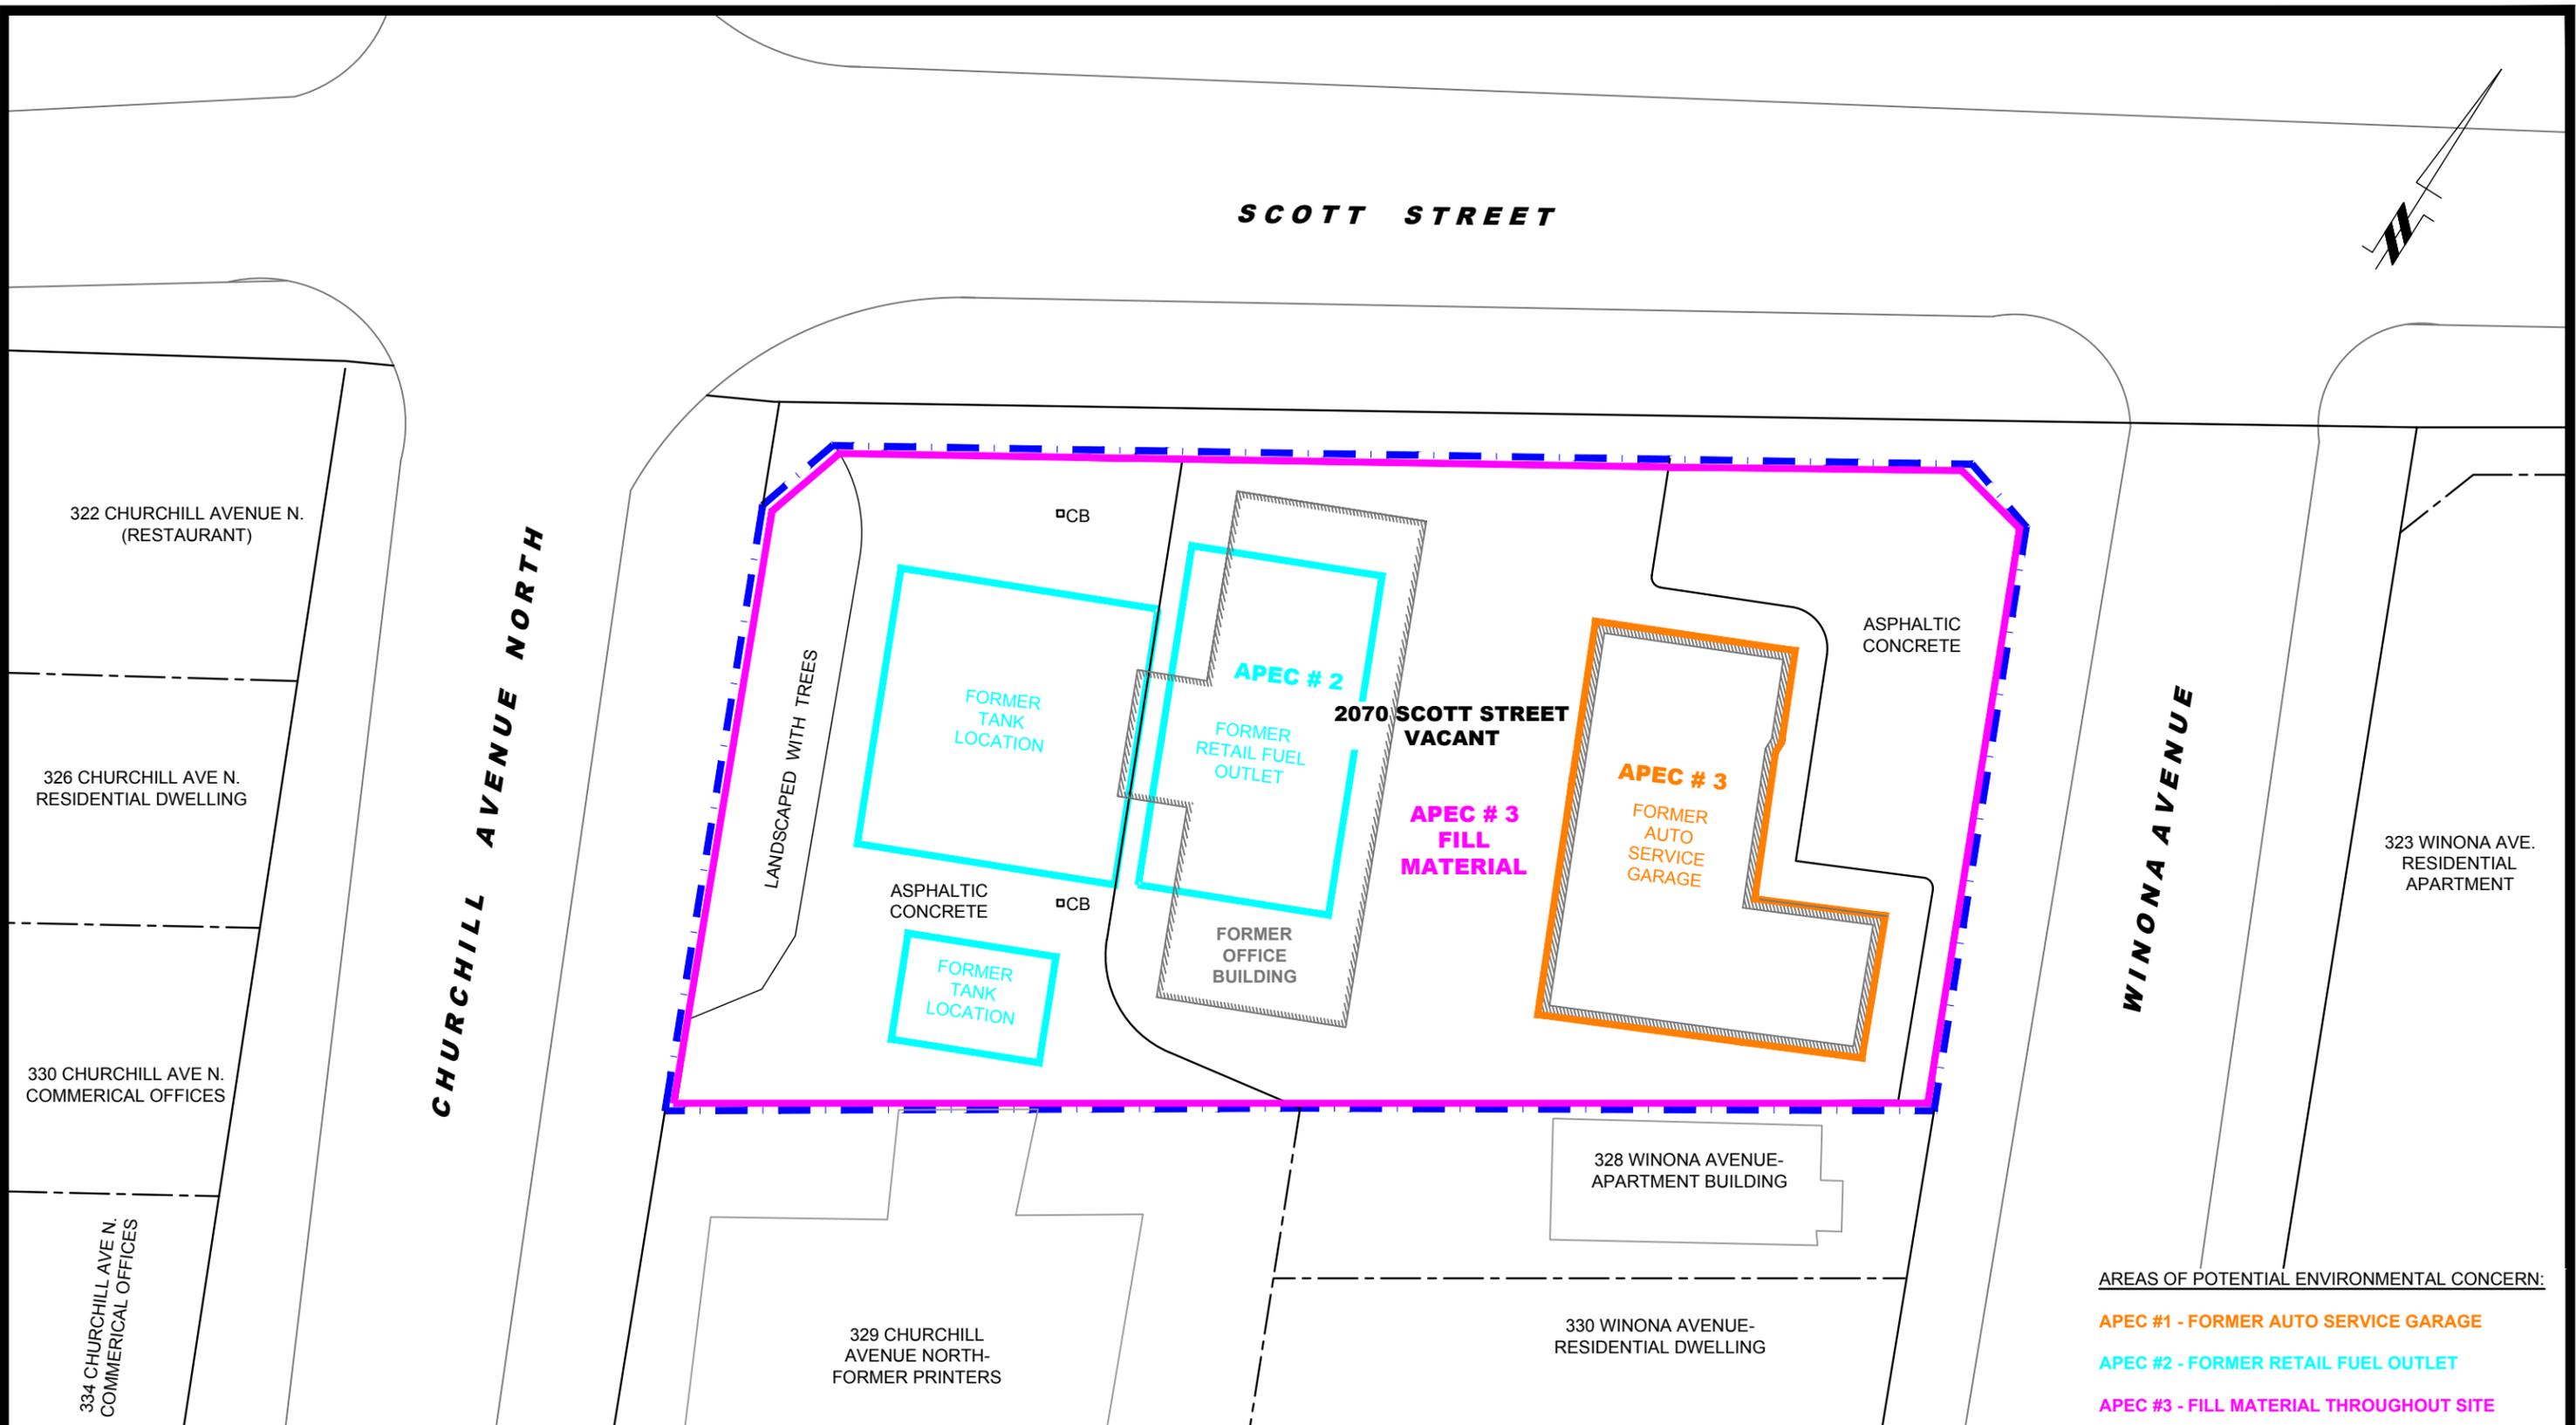
**DRAWING PE4435-1 – SITE PLAN**

AREAS OF POTENTIAL ENVIRONMENTAL CONCERN:

- APEC #1 - FORMER AUTO SERVICE GARAGE
- APEC #2 - FORMER RETAIL FUEL OUTLET
- APEC #3 - FILL MATERIAL THROUGHOUT SITE

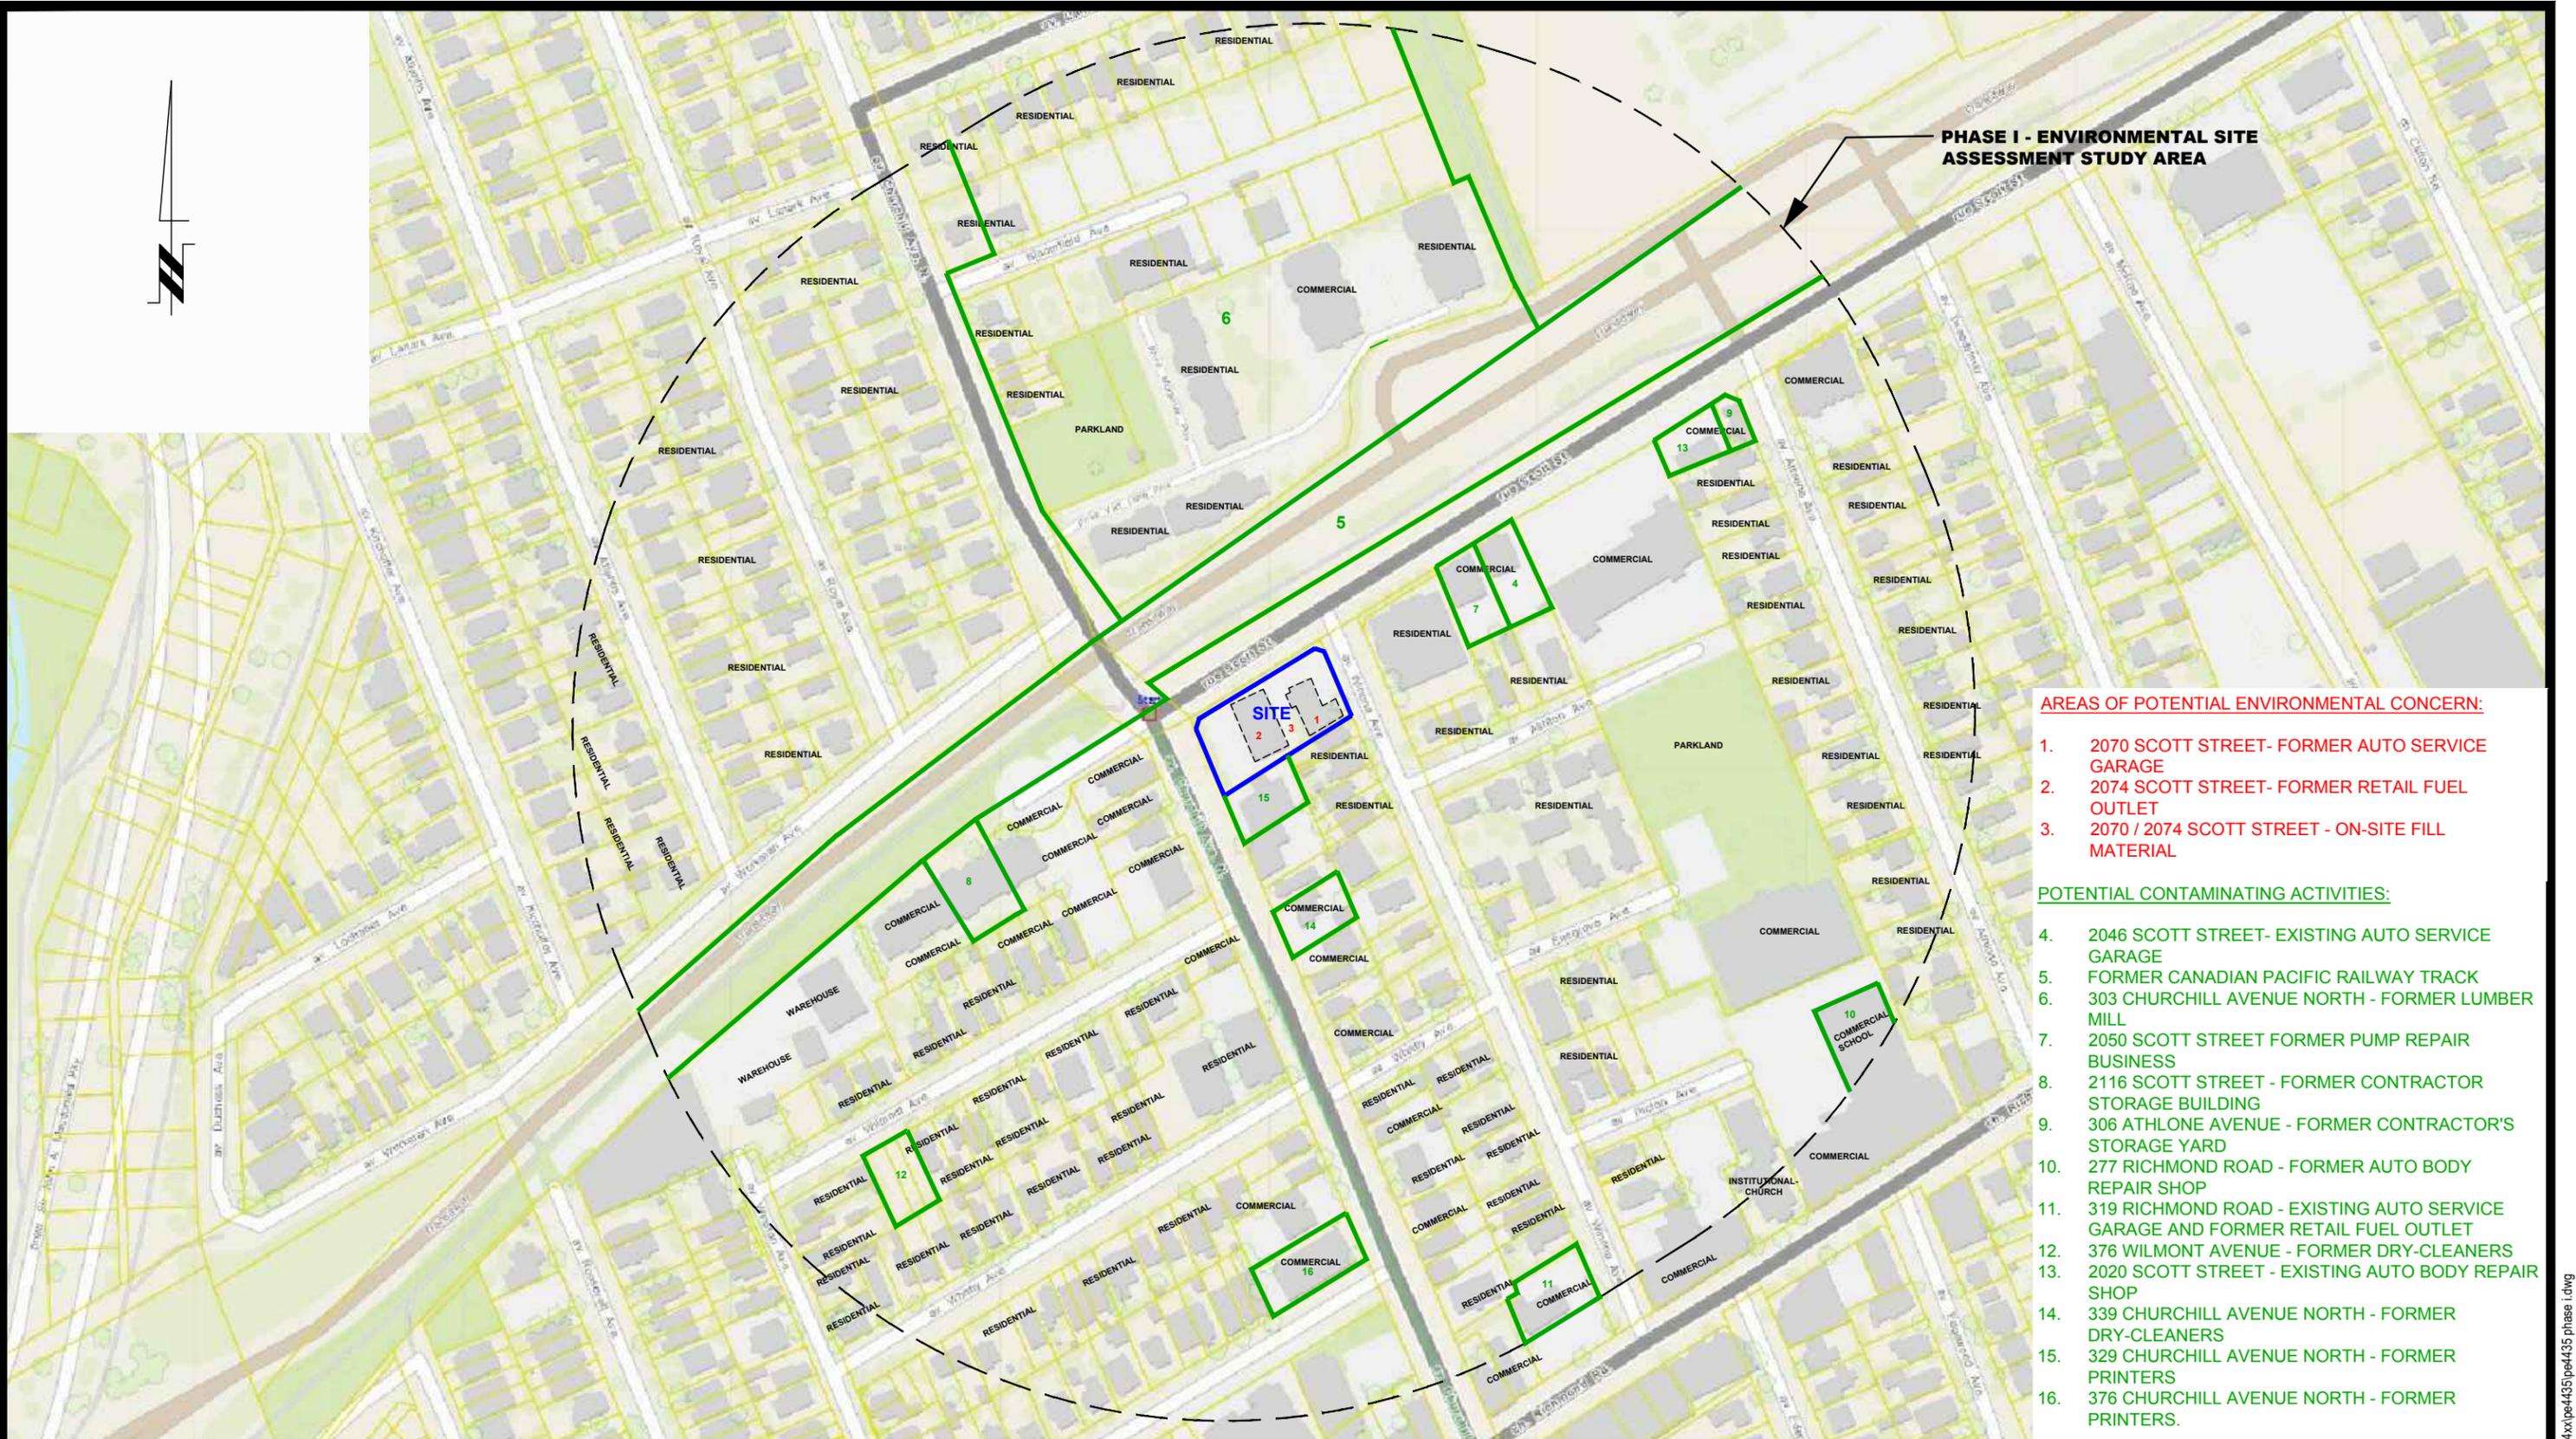
**DRAWING PE4435-2 – SURROUNDING LAND USE PLAN**

**AREAS OF POTENTIAL ENVIRONMENTAL CONCERN:**

1. 2070 SCOTT STREET- FORMER AUTO SERVICE GARAGE
2. 2074 SCOTT STREET- FORMER RETAIL FUEL OUTLET
3. 2070 / 2074 SCOTT STREET - ON-SITE FILL MATERIAL

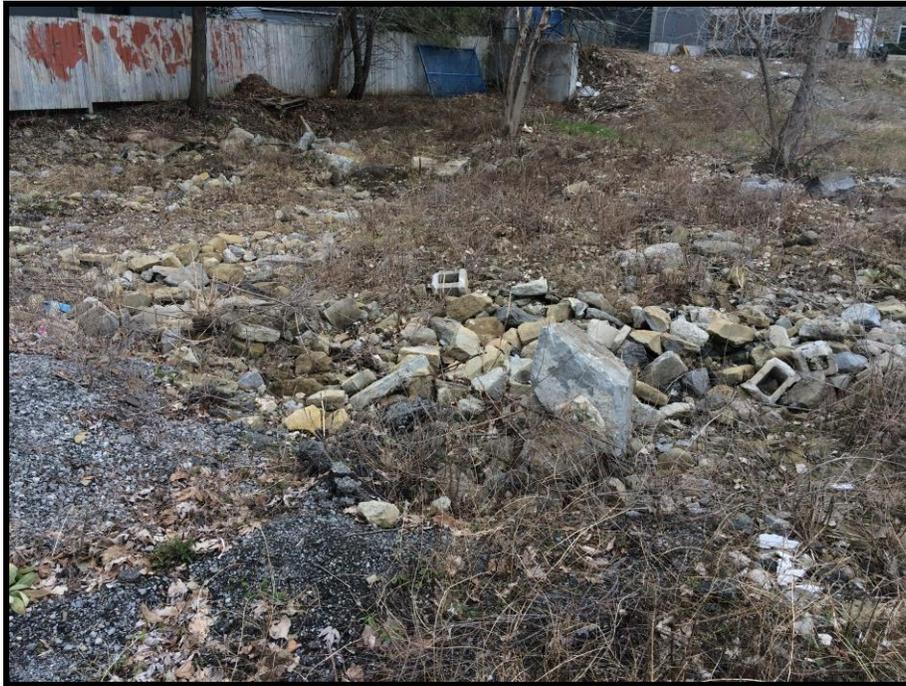
Photograph 5: View of a pile of stone, boulders, and concrete blocks, located on the western portion of the property.

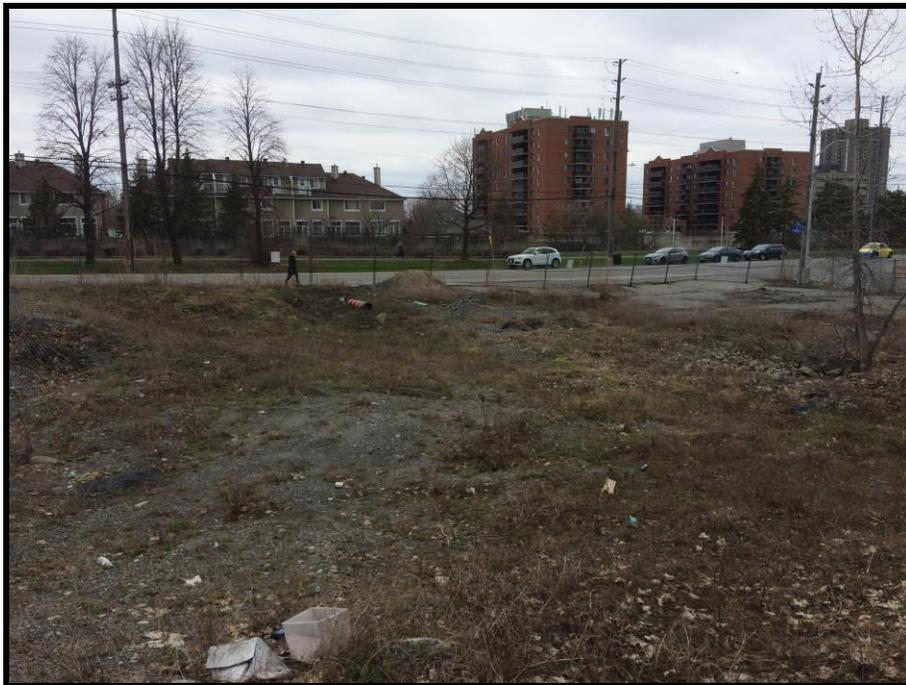
Photograph 6: View of the general ground cover in the central portion of the property. A small pile of native soil and gravel can be seen on the northern edge of the property.
