# Phase 1 Environmental Site Assessment

## 1131 & 1151 Teron Road, Ottawa, Ontario

**July 8, 2019**

**Oaktree Engineering Ltd.**

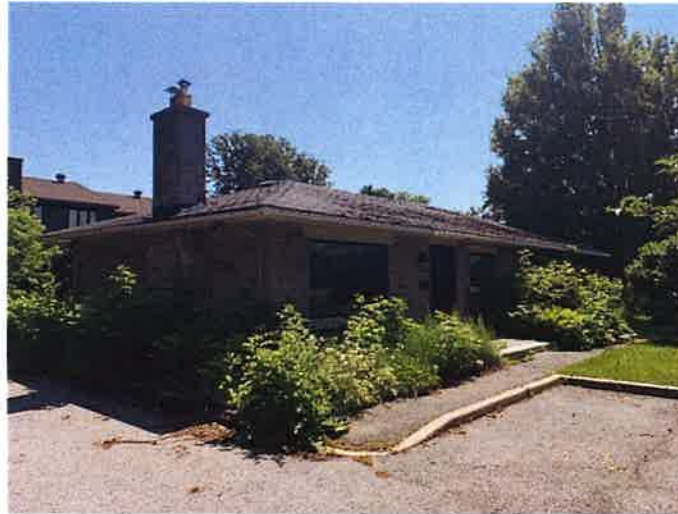
Photo 1 – Site Building 1131 Teron Road

1131 Teron Road is developed with a single storey masonry residential building with a concrete foundation and wood framed roof structure. There is an attached single car garage. The front of the building is assumed to face west onto Teron Road. The building is currently vacant.

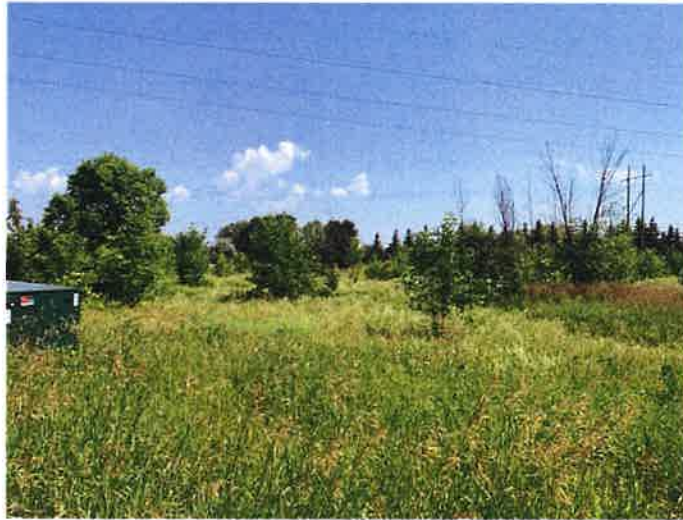
Photo 5 - Vacant Lot 1151 Teron Road

1151 Teron Road has lattice towers made from galvanized steel and wood to support the overhead power transmission lines. The power lines run parallel with March Road.

1151 Teron Road has lush green trees, shrubs, and tall grassed. No stressed or strained vegetation was observed.
