Hazardous Building Materials Assessment

320 McRae Avenue and 311 &
315 Tweedsmuir Avenue,
Ottawa, Ontario

February 14, 2020

Pinchin File: 230236.003

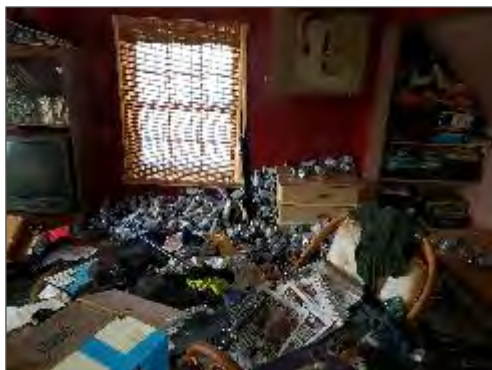
Area or Room	Reason
Second Floor, 315 Tweedsmuir Avenue	Limited access throughout the Second Floor due to the debris and possessions still present in the area.

Debris and possessions still present in the area.

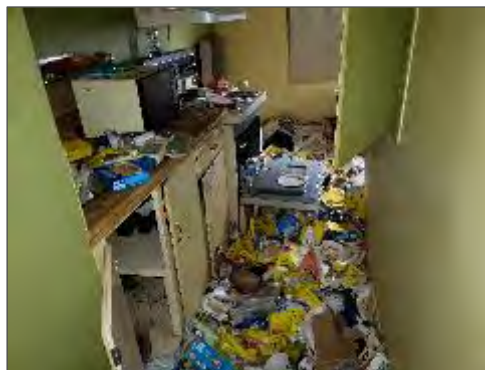
Debris and possessions still present in the area.

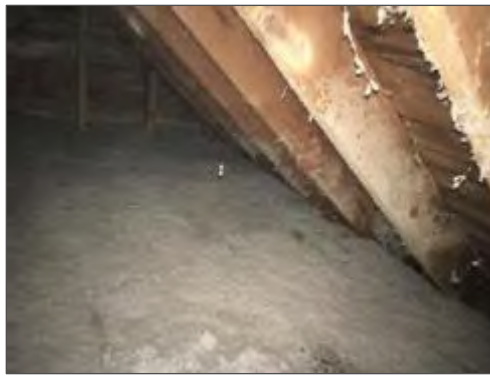
Non-asbestos spray-applied insulation and overspray is present in the ceiling space in Garage 1 at 320 McRae Avenue and in the crawlspace (attic) at 311 Tweedsmuir Avenue (samples 0001A-C and 0029A-C, respectively).

Non-asbestos spray-applied insulation present in the crawlspace (attic) at 311 Tweedsmuir Avenue.

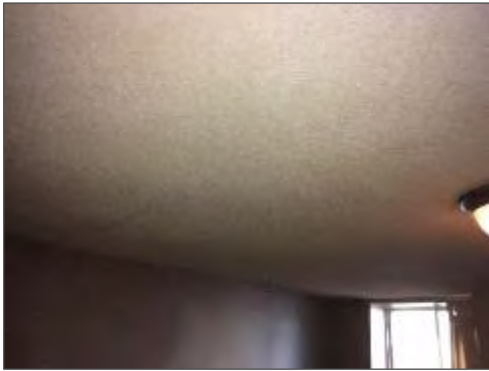
Ceiling stipple present on the drywall ceilings in the basement at 315 Tweedsmuir Avenue does not contain asbestos (samples 0036A-C).

Non-asbestos ceiling stipple present throughout the basement at 315 Tweedsmuir Avenue.

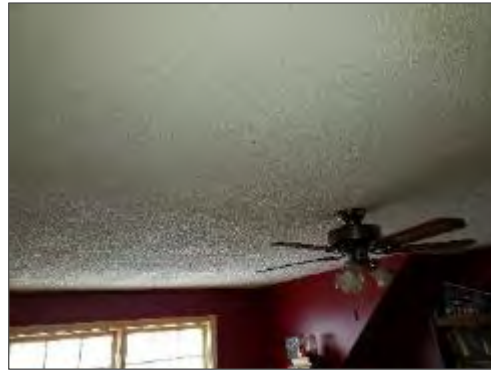
Ceiling stipple present on the plaster ceiling throughout the Second Floor at 315 Tweedsmuir Avenue does not contain asbestos (samples 0048A-C).

Non-asbestos ceiling stipple present throughout the second floor at 315 Tweedsmuir Avenue.

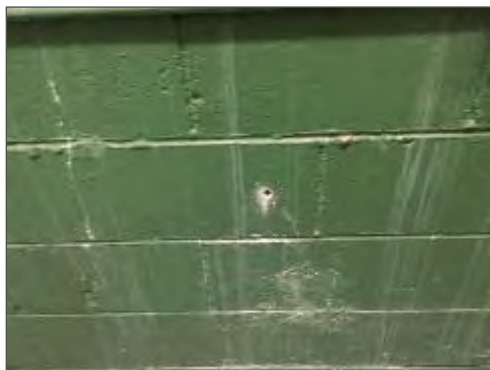
Destructive testing was conducted of masonry block walls. The masonry block walls were penetrated at representative locations, throughout 320 McRae Avenue, as well as at both 311 & 315 Tweedsmuir Avenue, loose fill vermiculite was not observed within the cavities. The locations of destructive testing have been indicated on the drawings in Appendix I.

No vermiculite was present in the block walls at 320 McRae Avenue.

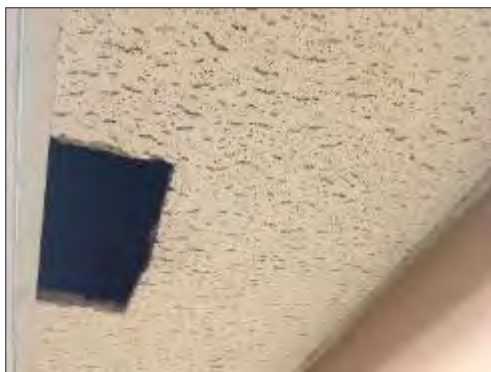
Non-asbestos acoustic ceiling tiles, 24"x48" with width-wise fissures and pinholes, present in Office 1 at 320 McRae Avenue.

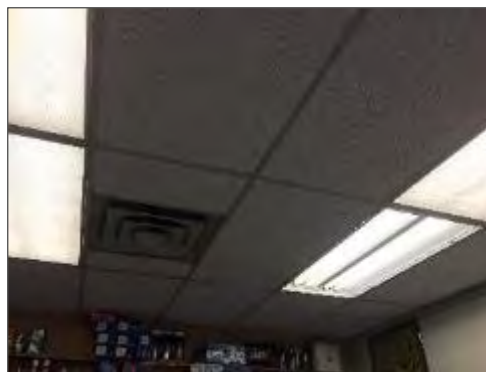
The ceiling tile in Photo 5 is presumed to be non-asbestos based on the date of manufacture determined from the date stamp applied to the top of the tiles. The tiles were manufactured after asbestos was stopped being used in acoustic ceiling tiles.

Non-asbestos acoustic ceiling tiles, 24"x48" with non-directional fissures and pinholes, present in Garage 1 at 320 McRae Avenue.

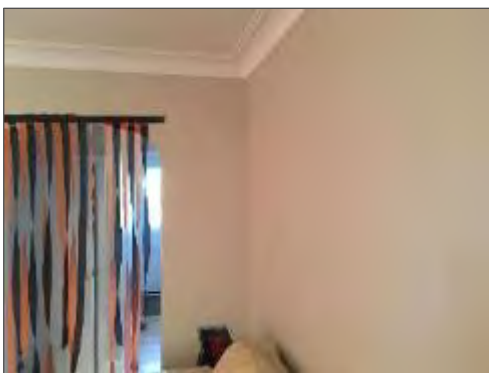
Smooth plaster, containing chrysotile asbestos in the base coat, is present on walls and ceilings, throughout the assessed area at 311 Tweedsmuir Avenue (samples 0030A-E). The plaster is applied to wood lath. Plaster is a non-friable material which may become friable during removal. The plaster is in good condition.

Asbestos-containing smooth plaster on the walls at 311 Tweedsmuir Avenue.

Material	Location, Quantity & Condition	Recommended Procedure
Smooth plaster	Walls and ceilings throughout the house (2,000 ft ² , good condition)	Follow Type 3 abatement procedures according to O.Reg 278/05 for abatement of asbestos-containing smooth plaster
Textured plaster	Ceiling throughout the Living Room (500 ft ² , good condition)	Follow Type 3 abatement procedures according to O.Reg 278/05 for abatement of asbestos-containing textured plaster
Aggregate-embedded stucco	Exterior cladding (1500 ft ² , good condition)	Follow Type 3 abatement procedures according to O.Reg 278/05 for abatement of asbestos-containing aggregate-embedded stucco
Vinyl sheet flooring	Kitchen Front entrance (50 ft ² , good condition)	Follow Type 2 abatement procedures according to O.Reg 278/05 for abatement of asbestos-containing vinyl sheet flooring. If the flooring becomes friable on removal, be prepared to stop and implement Type 3 abatement procedures according to O. Reg. 278/05.

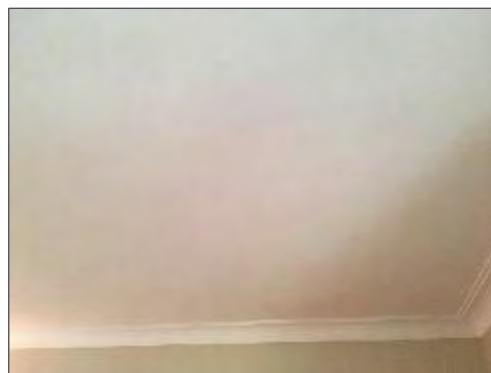
Textured plaster, containing chrysotile asbestos in the base coat, is present on ceilings, in the Living Room at 311 Tweedsmuir Avenue (samples 0031A-C). The plaster is applied to wood lath. Plaster is a non-friable material which may become friable during removal. The plaster is in good condition.

Asbestos-containing textured plaster on the ceiling at 311 Tweedsmuir Avenue.

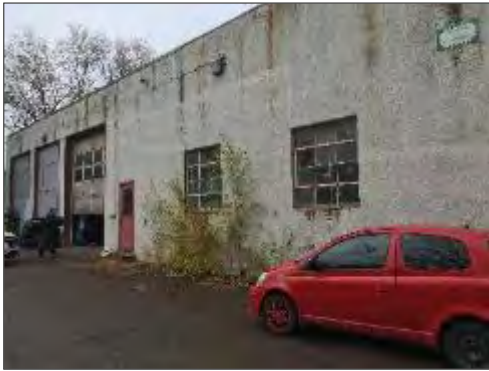
Aggregate-embedded stucco, containing chrysotile asbestos, is present as exterior cladding around Office 1, Garage 2, Garage 3 and Storage 2 at 320 McRae Avenue, as well as around both houses at 311 & 315 Tweedsmuir Avenue, (samples 0011A-C, 0012A-E, 0032A-E, 0040A-E). The stucco is applied to concrete. Stucco is a non-friable material which may become friable during removal. The stucco is painted, and in good condition.

Asbestos-containing aggregate-embedded stucco present on the exterior walls of Garage 2 and Storage 2 at 320 McRae Avenue.

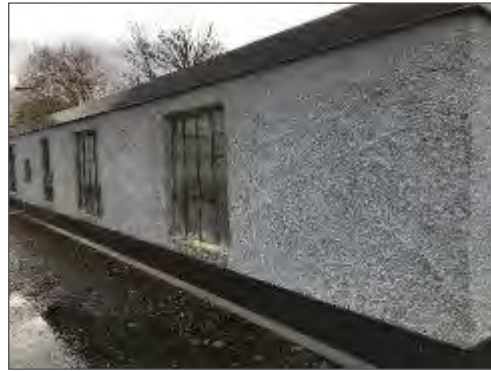
Asbestos-containing aggregate-embedded stucco present on the exterior walls of Storage 2 on the roof level at 320 McRae Avenue.

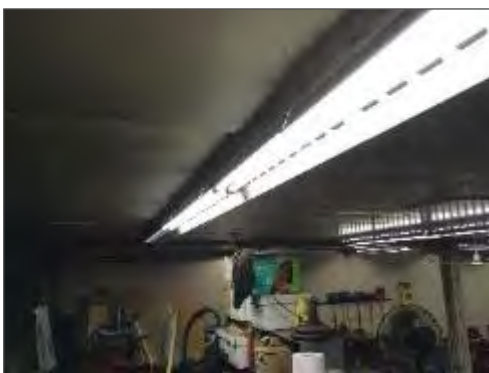
Drywall joint compound is a non-friable material, painted and is in good condition.

Asbestos-containing drywall joint compound present as the ceiling finish in Garage 2 and Storage 2 at 320 McRae Avenue.

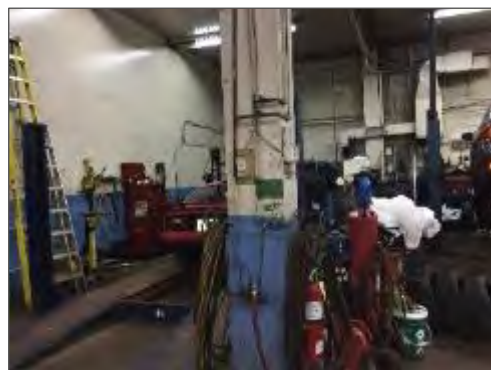
Asbestos-containing drywall joint compound present as the column finish in Garage 2 at 320 McRae Avenue.

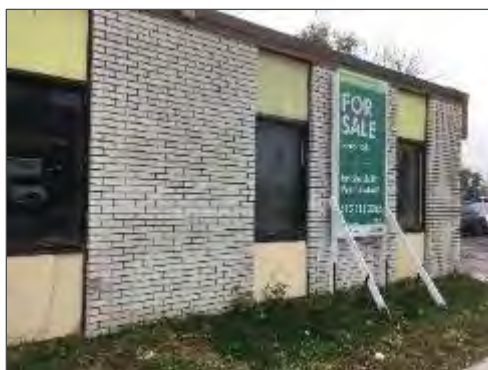
Cement board, containing chrysotile asbestos, is present as exterior cladding, above and below windows, on the East exterior around Offices 1 and 2 at 320 McRae Avenue (samples 0016A-C). The cement board is non-friable and is in good condition.

Asbestos-containing cement board present above and below the windows along Office 1 & 2 at 320 McRae Avenue.

Material	Location, Quantity & Condition	Recommended Procedure
Cement board	Office 1 and 2, east exterior wall (<80 ft ² , good condition)	Follow Type 1 abatement procedures according to O.Reg 278/05 for abatement of asbestos-containing cement board, using only non-powered hand tools, without cutting drilling breaking or abrading the material.
Swirl Textured Finish	Office 2, upper wall (150 ft ² , good condition)	Follow Type 3 abatement procedures according to O.Reg 278/05 for abatement of asbestos-containing swirl textured finish.
Aggregate-embedded stucco	Garage 2, Storage 2 and upper roof Storage 2 (2,400 ft ² , good condition) Garage 3 and Storage 3 (300 ft ² , good condition)	Follow Type 3 abatement procedures according to O.Reg 278/05 for abatement of asbestos-containing aggregate-embedded stucco.
Drywall joint compound	Office 1 and 2 (1330 ft ² , good condition) Garage 2 and Storage 2 (5000 ft ² , good condition)	Follow Type 2 abatement procedures according to O.Reg 278/05 for abatement of asbestos-containing drywall joint compound, using only non-powered hand tools.

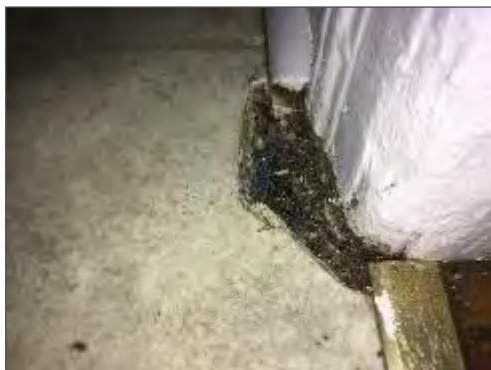
The vinyl sheet flooring is non-friable but can become friable upon removal due to the separation of the vinyl face and paper backing. Vinyl sheet flooring is in good condition.

Asbestos-containing vinyl sheet flooring present in the multi-layered flooring at 311 Tweedsmuir Avenue.

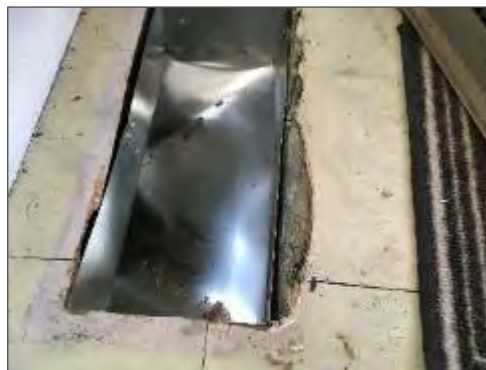
Asbestos-containing vinyl sheet flooring present as the base layer in the front entrance at 311 Tweedsmuir Avenue.

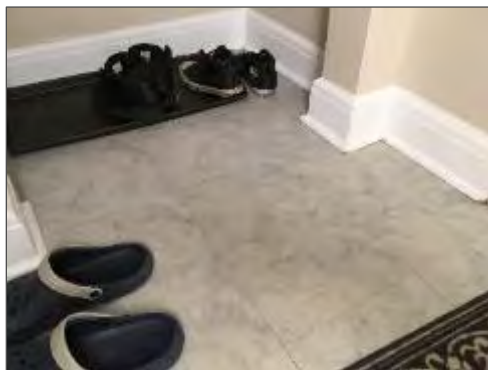
Non-asbestos peel and stick vinyl floor tiles present in the front entrance at 311 Tweedsmuir Avenue. **Asbestos-containing** vinyl sheet flooring is present underneath, as the base layer.

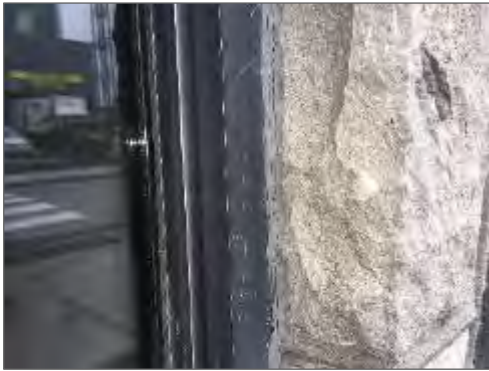
Asbestos-containing black caulking present around the east window frames at 320 McRae Avenue.

Black caulking	East exterior windows of Office 1 & 2, Garage 1 (80LF, good condition)	Follow Type 1 abatement procedures according to O.Reg 278/05 for abatement of asbestos-containing caulking.
White caulking	Exterior south door of Garage 2 (18LF, good condition)	Follow Type 1 abatement procedures according to O.Reg 278/05 for abatement of asbestos-containing caulking.

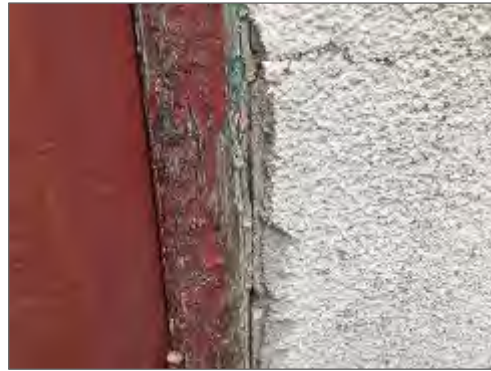
Asbestos-containing white caulking present around the south exterior door frame at 320 McRae Avenue.

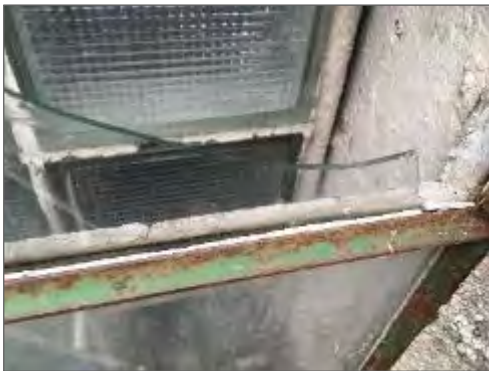
Asbestos-containing white putty present around the east window frames on the roof level at 320 McRae Avenue.

Material	Location, Quantity & Condition	Recommended Procedure
White putty	East exterior window glazing on Storage 2, Roof Level 2 (40 LF, good condition)	Follow Type 1 abatement procedures according to O.Reg 278/05 for abatement of asbestos-containing window putty.

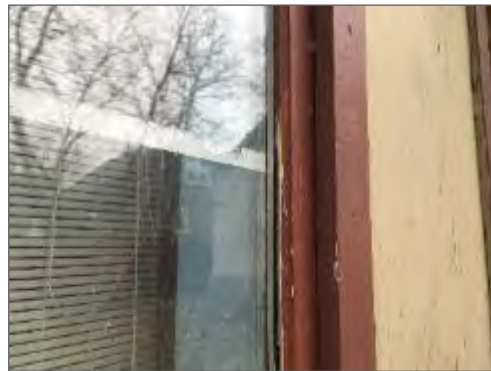
Asbestos-containing blue caulking present around the exterior window frame on the Garage at 315 Tweedsmuir Avenue.

Material	Location, Quantity & Condition	Recommended Procedure
Aggregate-embedded stucco	Exterior cladding (1,200 ft ² , good condition)	Follow Type 3 abatement procedures according to O.Reg 278/05 for abatement of asbestos-containing aggregate-embedded stucco
Window Caulking	Detached garage window (10 LF, good condition)	Follow Type 1 abatement procedures according to O.Reg 278/05 for abatement of asbestos-containing window caulking.

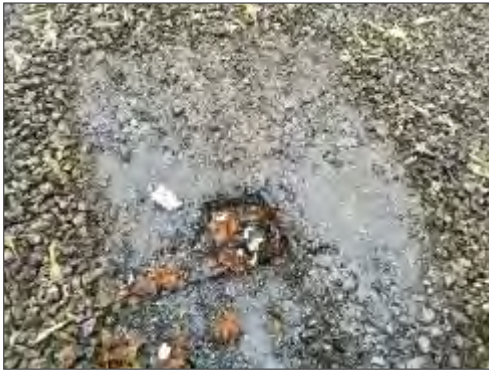
Non-asbestos built up roofing at 320 McRae Avenue.

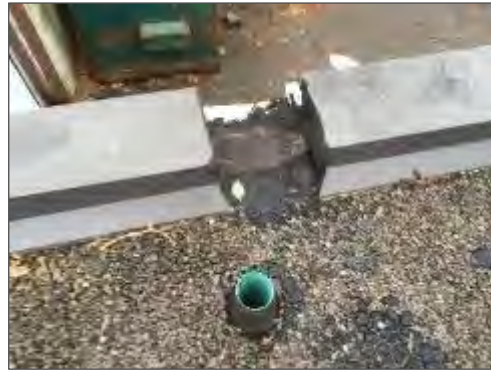
Non-asbestos tar on the roof at 320 McRae Avenue.

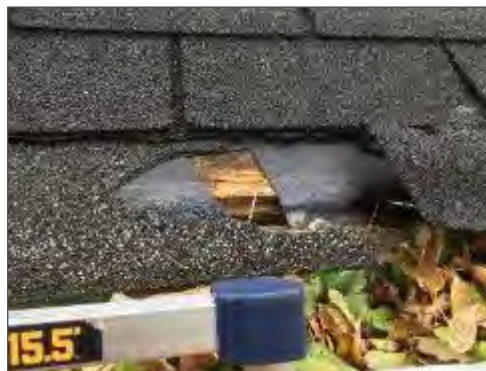
Tar Paper present on the roof at 315 Tweedsmuir Avenue does not contain asbestos (samples 0047A-C).

Non-asbestos tar paper present in the roof at 315 Tweedsmuir Avenue.

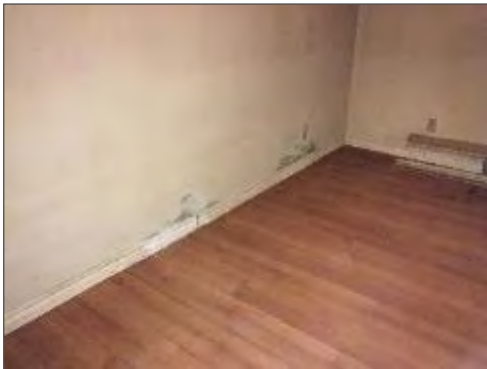
Visible mould growth and water staining is present on drywall walls in the Basement at 315 Tweedsmuir Avenue. There is approximately 100 sq ft of visible mould growth.

Mould present on the drywall walls in the Basement at 315 Tweedsmuir Avenue.

Material, Quantity & Condition	Location	Recommended Procedure
Walls and Ceilings, 315 Tweedsmuir Avenue, <100 ft ²	Basement bedroom and living room walls, main floor Bedroom 1 and living room ceilings, 2 nd floor unknown (no access), Garage ceiling	If any remedial activity of mould-impacted materials inside 315 Tweedsmuir Avenue is required, removal should be conducted in accordance with EACO Level 3 Procedures in the house and EACO Level 2 Procedures in the Garage.
		If the unit is to be mechanically demolished, from the exterior, equipment operators and adjacent property must be protected from the hazard with effective dust control.
		Note that other requirements related to the pre-demolition Type 3 abatement (O.Reg 278/05) of asbestos- containing exterior aggregate-embedded stucco finish also apply.

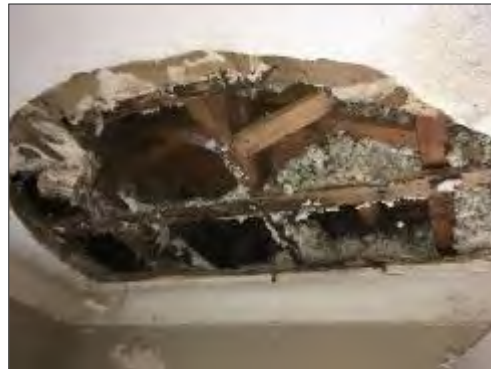
Mould present on the back side of the drywall/textured plaster ceiling finish in the front entrance at 315 Tweedsmuir Avenue.

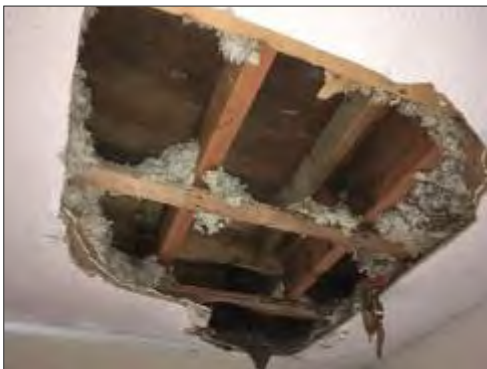
Mould present on the back side of the drywall/textured plaster ceiling finish in the front entrance at 315 Tweedsmuir Avenue.

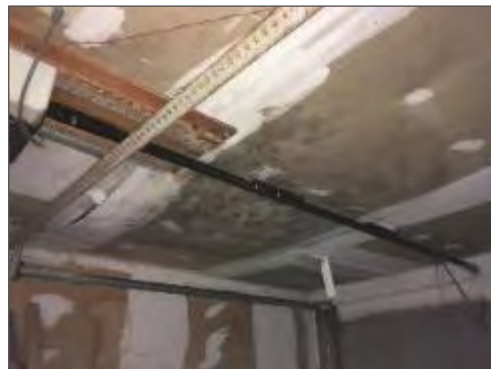
Visible mould growth and water staining is present on the drywall ceiling in the Garage at 315 Tweedsmuir Avenue. There is approximately 100 sq ft of visible mould growth.

Mould present on the drywall ceiling in the separate Garage at 315 Tweedsmuir Avenue.
