**Designated Substances Report**  
**177 & 179 Armstrong Street, Ottawa, Ontario**  
BCE PROJECT NUMBER **18-277**

September 23<sup>rd</sup>, 2018

**PREPARED FOR:**  
Danic Holdings  
54 Magnolia Way, Unit 204  
Ottawa, On K0G 1J0

**PERFORMED BY:**  
Buller Crichton Environmental Inc.

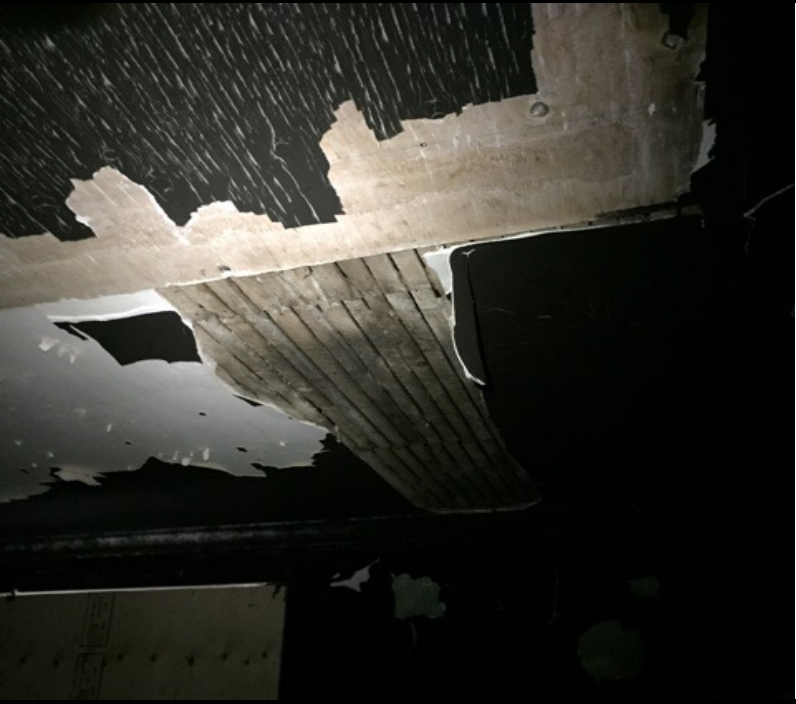
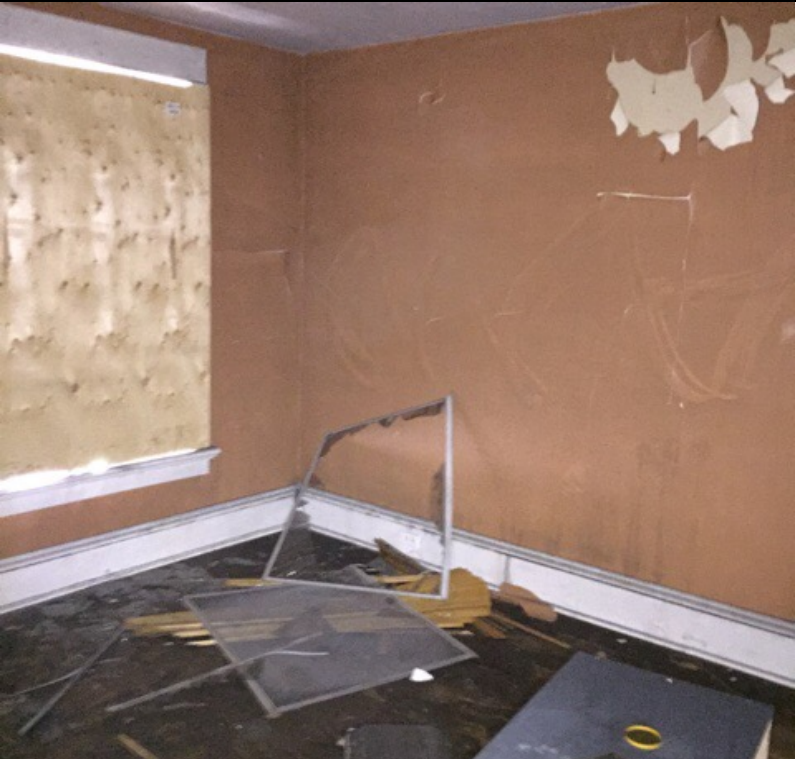
| Sample Reference | Material Description / Location | Results | Friable (Y/N) |
|---|---|---|---|
| AS-02A | Plaster (base and skim coat combined) / Walls and Ceilings Throughout | 1% CHRYSOTILE | N |

| Photo # | Location / Description | Photo |
|---|---|---|
| 1 | Asbestos Containing Plaster on Walls and Ceilings Throughout 179 Armstrong Street | |
| 2 | Asbestos Containing Plaster on Walls and Ceilings Throughout 179 Armstrong Street | |

Prior to demolition, all ACMs must be removed from the Site following procedures as prescribed in Ontario Regulation 278 / 05 – Designated Substance – Asbestos on Construction Sites and in Buildings and Repair Operations (O. Reg. 278 / 05).

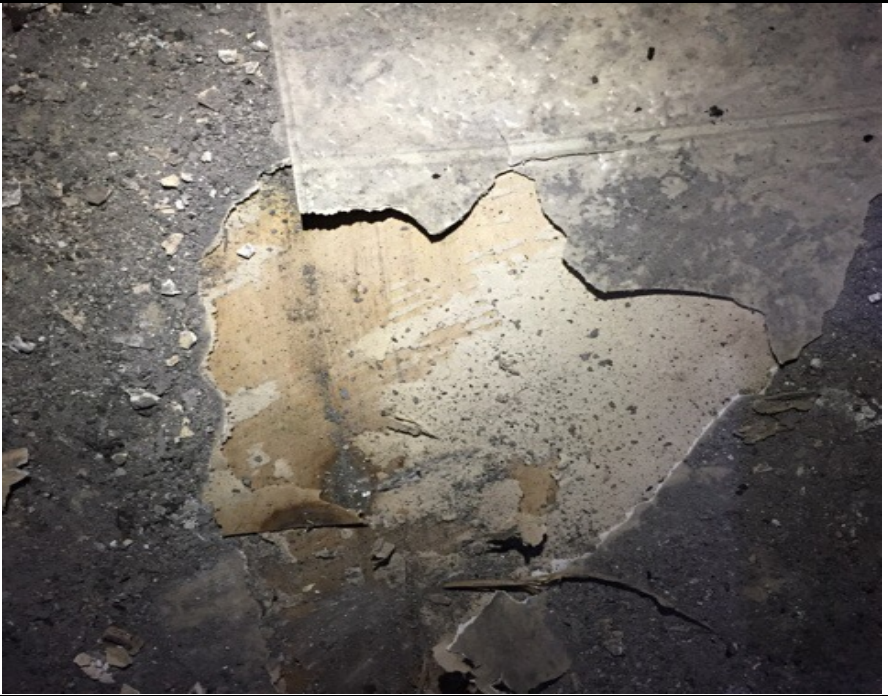
| Photo # | Location / Description | Photo |
|---|---|---|
| 3 | Asbestos Containing Flooring Materials Beneath Vinyl Floor in Second Floor Bathroom – 179 Armstrong Street | |

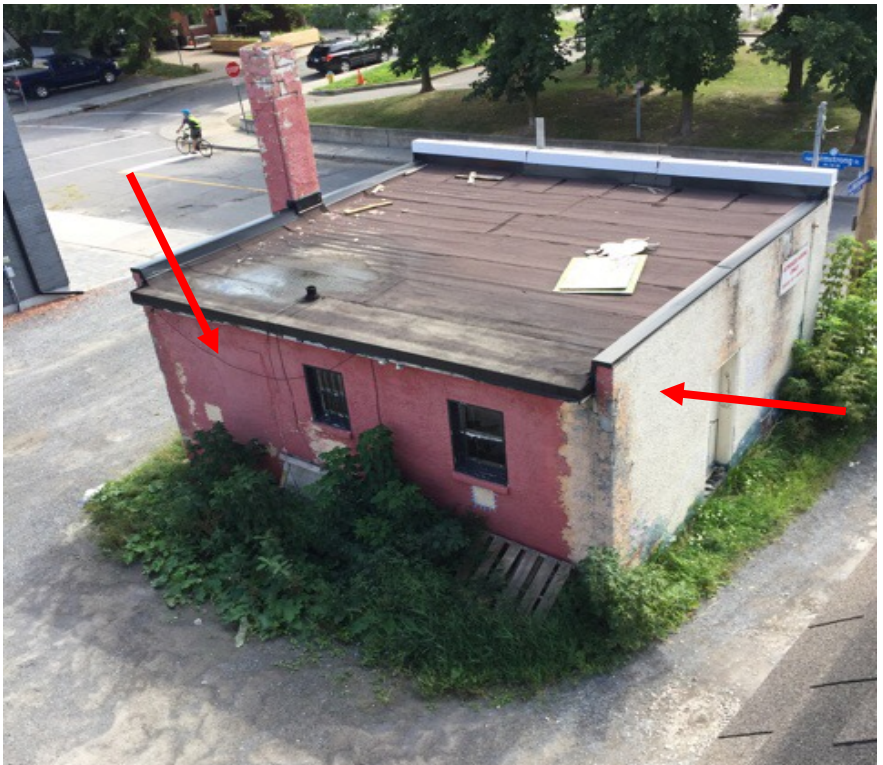
| Photo # | Location / Description | Photo |
|---|---|---|
| 4 | Asbestos Containing Plaster with Stone Inclusions – North, East and West Façade – 177 Armstrong Street | |

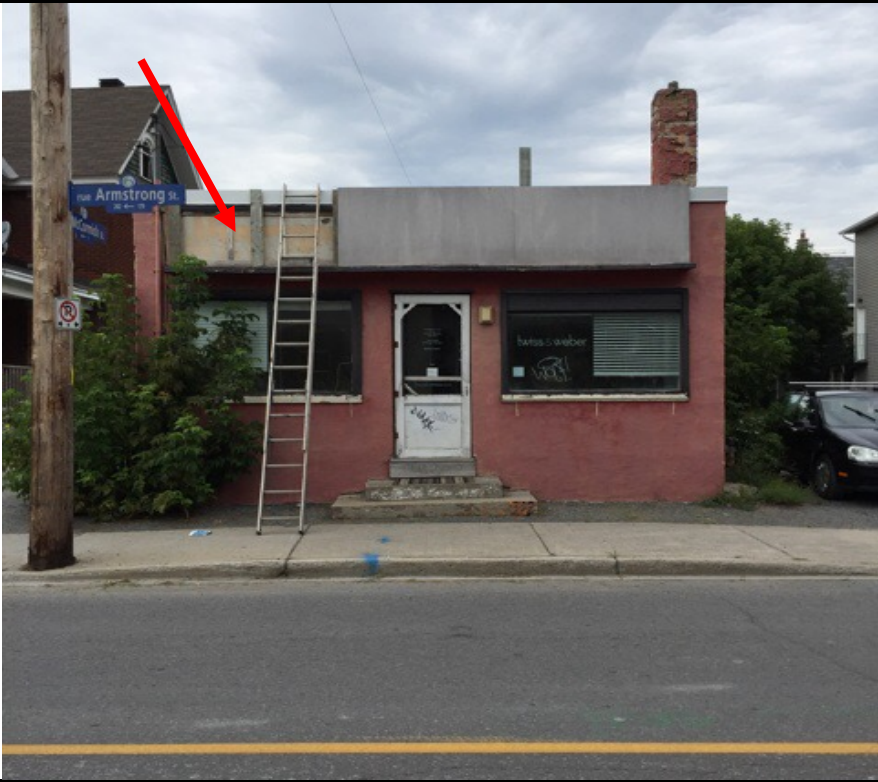
| 5 | Asbestos<br>Containing<br>Cement Board<br>Behind Sign –<br>177 Armstrong<br>Street | |

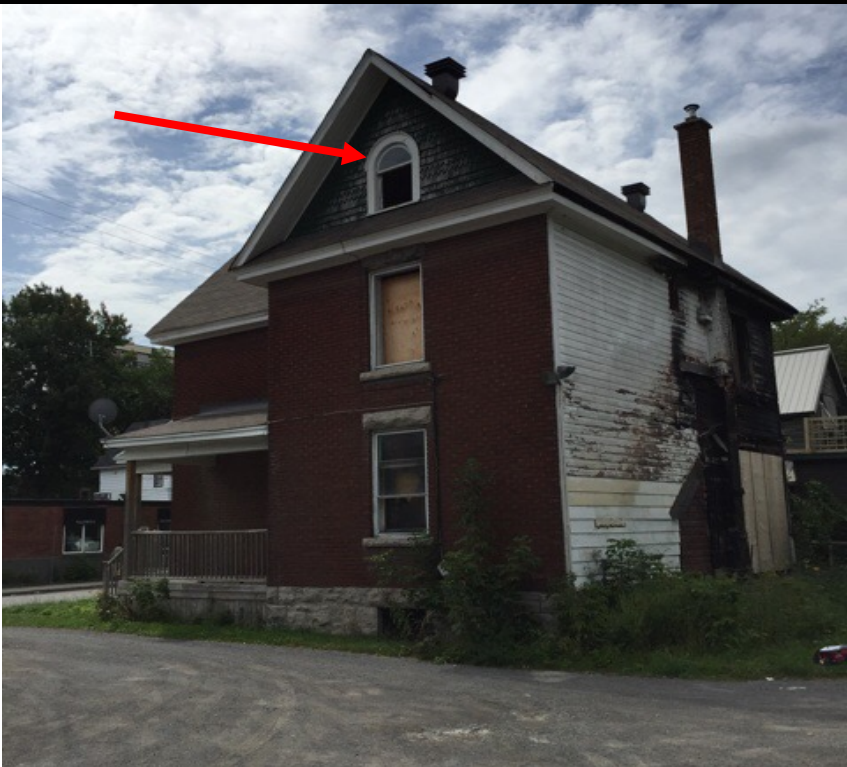
Five (5) samples of primary paint finishes were collected from the **179 Armstrong** with lead identified in all samples. High concentrations were found in the exterior white paint around windows. Low concentrations were identified in interior white, grey and cream paints on walls and ceilings as well as yellow paint in the entrance way and second floor hallway and rooms.

| 6 | Lead Containing<br>Paint on<br>Window Frames<br>– 179 Armstrong<br>Street | |

- 2) All workers present on site during demolition activities should be trained against the hazards of silica and lead exposure and provided with a respirator with P-100 High Efficiency Particulate Air (HEPA) filtration that is personally fit tested to the worker wearing it.

- 3) Water and ventilation should be used to keep dust levels to a minimum.
- 4) The work area should be isolated with banner tape warning of the hazards of silica and lead exposure. Workers within this isolated work area should be wearing the required personal protective equipment.

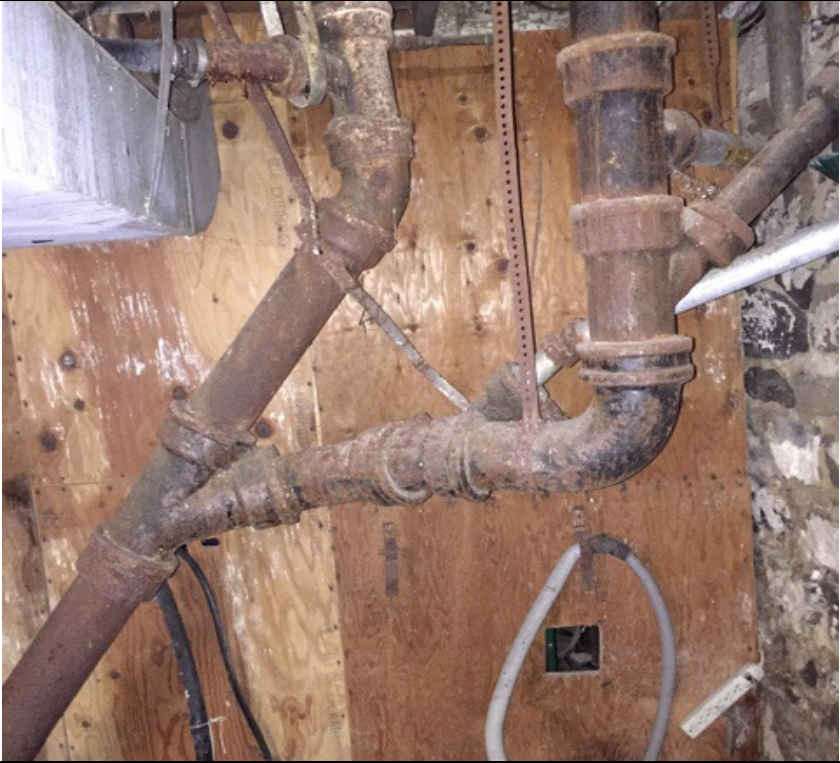
- 1) Cast Iron Bell Fitting Rope Caulking
  - a. A presumed asbestos-containing material (PACM) in the form of cast iron bell fitting rope caulking was identified throughout the basement of **both 177 & 179 Armstrong Street**. The noted material could not be sampled as sampling may break the joint seal. The noted material is known to contain >0.5% Amosite asbestos and must be treated as an ACM.
    - i. Approximately six (6) large and nine (9) small bell fittings at **177 Armstrong** and twenty-one (21) small bell fittings at **179 Armstrong** were identified.

| 7 | An Example of a Presumed Asbestos Containing in Bell Fittings | |
