**TREE INVENTORY, PRESERVATION PLANS, AND  
TREE CONSERVATION REPORT**

**4 RANGE ROAD MULTI-UNIT RESIDENTIAL DEVELOPMENT,  
CITY OF OTTAWA, ONTARIO**

**JULY, 2020**

**OUR FILE: LA 473-20**

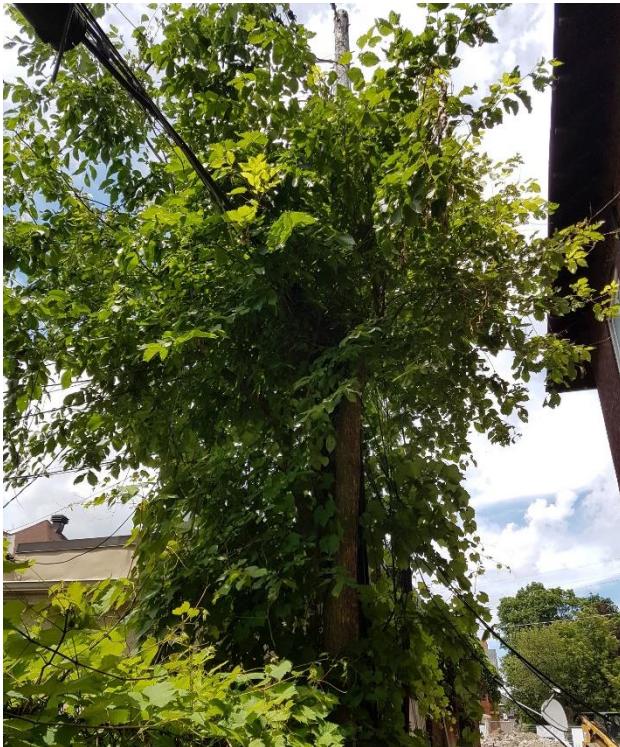
Many of the trees observed in the Table above are native and indigenous to the area and many of the assessed trees appeared to be in poor to marginal health given the lack of sunlight, and close proximity to the existing building. The advanced growth of Riverbank Grape Vine (Tree No.1) and the existing building impacting the root zones (Trees nos. 2, 3 and 4) exacerbates the poor health of the trees through water/nutrient uptake and competition for light which is vital for continued health. (**See Photo A, B & C in Appendix D**)

**Photo A:** Showing advanced growth of Riverbank Grape Vine, blocking sunlight to on-site trees.

In addition, further attention to the retained existing trees post development will significantly benefit the trees. The inclusion of planting beds, sod instead of asphalt, managing and eliminating existing vines (Riverbank Grape/Virginia Creeper), pruning by qualified personnel, and regular watering/care will not only mitigate any negative impacts caused by the development but also further benefit the trees in the future.

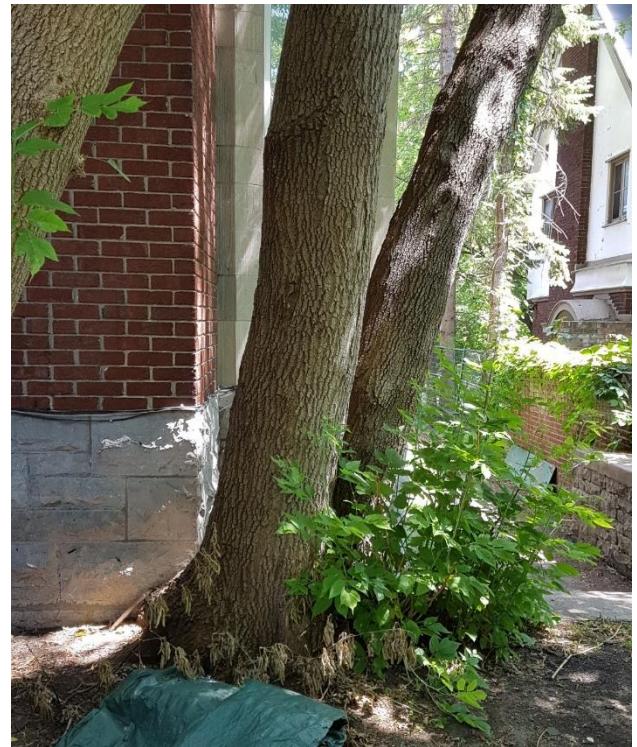
LEGroup staff observed trees with multiple trunks, trunk wounds (cracks), insects (carpenter ants), trunk crossover (merged basal flare), and suspected interior decay (Trees Nos. 2, 3, and 4), all of which are in close proximity to the existing building and are undermining the foundation and existing retaining wall (**see Photos B & C in Appendix D**). In addition, 3 White Spruce along the western boundary (trees nos. 6, 7 and 8) showed defects including branch dieback, exposed roots, minor sap bleeding, and the growth of the Virginia Creeper Vine.

**Photo B:** Showing multiple trunks, trunk crossover, and close proximity to the existing building characteristic of the Manitoba Maples

The remaining trees (Trees Nos. 1-5), due to their poor to marginal condition combined with their location within the expected development area, are recommended for removal to accommodate the development since the grading in the treed area of the site is expected to change.

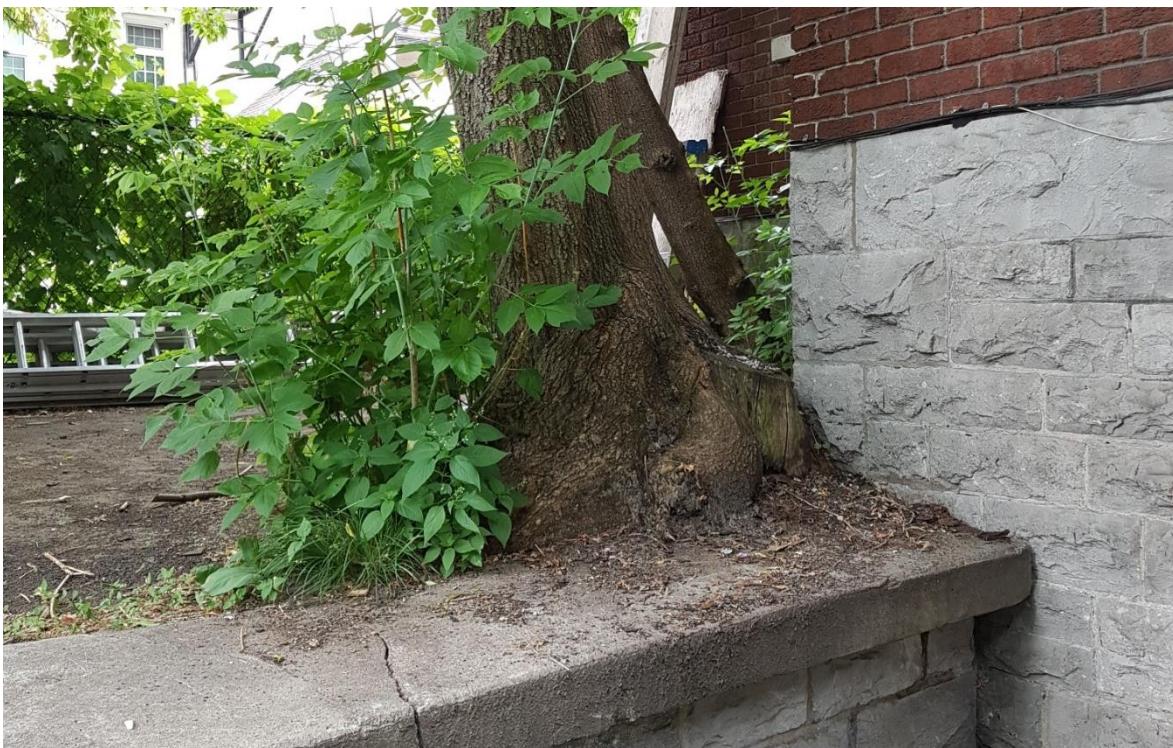
**Photo C:** Showing root system of a Manitoba Maple undermining the foundation of the existing building as well as the existing retaining wall.

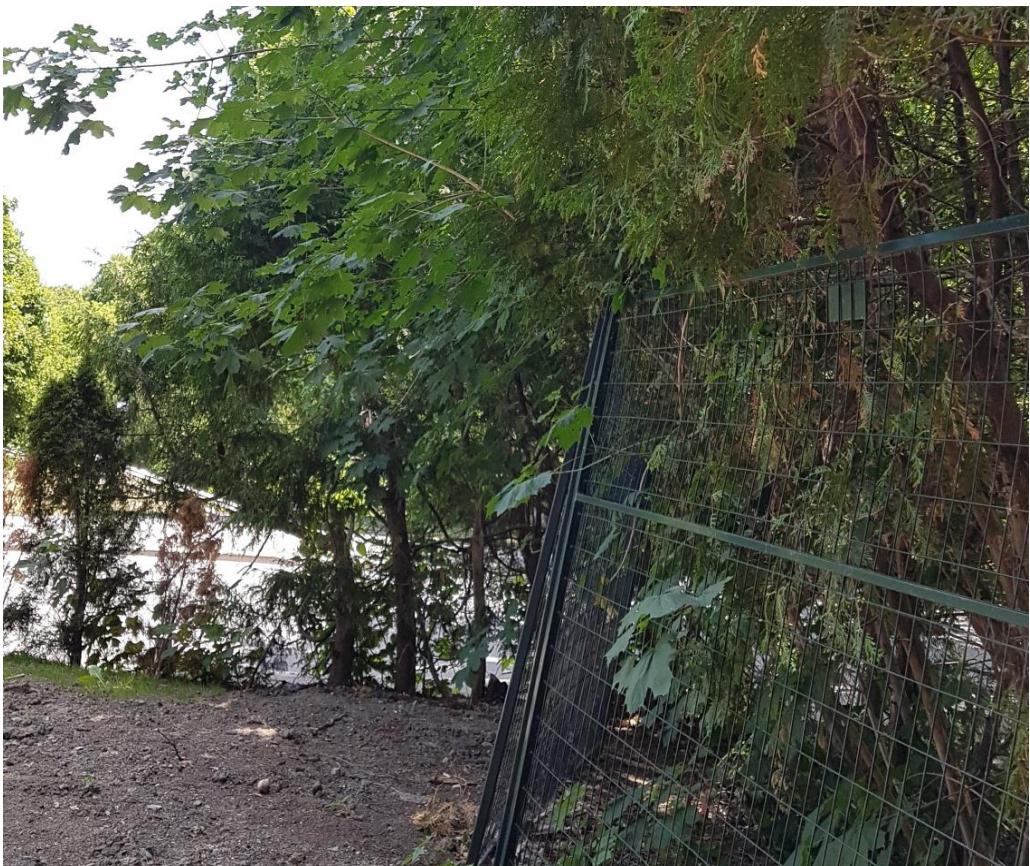
On the north east corner of the site, there is a cedar hedge made up of trees nos. 9-13 (**see Photos D & E in Appendix D**). Trees in this area were observed to have thin canopies, offset canopies, one sided branching, trunk wounds, and seem to be competing for light with a large offsite Sugar Maple.

The cedar hedge abutting Range Road (Trees Nos. 9-13), while in poor to marginal condition, provides both a visual buffer as well as a barrier to urban noise. All on-site trees would also contribute to stormwater management, however trees in poor condition would not be absorbing nearly as much CO<sub>2</sub> as a healthy tree.

**Photo D:** Showing Cedar hedge (trees nos. 9-13) to remain

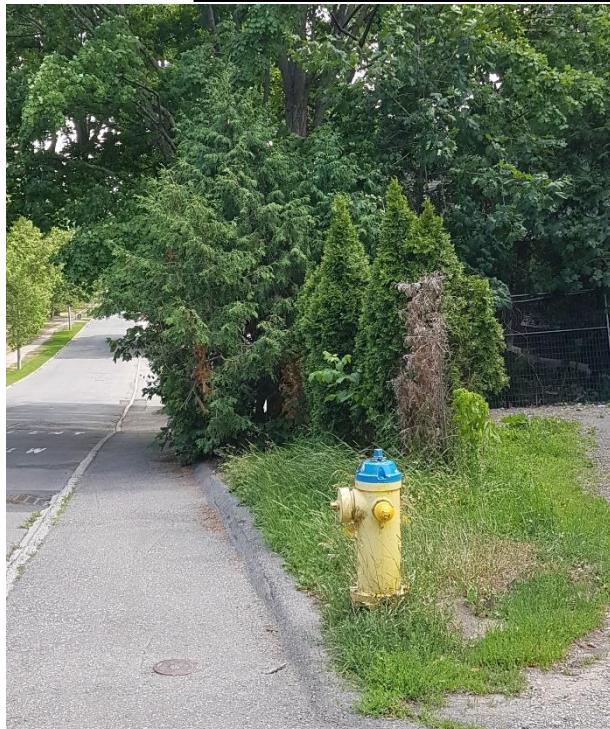
**Photo E:** Showing Cedar hedge (trees nos. 9-13) to remain

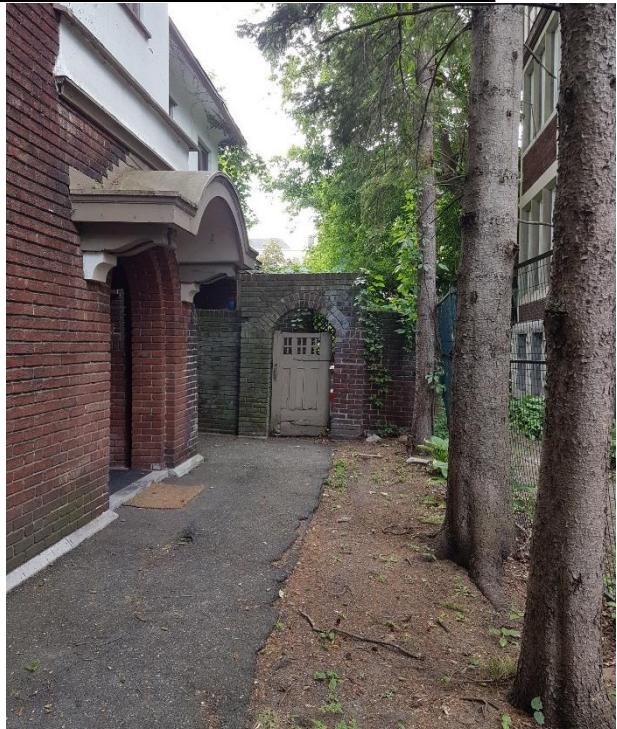
We note that there are a number of trees that were recorded to be over 10cm dbh that are recommended for retention (Tree Nos. 6, 7, 8, 9, 10, 11, 12 and 13 as set out in **Appendix C**) due to their optimum location and buffering/screening potential. (**see Photo D, E, & F in Appendix D**) These trees are located mainly on the south east, corner of the site.

**Photo F:** Showing 3 White Spruce trees to remain and proximity to existing building.
