Clifton Road Arborist Report

Clifton Property Development, City of Ottawa

Date: August 28, 2020

Arborist Report

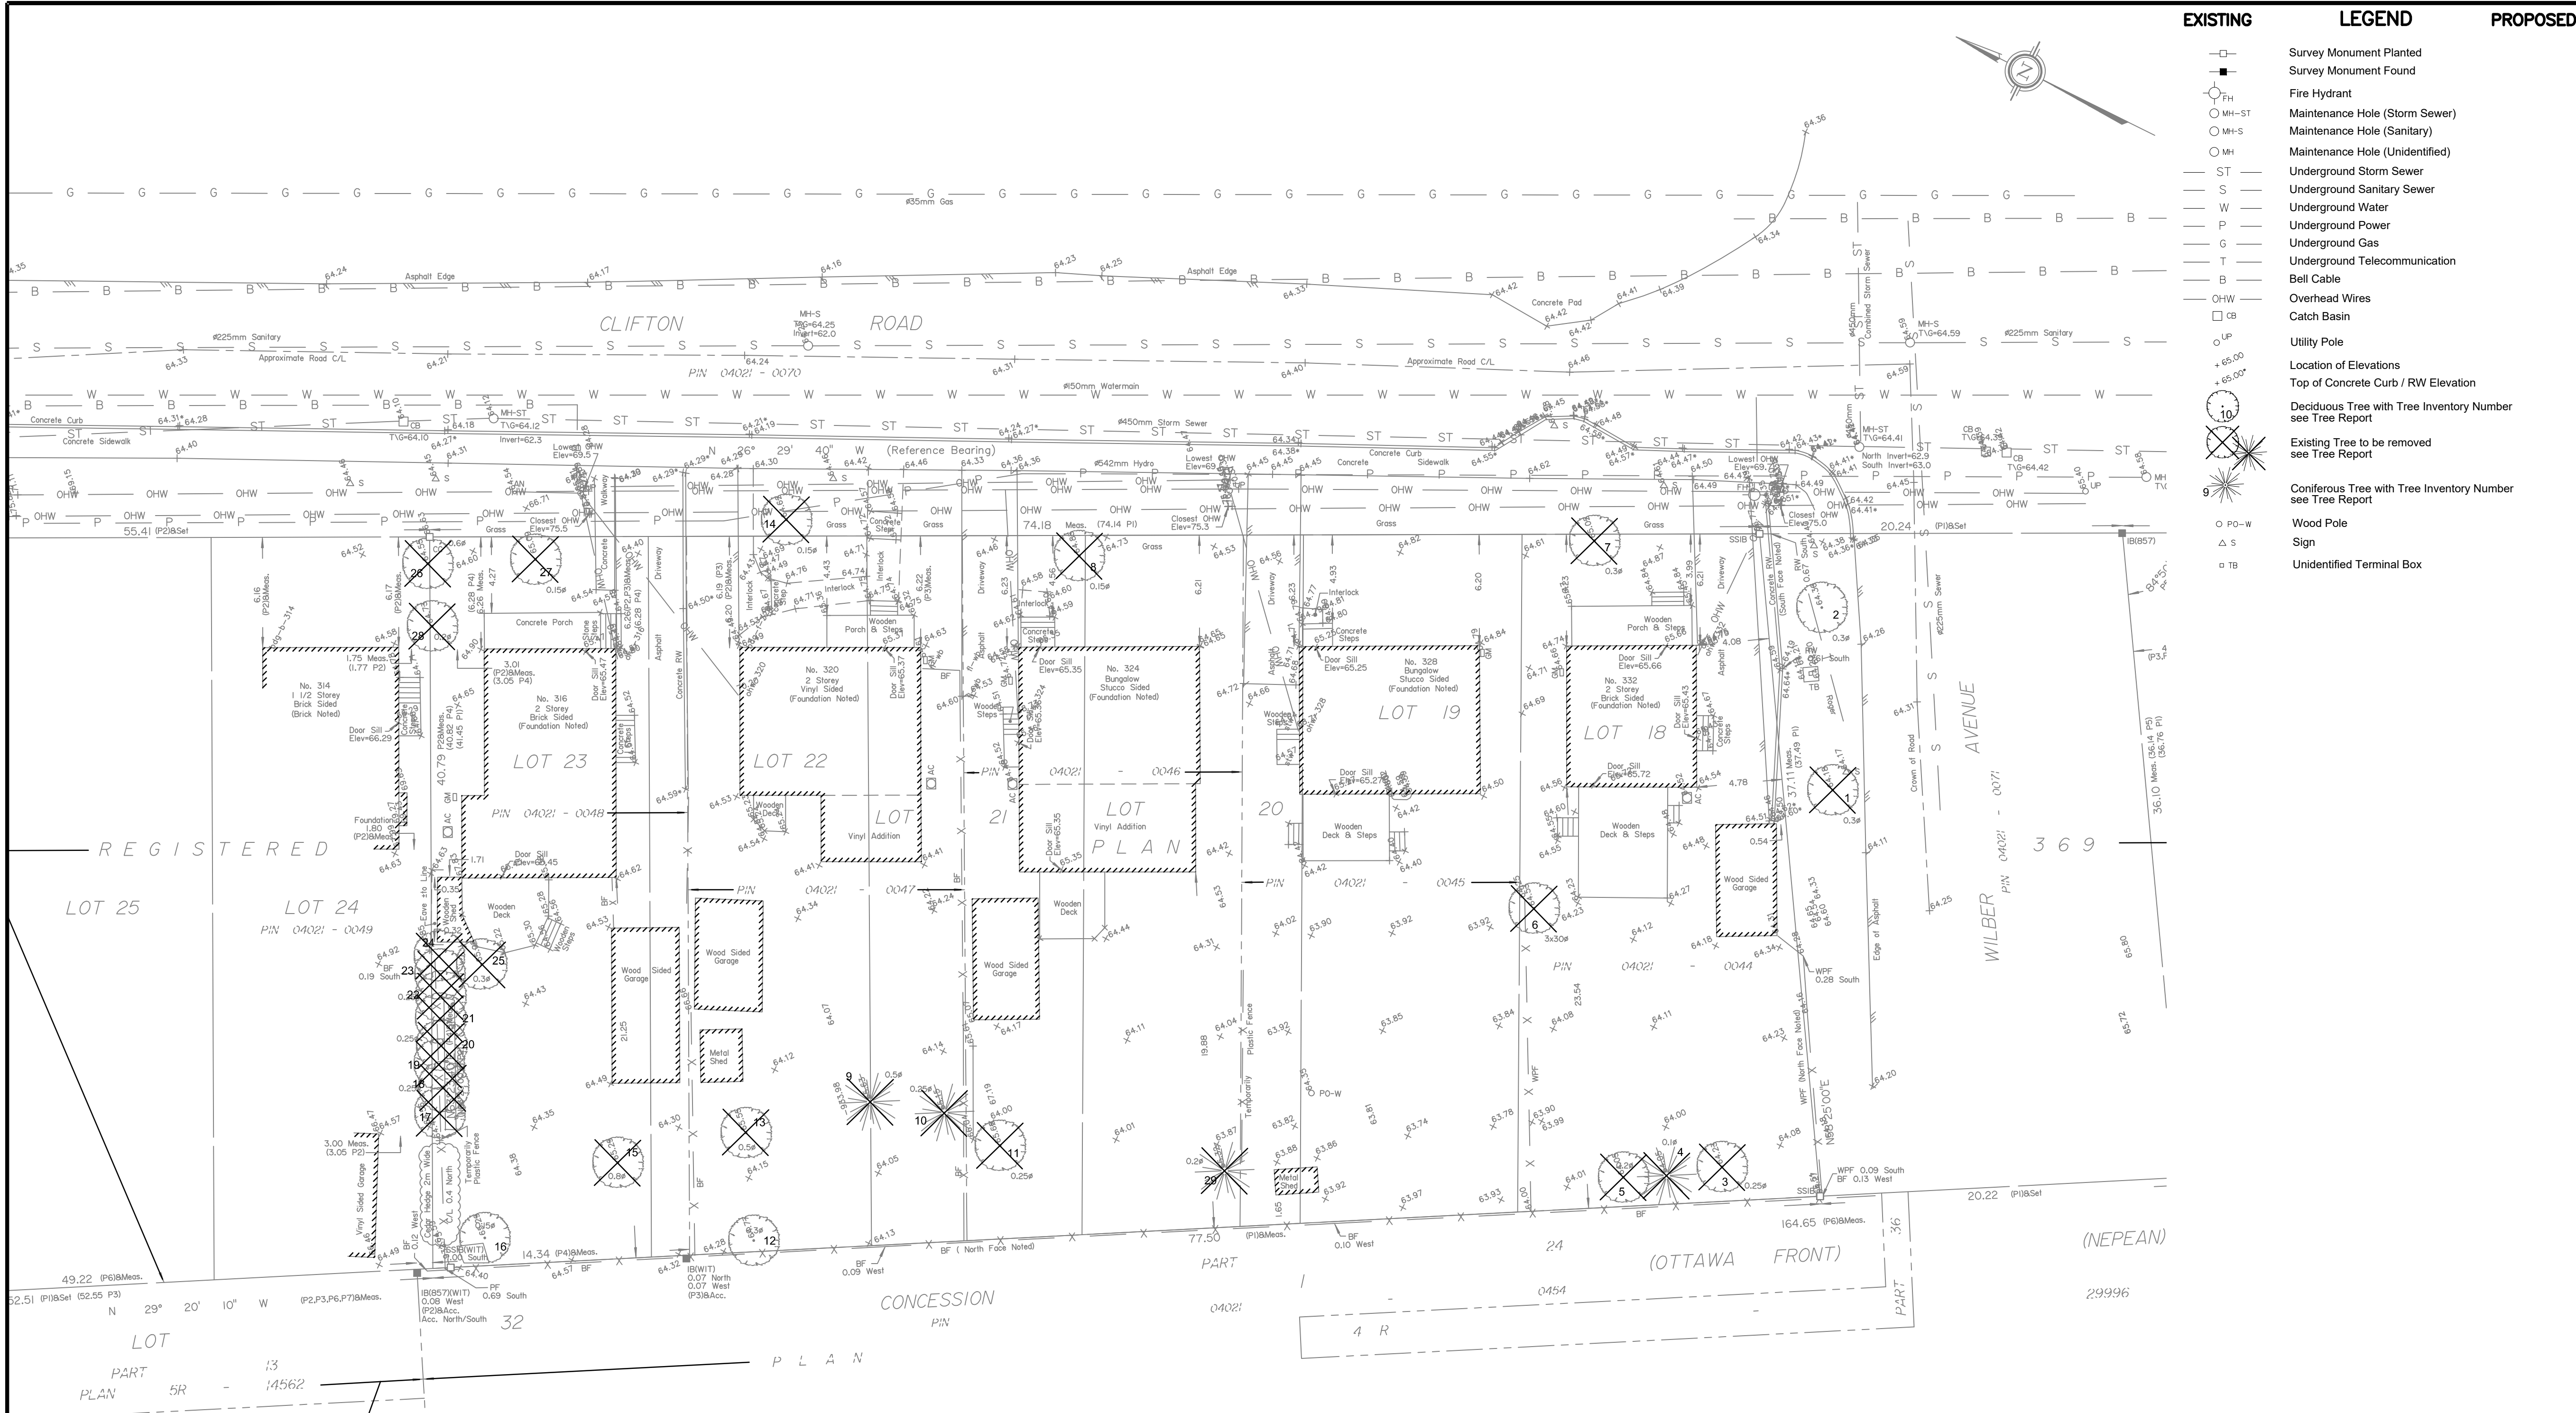
SHEET TITLE: **TREE INVENTORY AND ASSESSMENT**

A total of 26 trees are expected to require removal to facilitate the proposed development. Trees #2, #12 and #16 are to be retained and protected.

Tree #	Common name	Scientific name	DBH (cm) * approx.	Height (m)	Structural Defects							Overall Condition (O, (P), (F), (G), or (E))	Tree Impacts (Injure / Remove)	Comments	
					GR	COD	NA	INCL	CRB	M/R	DPR				SMD
1	Norway Maple	Acer platanoides	31	15			X	X	X			F	R	Canker	
2	Norway Maple	Acer platanoides	36	16								F	R	Canker	
3	Silver Maple	Acer saccharinum	24	15				X			X	F	R		
4	White Spruce	Picea glauca	14	12								F	R		
5	Littleleaf Linden	Tilia cordata	22	13				X				G	R		
6	Manitoba Maple	Acer negundo	41	20	X							G	R		
7	Ivory Silk Tree	Syringa reticulata	33	6	X				X	X	F	R			
8	Poplar	Populus sp.	21	10	X						X	F	R		
9	White Pine	Pinus strobus	51	18			X					F	R		
10	White Pine	Pinus strobus	30	18						X		F	R	Invasive buckthorn undergrowth	
11	Norway Maple	Acer platanoides	23	12								F	R		
12	Norway Maple	Acer platanoides	47	14		X	X	X				F	R		
13	Bur Oak	Quercus macrocarpa	52	17					X	X	X	P	R

14	Amur Maple	Acer ginnala	22	7	X							F	R	Crown appears to have been pruned due to proximity of power lines	
15	Silver Maple	Acer saccharinum	71	16	X			X	X	X	F	R		Canker	
16	Common Hackberry	Celtis occidentalis	19	10					X			F	R		
17	Norway Maple	Acer platanoides	22	15	X	X			X			G	R	4 codominant trunks at breast height. Invasive buckthorn	
18	Norway Maple	Acer platanoides	22	15	X				X			G	R	Small invasive buckthorn around tree base	
19	Norway Maple	Acer platanoides	16	15			X		X			P	R	Horizontal shear of bark around entire circumference of tree. Potential hazard.	
20	Norway Maple	Acer platanoides	21	15								F	R		
21	Norway Maple	Acer platanoides	14	15					X			F	R	Part of tightly packed group of Norways	
22	Norway Maple	Acer platanoides	21	15	X	X			X	X		F	R	Codominant trunk above 2m. Second trunk removed. Cut point well healed	
23	Norway Maple	Acer platanoides	29	15	X				X	X		F	R	Canker	
24	Norway Maple	Acer platanoides	21	15				X	X	X		F	R	On boundary of 314 and 316. Canker. Branches high up

25	Norway Maple	Acer platanoides	32	16	X	X						F	R		
26	Norway Maple	Acer platanoides	34	12	X	X	X	X	X			F	R	Multiple codominant trunks	
27	Norway Maple Crimson King	Acer platanoides 'Crimson King'	17	6	X				X	X		G	R	Crown growing near power lines, but doesn't appear to have been cut back	
28	Norway Maple	Acer platanoides	32	11				X	X			G	R		
29	White Pine	Pinus strobus	20	15						X		F	R

The most typical construction damage to trees is root damage from compaction and severance. While the dripline of a tree's canopy is typically thought to be associated with the root area, the root zones can actually extend significantly beyond the dripline of the tree, sometimes up to 2 or 3 times the height of the tree. Some of the trees inventoried are growing close to the edge of the proposed construction and will be at risk of contact with, and damage from, heavy equipment. It is recommended that tree protection fencing be installed along the Minimum Tree Protection Zone prior to construction.

Generally, to protect trees, grade changes and construction activities that could cause soil compaction should be kept away from trees as much as possible. If roots will be damaged by excavation equipment, it is better to cut roots cleanly with sharp pruning tools rather than allow them to be torn by large equipment. Clean cuts will help to minimize decay and entry points for disease. If branches are likely to hang in the way of passing equipment, the branches should be pruned by a qualified arborist to avoid tearing and undue injury to the tree.
