# **Kizell Drain Downstream of 7000 Campeau Drive Geomorphological and Erosion Threshold Assessment**

**Kizell Drain  
Kanata, Ontario**

May 18, 2021  
PN20053

Report Title: Kizell Drain Downstream of 7000 Campeau Drive  
Geomorphological and Erosion Threshold Assessment

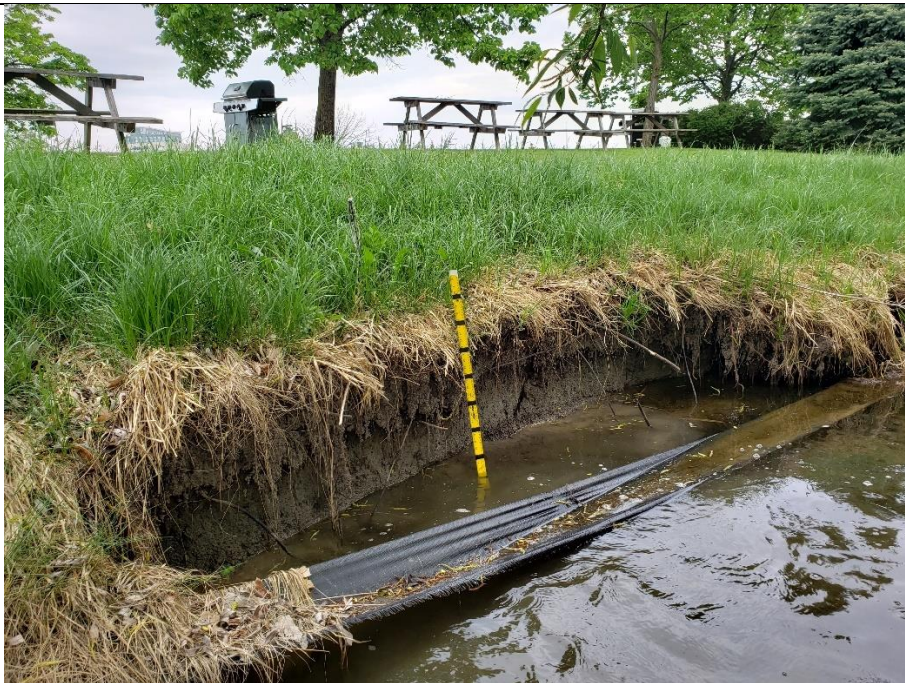
Kizell Drain, KDR-3 – Kanata, Ontario

In this instance of bank erosion, the riparian vegetation has been cut and maintained. The lack of riparian vegetation and rooting structure is assumed to have resulted in the increased erosion.

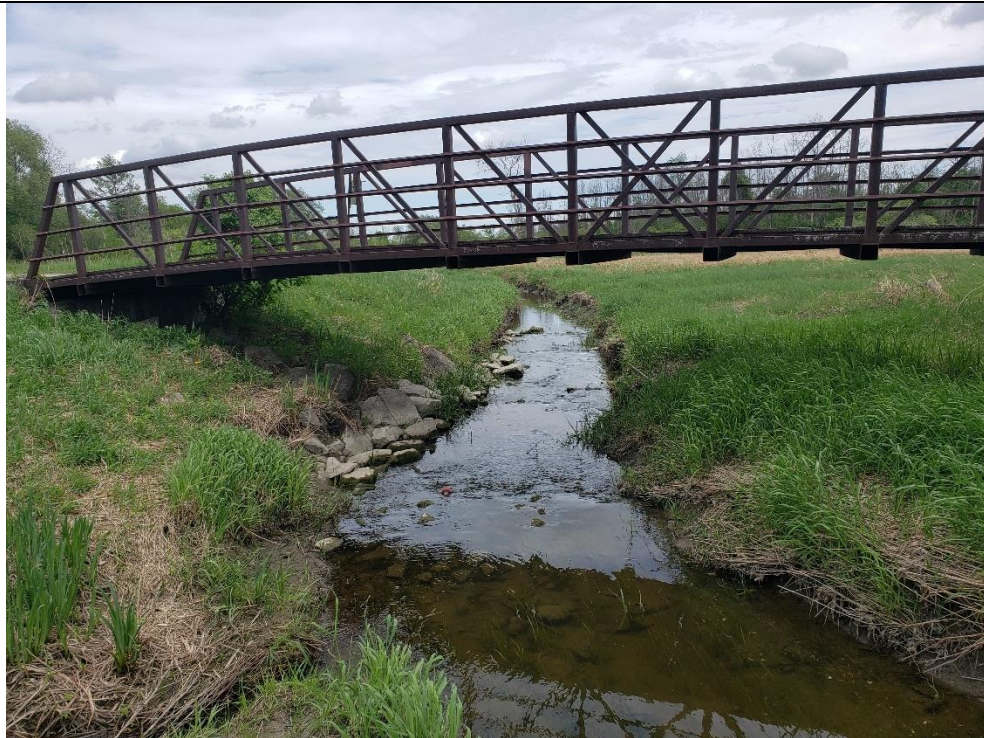
Kizell Drain, KDR-1 – Kanata, Ontario

Pedestrian bridge marking the upstream extent of KDR-1. Here, there is an approximately 15 m long riffle

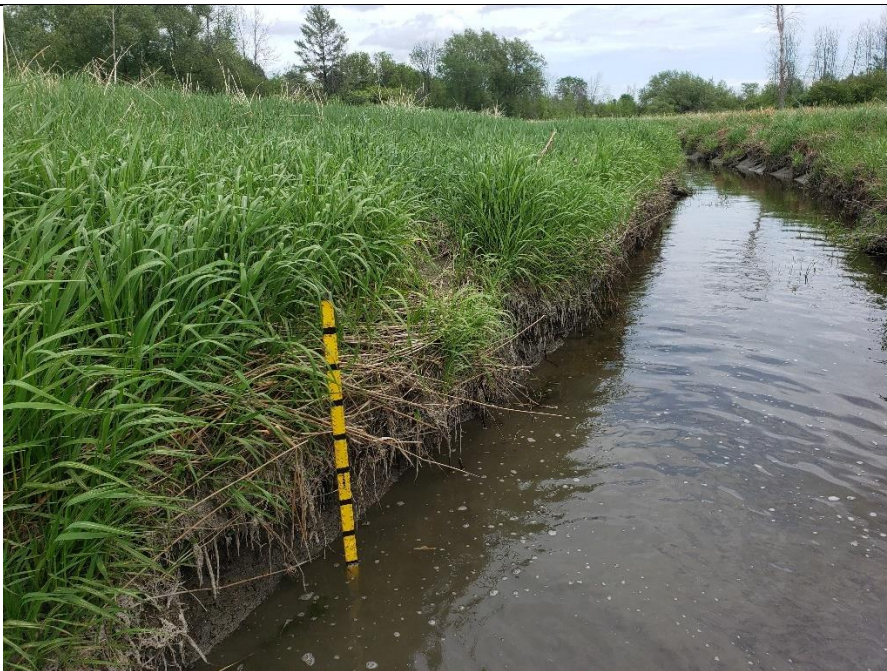
Kizell Drain, KDR-1 – Kanata, Ontario

KDR-1 is relatively straight and represents a section of the furthest downstream reach of the Kizell Drain before its confluence with Watts Creek. The channel in this location is incised into the compact clay at its bed with undercutting observed along the banks.

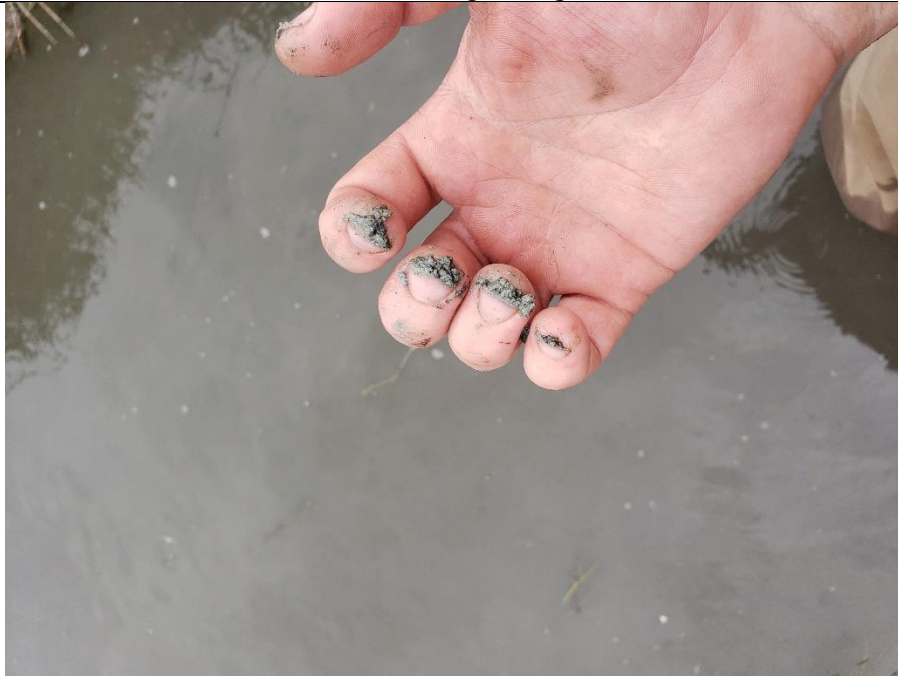
Kizell Drain, KDR-1 – Kanata, Ontario

Through the majority of the reach, the bed was composed of highly compact grey clay which could only be disturbed by scratching at the bed.
