PHASE ONE ENVIRONMENTAL SITE ASSESSMENT

**1161 Old Montreal Road
(Vacant Land, North of Old Montreal Road (Registered Plan 4R24727, Part of Part
1, Part of Lot 28 Concession 1 [Old Survey], Cumberland)
Ottawa, Ontario**

RiskCheck Project No. 29870

December 1, 2021

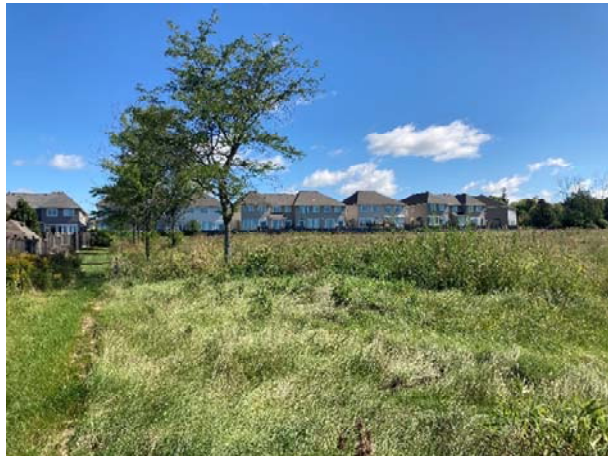
Photo 1.
View of the north portion of the Phase One Property, looking east from the northwest corner of the Phase One Property.

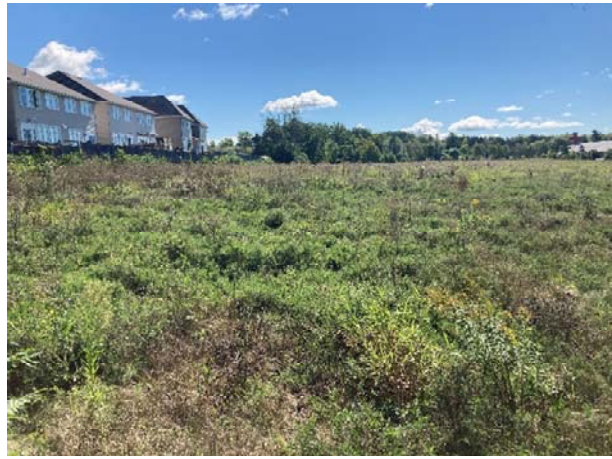
Photo 2.
View of the east portion of the Phase One Property, looking south from the northeast corner of the Phase One Property.

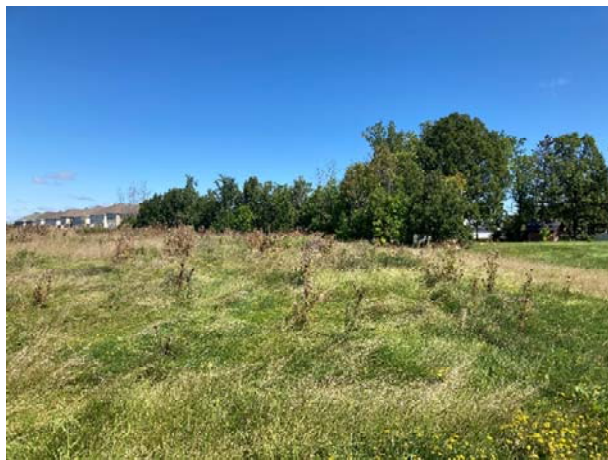
Photo 3.
View of the south portion of the Phase One Property, looking east from the southwest corner of the Phase One Property.

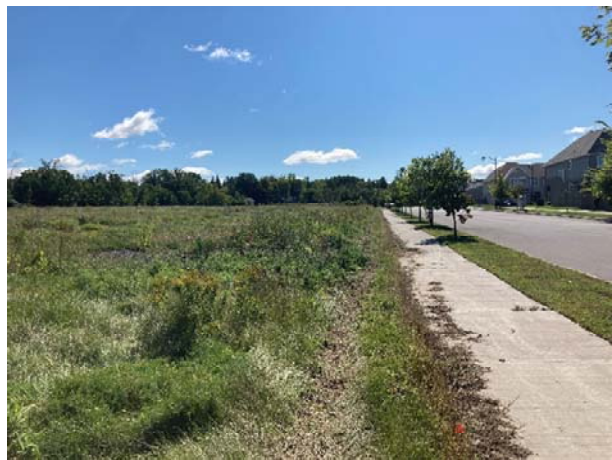
Photo 4.
View of the west portion of the Phase One Property, looking south from the northwest corner of the Phase One Property.

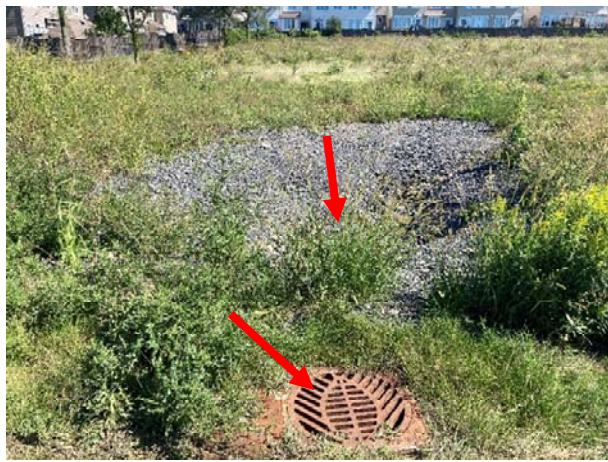
Photo 5.
View of the two catch basins (see arrows) observed on the northwest portion of the Phase One Property.

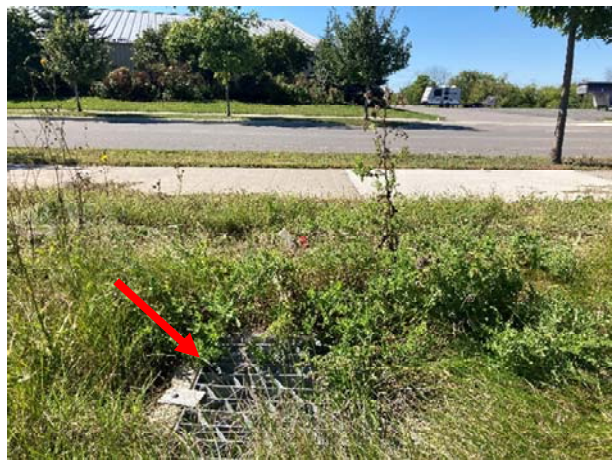
Photo 6.
View of the catch basin (see arrow) observed on the southwest portion of the Phase One Property.

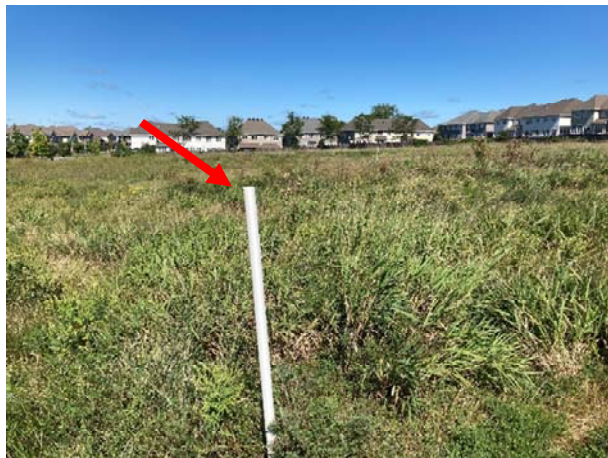
Photo 7.
View of a monitoring well (piezometer, see arrow) observed on the southeast portion of the Phase One Property.

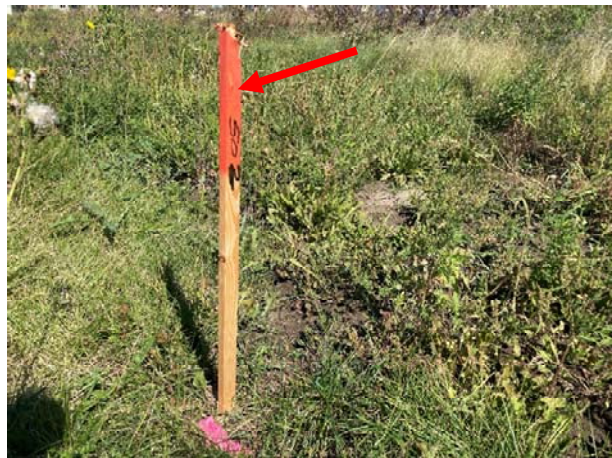
Photo 8.
View of the marked buried Hydro One electrical utility line (see arrow) observed adjacent to the west portion of the Phase One Property.

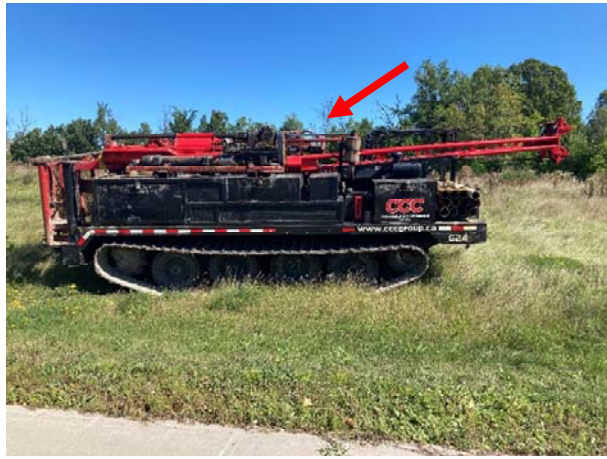
Photo 9.
View of the drill rig (see arrow) observed on the southwest portion of the Phase One Property.

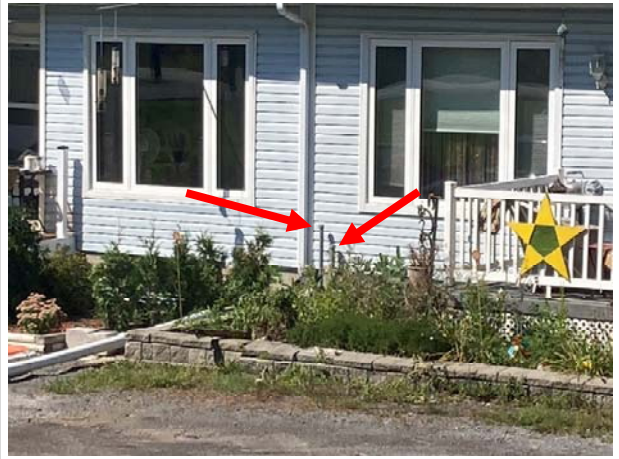
Photo 10.
View of the vent pipe (see left arrow) and fill pipe (see right arrow) observed on the neighbouring property to the southeast of the Phase One Property at 1201 Old Montreal Road.

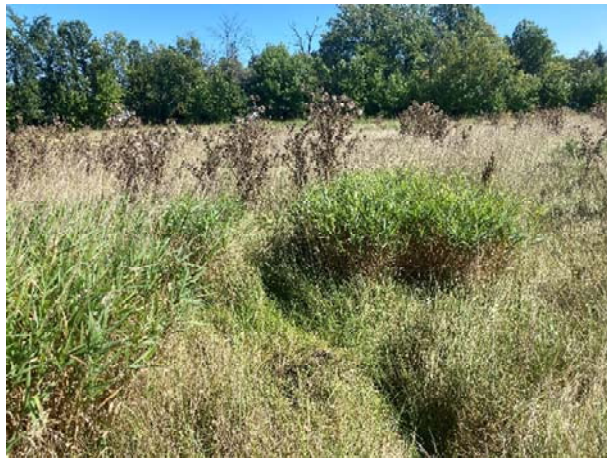
Photo 11.
View of a portion of the overgrown vegetation observed throughout the Phase One Property.

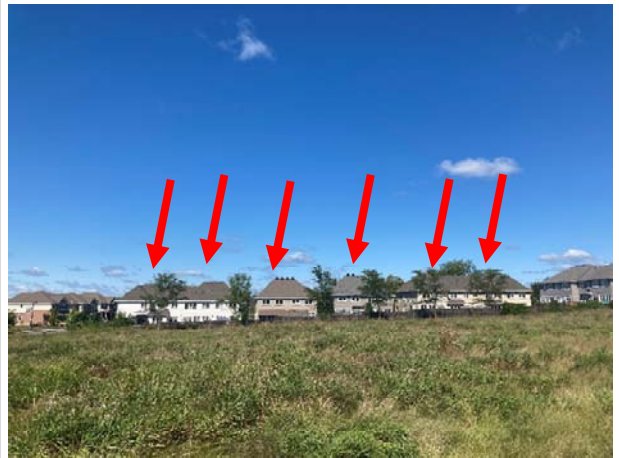
Photo 12.
View of the adjacent properties to the north at 300-322 Mishawashkode Street (see arrows), looking north from the central portion of the Phase One Property.

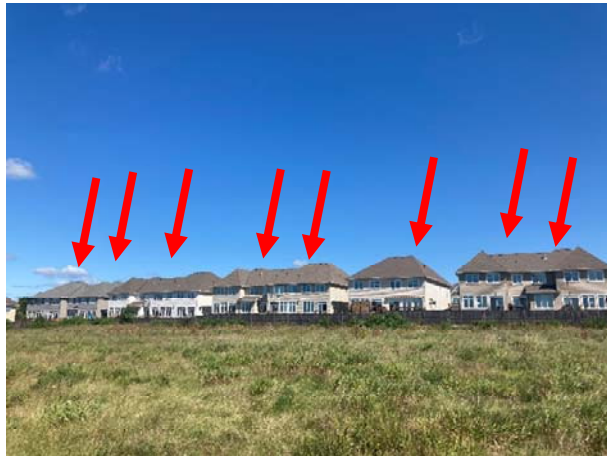
Photo 13.
View of the adjacent properties to the east at 685-709 Cartographe Street (see arrows), looking east from the west portion of the Phase One Property.

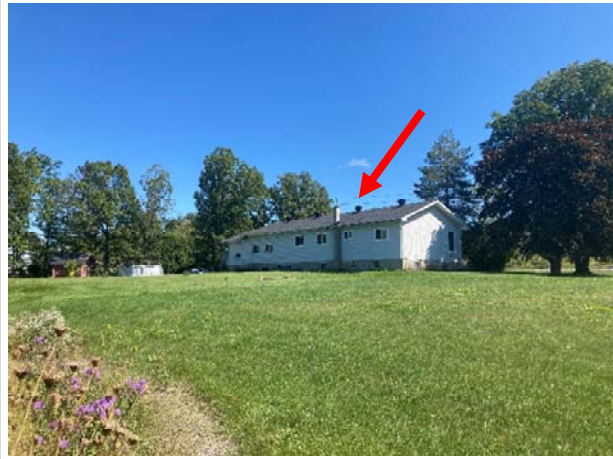
Photo 14.
View of the adjacent property to the south at 1171 Old Montreal Road (see arrow), looking southeast from the southwest corner of the Phase One Property.

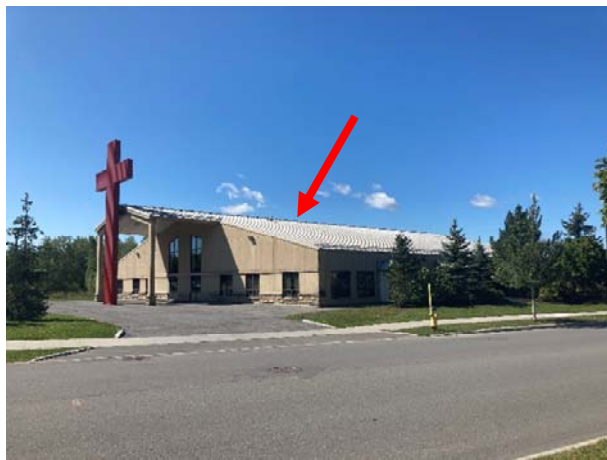
Photo 15.
View of the neighbouring property to the west (across Famille-Laporte Avenue) at 1123 Old Montreal Road (see arrow), looking northwest from across Famille-Laporte Avenue.

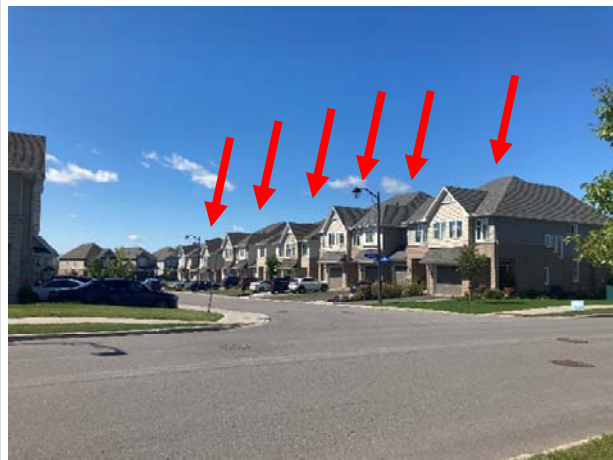
Photo 16.
View of the neighbouring properties to the west at 100-124 Minoterie Ridge (see arrows), looking northwest from the west Phase One Property boundary.
