Martin Chenier
Trim Road I LP
7 de Tellier
Gatineau, Québec
J8T 8C2

November 15, 2021

**Re.: Tree Conservation Report for 1009 Trim, Ottawa, Ontario – Rehabilitation Works
Phase 1**

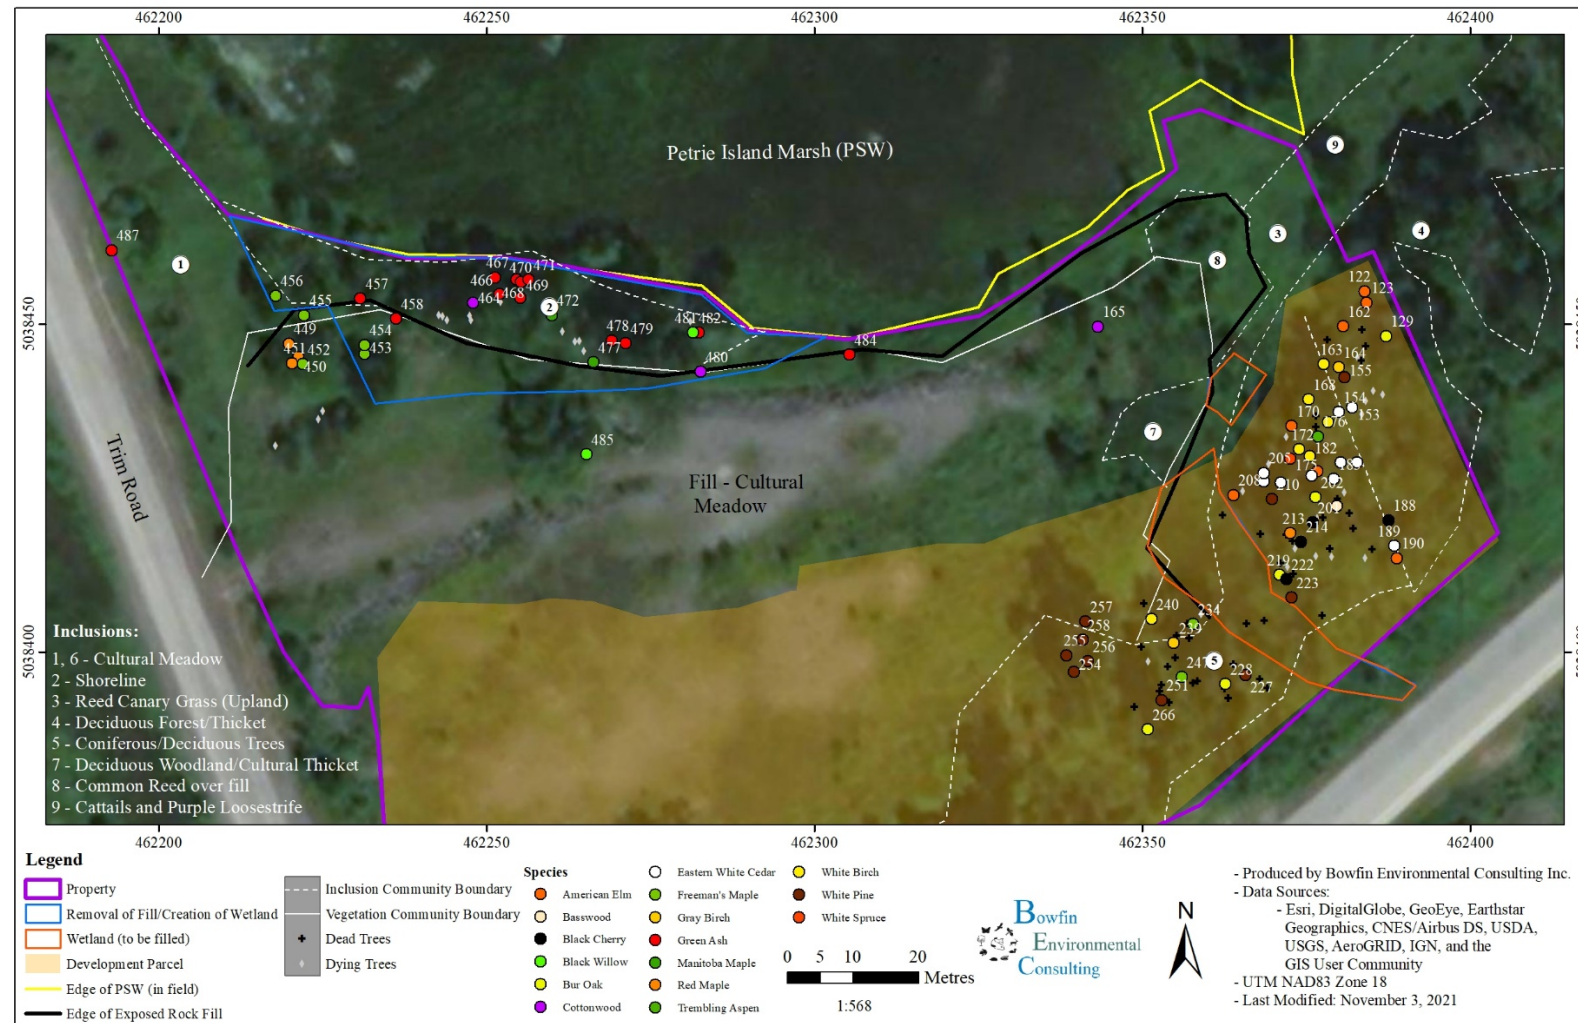
Figure 3: Location of Existing Trees

With respect to this TCR, a total of 149 individual trees assessed on the full property. The most common species were: ash species (including black, green, and white) and bur oak. A summary of these is provided in **Error! Reference source not found.** and in Table 1**Error! Reference source not found.** The trees varied in health. Many of the ash trees were in poor condition or dead. Those assessed as poor contained no live crown, only live shoots at the base of the tree. Most of the other tree species were healthy.

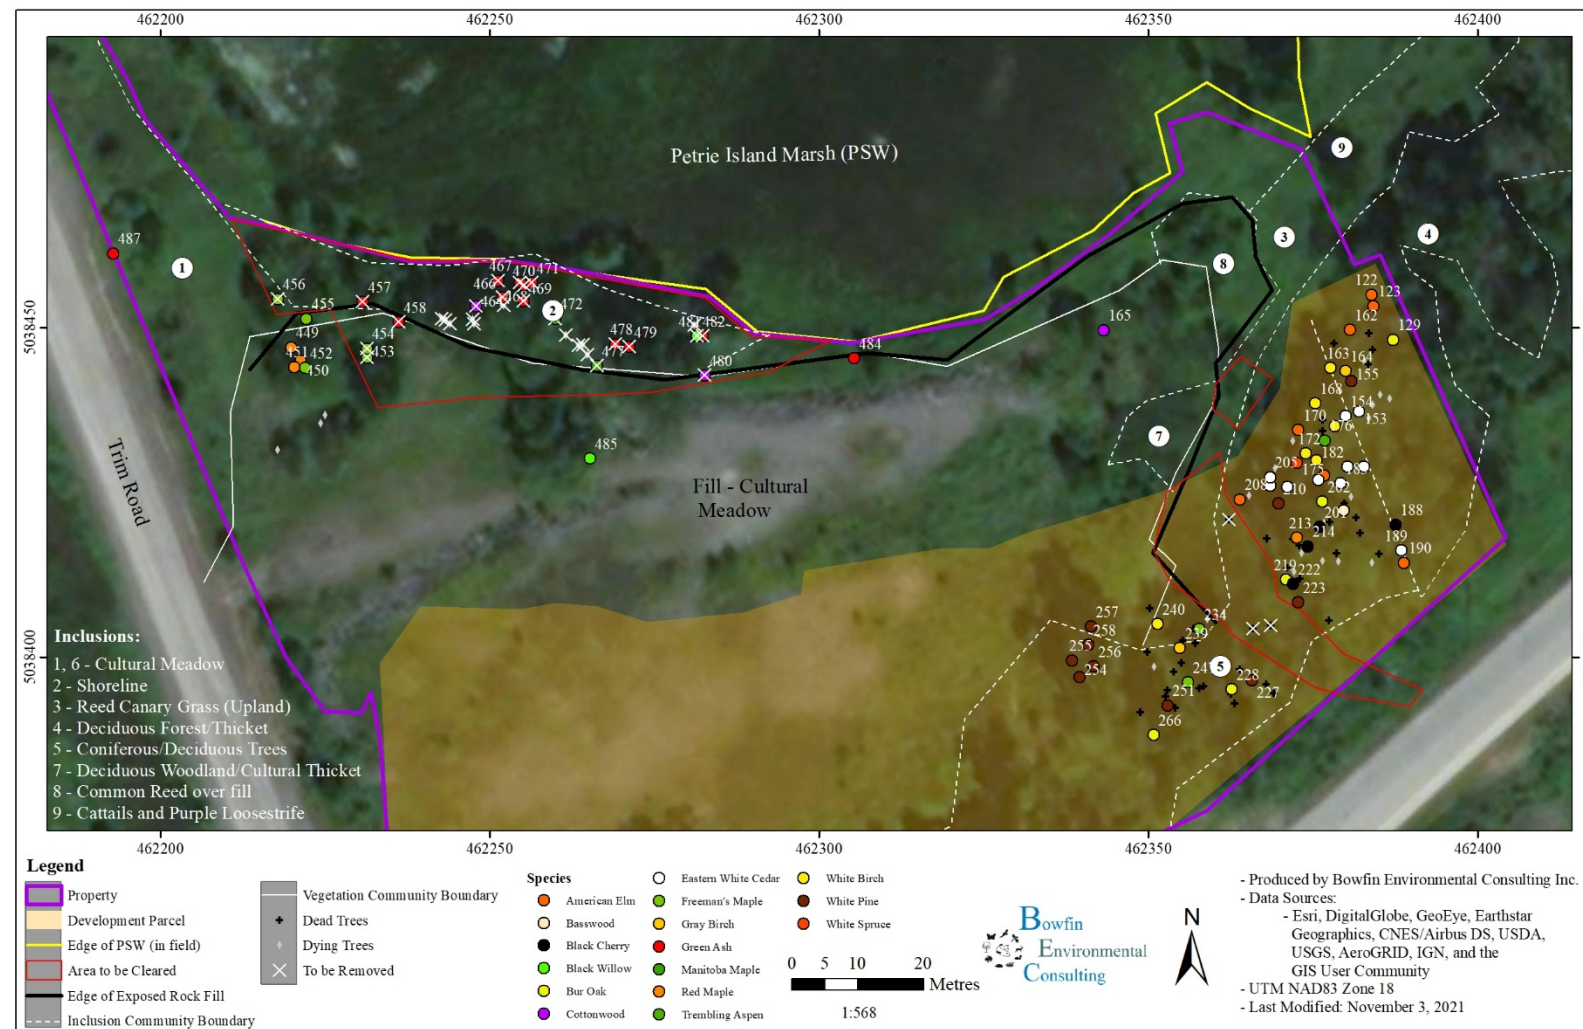
Figure 4: Location of Trees to be Removed

The work activities associated with Phase 1 rehabilitation will require the removal of **33 individuals** (highlighted in Table 1 and in Appendix B). These are mostly green ash with a few Freeman's maple, Manitoba maple, willow and cottonwood (Table 1). The details of the individual trees is found in Appendix B.

The Phase 1 of the rehabilitation plan requires the removal of the trees from the fill as well as the potential to remove trees from the west side of the headwater feature (for machinery to access). There are a total of 33 individuals of which 3 were dead, 11 were in poor condition and 19 were in good health. All trees to be removed are own by the proponent. To complete the Phase 1 rehabilitation works all will need to be removed. No trees in these areas are proposed for retention.

- A permit for the removal of trees that are 10 cm or larger in diameter is required from the City of Ottawa.

- Any roots that must be cut will be cut cleanly to allow for healing.
- The removal of trees is to occur between October 1 and March 30. This is to avoid both the active bat season and the breeding bird season (see timing and measures from above).

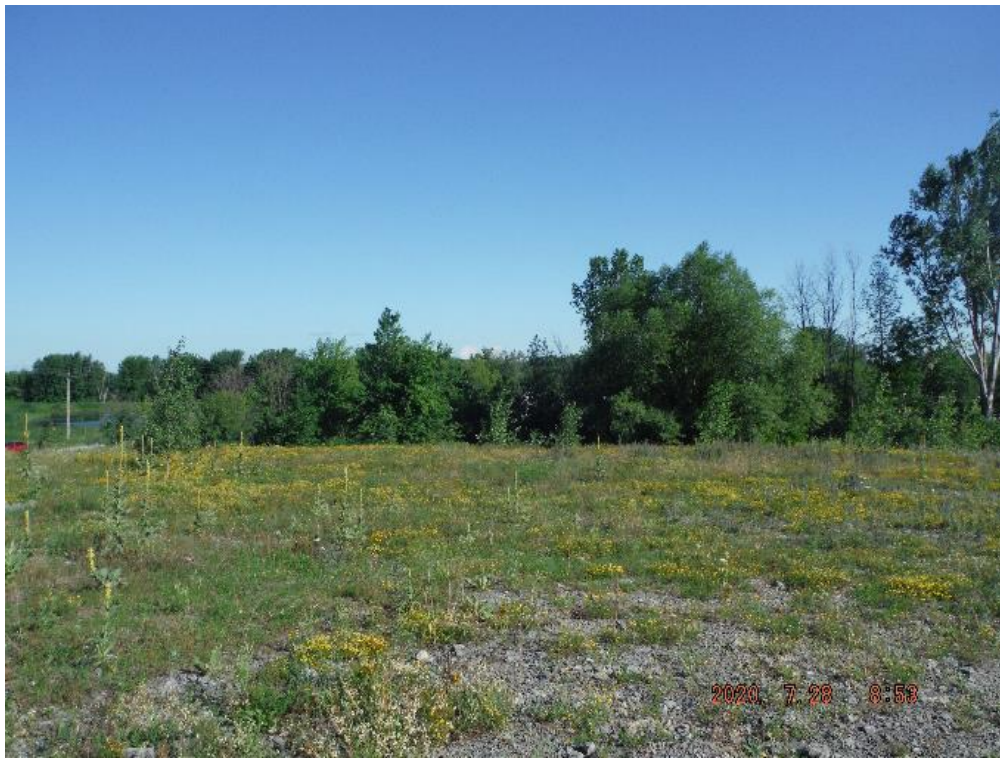
Much of the lands to be developed consisted of heavily compacted rocky fill vegetated with broad leaf herbaceous species such as bird's foot trefoil, common sow thistle, white sweet clover, wild carrot, cow vetch, burdock, viper's bugloss, field bindweed, smooth brome, coltsfoot, and common mullein. There were also a few scattered, young, eastern cottonwoods. These were less than 2 m tall and provided very little in terms of cover.

Photo 1: Looking across towards Trim Road (July 28, 2020)

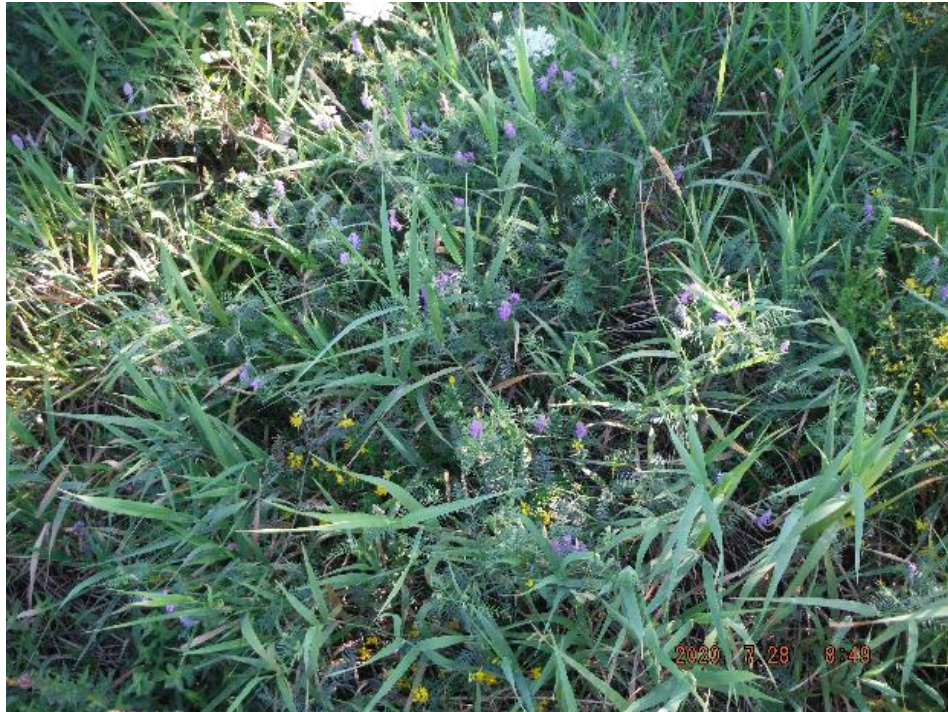
This area also consisted of a cultural meadow but contained wetland species as well as upland. This area is the embankment of Trim Road and some of the area has been disturbed by the fill activities. The area is classed as upland because of the significant presence of upland species (bird's foot trefoil, wild carrot, and cow vetch) (Photo 2).

Photo 2: Cultural Meadow along Trim Road (July 28, 2020)

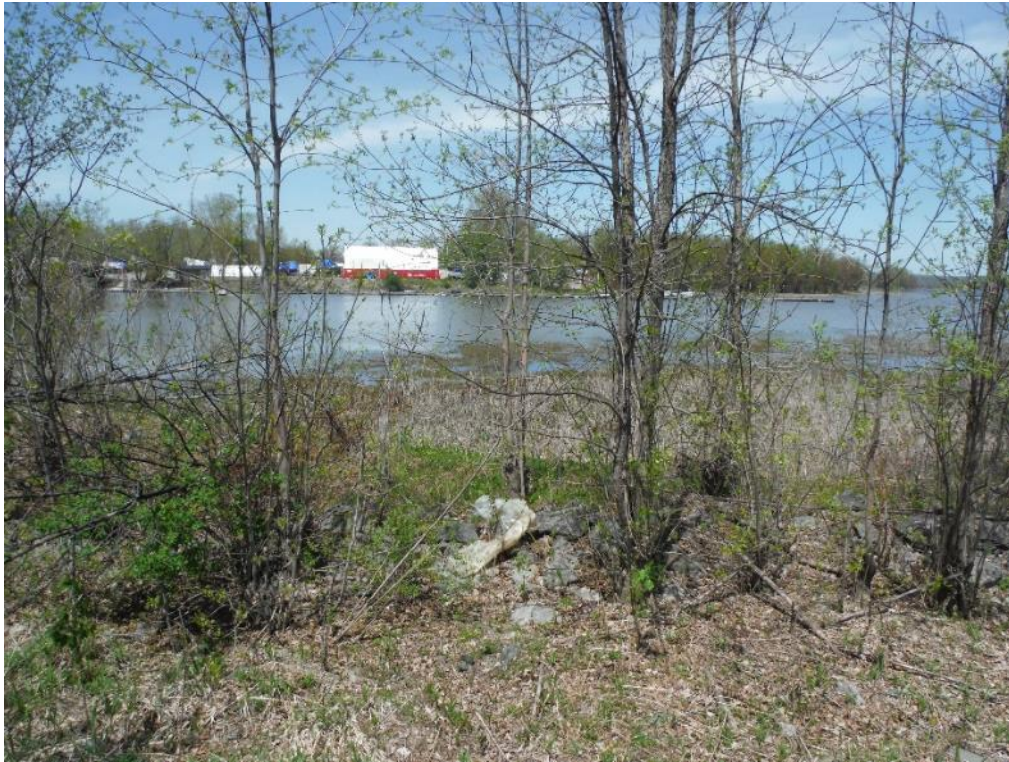
The shoreline of the fill is much too small and disturbed to have an ELC community assigned to it, however, the plants have been described as it is shown as being part of the existing PSW boundary. The soil consisted of fill. The species here were eastern cottonwood, black willow, Freeman's maple, green ash, red maple, and Manitoba maple with staghorn sumac (both 1-2 m tall and regeneration) and the ground layer included white sweet clover, bird's foot trefoil and tall goldenrod. This area is on fill and is upland habitat.

Photo 3: Shoreline (May 21, 2020)

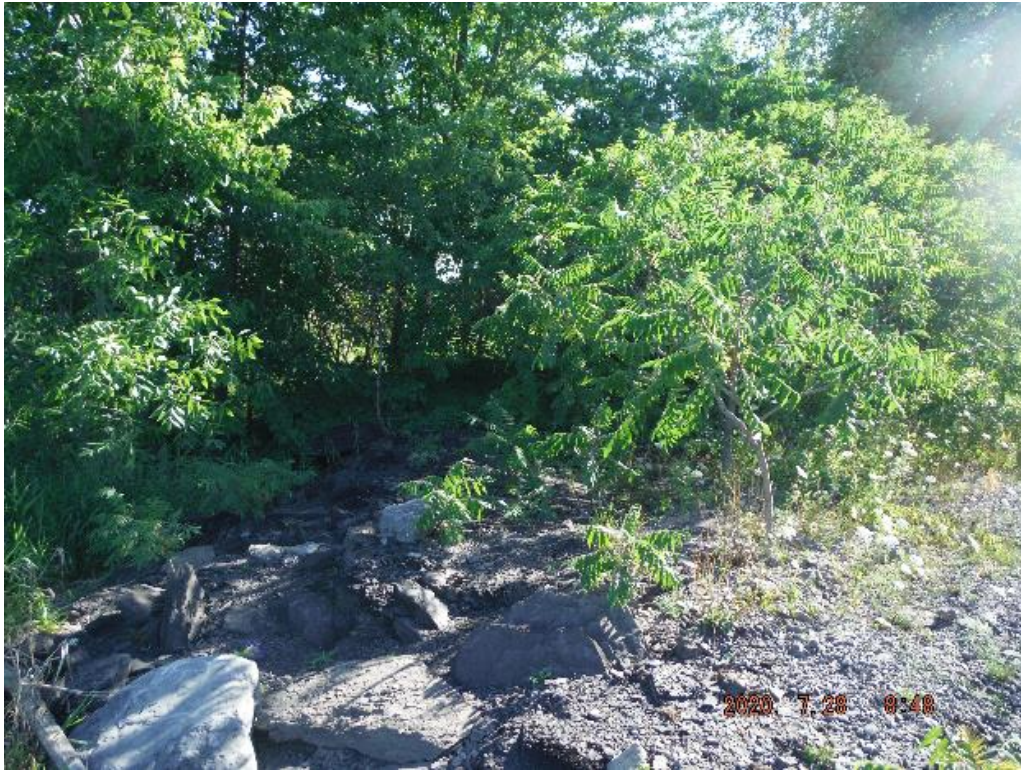
Photo 4: Shoreline (July 28, 2020)

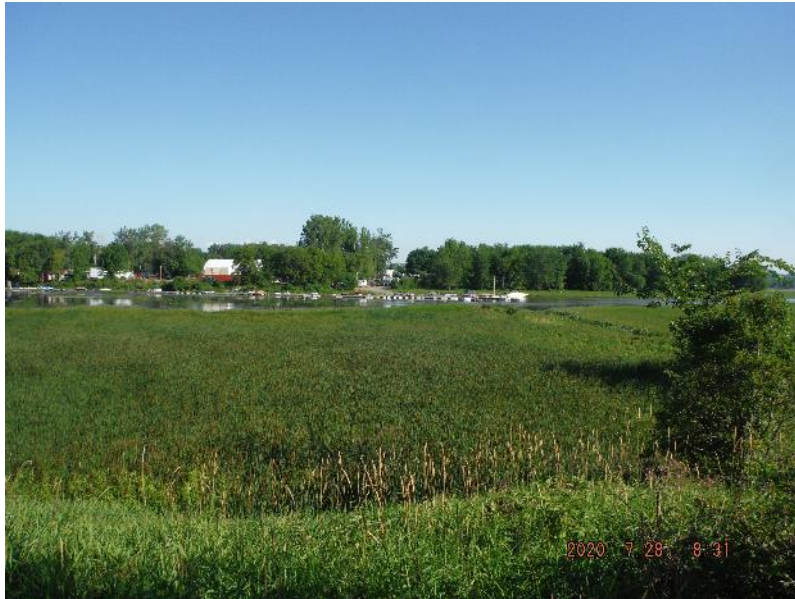
Photo 5: Robust Emergent Dominated Wetland of the PSW (July 28, 2020)

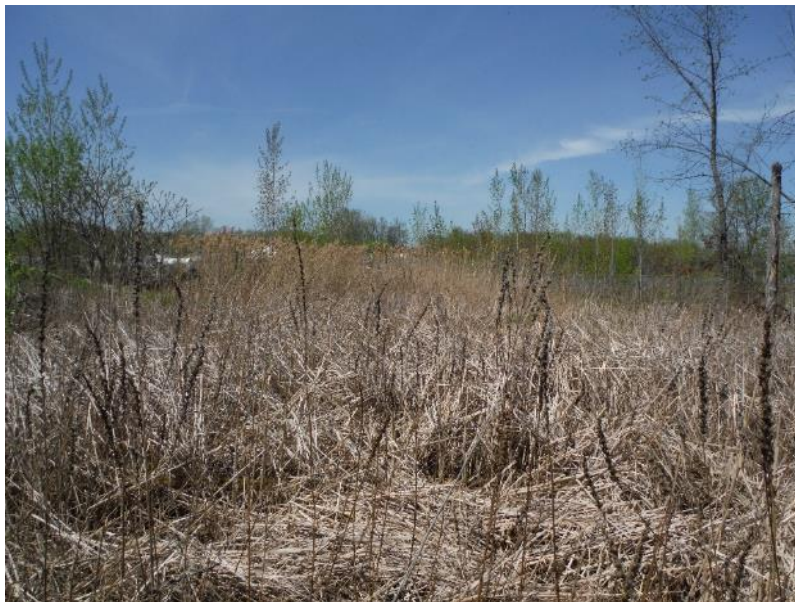
Along the east side of the fill, where the headwater feature is located, there were pockets of wetland habitat isolated from the PSW by the upland reed canary grass community and the deciduous woodland/thicket. These small areas consisted common reed (an invasive species) over fill (Community 8) and another of cattails and purple loosestrife (also an invasive species) (Community 9). These two communities were noted to have surface water (<10-15 cm) year round. Some of the water had the gas look associated with ground water seepage however, the location (elevation, placement on clay fill) makes this uncertain. On a side note, iron staining was noted along Trim Road ditch next to the rock fill in Phase 1. There was no overwintering habitat for turtles.

Photo 6: Purple Loosestrife and Common Reed (*Phragmites*) dominated areas (May 21, 2020)
