# **Geotechnical Investigation**

## **Proposed Residential Development**

4386 Rideau Valley Drive  
Ottawa, Ontario

Report PG5828-1 Revision 2 dated October 14, 2022

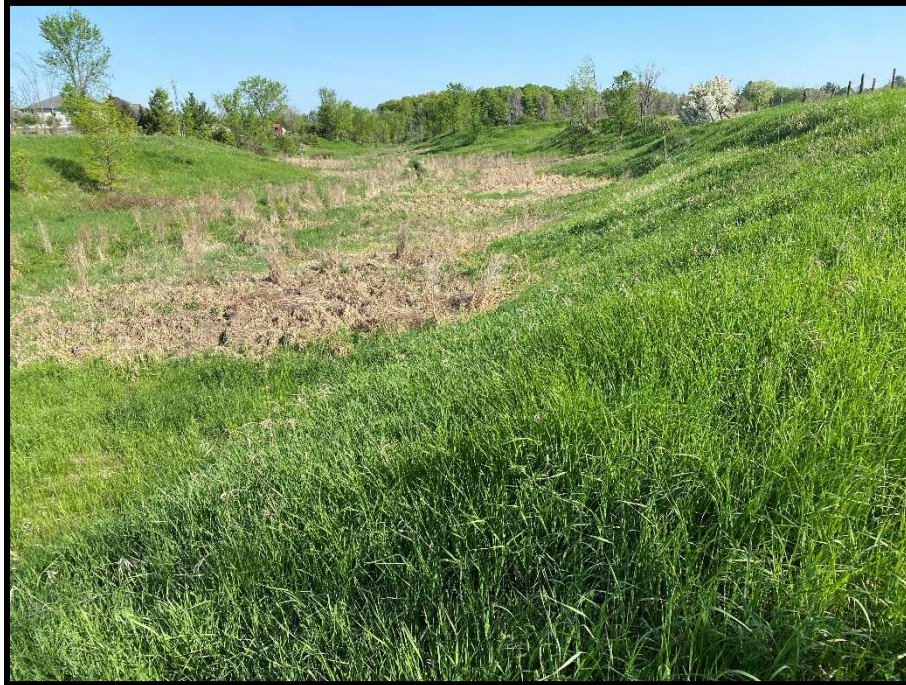
Photo 1: Area located at the bottom of the slope along the south-west portion of the subject site. Area is well vegetated and sloped gradually towards the valley floor.

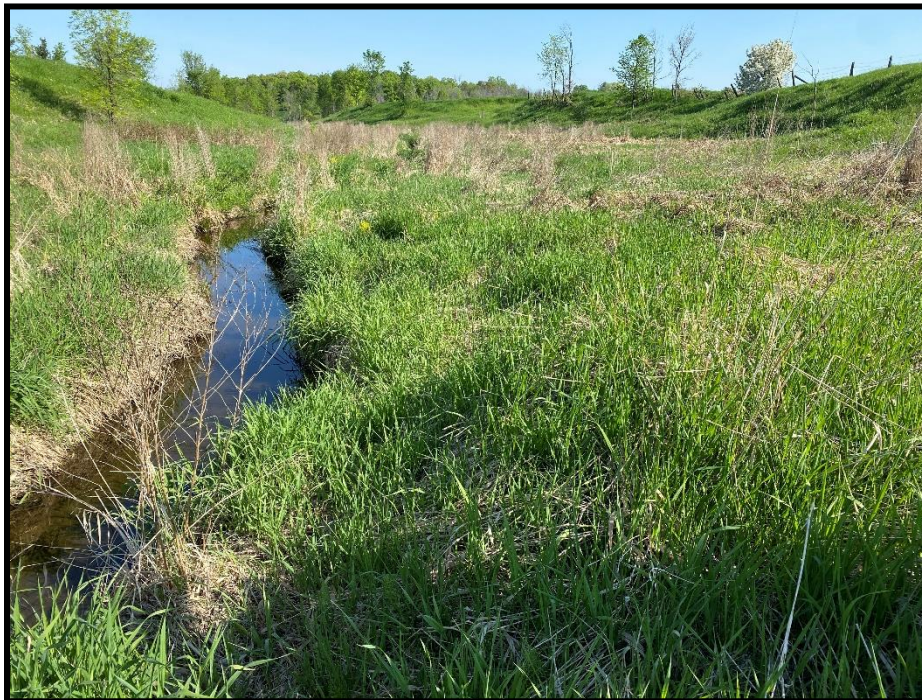
Photo 2: Area along creek tributary and south-west portion of the subject site. Area appeared to be well vegetated and did not appear to be eroded at the time of site visit. Water throughout creek tributary appeared to be flowing very slowly and/or ponding.

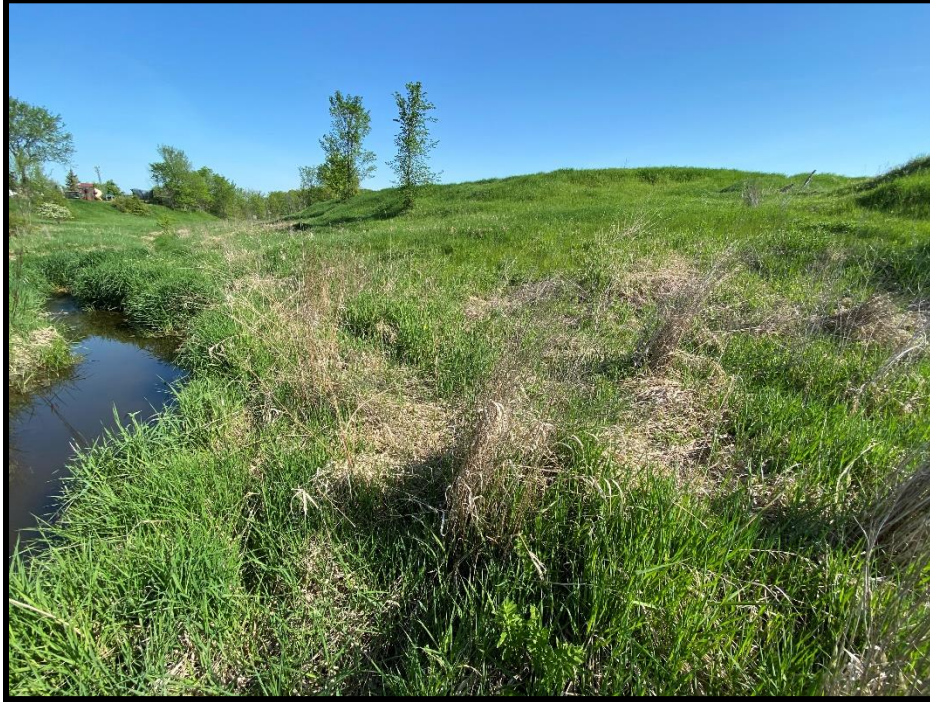
Photo 3: Area along creek tributary and south-west portion of the subject site. Area appeared to be well vegetated and did not appear to be eroded at the time of site visit. Gradual slope observed from subject site to the valley floor.

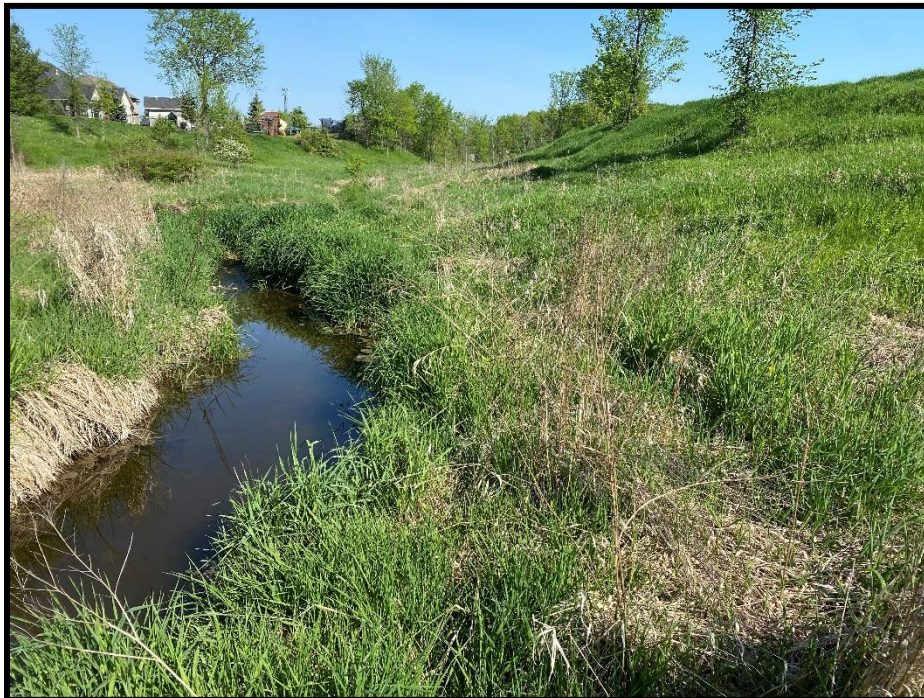
Photo 4: Area along creek tributary and south-west portion of the subject site. Area appeared to be well vegetated and did not appear to be eroded at the time of site visit. Water throughout creek tributary appeared to be flowing very slowly and/or ponding.

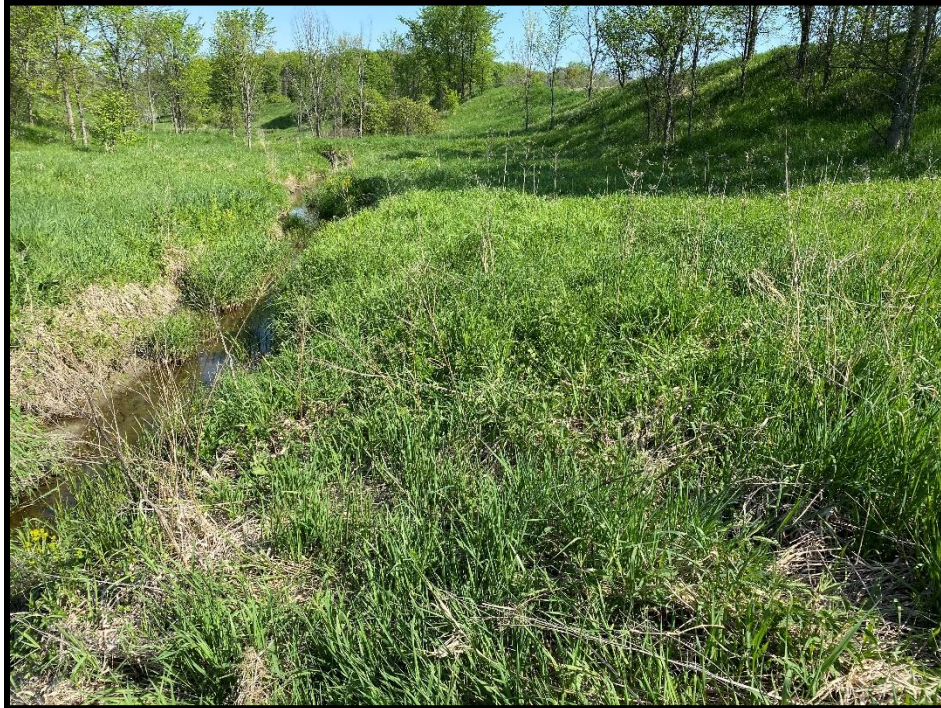
Photo 5: Area along creek tributary and south-west portion of the subject site. Area appeared to be well vegetated and did not appear to be eroded at the time of site visit. Water throughout creek tributary appeared to be flowing very slowly and/or ponding.

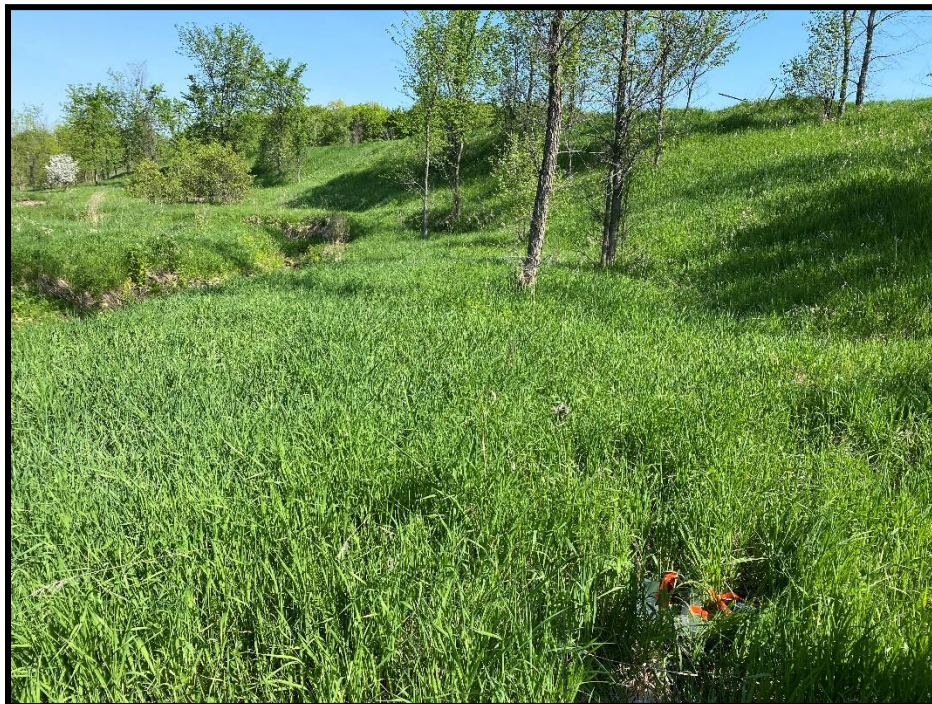
Photo 6: Area along creek tributary and west portion of the subject site. Area appeared to be well vegetated and did not appear to be eroded at the time of site visit. Gradual slope observed from subject site to the valley floor.

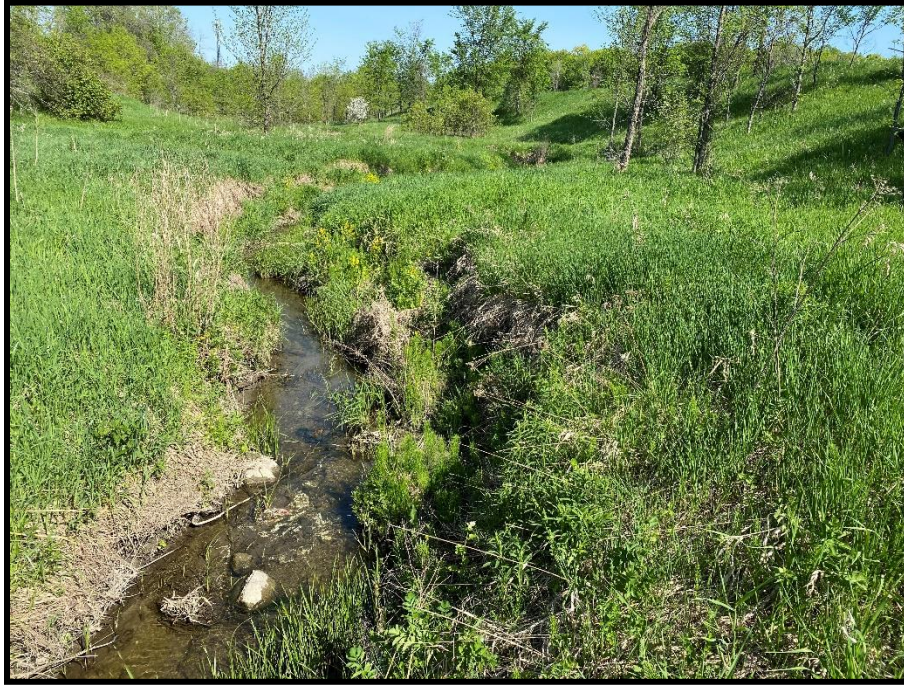
Photo 7: Area along creek tributary and west portion of the subject site. Area appeared to be well vegetated with a slightly steeper bank along the tributary at the time of site visit. Gradual slope observed from subject site to the valley floor. Active erosion was not observed.

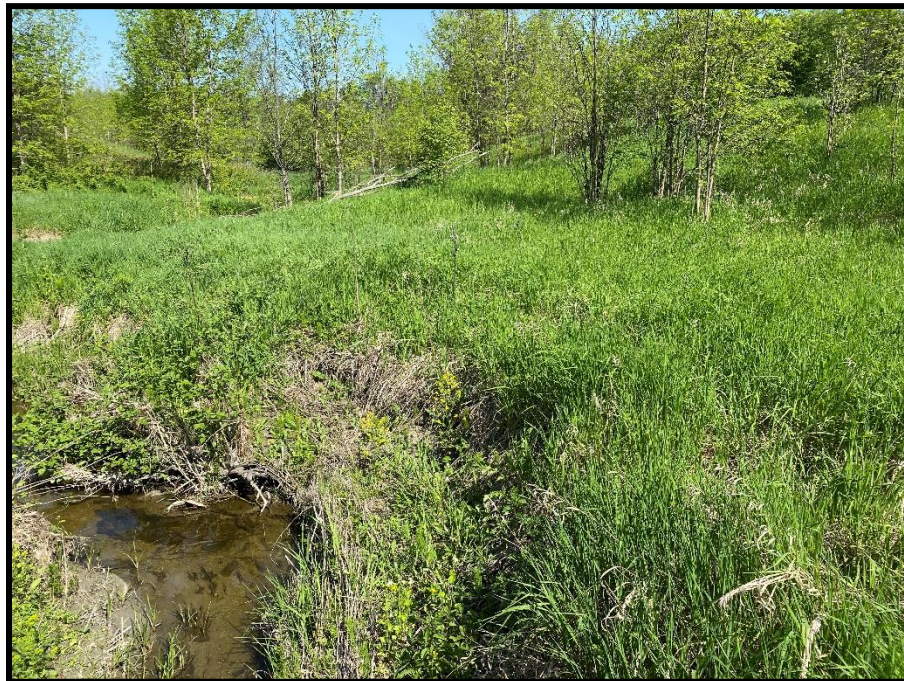
Photo 8: Area along creek tributary and west portion of the subject site. Area appeared to be well vegetated with a slightly steeper bank along the tributary at the time of site visit. Gradual slope observed from subject site to the valley floor. Active erosion was not observed.

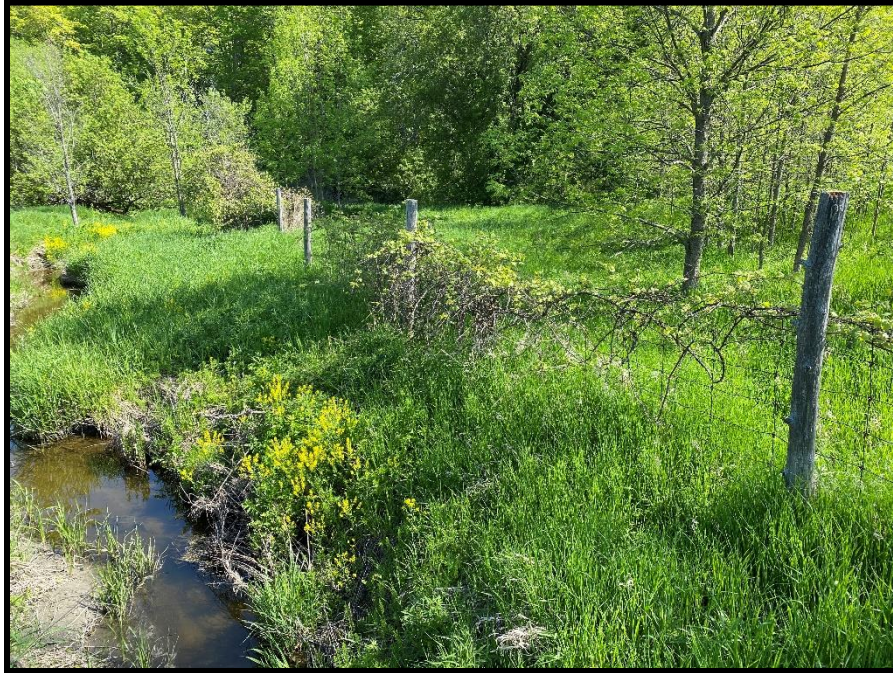
Photo 9: Area along creek tributary and north-west portion of the subject site. Area appeared to be well vegetated with a gentle flow throughout the tributary at the time of site visit. Gradual slope observed from subject site to the valley floor.

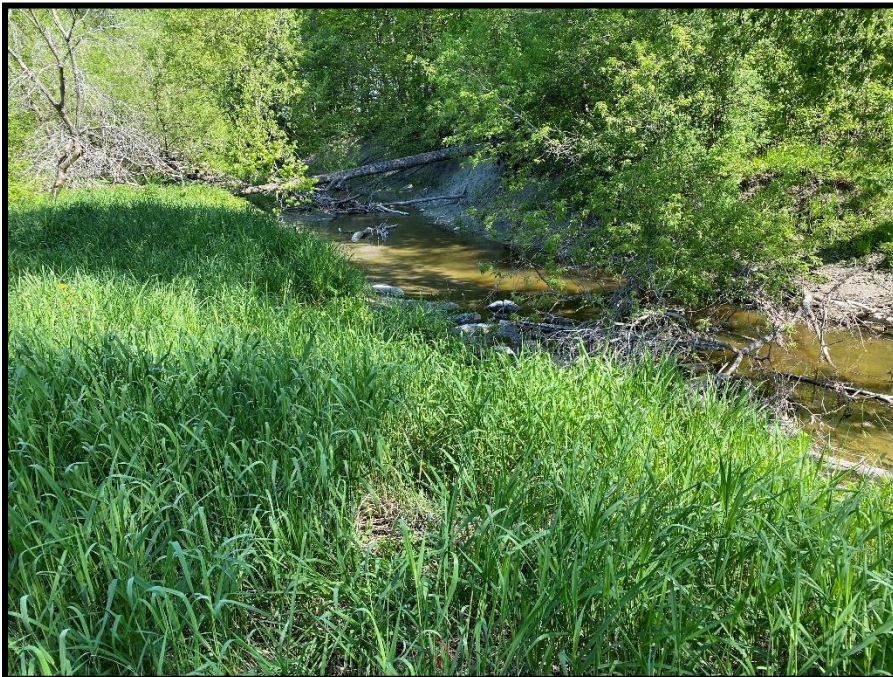
Photo 10: Area of intersection of tributary along west portion of subject site and Ruisseau Mud Creek. Area of Ruisseau Mud Creek appeared to have banks exposed to streams flow. Mature trees noted to have previously fallen across creek alignment. Some over-steepening of banks also observed at the time of site visit.

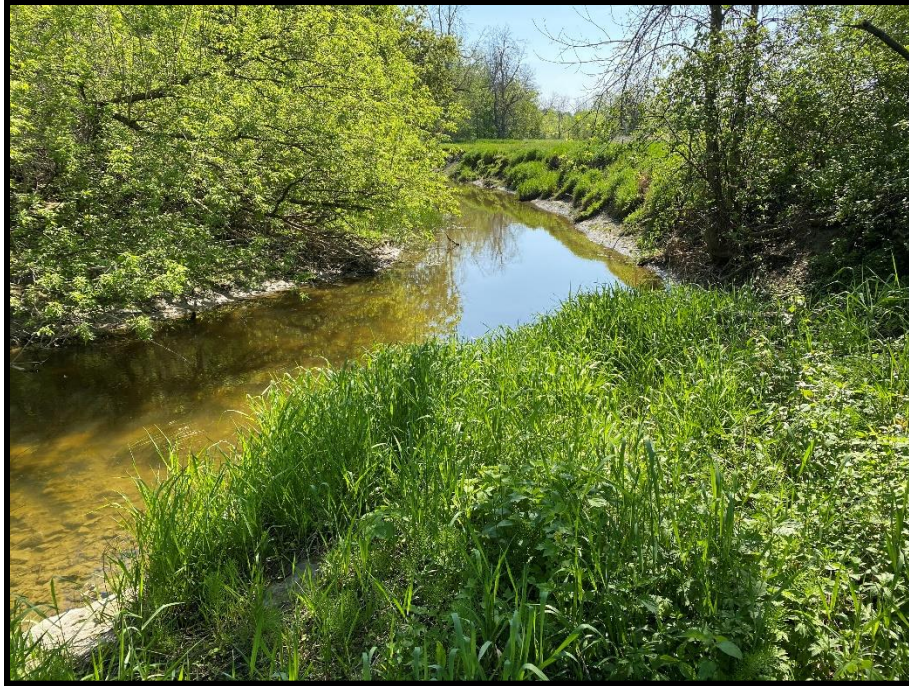
Photo 11: Area of Ruisseau Mud Creek along north-west portion of subject site. Area appeared to have banks exposed to streams flow and lack of well rooted vegetation along bank. Some oversteepening of banks also observed. Creek appeared to be flowing very slowly at the time of site visit.

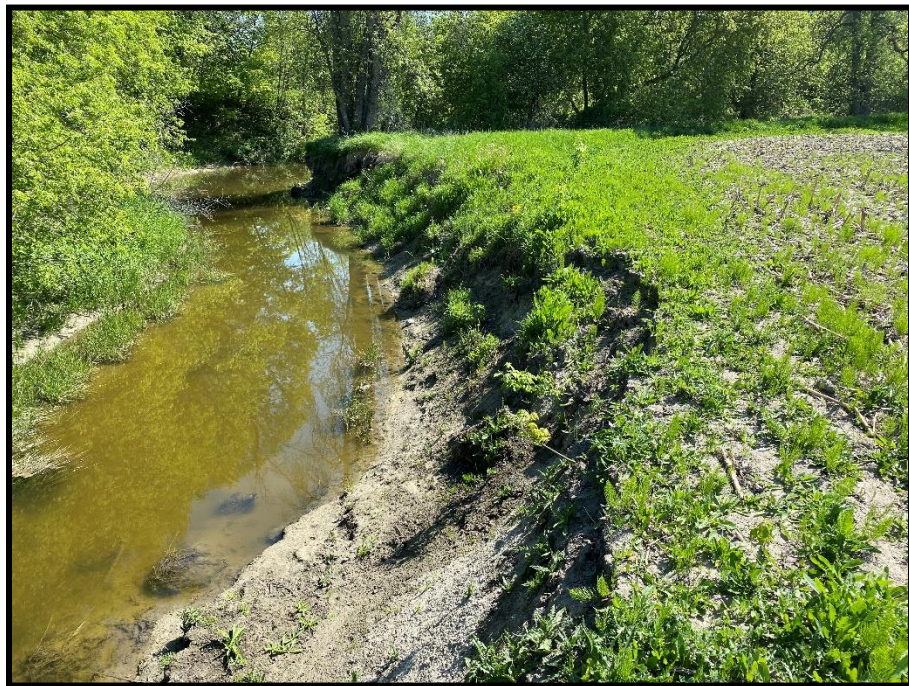
Photo 12: Area of Ruisseau Mud Creek along north-west portion of subject site. Area appeared to have banks exposed to streams flow and along with slumping and oversteepening of banks at the time of our site visit.

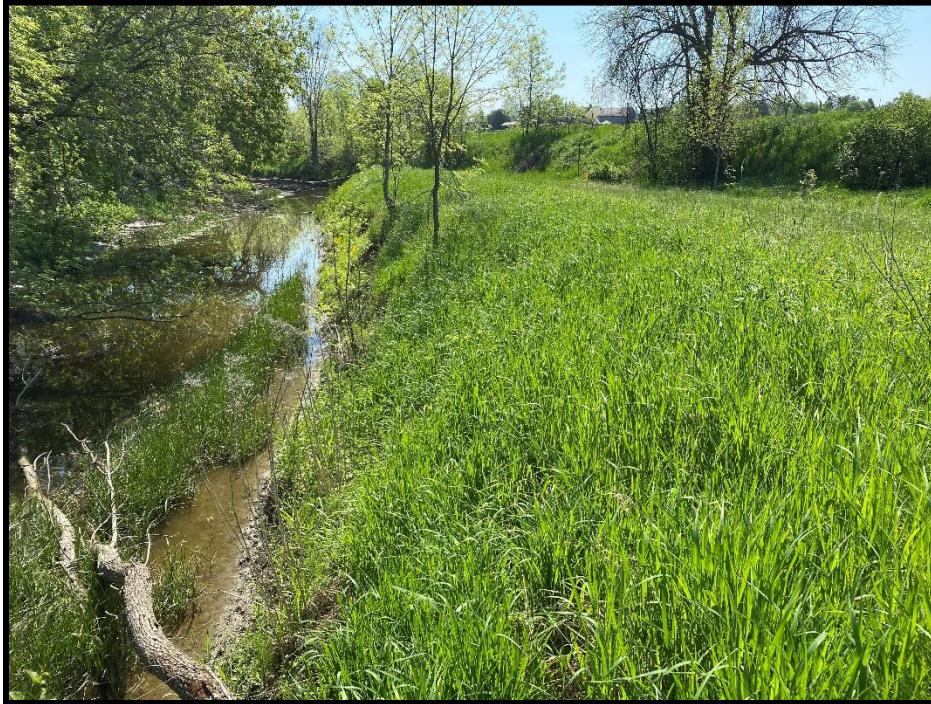
Photo 13: Area of Ruisseau Mud Creek along north-west portion of subject site. Area of valley floor appeared to have well rooted vegetation with relatively steep banks along creek. No active erosion observed along photographed portion of creek at the time of site visit.

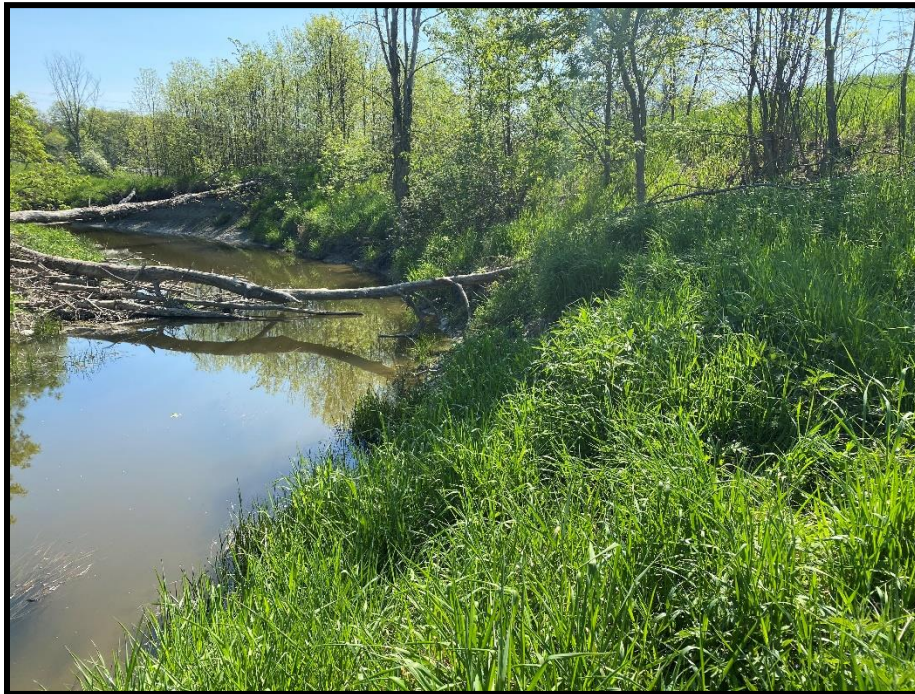
Photo 14: Area of Ruisseau Mud Creek along north-west portion of subject site. Area of valley floor appeared to have well rooted vegetation with relatively steep banks along creek. Some active erosion and fallen trees observed along photographed portion of creek.

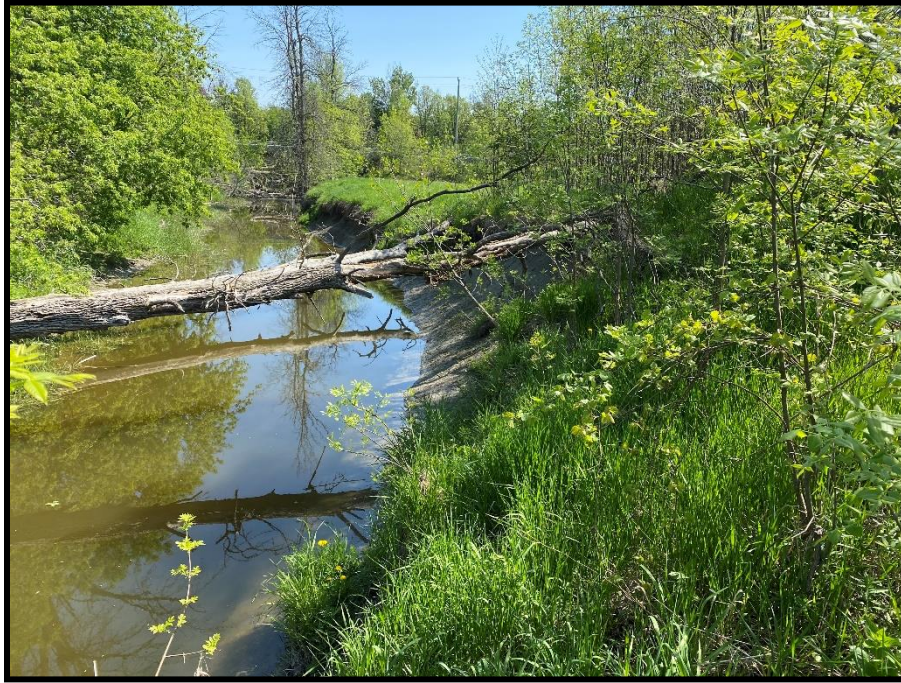
Photo 15: Area of Ruisseau Mud Creek along northern portion of subject site. Photographed area appeared to have banks exposed to streams flow along with slumping and undercutting of banks at the time of our site visit.

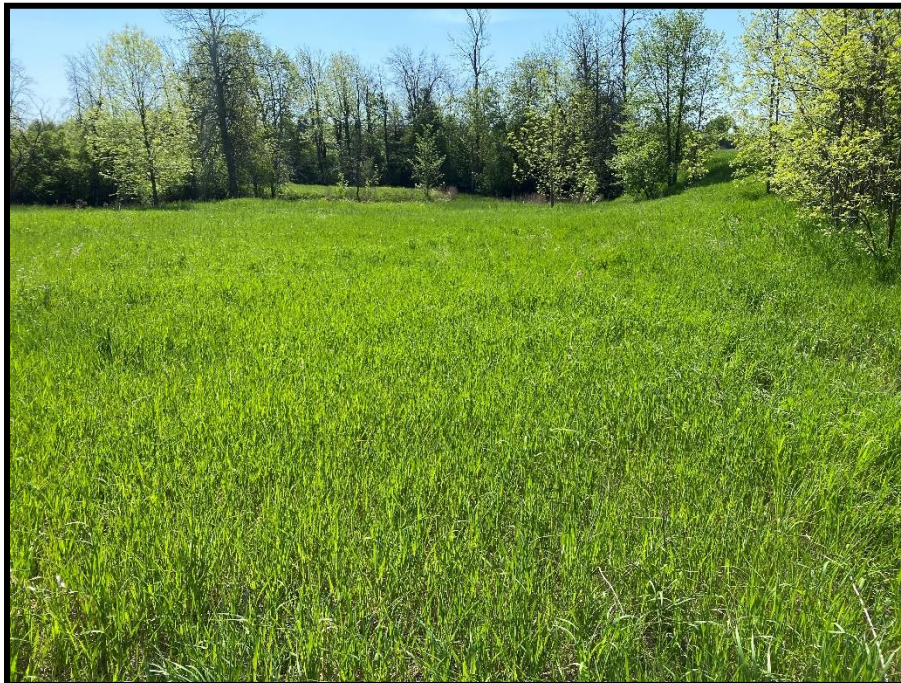
Photo 16: Area of Ruisseau Mud Creek valley floor along north-east portion of subject site. Photographed area appeared to contain well rooted vegetation and mature trees.

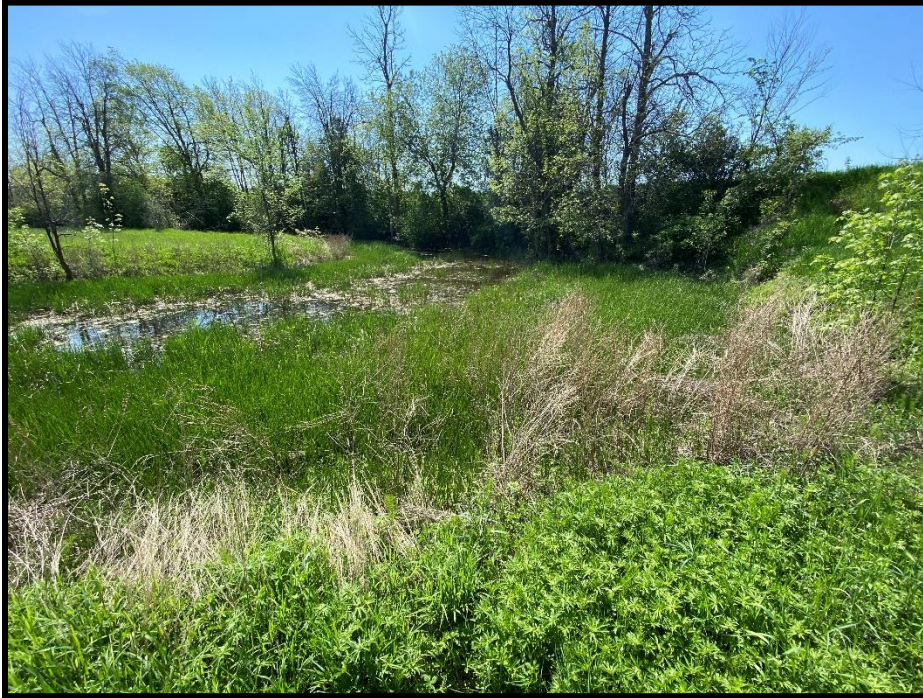
Photo 17: Area of Ruisseau Mud Creek valley floor along north-east portion of subject site. Photographed area appeared to contain well rooted vegetation and mature trees. No erosion observed along toe of slope at time of site visit.

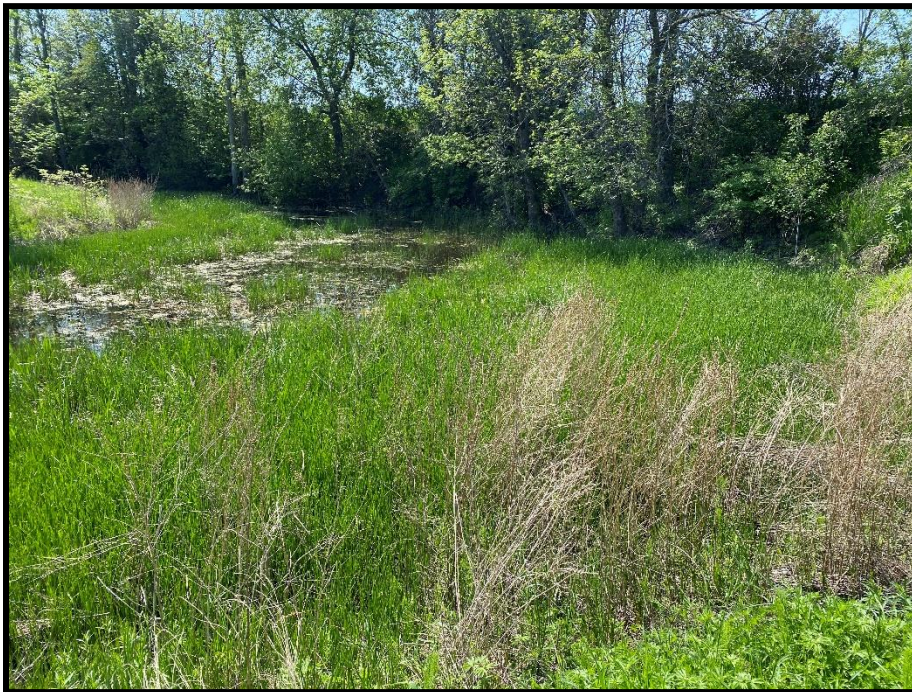
Photo 17b: Close-up of Photo 17 - Area of Ruisseau Mud Creek valley floor along north-east portion of subject site. Photographed area appeared to contain well rooted vegetation and mature trees. No erosion observed along toe of slope at time of site visit.
