July 5, 2022
PG5828-LET.01 Rev. 1

Subject: **Slope Stability Assessment
Proposed River Park
4386 Rideau Valley Drive - Ottawa, Ontario**

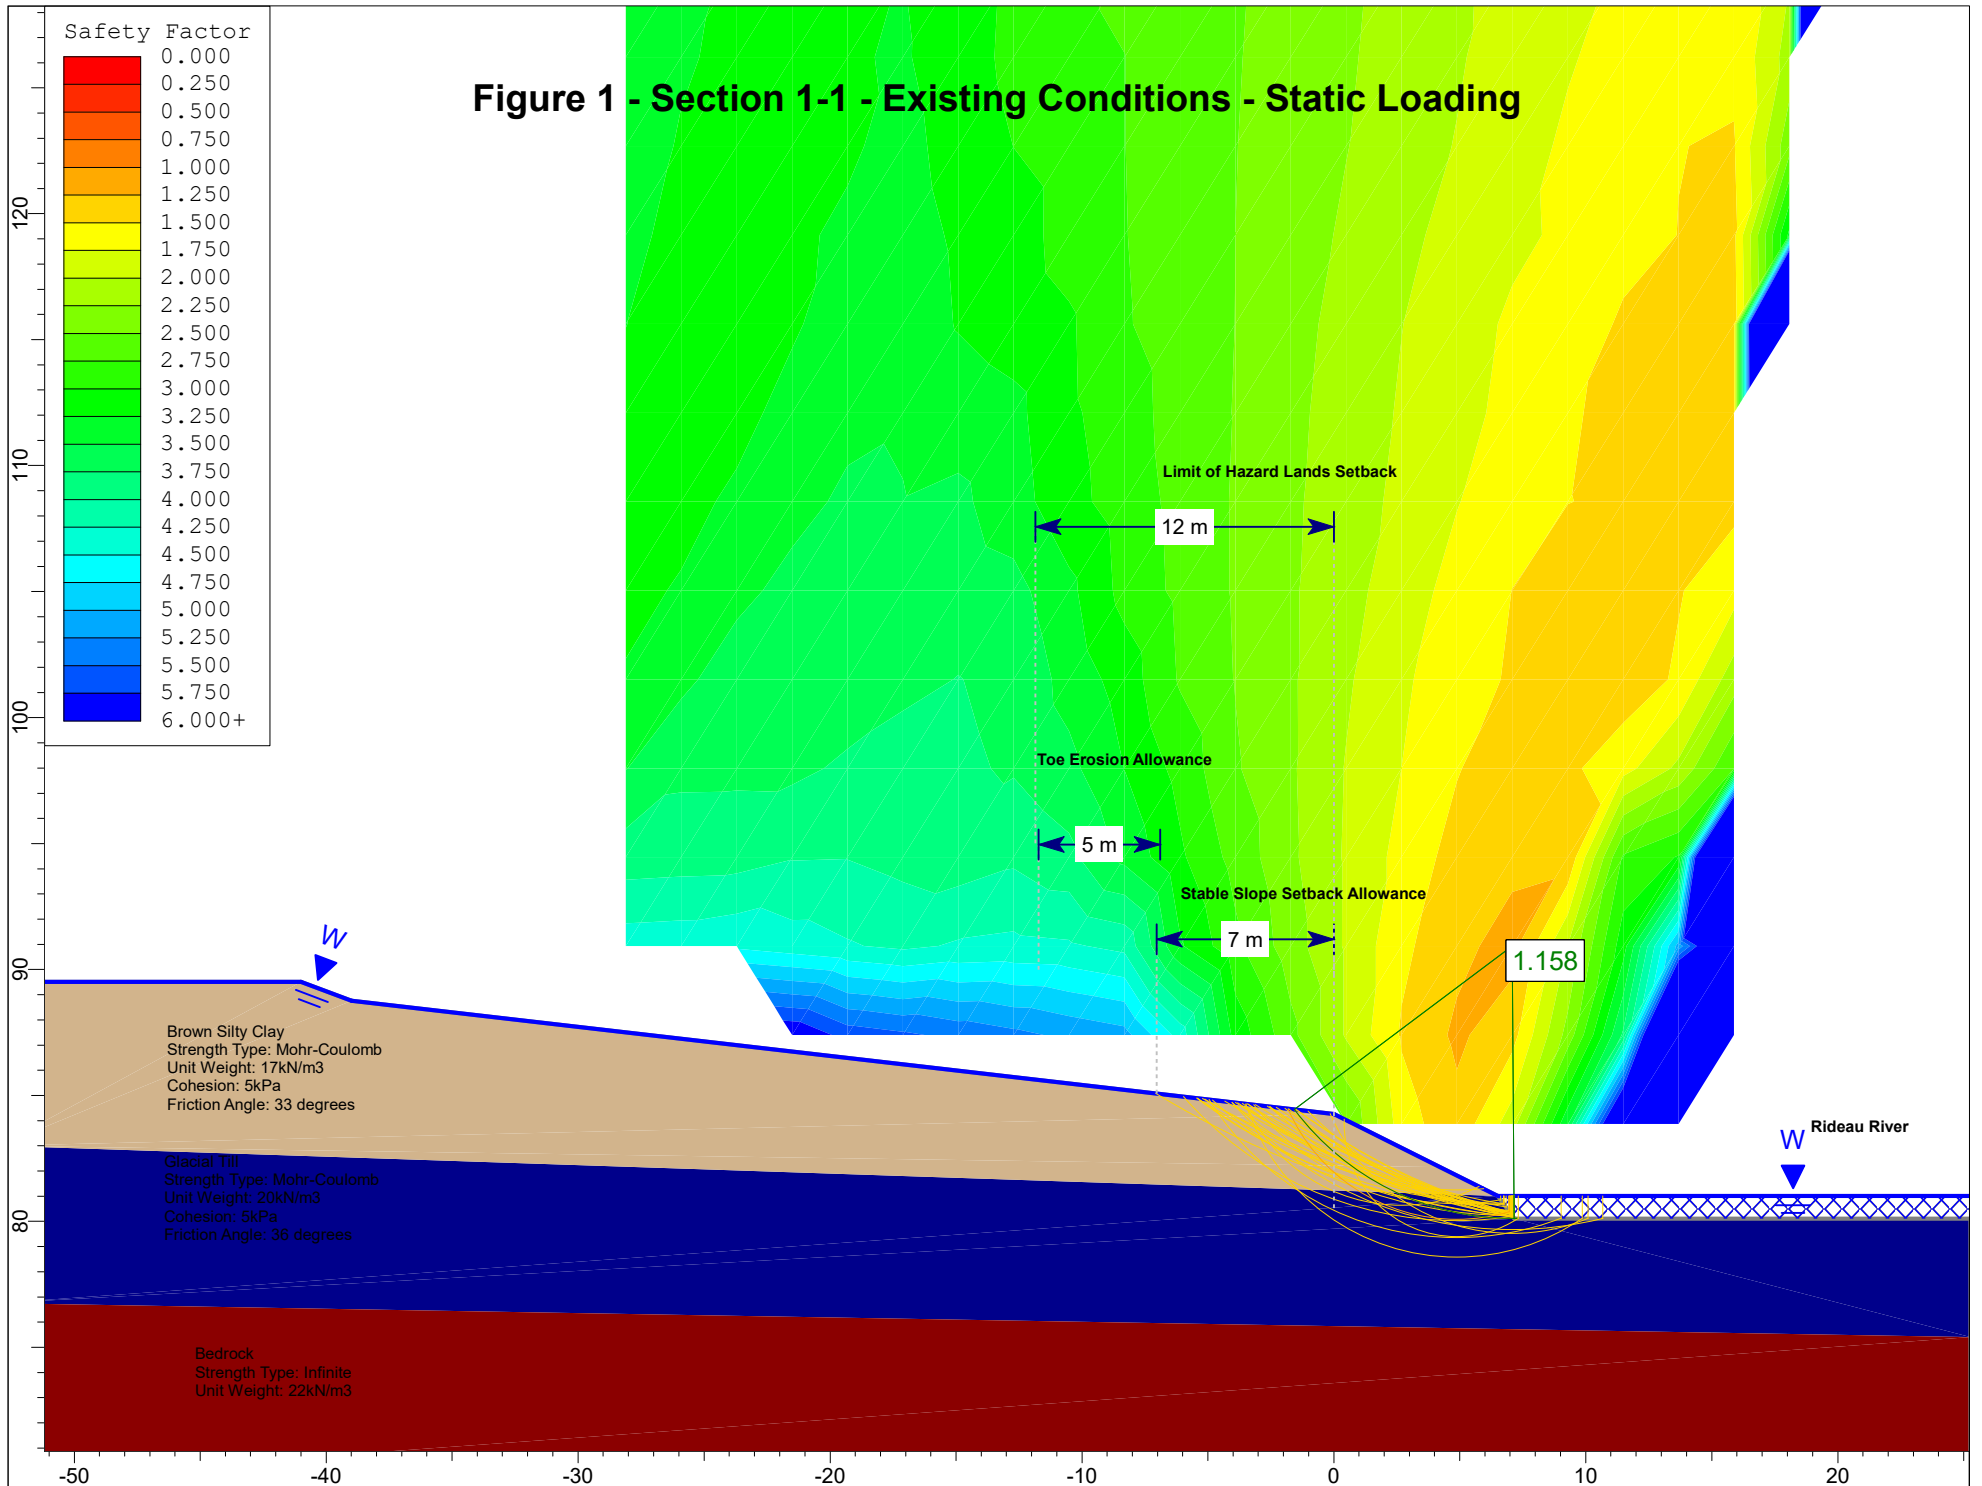
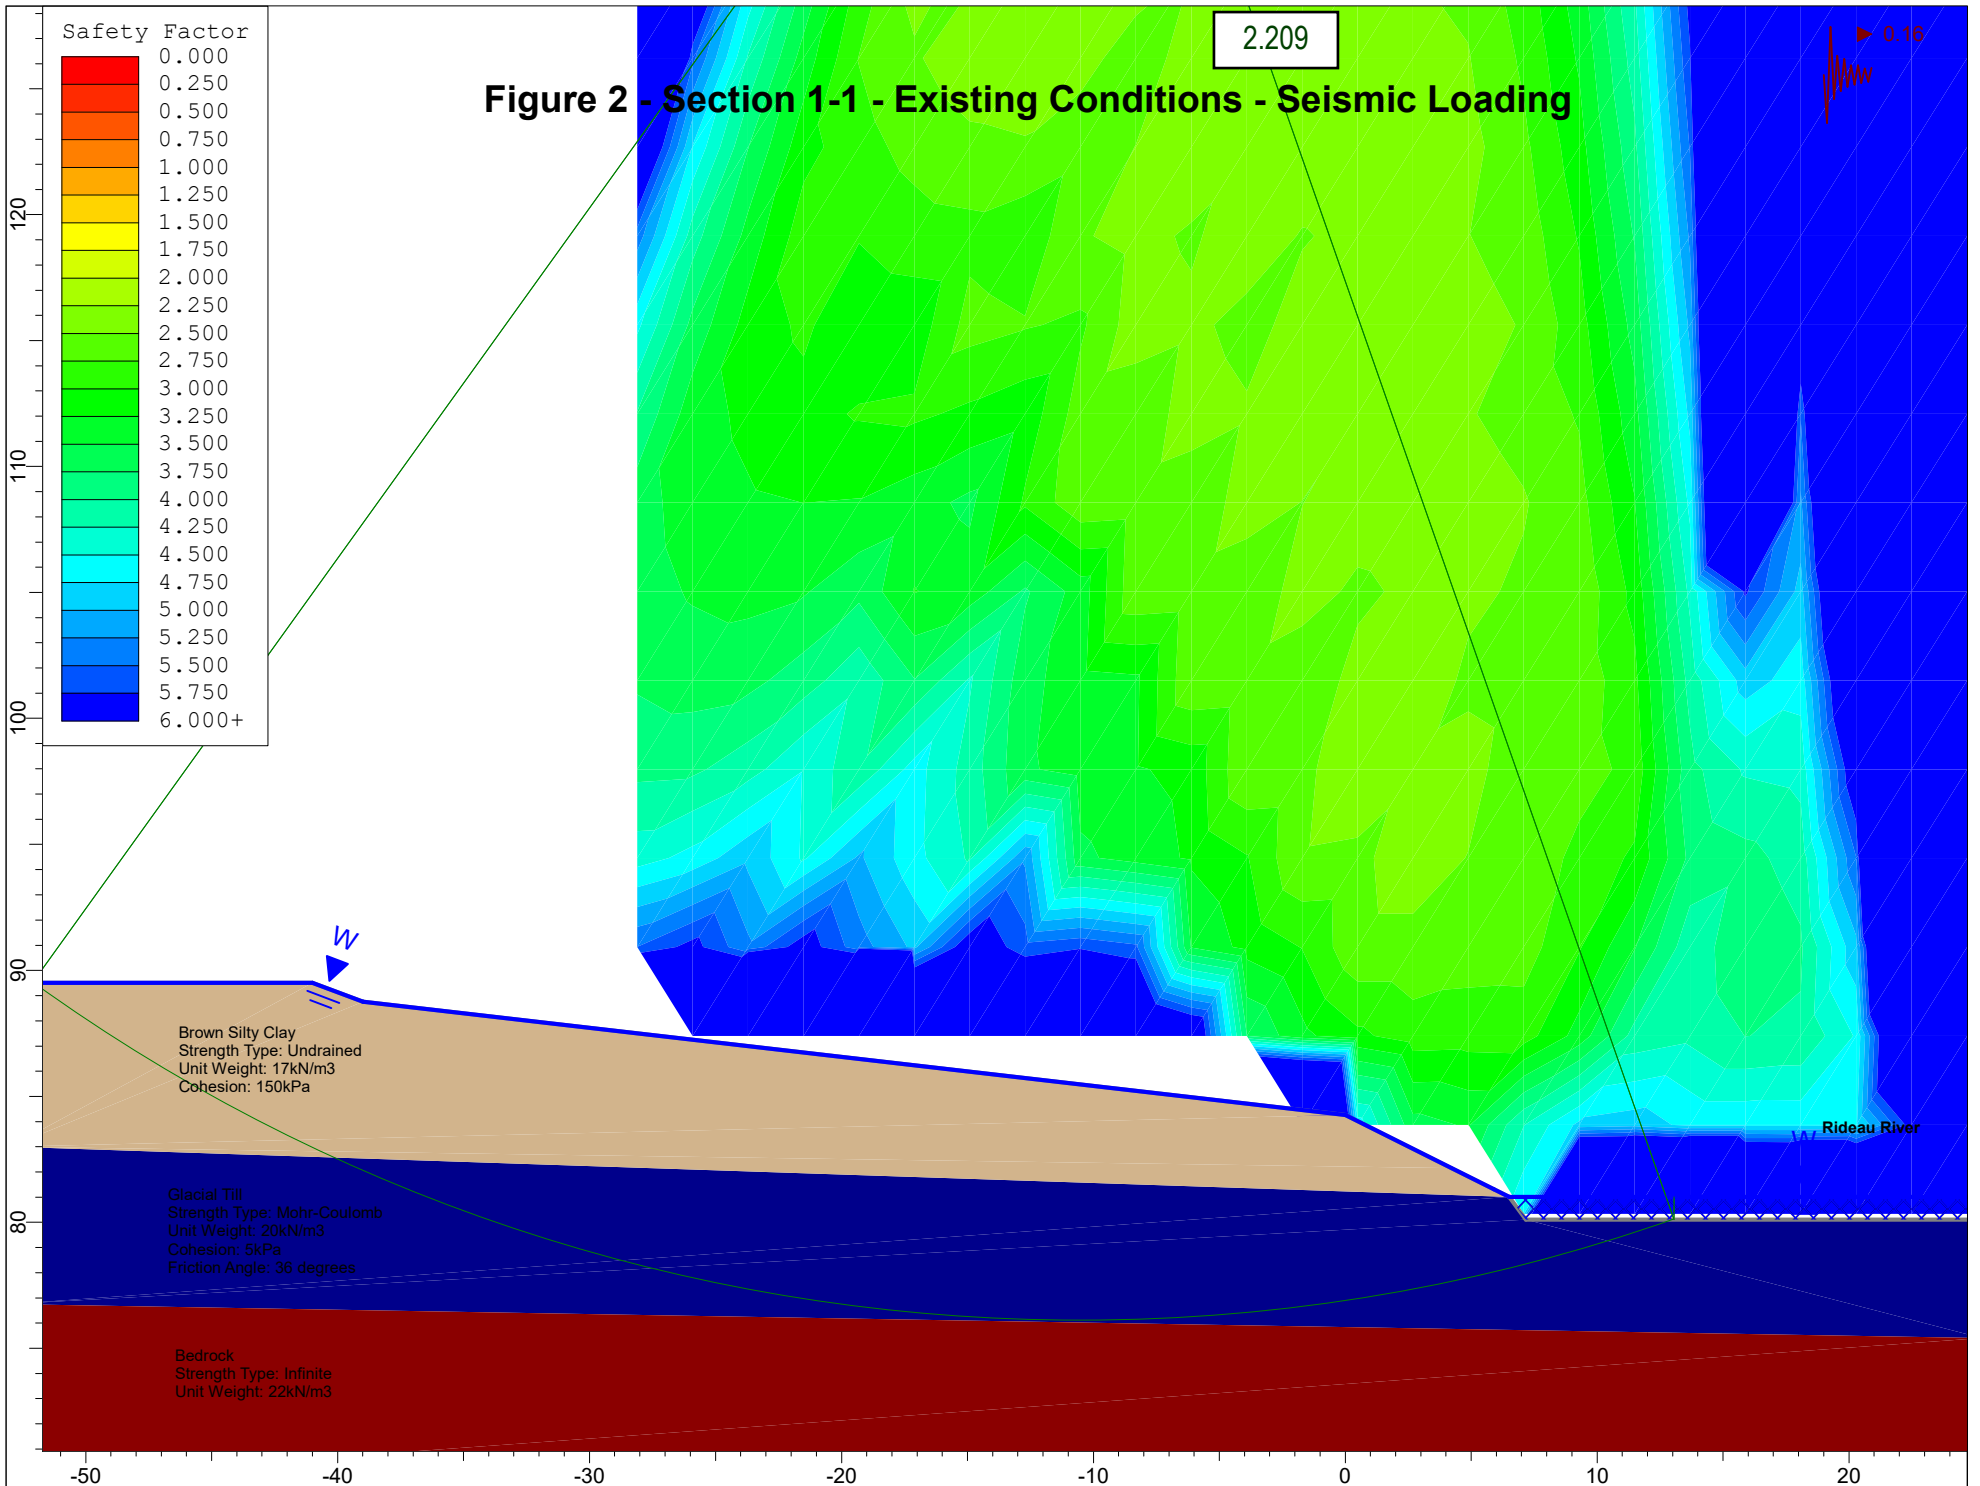
Figure 1 - Section 1-1 - Existing Conditions - Static Loading

The results are shown in Figures 1, 3, and 5. The results indicate a slope with a factor of safety of 1.16, 1.66, and 0.4 at Sections 1, 2, and 3, respectively. Based on these results, a stable slope setback varying between 7 and 9 m from the top of the slope are required for sections 1-1 and 3-3 to achieve a factor of safety of 1.5 for the limit of the hazard lands in the park area. Section 2-2 will not require a stable slope allowance.

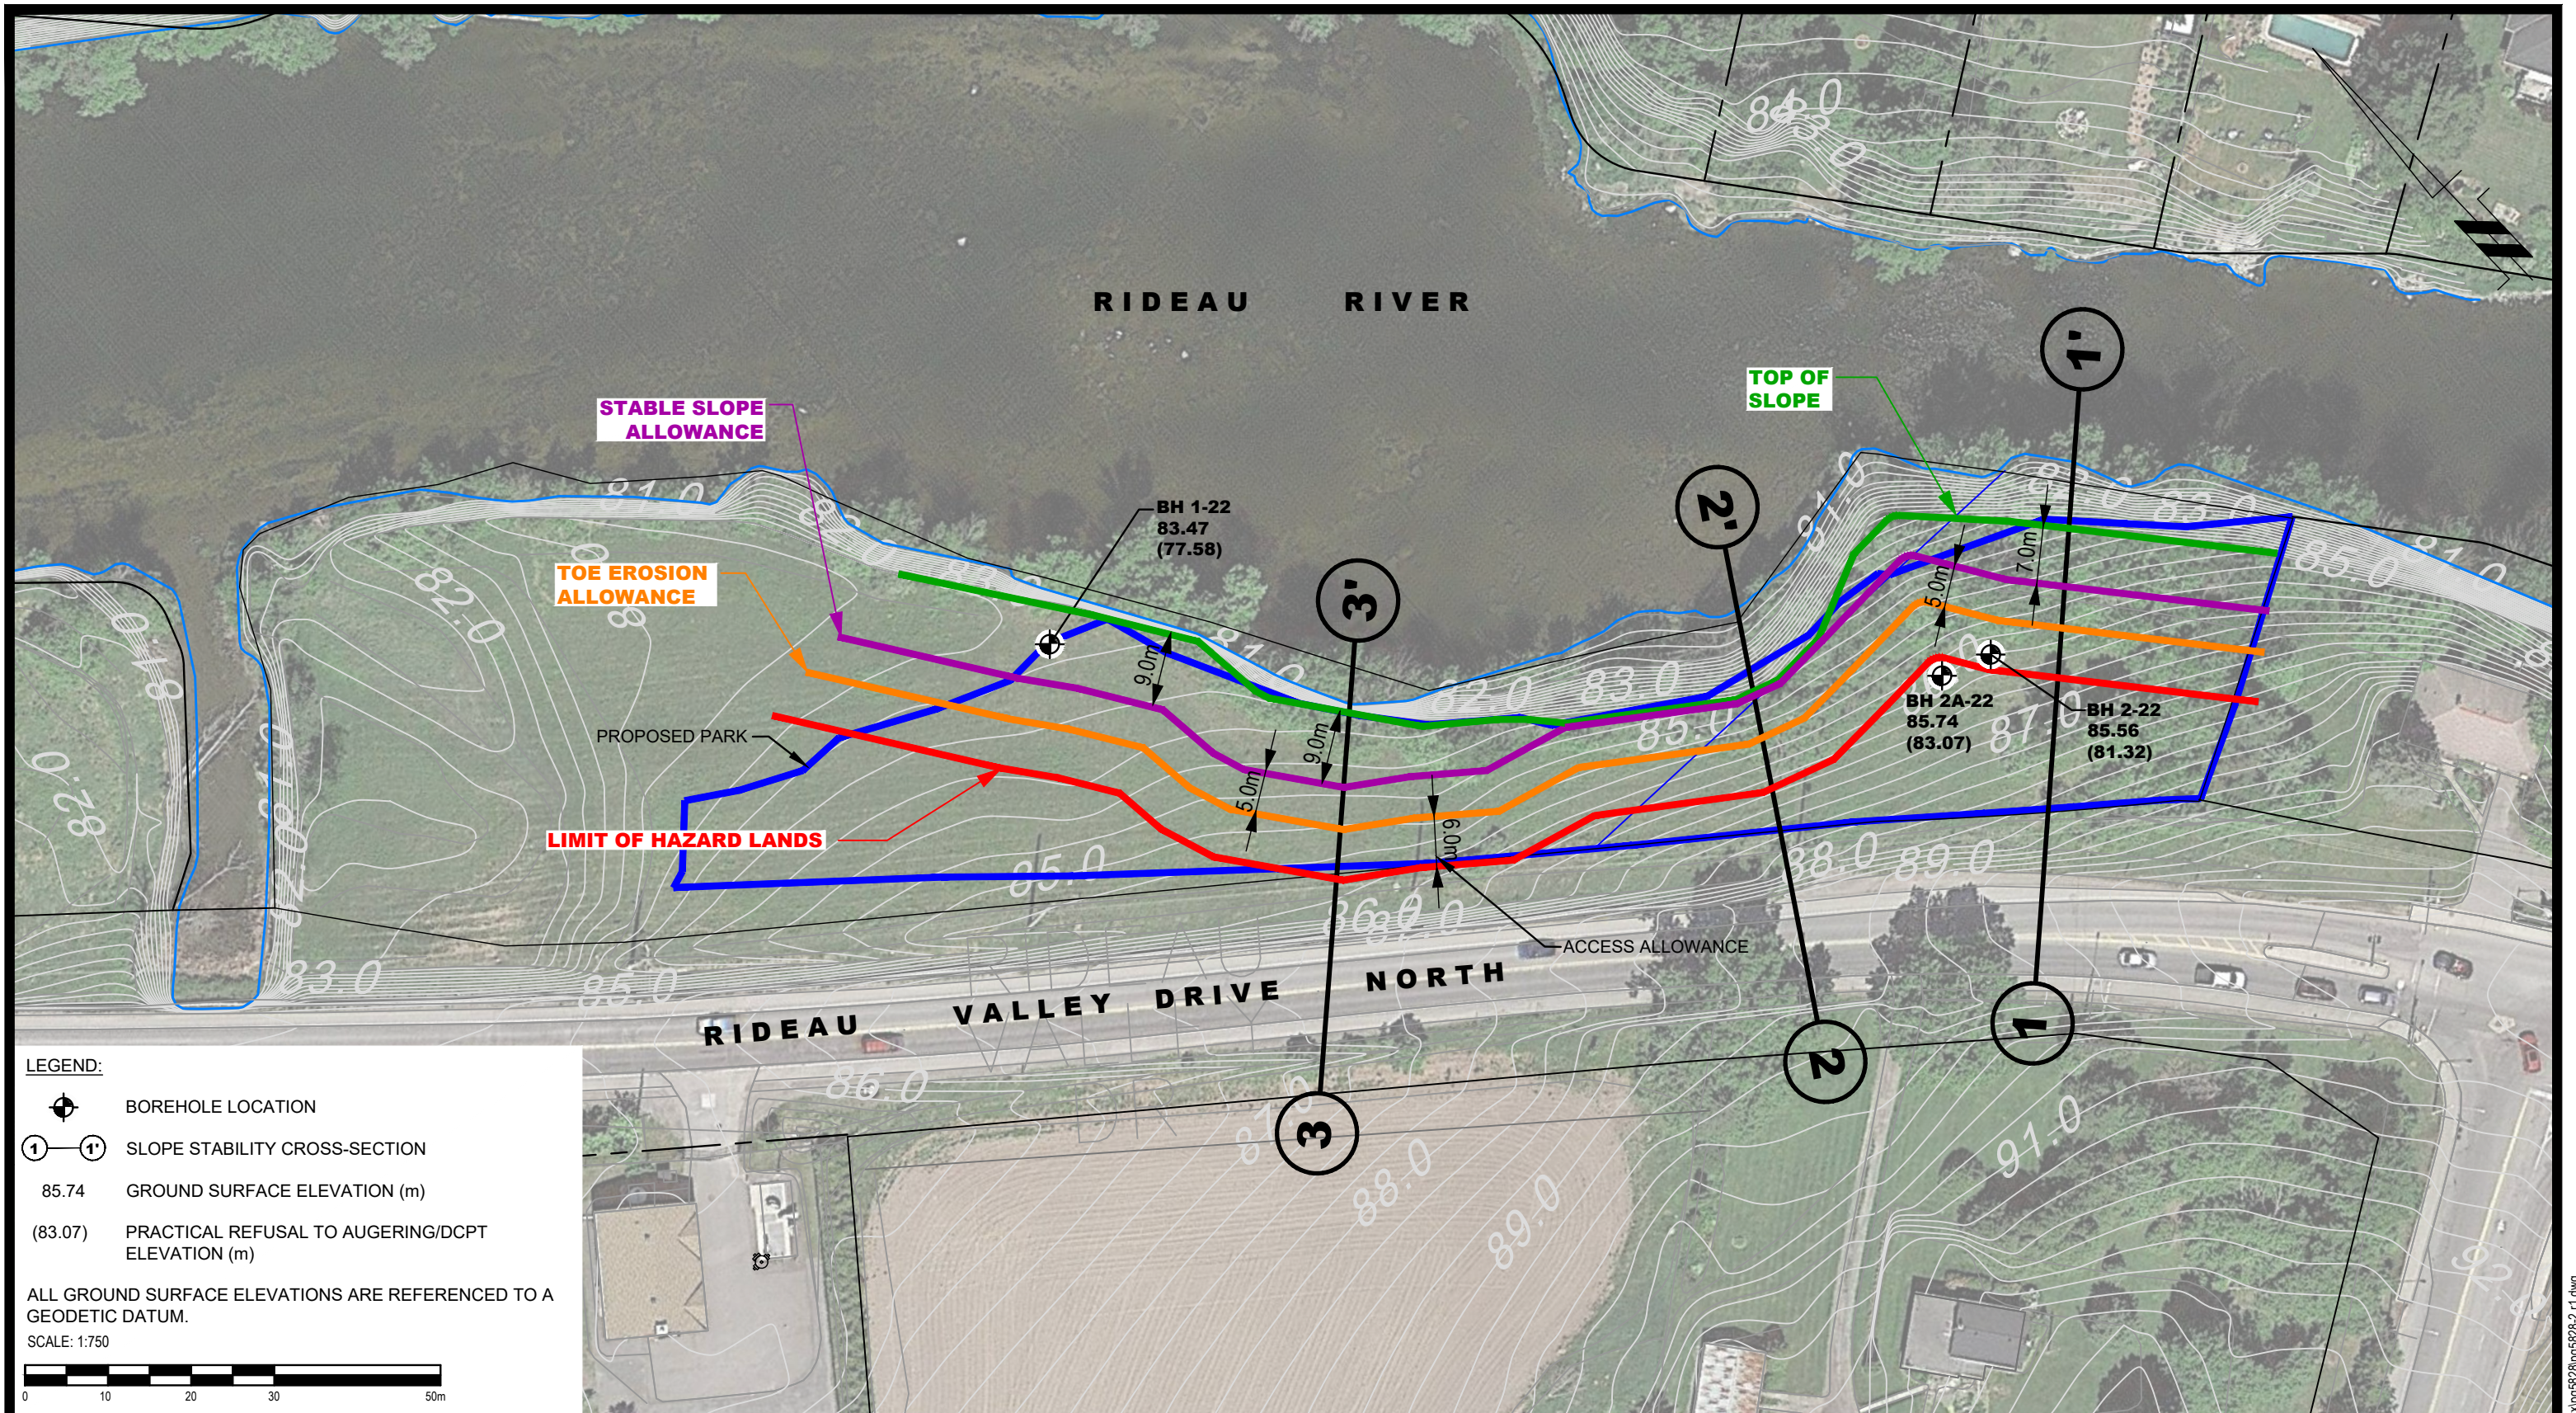
Title: **LIMIT OF HAZARD LANDS PLAN**

Based on the soil profiles encountered at the borehole locations and the soil encountered throughout the river, a stiff grey silty clay is anticipated to be subject to erosion activity by the river flow. Based on the encountered soils and the observed active erosion, a toe erosion allowance of 5 m should be applied for the subject slope. Furthermore, a minimum 6 m access allowance should be considered.

Based on the above, a setback taken from the top of the current slope has been provided as based on the above-noted observations and analysis. Reference should be made to Drawing PG5828-2 – Limit of Hazard Lands Plan for the proposed River Park at the subject site.
