June 6, 2019

Chmiel Architects Inc.
Attention Richard Chmiel
200-109 Bank Street
Ottawa, Ontario, K1P 5N5

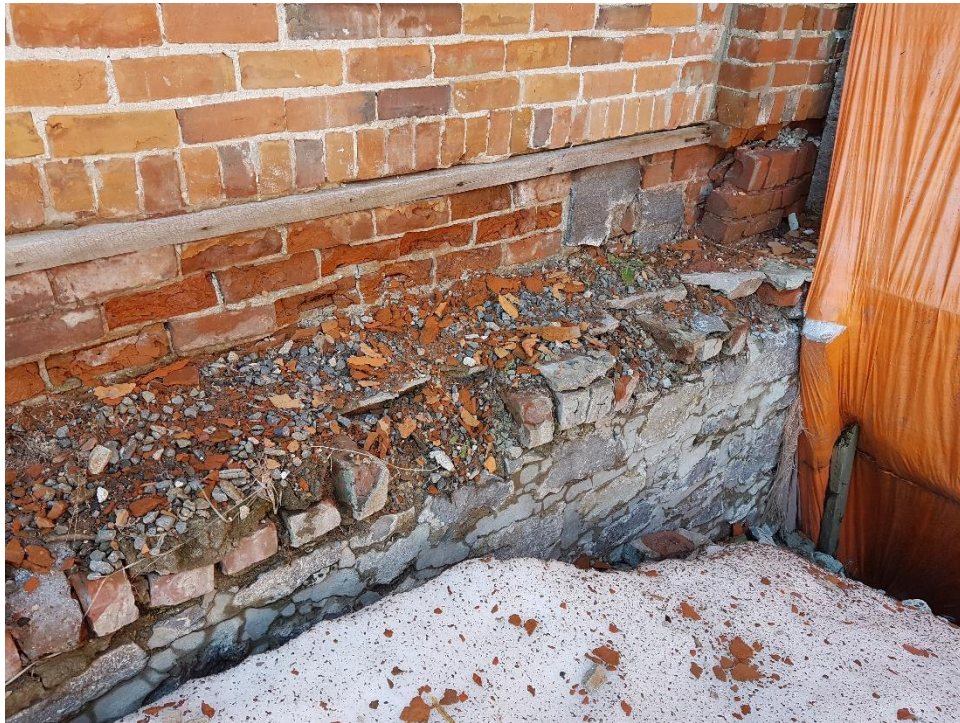
Photograph 8: Area of severe brick deterioration on the south wall (above foundation wall).

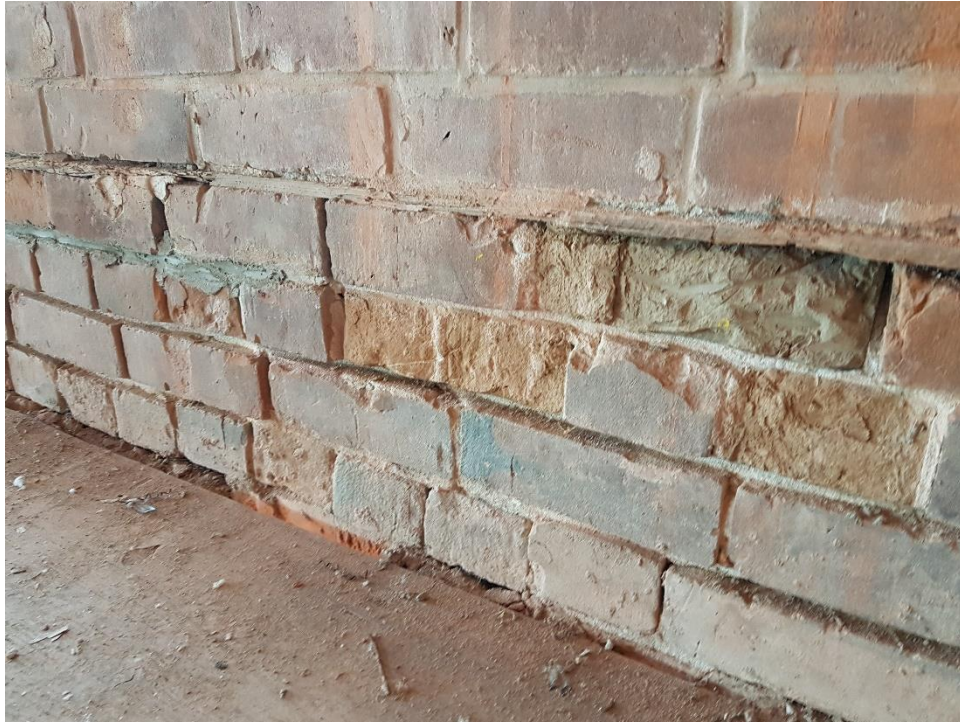
Photograph 9: Area of noted brick deterioration on the interior wythe of second floor, north wall.

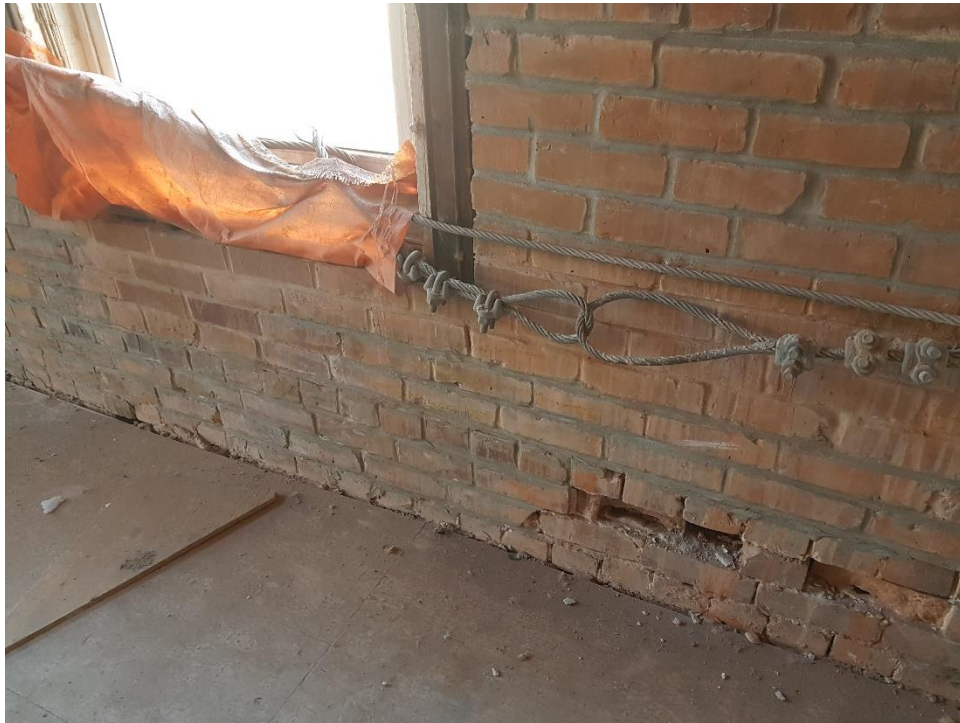
Photograph 10: Area of noted brick deterioration on the interior wythe of second floor, north wall.

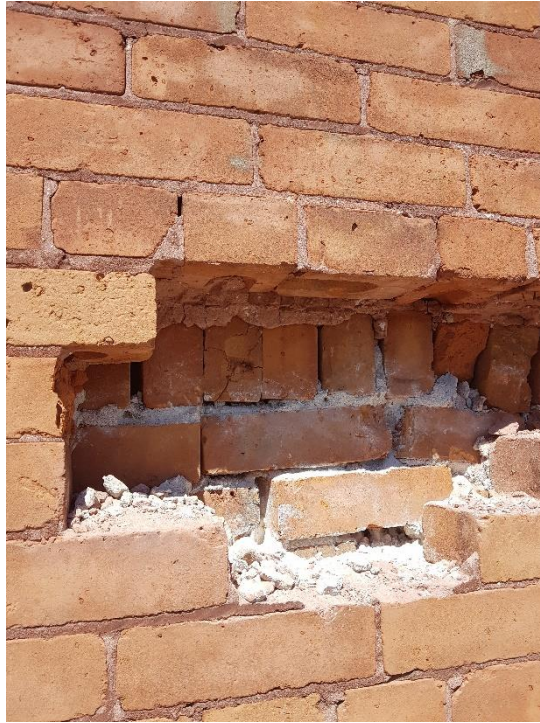
Photograph 11: View of the middle wythe condition. Mortar in poor condition and some cracked bricks.
Opening on south wall, third floor.

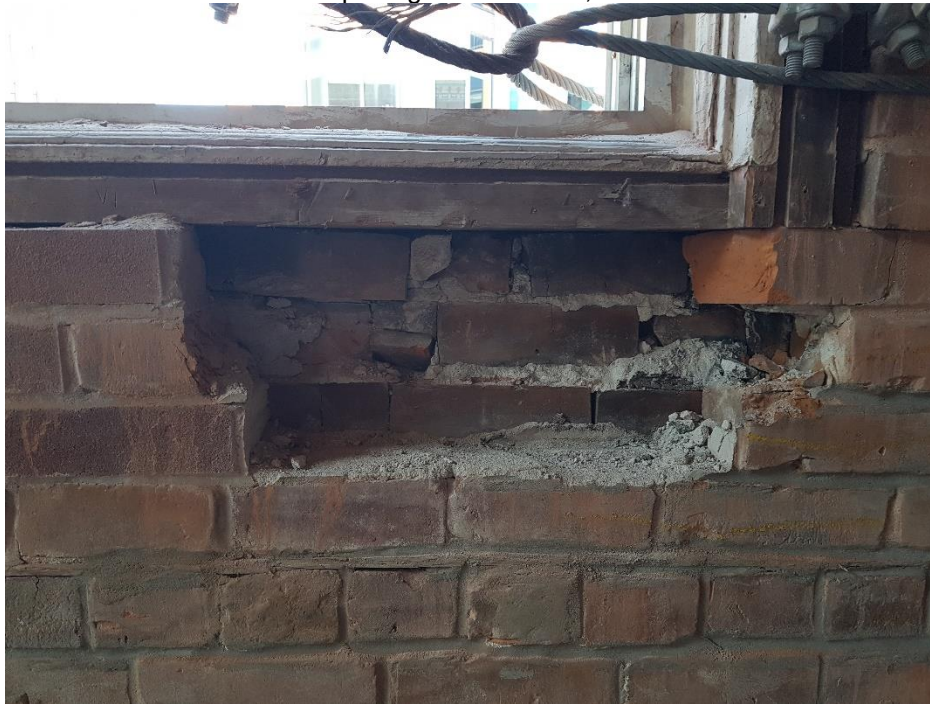
Photograph 12: View of the middle wythe condition. Mortar in poor condition and some cracked bricks.
Opening on north wall, second floor (below window to extract middle wythe).

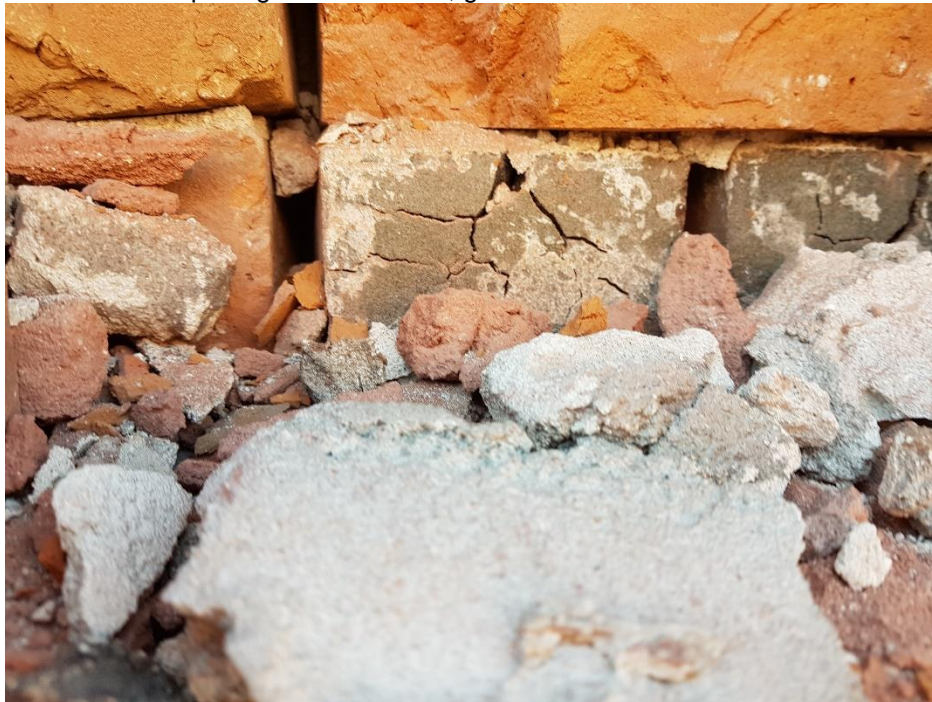
Photograph 14: Close-up view of the middle wythe condition. Mortar deteriorated, crack and crushed bricks. Opening on the exterior, ground floor of the north elevation.
