PRE-CONSTRUCTION CCTV INSPECTION REPORT

PC-5226 29 RUSSELL AVENUE

Sanitary

July 18th, 2022

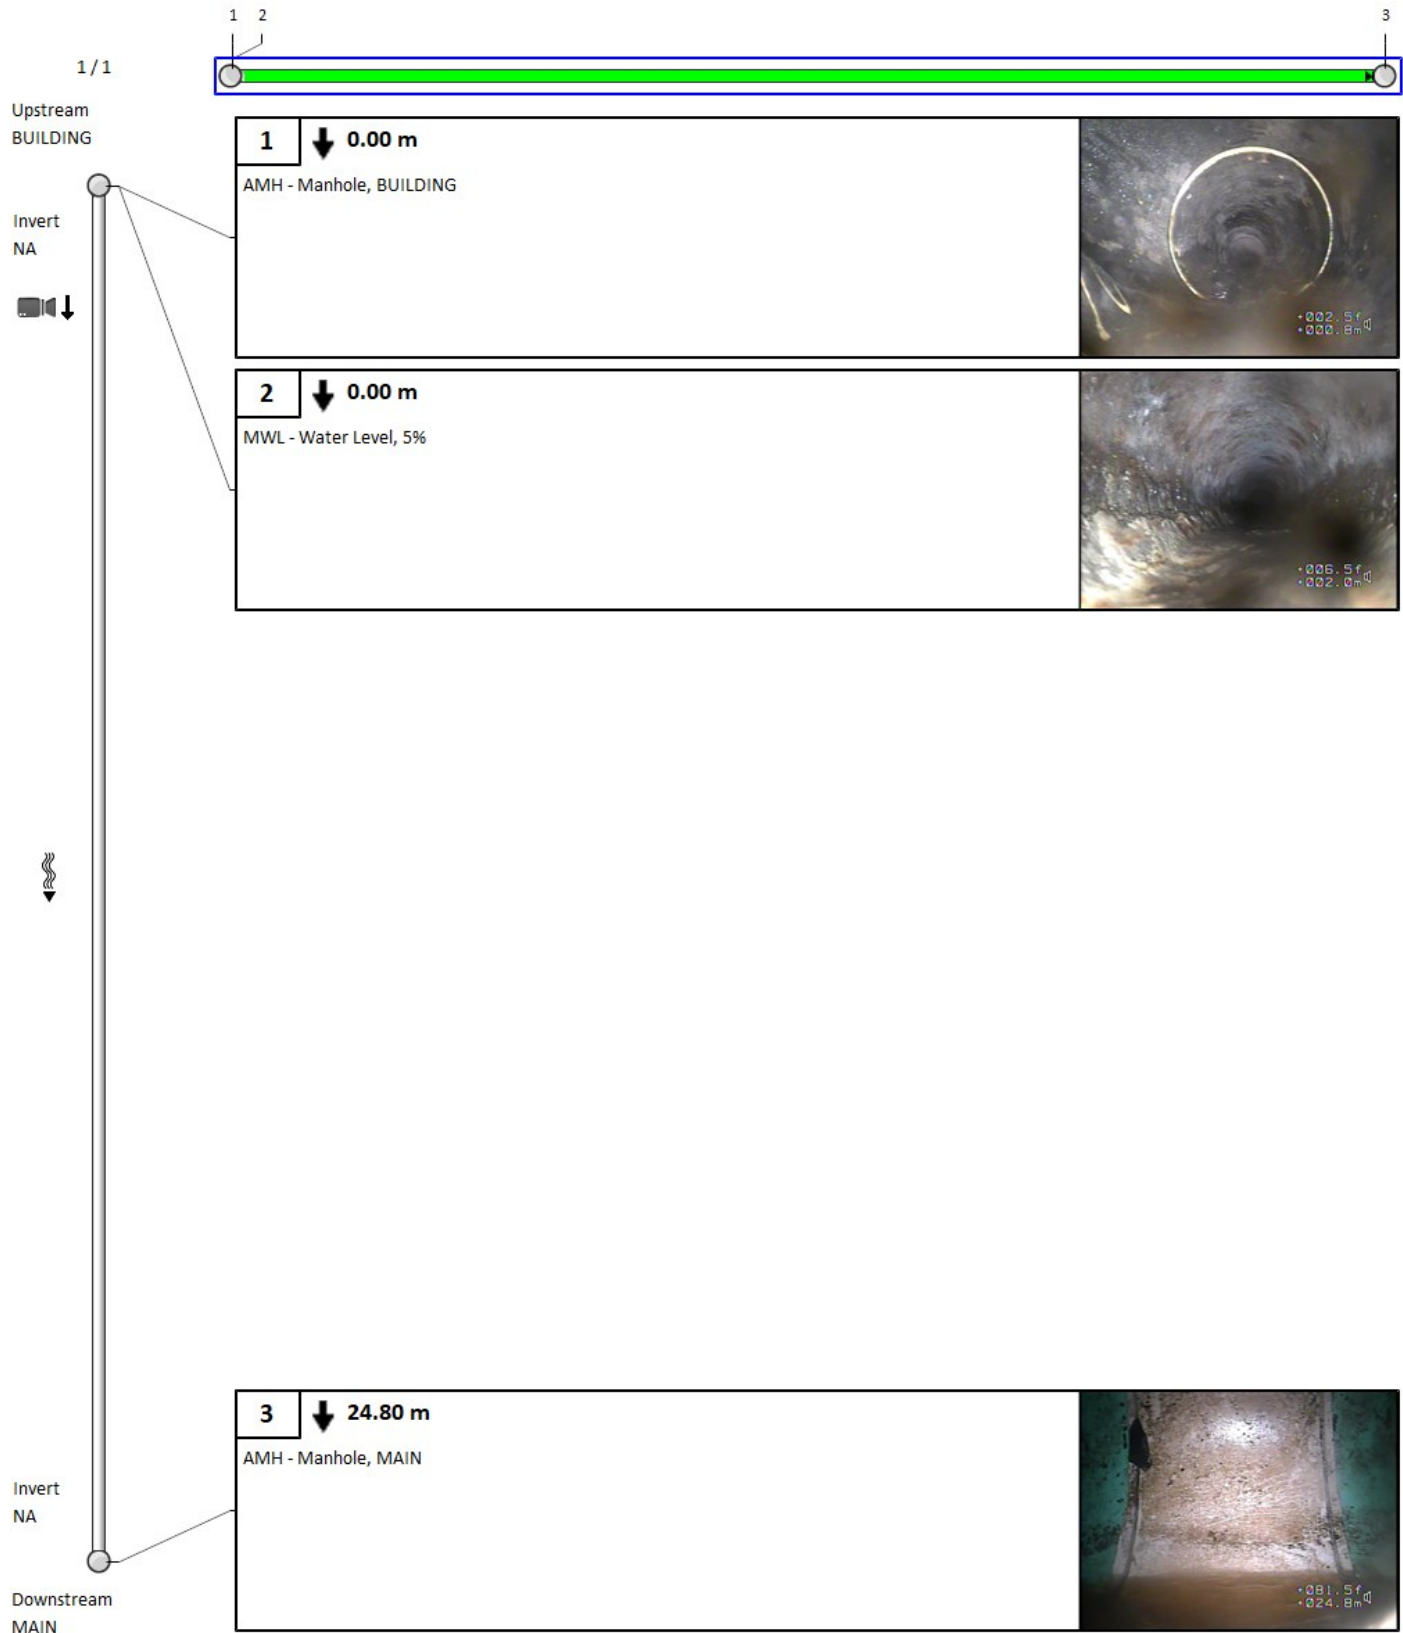
4. Pipe summary and condition details

Structural rating

Peak: 0
 Quick rating: 0000
 Score: 0
 Index: 0

O&M rating

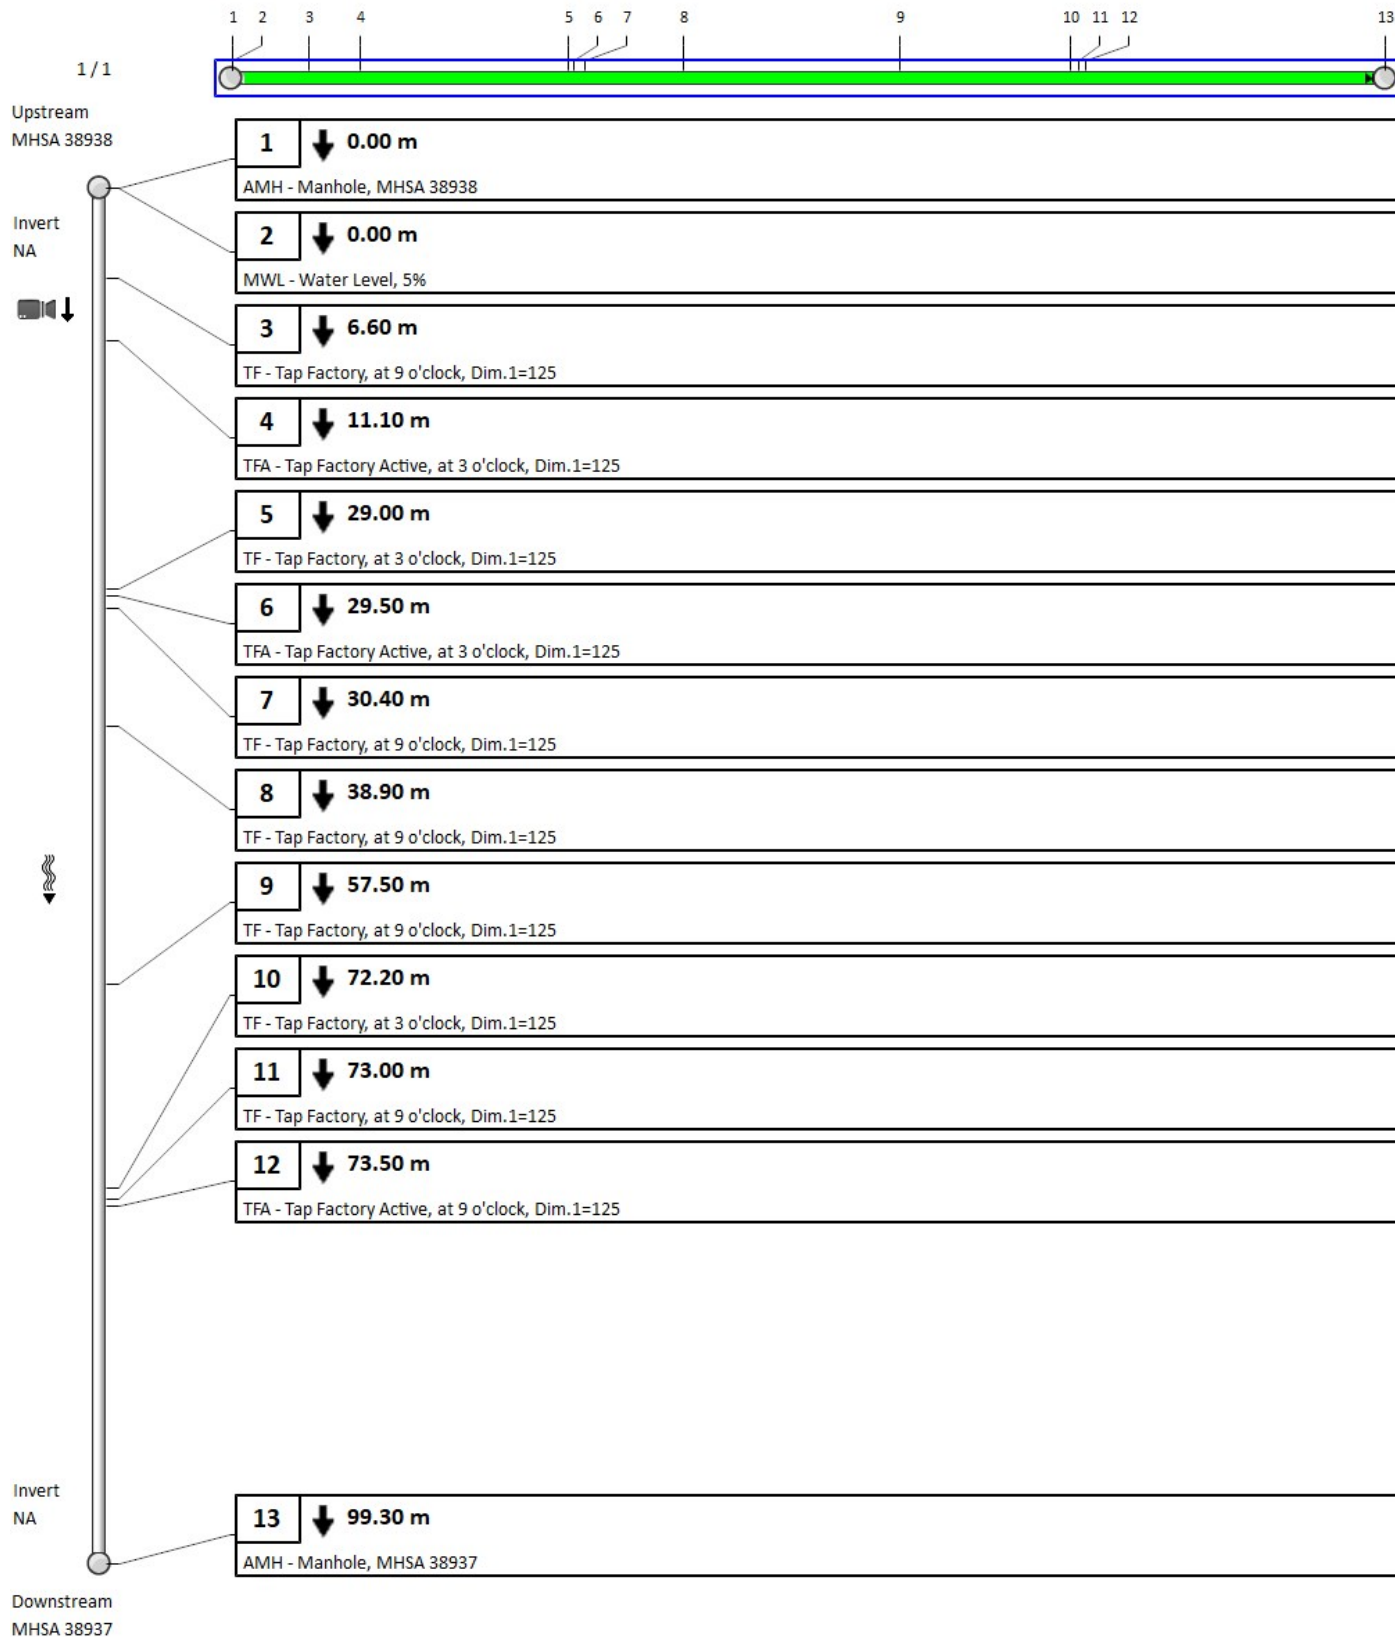
4. Pipe summary and condition details

Structural rating

Peak: 0
 Quick rating: 0000
 Score: 0
 Index: 0

O&M rating
