TREE CONSERVATION REPORT

1887 St Joseph Boulevard, Ottawa, ON

Tree Conservation Report submitted as Partial
Requirements for a Rezoning Application, July
13, 2023

Dendron Forestry Services

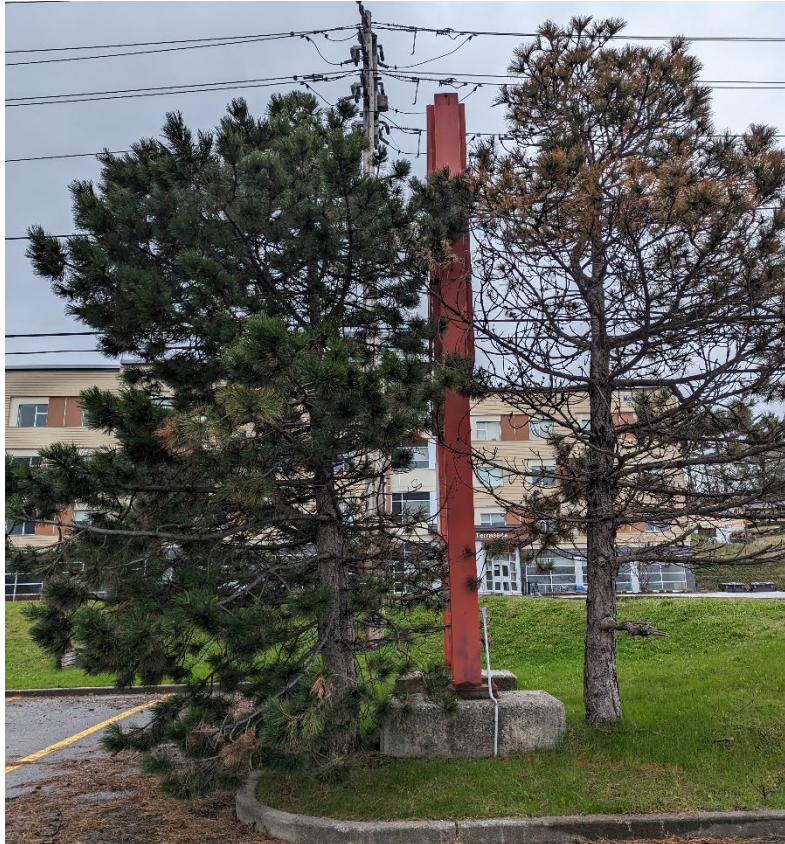
Tree 2 (right) and Tree 3 (left)

Tree ¹	Species	Diameter at breast height (cm)	Ownership ^{2,3}	Condition	Action
1	Crabapple (<i>Malus spp.</i>)	28	Subject property – possibly jointly owned with City	Fair/Good: growing under wires, epicormic shoots	Remove due to impacts of development
2	Austrian pine (<i>Pinus nigra</i>)	30	Subject property	Poor: Live Crown Ratio 30%, chlorosis on remaining	Remove due to impacts of development
3	Austrian pine (<i>Pinus nigra</i>)	22, 23	Subject property	Fair: poor structure, minor chlorosis	Remove due to impacts of development
4 ⁴	White spruce (<i>Picea glauca</i>)	21	Subject property	Poor: Live Crown Ratio 5% - rest dead	Remove due to health
5 ⁴	Manitoba maple (<i>Acer negundo</i>)	14 10, 9, 15	Subject property	Fair: poor structure; growing beside fence	Remove due to impacts of development
6 ⁴	Norway spruce (<i>Picea abies</i>)	24	Subject property	Fair/Good: minor defoliation	Remove due to impacts of development

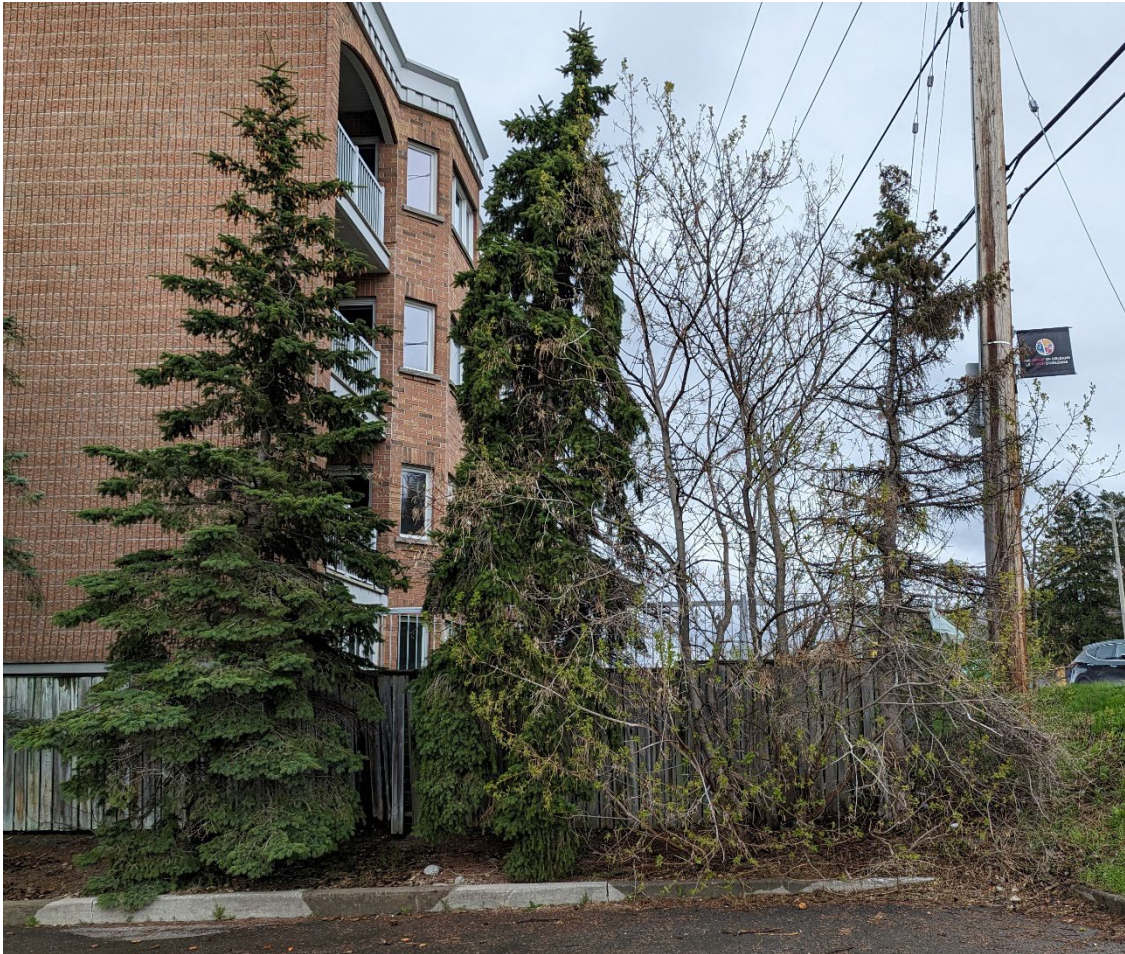
Trees 4-7 (right to left)

7 ⁴	Norway spruce (<i>Picea abies</i>)	19	Subject property	Fair/Poor: thin crown; poor structure	Remove due to impacts of development
8 ⁴	Norway spruce (<i>Picea abies</i>)	29	Subject property	Fair/Poor: thin crown; being girdled	Remove due to impacts of development
9 ⁴	Norway spruce (<i>Picea abies</i>)	22, 15	Subject property	Fair: some deadwood in crown; codominant stems split at 70cm	Remove due to impacts of development
10 ⁴	Norway spruce (<i>Picea abies</i>)	26, 18	Subject property	Fair: some deadwood in crown; codominant stems split at 70cm	Remove due to impacts of development
11 ⁴	Norway spruce (<i>Picea abies</i>)	30, 19	Subject property	Fair/Poor: very thin crown; split at 1.2m	Remove due to impacts of development
12 ⁴	Norway spruce (<i>Picea abies</i>)	16, 17	Subject property	Fair: some deadwood in crown	Remove due to impacts of development
13 ⁴	Norway spruce (<i>Picea abies</i>)	35, 16	Subject property	Fair: some dead wood in crown	Remove due to impacts of development

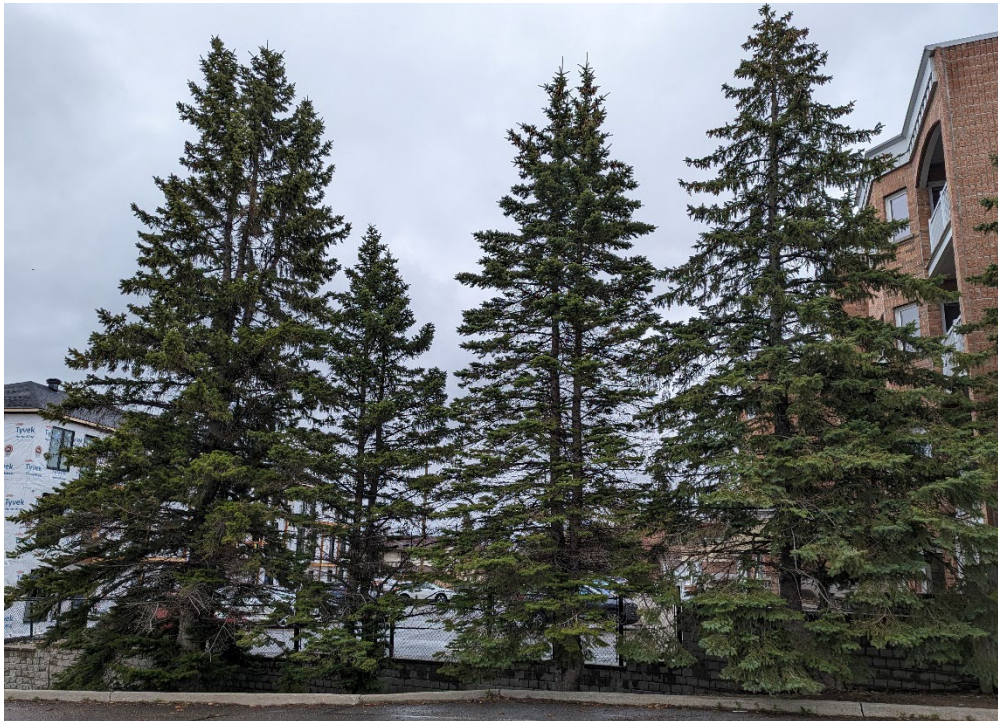
Trees 13-16 (right to left)

14 ⁴	Norway spruce (<i>Picea abies</i>)	23, 25	Subject property	Fair	Remove due to impacts of development
15 ⁴	Norway spruce (<i>Picea abies</i>)	23, 7, 19	Subject property	Fair/Poor	Remove due to impacts of development
16 ⁴	Norway spruce (<i>Picea abies</i>)	41, 16	Subject property	Fair/Good: some deadwood	Remove due to impacts of development
17 ⁴	Norway maple (<i>Acer platanoides</i>)	25	Subject property	Poor: moderate lean; sprouts at base becoming trees; decay in old wounds	Remove due to health
18	Norway maple (<i>Acer platanoides</i>)	38	Subject property	Poor: canker; leaning away	Remove due to health
19	Norway maple (<i>Acer platanoides</i>)	40	Subject property	Fair/Poor: dead central leader has decay; possible canker	Remove due to health

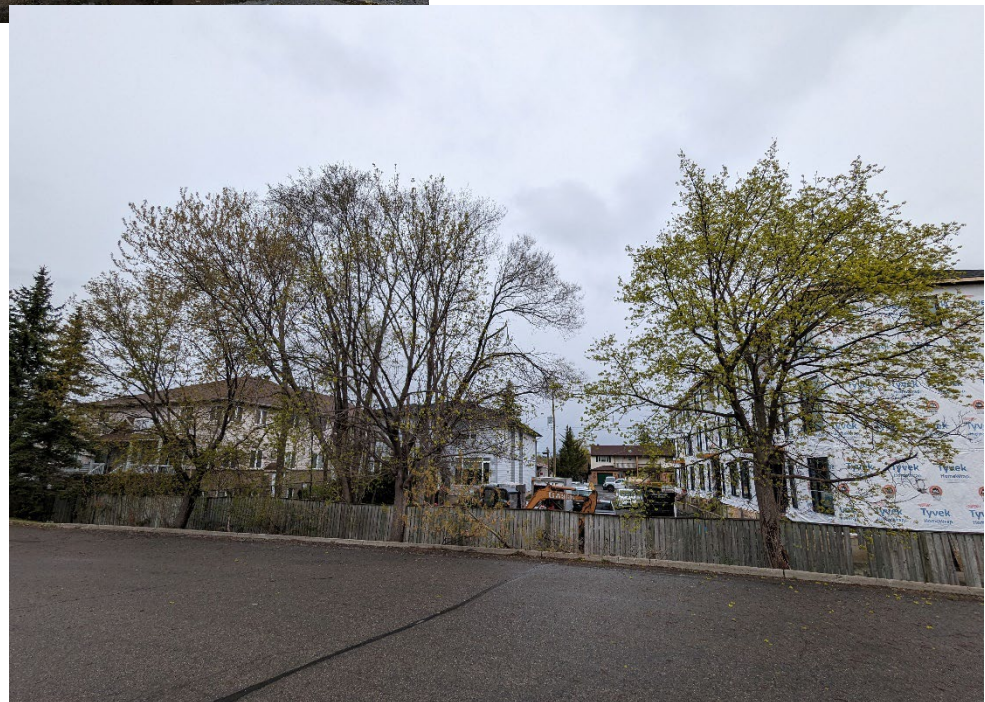
Trees 18-22 (right to left)

Tree 20 is a group of 14 Siberian elms (*Ulmus pumila*) on the adjacent property but growing quite close to the fence. Many of these trees will likely suffer deleterious effects from the changes in grade on the subject property and from the installation of the proposed landscaping wall along the eastern property line, so it is possible they will need to be removed in the future. At this time, they are recommended for retention with the following mitigations recommended: prior to excavation for the proposed landscape wall, a certified arborist should expose the roots by air spade and sever them cleanly by hand. This will promote faster sealing after construction. The arborist can then make a determination about tree stability and health based on the size of roots severed.

beginning; cracks in branches; lost limb	
20	Siberian elm (<i>Ulmus pulmila</i>)	14 stems: 10-40	Adjacent – 1250/1252 Marenger	14 stems between 10 and 40cm	Retain. Certified arborist to expose roots and sever roots by hand prior to excavation for proposed landscape wall
21	Norway maple (<i>Acer platanoides</i>)	40	Subject property	Poor; poor union; Center of stem decayed away; possible canker	Remove due to health
22	Norway maple (<i>Acer platanoides</i>)	25 (est)	Boundary - 1250/1252 Marenger	Poor: leaning heavily on, and growing over, fence	Remove due to impacts of development
23	Norway spruce (<i>Picea abies</i>)	25	Subject property	Fair: thin crown	Remove due to impacts of development
24	Norway spruce (<i>Picea abies</i>)	38	Subject property	Fair/Good: minor defoliation	Remove due to impacts of development
25	Norway spruce (<i>Picea abies</i>)	34	Subject property	Fair: crown thin at top	Remove due to impacts of development

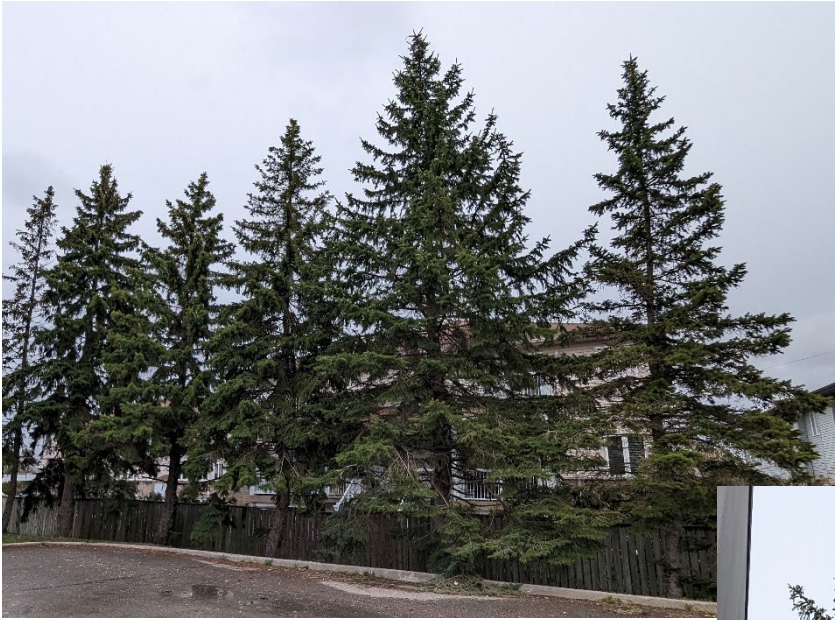
Above - Trees 23-28 (right to left)

26	Norway spruce (<i>Picea abies</i>)	38	Subject property	Fair/Good: minor defoliation	Remove due to impacts of development
27	Norway spruce (<i>Picea abies</i>)	36	Subject property	Good	Remove due to impacts of development
28 ⁴	White spruce (<i>Picea glauca</i>)	22	Subject property	Poor: major defoliation/dead branches	Remove due to health
29	White spruce (<i>Picea glauca</i>)	23	Subject property	Poor: major defoliation/dead branches	Remove due to health
30	Norway maple (<i>Acer platanoides</i>)	41	Subject property	F: exposed roots with damage; large wound with decay (canker?)	Remove due to impacts of development
31	Norway spruce (<i>Picea abies</i>)	29	Subject property	Fair/Good: asymmetrical crown, minor defoliation	Retain and protect
32	White spruce (<i>Picea glauca</i>)	31, 32	Subject property	Fair: Codominant stems at 40cm; minor defoliation	Retain and protect
33	Colorado spruce (<i>Picea pungens</i>)	35	Subject property	Good: asymmetrical crown	Remove due to impacts of development

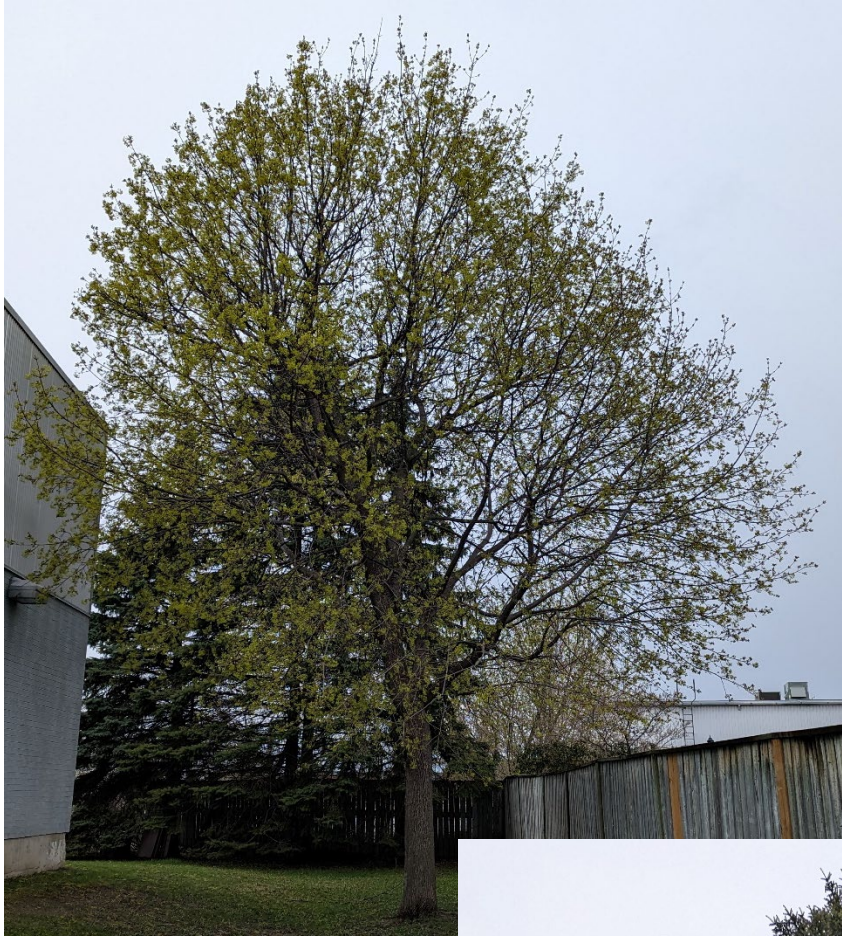
Above - Tree 30

30	Norway maple (<i>A. platanoides</i>)	41	Subject property	F: exposed roots with damage; large wound with decay (canker?)
31	Norway spruce (<i>P. abies</i>)	29	Subject property	Fair/Good: asymmetrical crown, minor defoliation
32	White spruce (<i>Picea glauca</i>)	31, 32	Subject property	Fair: Codominant stems at 40cm; minor defoliation
33	Colorado spruce (<i>Picea pungens</i>)	35	Subject property	Good: asymmetrical crown
34 ⁴	Norway maple (<i>A. platanoides</i>)	18 est	Boundary – 1479 Youville	Fair/Poor: heavy lean; wounds; growing under fence
35 ⁴	Norway maple (<i>A. platanoides</i>)	5-10	Adjacent – 1479 Youville	Fair: Weed trees along back fence line
36	Norway maple (<i>A. platanoides</i>)	36	Subject property	Fair: slight lean, some dead branches
37	Norway maple (<i>A. platanoides</i>)	57	Subject property	Fair/Poor: large wound at base; poor structure; lean towards subject property
38	Norway maple (<i>A. platanoides</i>)	49	Subject property	Fair/Good: slight lean towards subject property; exposed roots

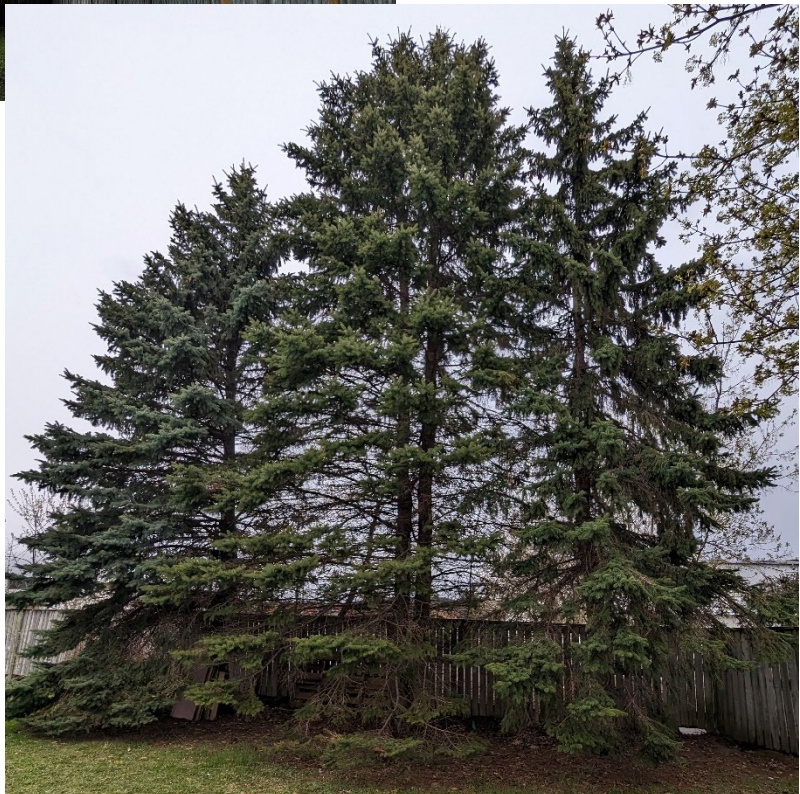
Right - Trees 31-34

Due to the intensification on this site, tree preservation will be very difficult. The northeast corner of the property, where there is less activity proposed, is the one location recommended for tree preservation and protection. **Trees 31 and 32** appear to be far enough from proposed building and roadways to survive. These trees have the potential to grow large and could contribute to canopy cover once construction is complete. Protective fencing as described below should be installed prior to any site works.

34 ⁴	Norway maple (<i>Acer platanoides</i>)	18 est	Boundary – 1479 Youville	Fair/Poor: heavy lean; wounds; growing under fence	Remove due to impacts of development
35 ⁴	Norway maple (<i>Acer platanoides</i>)	5-10	Adjacent – 1479 Youville	Fair: Weed trees along back fence line	No action required
36	Norway maple (<i>Acer platanoides</i>)	36	Subject property	Fair: slight lean, some dead branches	Remove due to impacts of development
37	Norway maple (<i>Acer platanoides</i>)	57	Subject property	Fair/Poor: large wound at base; poor structure; lean towards subject property	Remove due to impacts of development
38	Norway maple (<i>Acer platanoides</i>)	49	Subject property	Fair/Good: slight lean towards subject property; exposed roots	Remove due to impacts of development
39	Norway spruce (<i>Picea abies</i>)	32	Subject property	Fair: some defoliation, some chlorosis	Remove due to impacts of development

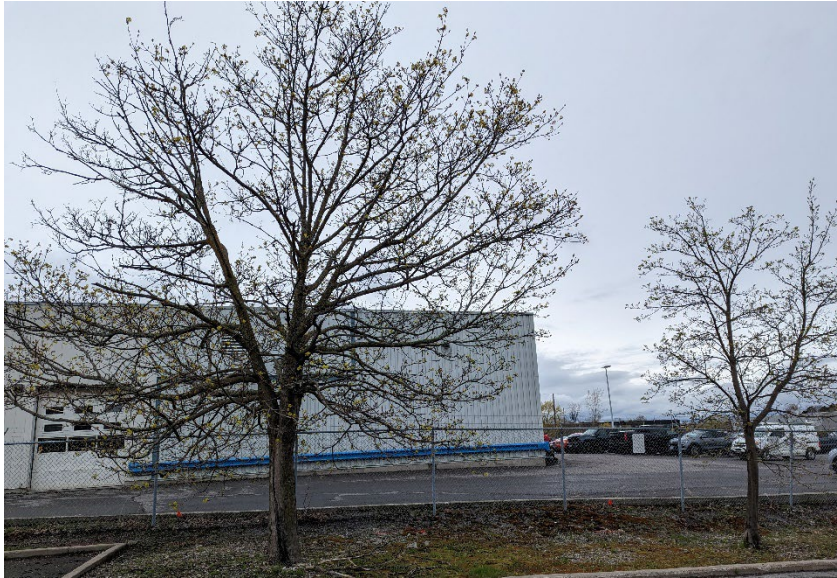
Above - Tree 44 (right) Tree 45 (left)

42	Norway spruce (<i>Picea abies</i>)	39	Subject property	Good	Remove due to impacts of development
43	Norway maple (<i>Acer platanoides</i>)	30	Subject property	Poor: canker at base; decay in center of stem; main leader is dead	Remove due to impacts of development
44	Norway maple (<i>Acer platanoides</i>)	20	Subject property	Fair/Good: lean in to subject property; small wounds with decay	Remove due to impacts of development
45	Norway maple (<i>Acer platanoides</i>)	39	Subject property	Fair/Poor: one of three main leaders dying from top; likely decay in center of stem	Remove due to health
46 ⁴	Ash (<i>Fraxinus spp.</i>)	10, 8, 9	Subject property	Poor: sprouts from dead stem	Remove due to health
47 ⁴	Ash (<i>Fraxinus spp.</i>)	11, 10, 8, 8	Subject property	Poor: sprouts from dead stem	Remove due to health
48 ⁴	Norway maple	10	Subject property	Fair/Good: recently planted; wound at base sealing	Remove due to health

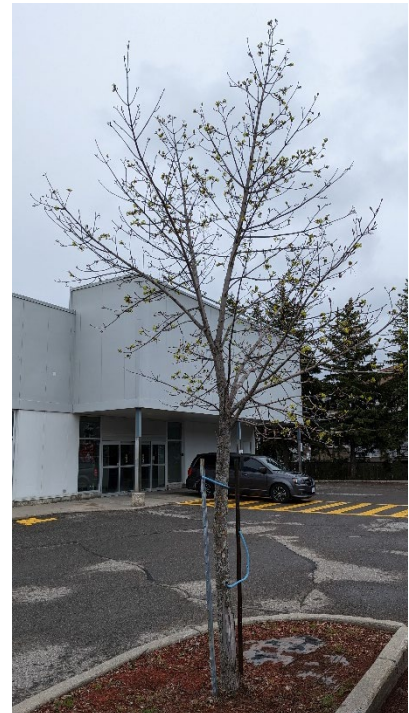
Below - Tree 48

48 ⁴	Norway maple (<i>A. platanoides</i>)	10	Subject property	Fair/Good: recently planted; wound at base sealing
49	Manitoba maple (<i>A. negundo</i>)	12	Boundary – 1252 Marenger	Poor: small stem growing from old stump; heavy lean
