Tree Conservation Report

30 Cleary Avenue

CIMA+ file number: A001443
November 17, 2023 – Review 002

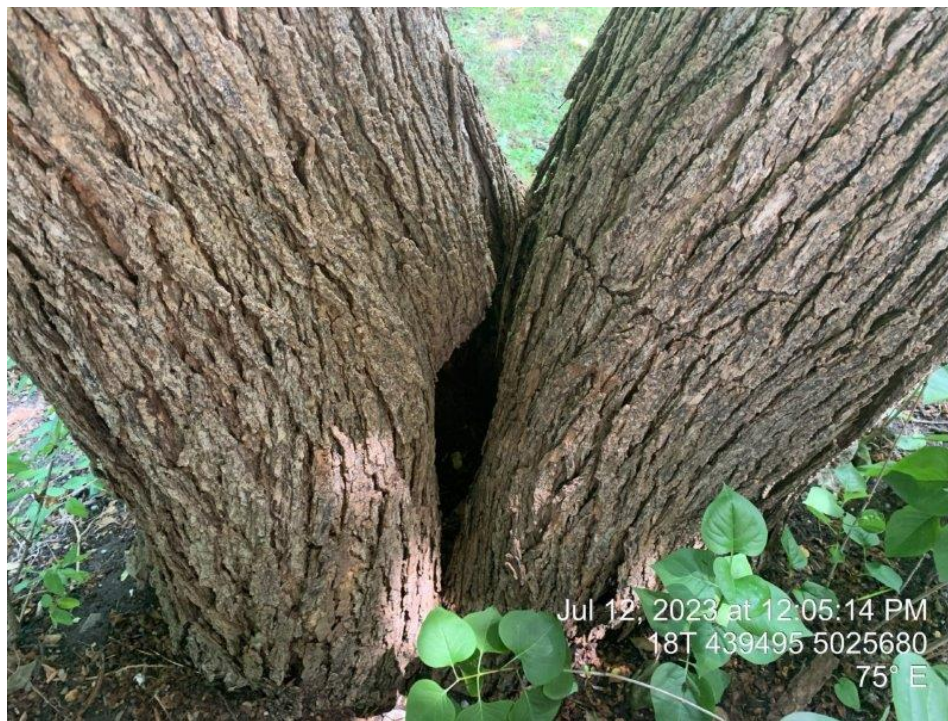
It should be noted that the condition of one (1), 2-stem northern catalpa (tree #7 - **Appendix A**) situated within the community garden was assessed as Good, however is experiencing some crotch decay. It is recommended that prior to construction, an ISA certified Tree Risk Assessor (ISA TRAQ) complete a Risk Assessment for this tree, and comment on its candidacy for cabling the 2 stems to strengthen its structure integrity. **Photo 1** below displays the codominant union of the trunks of tree #7.

Photo 1 : View of crotch decay and codominant leaders of Tree #7 – Northern Catalpa

7	Northern Catalpa	<i>Catalpa speciosa</i>	2	44;45	9	<input checked="" type="checkbox"/>	<input checked="" type="checkbox"/>	<input type="checkbox"/>	<input checked="" type="checkbox"/>	<input checked="" type="checkbox"/>	<input type="checkbox"/>	<input type="checkbox"/>	<input type="checkbox"/>	Good	14.8	Prune and Protect	In community garden; Crotch rot; Consider cabling 2 stems; Multi-stemmed Amur maple and lilac underneath.
8	American Elm	<i>Ulmus americana</i>	1	42	9	<input checked="" type="checkbox"/>	<input checked="" type="checkbox"/>	<input type="checkbox"/>	<input checked="" type="checkbox"/>	<input checked="" type="checkbox"/>	<input type="checkbox"/>	<input type="checkbox"/>	<input type="checkbox"/>	Good	0	Retain	In community garden.
9	Norway Maple	<i>Acer platanoides</i>	1	39	8	<input checked="" type="checkbox"/>	<input checked="" type="checkbox"/>	<input type="checkbox"/>	<input type="checkbox"/>	<input checked="" type="checkbox"/>	<input type="checkbox"/>	<input checked="" type="checkbox"/>	<input type="checkbox"/>	Good	0	Retain	In community garden.

A list of proposed avoidance and mitigation measures have been included in Section 7 of this report in relation to tree removals, tree protection, and tree preservation. This includes recommendation for further assessment of Tree #7 to determine the potential risk of the tree and whether it would be a good candidate for cabling to strengthen to codominant trunk union.
