TREE CONSERVATION REPORT V2.0

1657 Carling Avenue

Tree Conservation Report submitted as Partial
Requirements for a Zoning Bylaw Amendment
Application, May 30, 2024

Tree Conservation Report

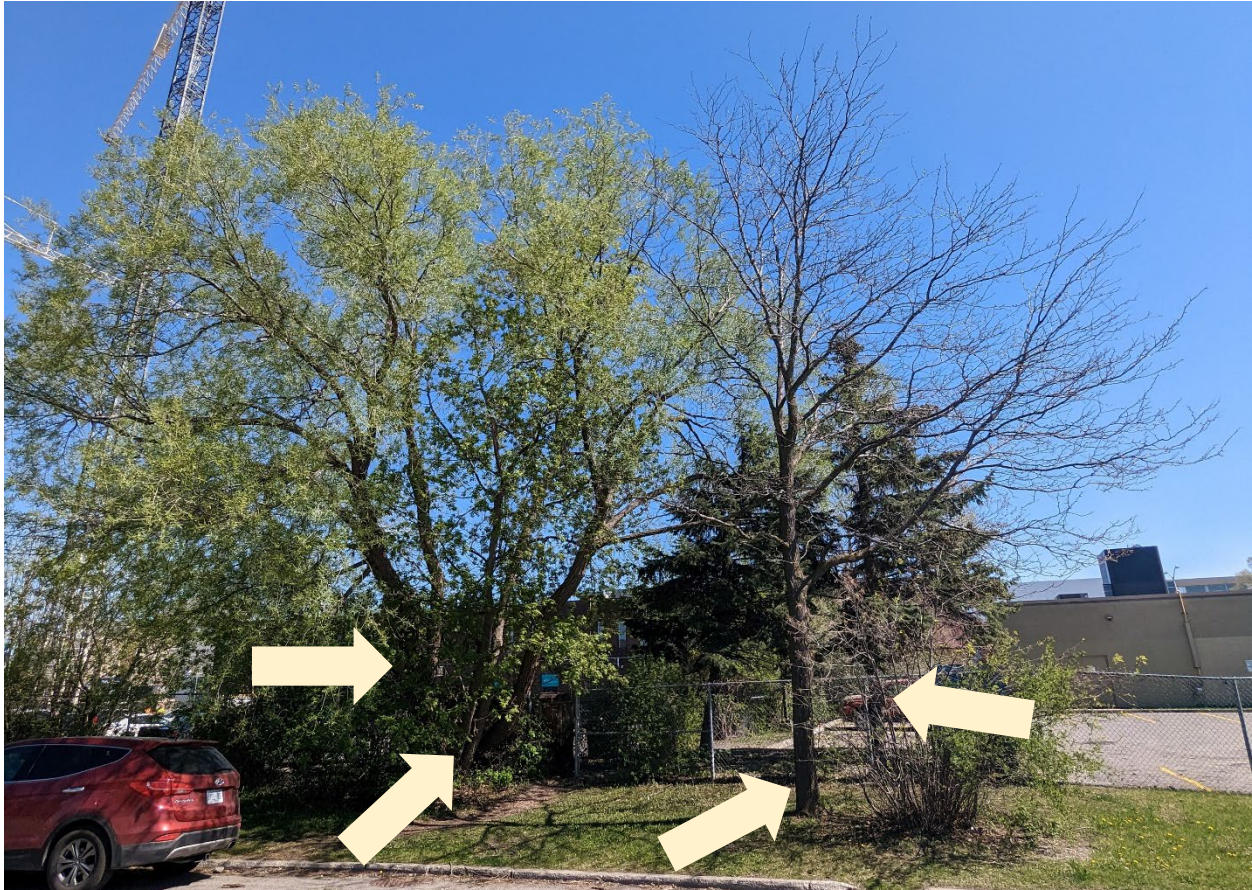
Trees 1-5 are far enough that impacts from construction will be lessened, however it is expected the CRZs will be affected by construction. Fencing should be erected as described below.

Figure 1 – (left to right) Tree 3: City willow, Tree 2: City Manitoba maple, Tree 1: City honey locust, Tree 4 and 5: adjacent Colorado spruces

Prior to any site works, protective fencing should be installed around the TPA as indicated in the attached Tree Information Map and maintained until all construction on site has been completed as per the **City of Ottawa Tree Protection Specifications (March 2021)**. Within the fenced area, the following tree protection guidelines should be applied:

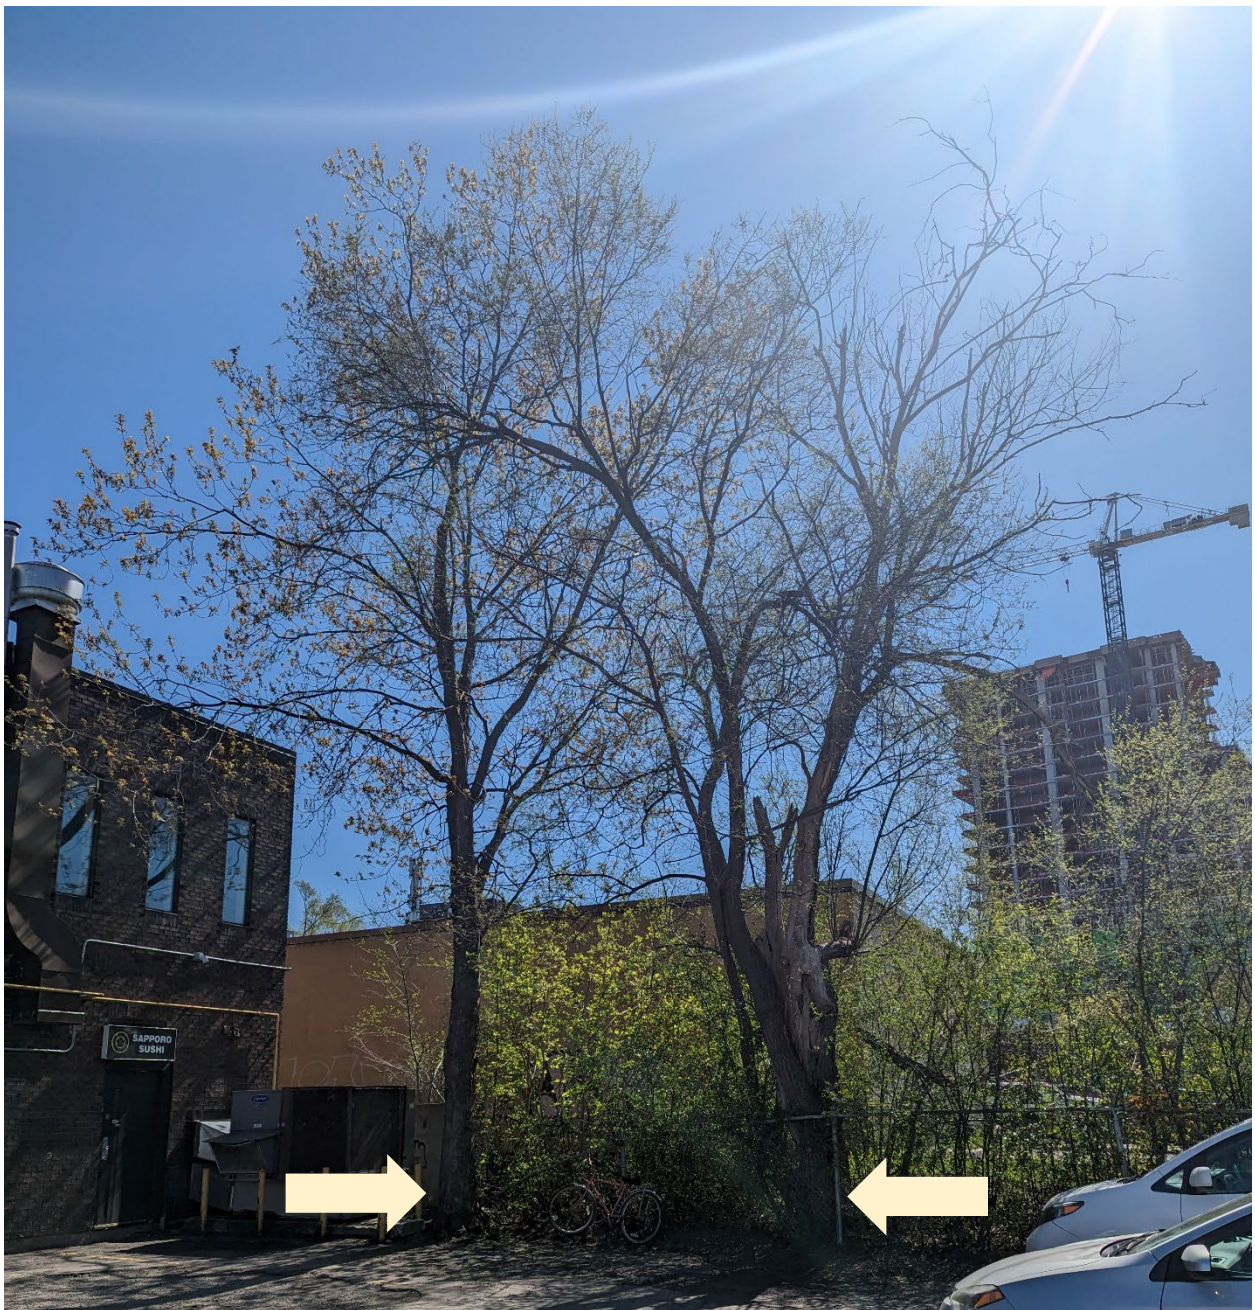
Trees 6-8, 16, 18 and 19 are in poor health and are not expected to endure the impacts of construction. Attempting to retain these trees during intense construction activities will not only be operationally difficult but could lead to safety issues.

6	Siberian elm (<i>Ulmus pumila</i>)	35 (estimate)	Boundary – 1677 Carling	Poor: only one branch with growth	Remove due to health status.
7 ⁴	Manitoba maple (<i>A. negundo</i>)	15, 15	Boundary – 376 Tillbury	Poor: old wounds have decay – tree nearly dead	Remove due to health status.
8	Red maple (<i>Acer rubrum</i>)	61	Subject property	Poor: significant dieback; ants in stem; old wounds not sealing – decay	Remove due to health status.

Figure 2 - (left) Tree 16: private maple (right) Tree 6: boundary elm

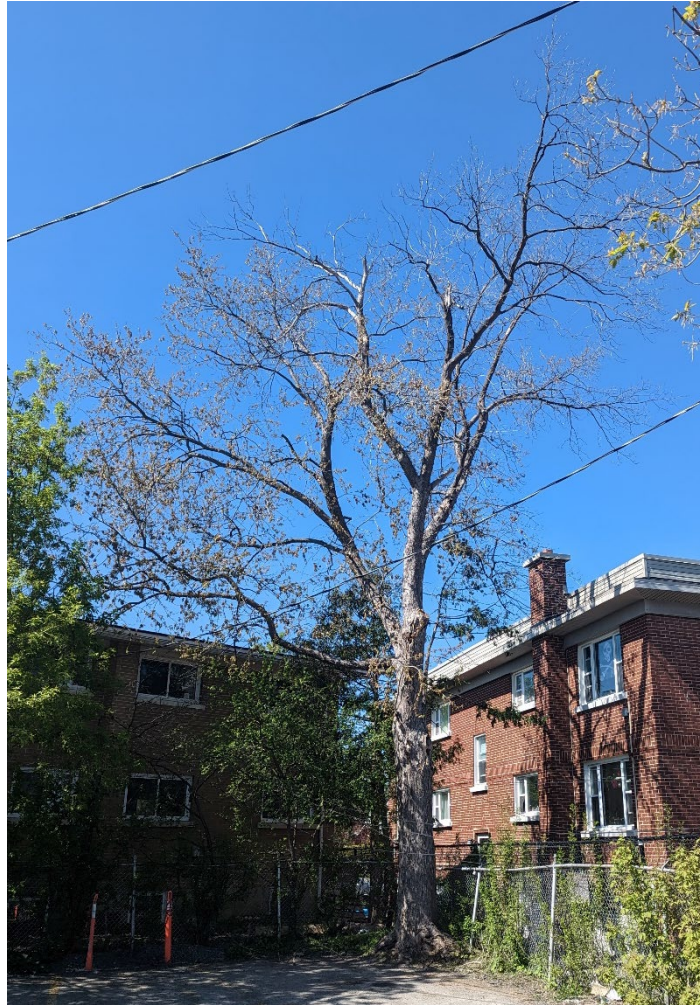
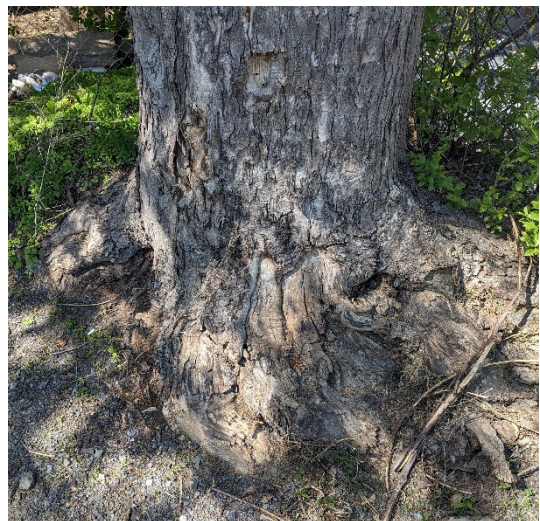
present; roots cut long ago for parking lot	
9 ⁴	Eastern white cedar (<i>Thuja occidentalis</i>)	15	Adjacent – 376 Tillbury	Fair: being girdled by wire; suppressed by Tree 8	Retain and protect as per the City of Ottawa Tree Protection Specifications (March 2021)
10 ⁴	Eastern white cedar (<i>Thuja occidentalis</i>)	12	Adjacent – 390 Tillbury	Fair: suppressed by Tree 8	Retain and protect as per the City of Ottawa Tree Protection Specifications (March 2021)
11 ⁴	Manitoba maple (<i>A. negundo</i>)	12	Boundary – 390 Tillbury	Fair: growing around fence	Remove due to health status, poor growing location and impacts from construction.
12 ⁴	Manitoba maple (<i>A. negundo</i>)	10	Boundary – 390 Tillbury	Fair: lean	Remove due to health status, poor growing location and impacts from construction.
13 ⁴	Manitoba maple (<i>A. negundo</i>)	21	Boundary – 390 Tillbury	Fair	Remove due to health status, poor growing location and impacts from construction.

Figure 3 – (Above) Tree 8: Private maple

(Right) base of Tree 8

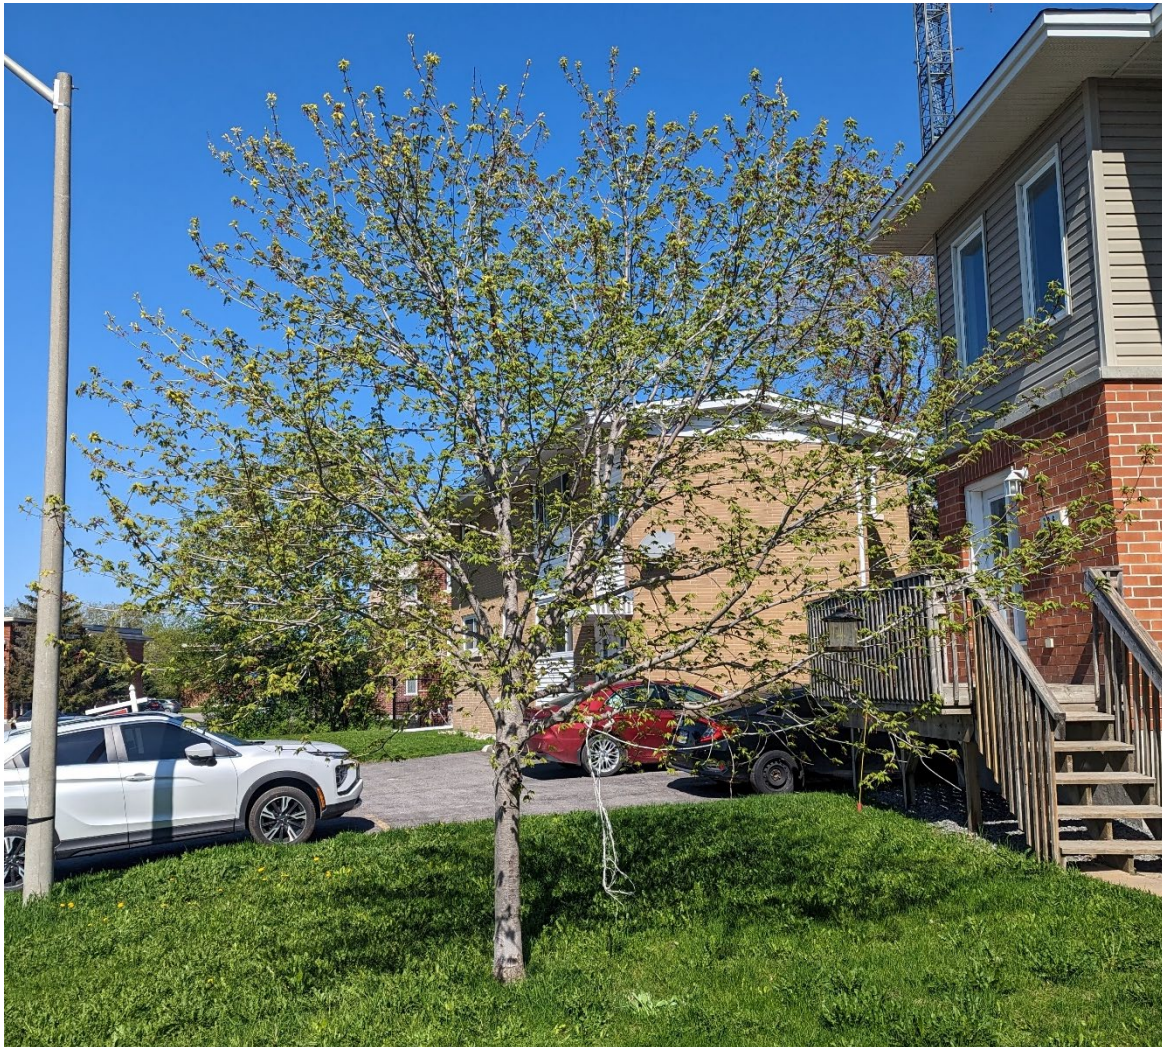
18 ⁴	Ash spp. (<i>Fraxinus</i> spp.)	11	Subject property	Poor	Remove due to health status and growing location
19 ⁴	Siberian elm (<i>U. pumila</i>)	12, 14	Subject property	Poor: growing from under deck, out of concrete	Remove due to health status and growing location
20	Red maple (<i>A. rubrum</i>)	13	City	Good	Remove due to plans

Figure 4 - Tree 20: City maple.

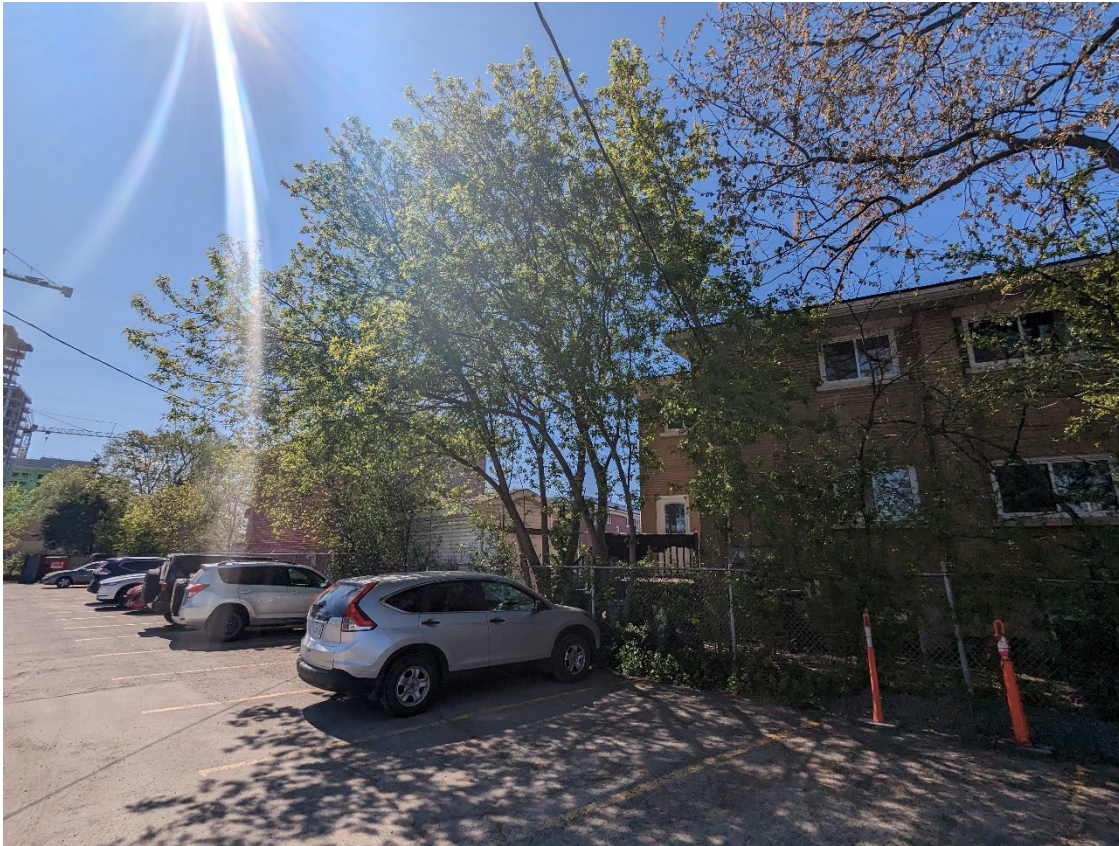
Tree 11-15 are likely self-seeded Manitoba maples (*Acer negundo*) growing along the fence line between the subject property and 390 Tillbury. These trees are not in good health and have not been maintained. It is expected that excavation for this build will be extensive and come near this property line. This is likely to sever large portions of the trees' CRZs, potentially leading to tree destabilization and safety issues. What is more, several of the trees are growing around the fence and have poor future growth potential as they stand.

14 ⁴	Manitoba maple (<i>A. negundo</i>)	20, 20, 15, 13	Boundary – 390 Tillbury	Fair: growing on fence; poor form	Remove due to health status, poor growing location and impacts from construction.
15 ⁴	Manitoba maple (<i>A. negundo</i>)	14, 8, 11	Subject property	Fair/Good: very close to house and fence	Remove due to health status, poor growing location and impacts from construction.
16	Silver maple (<i>Acer saccharinum</i>)	45	Subject property	Fair: minor broken branch; some dieback in crown; very poor growing location	Remove due to health status and impacts from construction.
17 ⁴	Manitoba maple (<i>A. negundo</i>)	9, 12, 5	Subject property	Fair: growing on fence	Remove due to poor growing location (removal of fence to create amenity space will necessitate removal of the tree)

Figure 5 - Trees 11-14: Manitoba maples growing along the fence

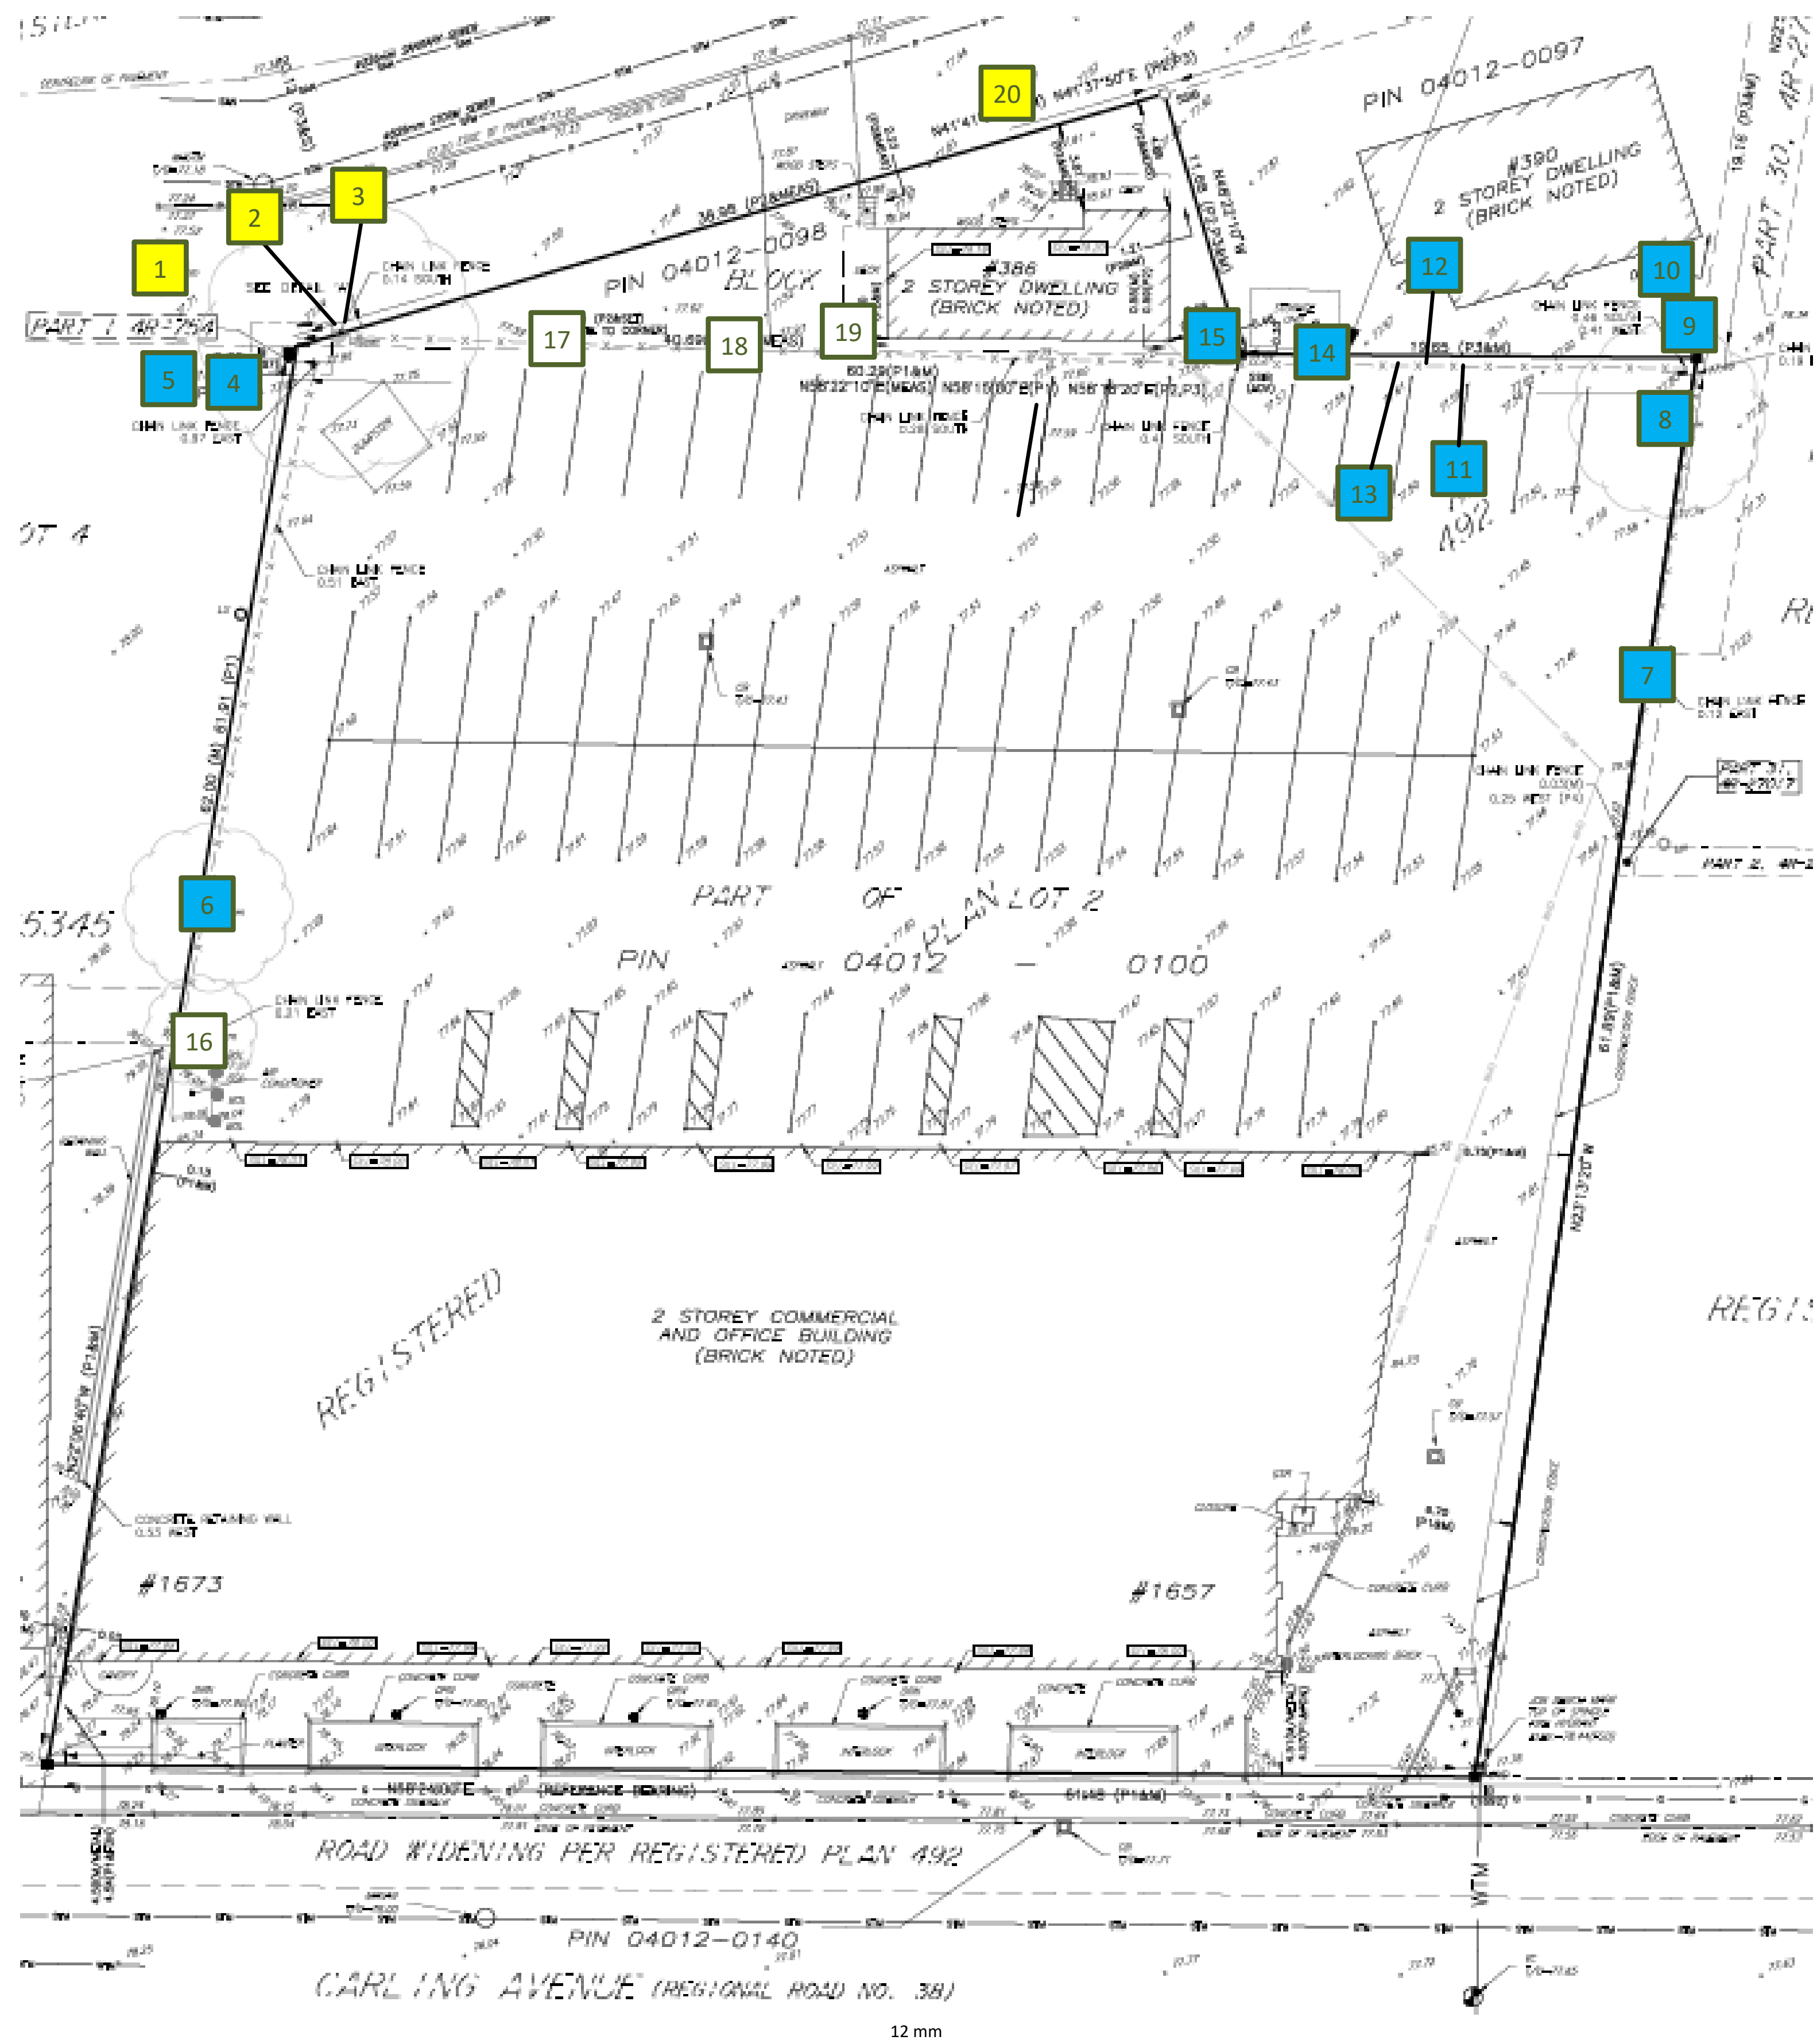
Tree Conservation Report – 1657 Carling Avenue
 Map 1, Existing Conditions
 Tree layer prepared by Dendron Forestry Services, May 15, 2023
 For more information, please contact info@dendronforestry.ca

Tree ¹	Species	DBH (cm)	Ownership ^{2,3}	Condition
1	Honey Locust (<i>Gleditsia triacanthos</i>)	29	City	Good
2	Manitoba maple (<i>Acer negundo</i>)	25, 19	City	Fair: crack at union of stems; significant lean towards road
3	Willow spp. (<i>Salix sp.</i>)	35, 45, 42	City	Fair: large stems fusing – poor form; lean towards road; old wounds sealing slowly
4 ⁴	Colorado spruce (<i>Picea pungens</i>)	23	Adjacent – 1677 Carling	Fair/Poor: suppressed by Tree 3
5 ⁴	Colorado spruce (<i>Picea pungens</i>)	27	Adjacent – 1677 Carling	Fair/Poor: central leader is dead
6	Siberian elm (<i>Ulmus pumila</i>)	35 (estimate)	Boundary – 1677 Carling	Poor: only one branch with growth
7 ⁴	Manitoba maple (<i>A. negundo</i>)	15, 15	Boundary – 376 Tillbury	Poor: old wounds have decay – tree nearly dead
8	Red maple (<i>Acer rubrum</i>)	61	Subject property	Poor: significant dieback; ants in stem; old wounds not sealing – decay present; roots cut long ago for parking lot

9 ⁴	Easter white cedar (<i>Thuja occidentalis</i>)	15	Adjacent – 376 Tillbury	Fair: being girdled by wire; suppressed by Tree 8
10 ⁴	Easter white cedar (<i>Thuja occidentalis</i>)	12	Adjacent – 390 Tillbury	Fair: suppressed by Tree 8
11 ⁴	Manitoba maple (<i>A. negundo</i>)	12	Boundary – 390 Tillbury	Fair: growing around fence
12 ⁴	Manitoba maple (<i>A. negundo</i>)	10	Boundary – 390 Tillbury	Fair: lean
13 ⁴	Manitoba maple (<i>A. negundo</i>)	21	Boundary – 390 Tillbury	Fair
14 ⁴	Manitoba maple (<i>A. negundo</i>)	20, 20, 15, 13	Boundary – 390 Tillbury	Fair: growing on fence; poor form
15 ⁴	Manitoba maple (<i>A. negundo</i>)	14, 8, 11	Subject property	Fair/Good: very close to house and fence
16	Silver maple (<i>Acer saccharinum</i>)	45	Subject property	Fair: minor broken branch; some dieback in crown; very poor growing location
17 ⁴	Manitoba maple (<i>A. negundo</i>)	9, 12, 5	Subject property	Fair: growing on fence

18 ⁴	Ash spp. (<i>Fraxinus spp.</i>)	11	Subject property	Poor
19 ⁴	Siberian elm (<i>U. pumila</i>)	12, 14	Subject property	Poor: growing from under deck, out of concrete
20	Red maple (<i>A. rubrum</i>)	13	City	Good

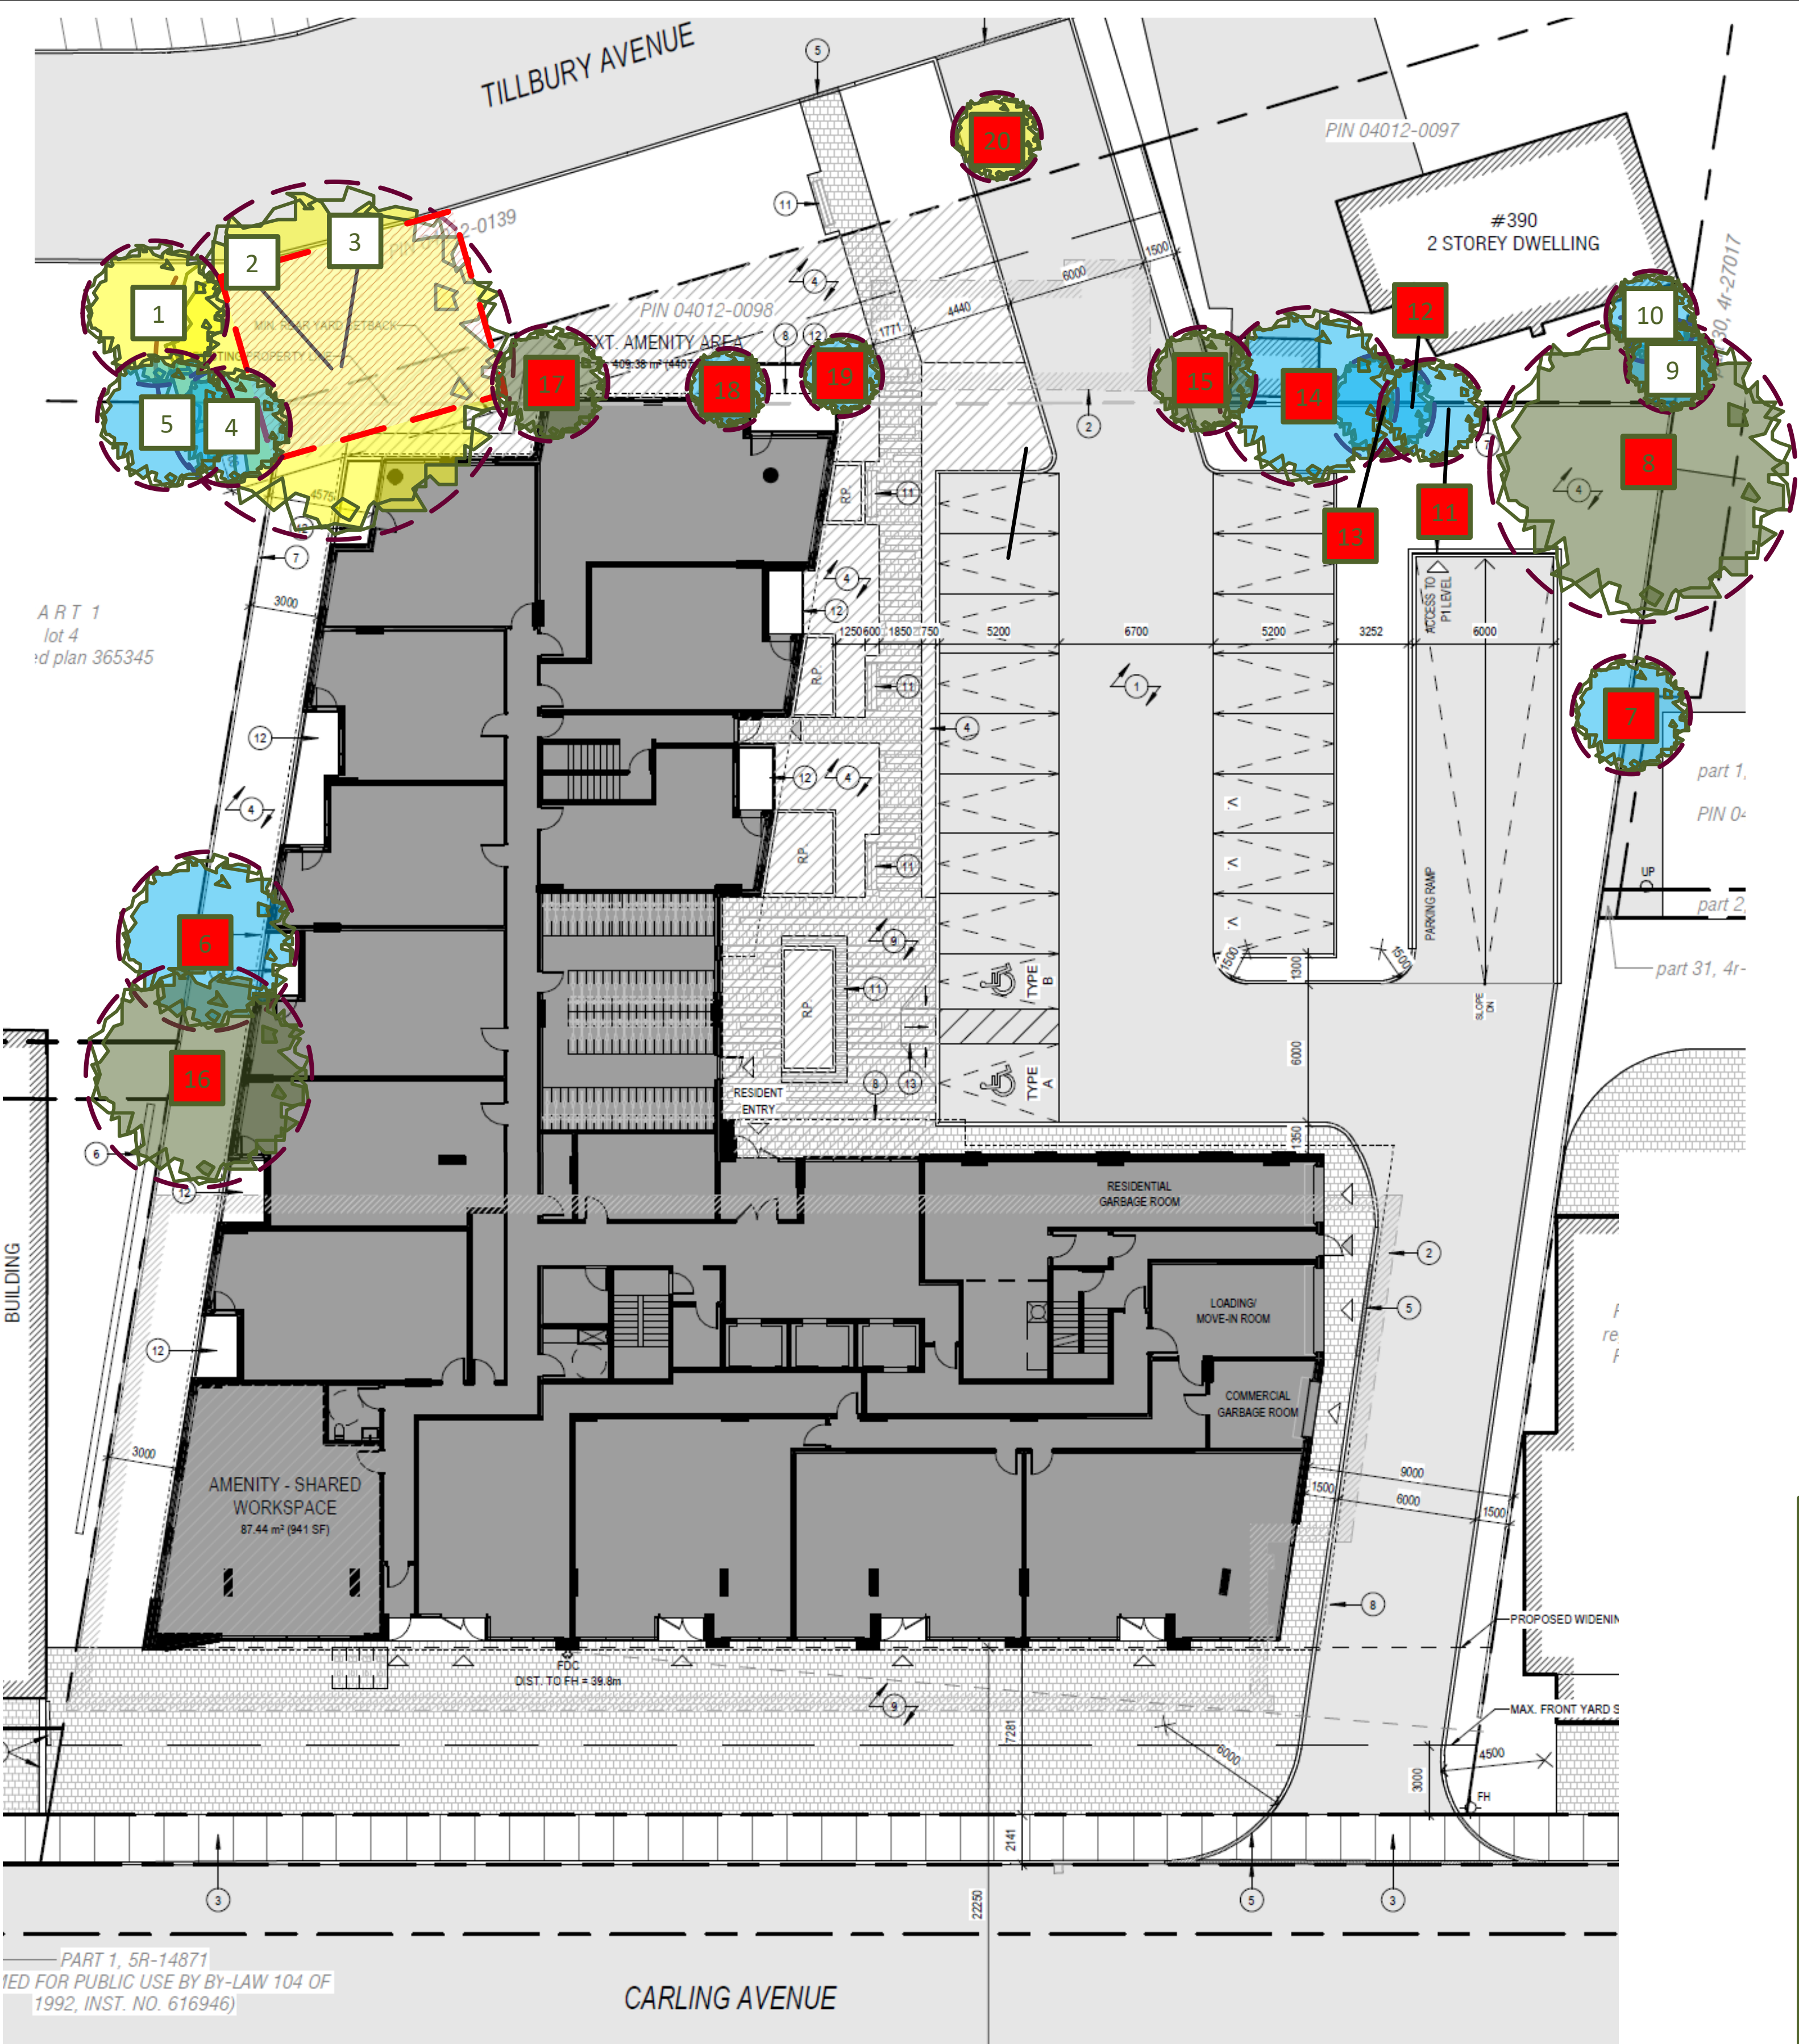
Tree Conservation Report – 1657 Carling Avenue
Tree layer prepared by Dendron Forestry Services
Version 2.0, May 30, 2023
For more information, please contact info@dendronforestry.ca

Tree ¹	Species	DBH (cm)	Condition	Forester recommended action
1	Honey Locust (<i>Gleditsia triacanthos</i>)	29	Good	Retain and protect as per the City of Ottawa Tree Protection Specifications (March 2021)
2	Manitoba maple (<i>Acer negundo</i>)	25, 19	Fair: crack at union of stems; significant lean towards road	Retain and protect as per the City of Ottawa Tree Protection Specifications (March 2021)
3	Willow spp. (<i>Salix</i> sp.)	35, 45, 42	Fair: large stems fusing – poor form; lean towards road; old wounds sealing slowly	Retain and protect as per the City of Ottawa Tree Protection Specifications (March 2021)
4 ⁴	Colorado spruce (<i>Picea pungens</i>)	23	Fair/Poor: suppressed by Tree 3	Retain and protect as per the City of Ottawa Tree Protection Specifications (March 2021)
5 ⁴	Colorado spruce (<i>Picea pungens</i>)	27	Fair/Poor: central leader is dead	Retain and protect as per the City of Ottawa Tree Protection Specifications (March 2021)

6	Siberian elm (<i>Ulmus pumila</i>)	35 (estimate)	Poor: only one branch with growth	Remove due to health status.
7 ⁴	Manitoba maple (<i>A. negundo</i>)	15, 15	Poor: old wounds have decay – tree nearly dead	Remove due to health status.
8	Red maple (<i>Acer rubrum</i>)	61	Poor: significant dieback; ants in stem; old wounds not sealing – decay present; roots cut long ago for parking lot	Remove due to health status.
9 ⁴	Easter white cedar (<i>Thuja occidentalis</i>)	15	Fair: being girdled by wire; suppressed by Tree 8	Retain and protect as per the City of Ottawa Tree Protection Specifications (March 2021)
10 ⁴	Easter white cedar (<i>Thuja occidentalis</i>)	12	Fair: suppressed by Tree 8	Retain and protect as per the City of Ottawa Tree Protection Specifications (March 2021)
11 ⁴	Manitoba maple (<i>A. negundo</i>)	12	Fair: growing around fence	Remove due to health status, poor growing location and impacts from construction.

12 ⁴	Manitoba maple (<i>A. negundo</i>)	10	Fair: lean	Remove due to health status, poor growing location and impacts from construction.
13 ⁴	Manitoba maple (<i>A. negundo</i>)	21	Fair	Remove due to health status, poor growing location and impacts from construction.
14 ⁴	Manitoba maple (<i>A. negundo</i>)	20, 20, 15, 13	Fair: growing on fence; poor form	Remove due to health status, poor growing location and impacts from construction.
15 ⁴	Manitoba maple (<i>A. negundo</i>)	14, 8, 11	Fair/Good: very close to house and fence	Remove due to health status, poor growing location and impacts from construction.
16	Silver maple (<i>Acer saccharinum</i>)	45	Fair: minor broken branch; some dieback in crown; very poor growing location	Remove due to health status and impacts from construction.
17 ⁴	Manitoba maple (<i>A. negundo</i>)	9, 12, 5	Fair: growing on fence	Remove due to poor growing location (removal of fence to create amenity space will necessitate removal of the tree)

18 ⁴	Ash spp. (<i>Fraxinus</i> spp.)	11	Poor	Remove due to health status and growing location
19 ⁴	Siberian elm (<i>U. pumila</i>)	12, 14	Poor: growing from under deck, out of concrete	Remove due to health status and growing location
20	Red maple (<i>A. rubrum</i>)	13	Good	Remove due to plans

Prior to any site works, protective fencing should be installed around the TPA as indicated in Map and maintained until all construction on site has been completed as per the City of Ottawa Tree Protection Specifications (March 2021). **Failure to install and maintain the indicated fencing may result in fines from the City.**

The tree protection fencing must be 1.2 m in height and constructed of a rigid or framed material (e.g. modulus – steel, plywood hoarding, or snow fence on a 2”X4” wood frame) with posts 2.4 m apart such that the fence location cannot be altered. All supports must be placed outside of the CRZ and installation must minimize damage to existing roots.

- Place a layer of 6-12 inches (15 to 30 cm) of woodchip mulch to the area
- Apply ¾ (2 cm) inch plywood, or road mats over a 4+ inch (10 cm) thick layer of the wood chip mulch
- Apply 4-6 inches (10 to 15 cm) of gravel over a taut, staked, geotextile fabric
