# **Geotechnical Investigation**

## **Proposed Residential Development**

4386 Rideau Valley Drive  
Ottawa, Ontario

Report PG5828-1 Revision 5 dated July 19, 2024

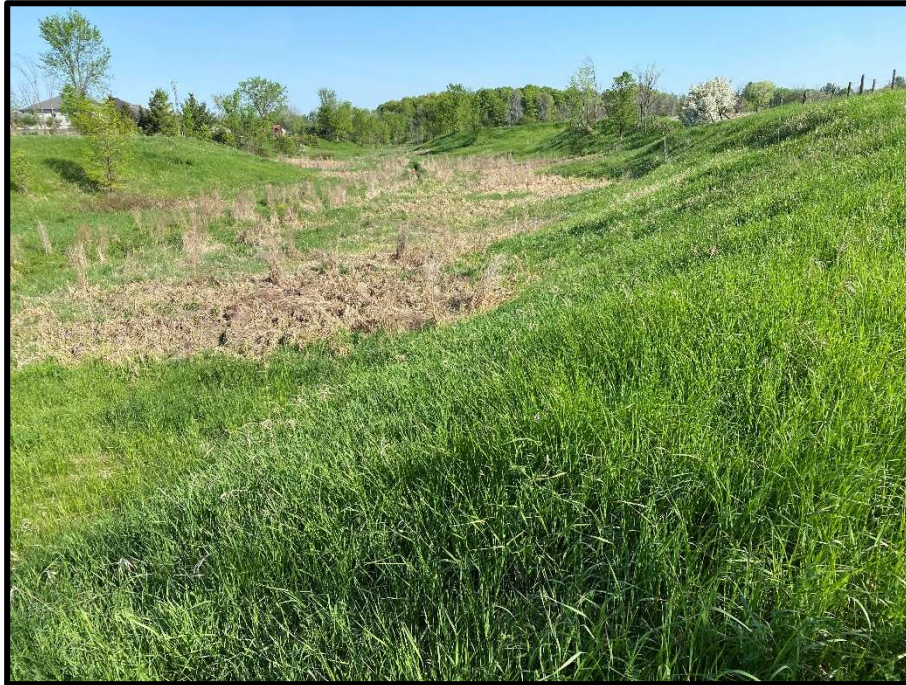
Photo 1: Area located at the bottom of the slope along the south-west portion of the subject site. Area is well vegetated and sloped gradually towards the valley floor.

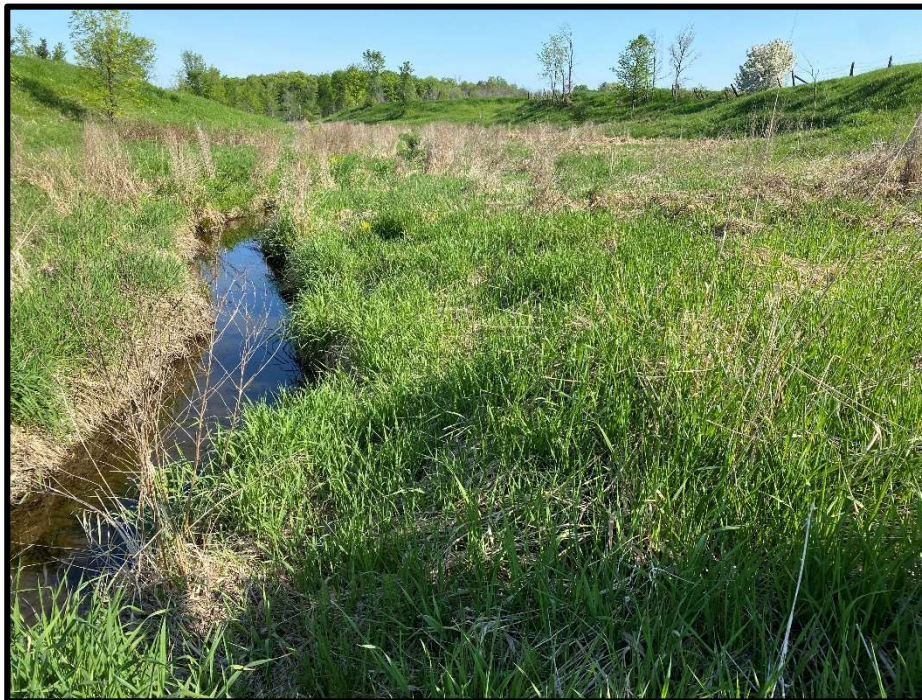
Photo 2: Area along Wilson Cowan Drain and south-west portion of the subject site. Area appeared to be well vegetated and did not appear to be eroded at the time of site visit. Water throughout Wilson Cowan Drain appeared to be flowing very slowly and/or ponding.

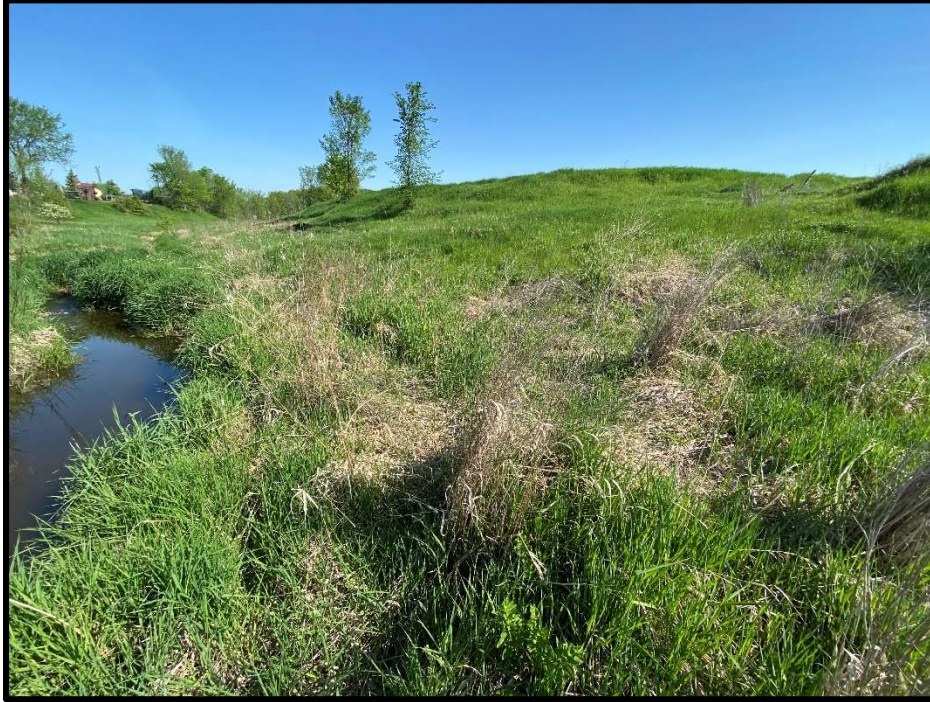
Photo 3: Area along Wilson Cowan Drain and south-west portion of the subject site. Area appeared to be well vegetated and did not appear to be eroded at the time of site visit. Gradual slope observed from subject site to the valley floor.

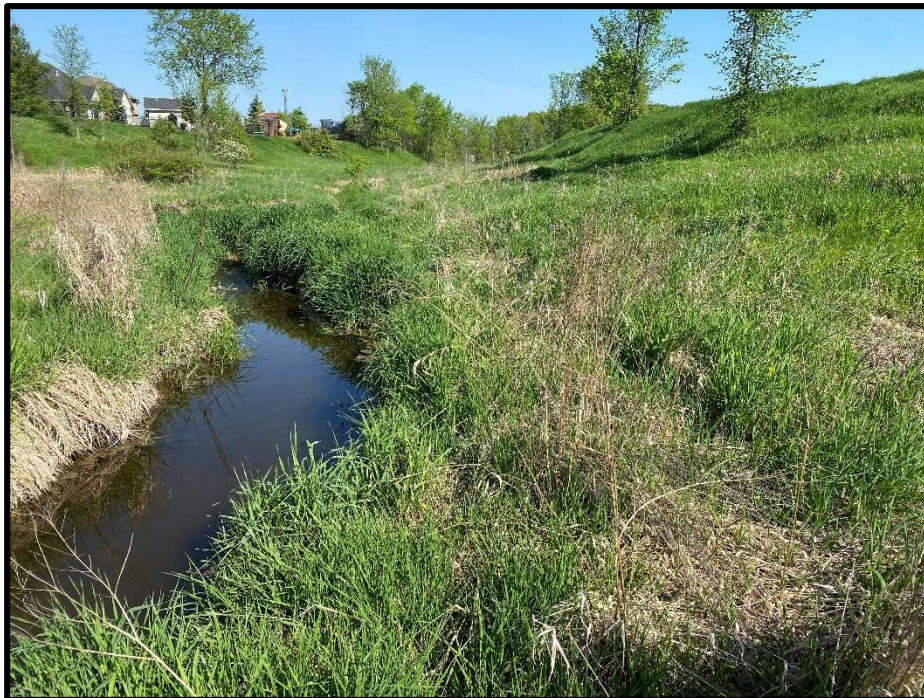
Photo 4: Area along Wilson Cowan Drain and south-west portion of the subject site. Area appeared to be well vegetated and did not appear to be eroded at the time of site visit. Water throughout Wilson Cowan Drain appeared to be flowing very slowly and/or ponding.

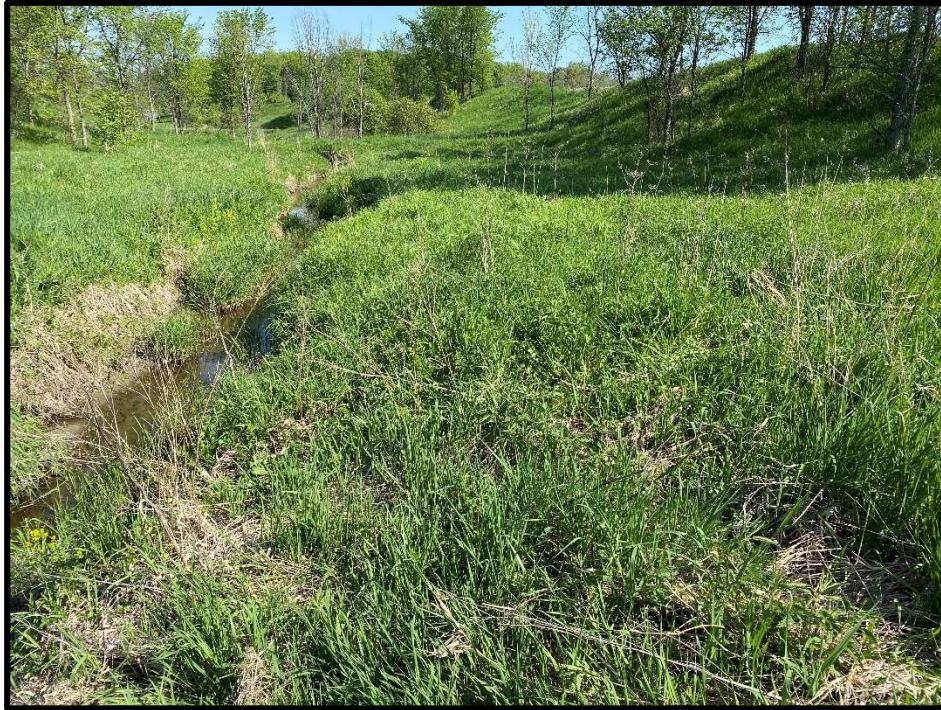
Photo 5: Area along Wilson Cowan Drain and south-west portion of the subject site. Area appeared to be well vegetated and did not appear to be eroded at the time of site visit. Water throughout Wilson Cowan Drain appeared to be flowing very slowly and/or ponding.

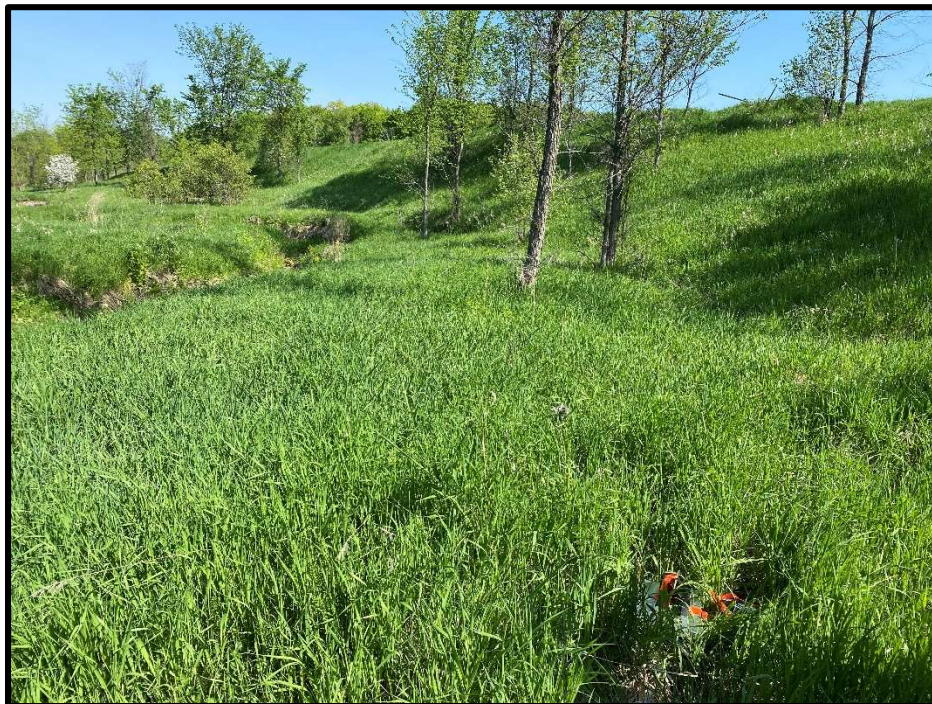
Photo 6: Area along Wilson Cowan Drain and west portion of the subject site. Area appeared to be well vegetated and did not appear to be eroded at the time of site visit. Gradual slope observed from subject site to the valley floor.

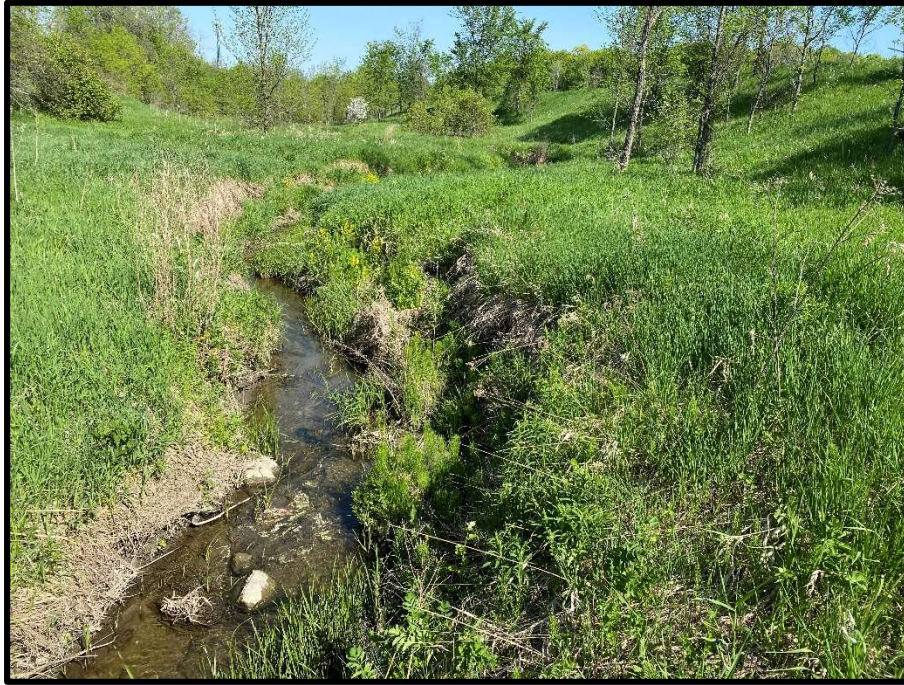
Photo 7: Area along Wilson Cowan Drain and west portion of the subject site. Area appeared to be well vegetated with a slightly steeper bank along Wilson Cowan Drain at the time of site visit. Gradual slope observed from subject site to the valley floor. Active erosion was not observed.

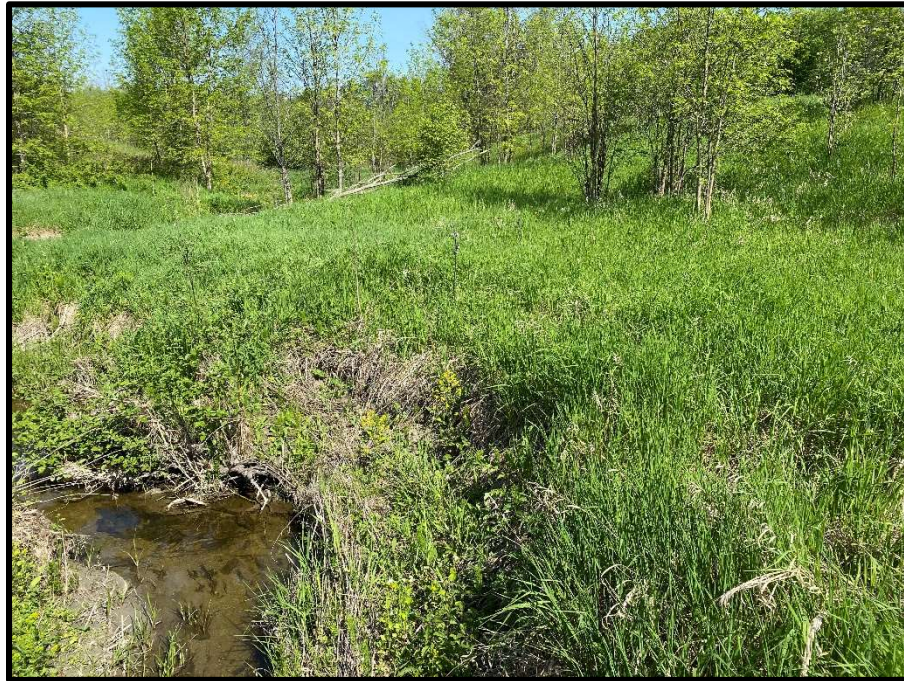
Photo 8: Area along Wilson Cowan Drain and west portion of the subject site. Area appeared to be well vegetated with a slightly steeper bank along Wilson Cowan Drain at the time of site visit. Gradual slope observed from subject site to the valley floor. Active erosion was not observed.

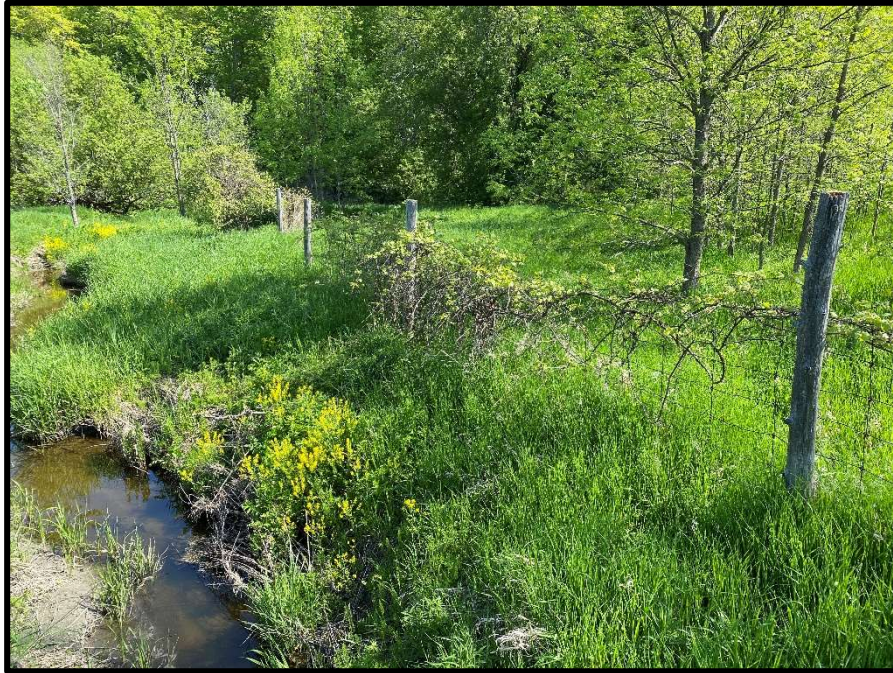
Photo 9: Area along Wilson Cowan Drain and north-west portion of the subject site. Area appeared to be well vegetated with a gentle flow throughout Wilson Cowan Drain at the time of site visit. Gradual slope observed from subject site to the valley floor.

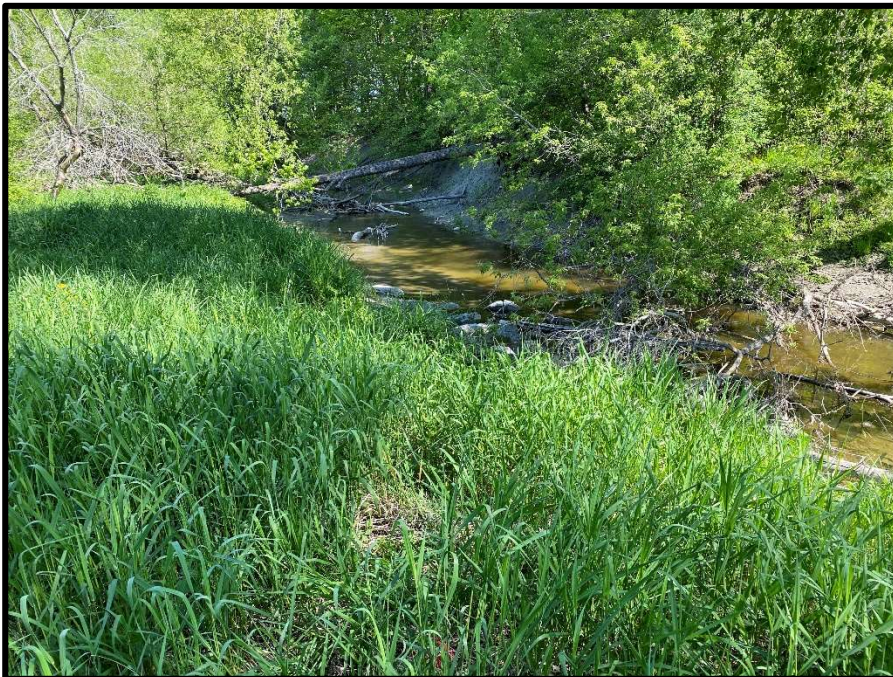
Photo 10: Area of intersection of Wilson Cowan Drain along west portion of subject site and Mud Creek. Area of Mud Creek appeared to have banks exposed to streams flow. Mature trees noted to have previously fallen across creek alignment. Some over-steepening of banks also observed at the time of site visit.

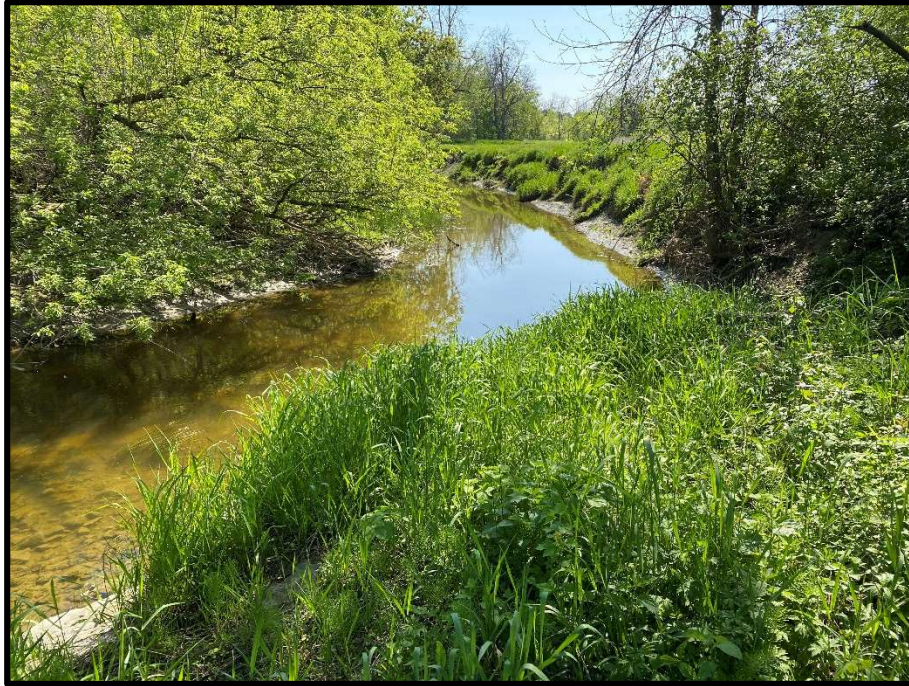
Photo 11: Area of Mud Creek along north-west portion of subject site. Area appeared to have banks exposed to streams flow and lack of well rooted vegetation along bank. Some oversteepening of banks also observed. Creek appeared to be flowing very slowly at the time of site visit.

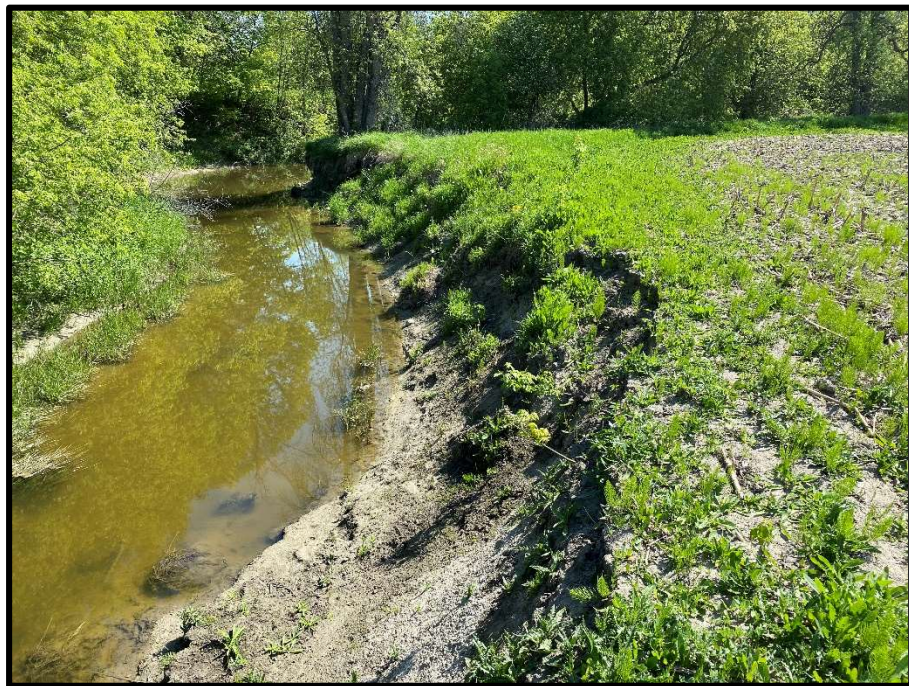
Photo 12: Area of Mud Creek along north-west portion of subject site. Area appeared to have banks exposed to streams flow and along with slumping and oversteepening of banks at the time of our site visit.

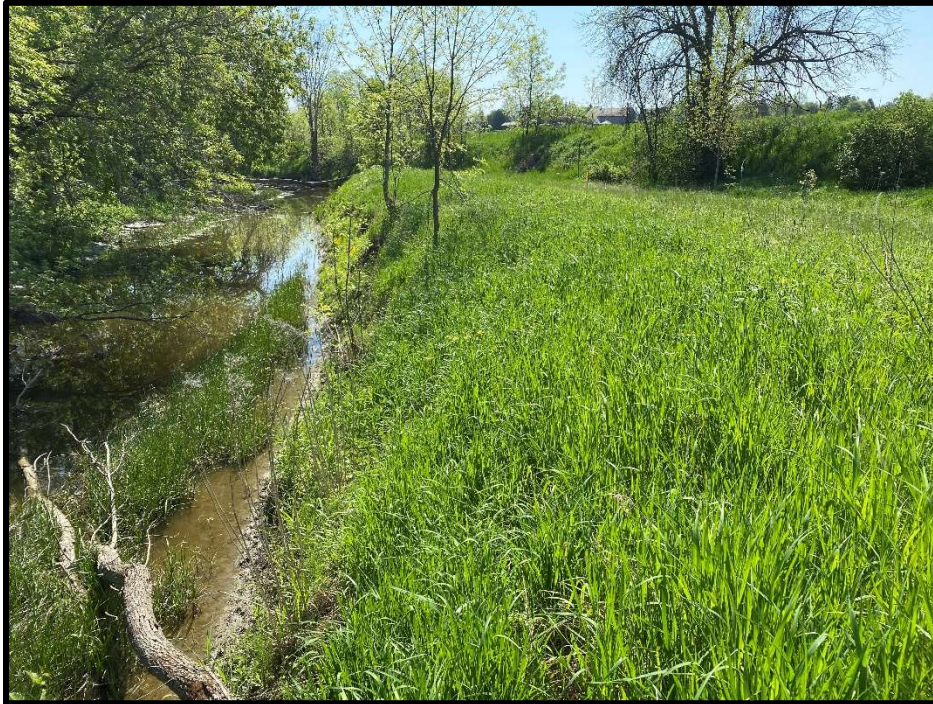
Photo 13: Area of Mud Creek along north-west portion of subject site. Area of valley floor appeared to have well rooted vegetation with relatively steep banks along creek. No active erosion observed along photographed portion of creek at the time of site visit.

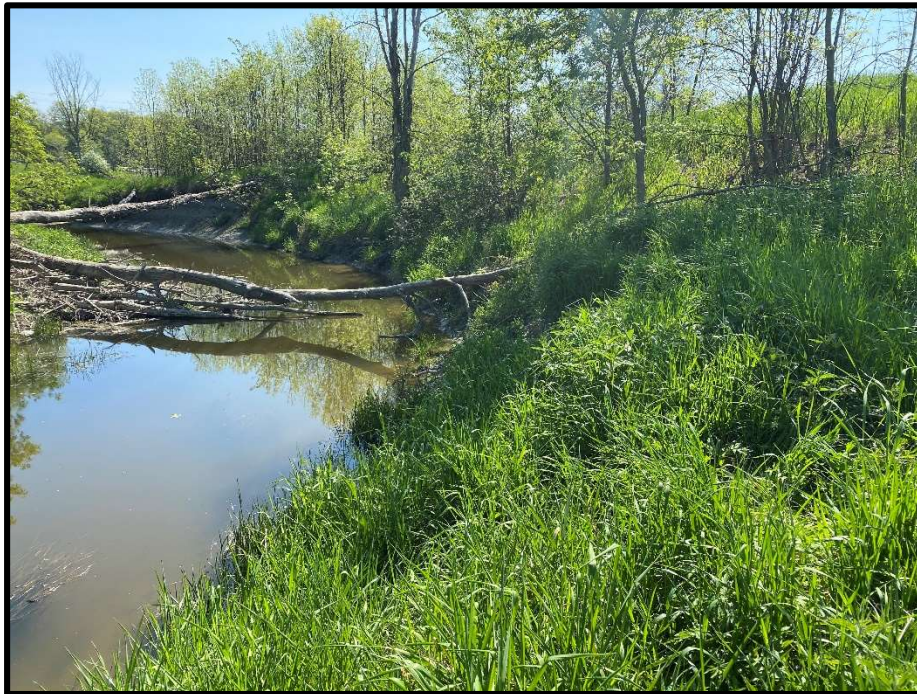
Photo 14: Area of Mud Creek along north-west portion of subject site. Area of valley floor appeared to have well rooted vegetation with relatively steep banks along creek. Some active erosion and fallen trees observed along photographed portion of creek.

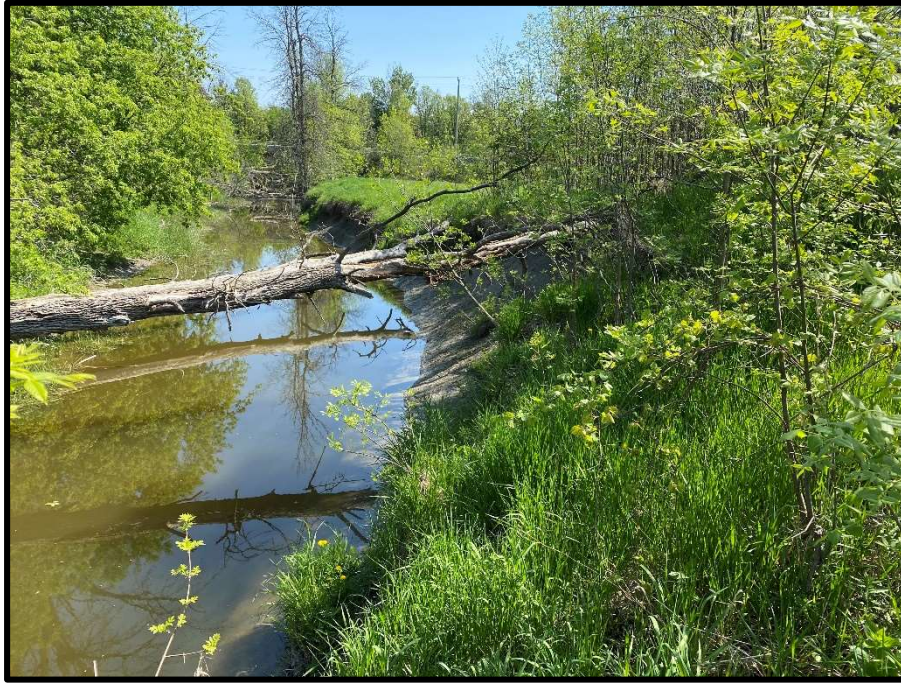
Photo 15: Area of Mud Creek along northern portion of subject site. Photographed area appeared to have banks exposed to streams flow along with slumping and undercutting of banks at the time of our site visit.

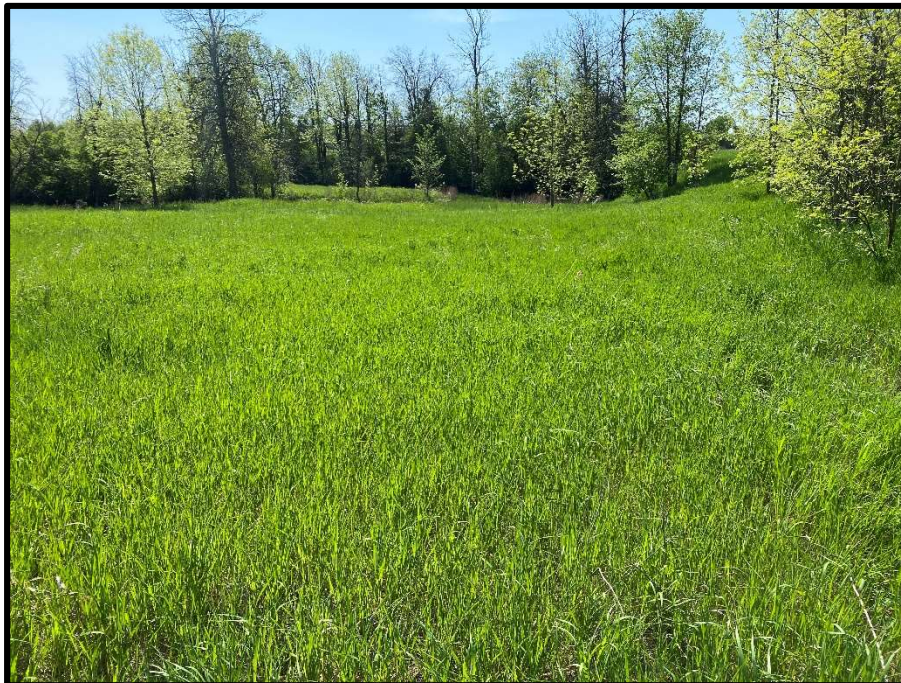
Photo 16: Area of Mud Creek valley floor along north-east portion of subject site. Photographed area appeared to contain well rooted vegetation and mature trees.

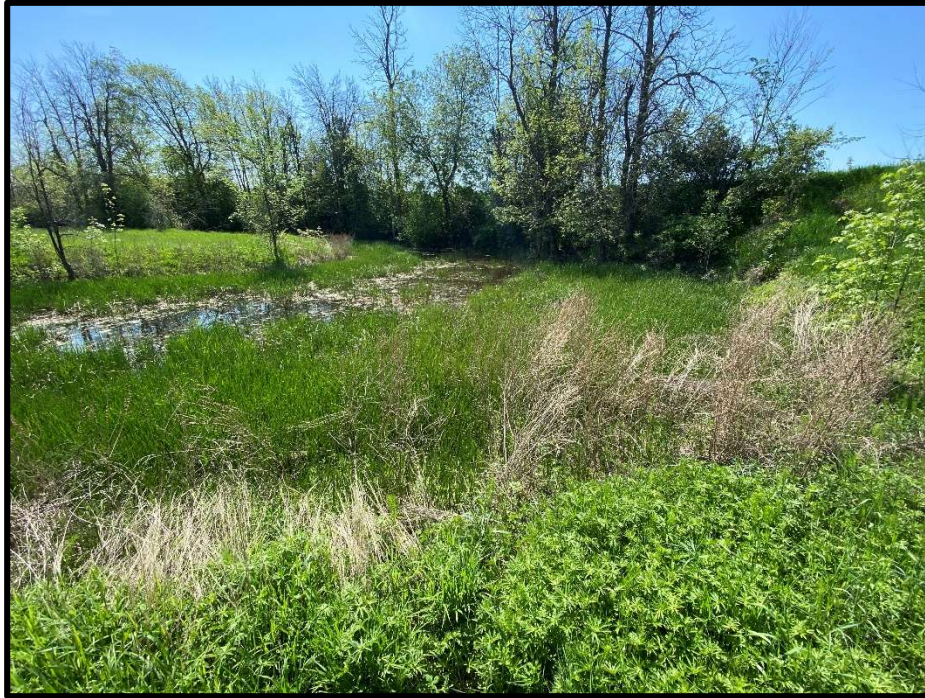
Photo 17: Area of Mud Creek valley floor along north-east portion of subject site. Photographed area appeared to contain well rooted vegetation and mature trees. No erosion observed along toe of slope at time of site visit.

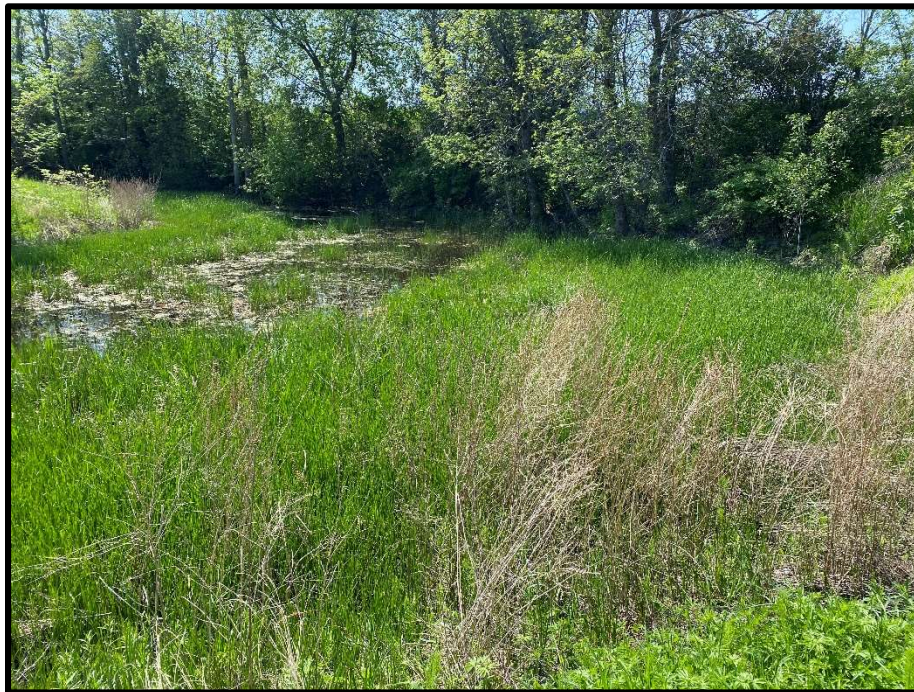
Photo 17b: Close-up of Photo 17 - Area of Mud Creek valley floor along north-east portion of subject site. Photographed area appeared to contain well rooted vegetation and mature trees. No erosion observed along toe of slope at time of site visit.
