ADDENDUM #1: CONSERVATION PLAN

John Stewart Commonwealth
June 20, 2024

1.0 CONSERVATION PLAN FOR 168 & 174 MURRAY STREET

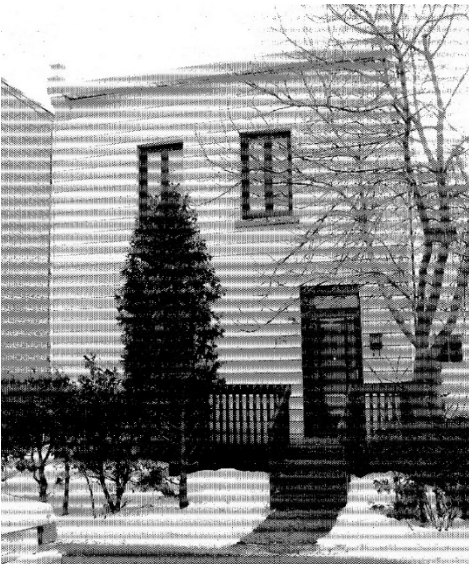
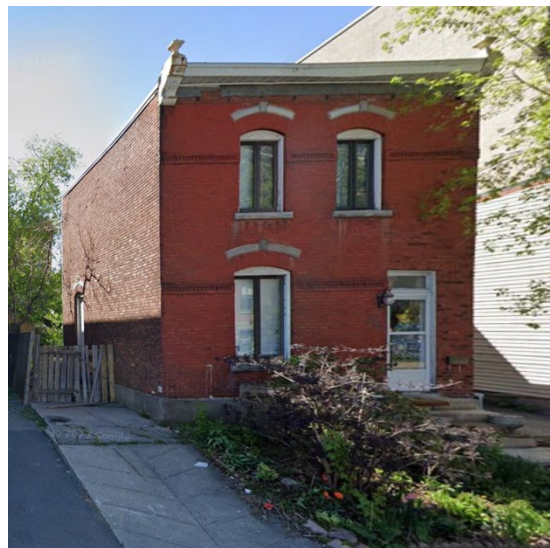
Figure 9 and 10: Two views 1992 and 2021 174 Murray (left) prior to the vinyl siding being removed and rehabilitated front. Note: A section of the cornice will need to be replicated. There is bulging of the brick along the 2nd floor between the windows. Also noted is the different brick at the corner (both size and colour)

consistency) and the lack of corbelled banding and the transom treatment. Earlier photos document a decorative hood over the door has been removed.

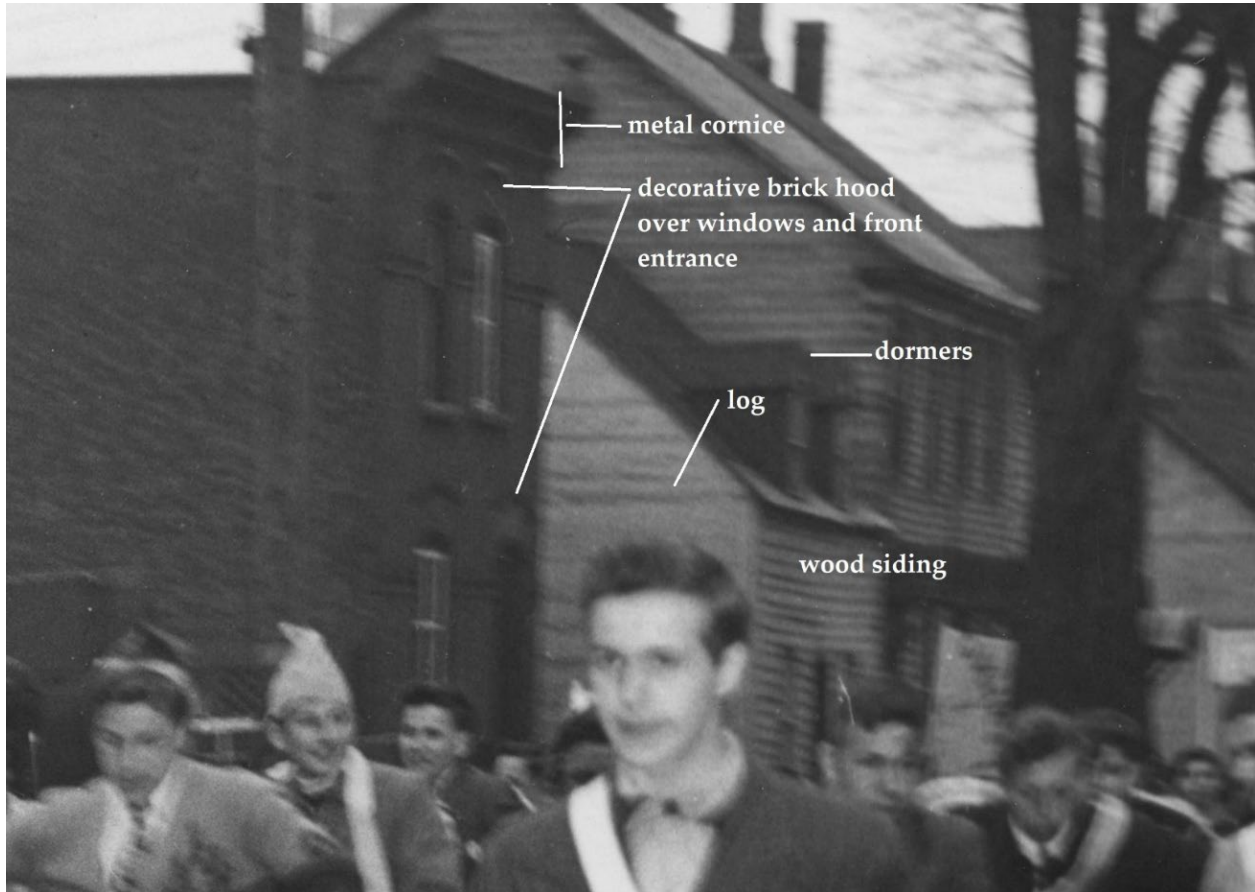
Figure 11: A c.1949 photograph clearly documents the 2-storey brick siding of 174 Murray Street with its off-set door and decorative arched headers over the door and windows. The cottage form of the neighbouring 168 Murray with the textured log sidewall of squared log. The log has been covered over on the front façade with a horizontal siding. Source: Marc Aubin's collection

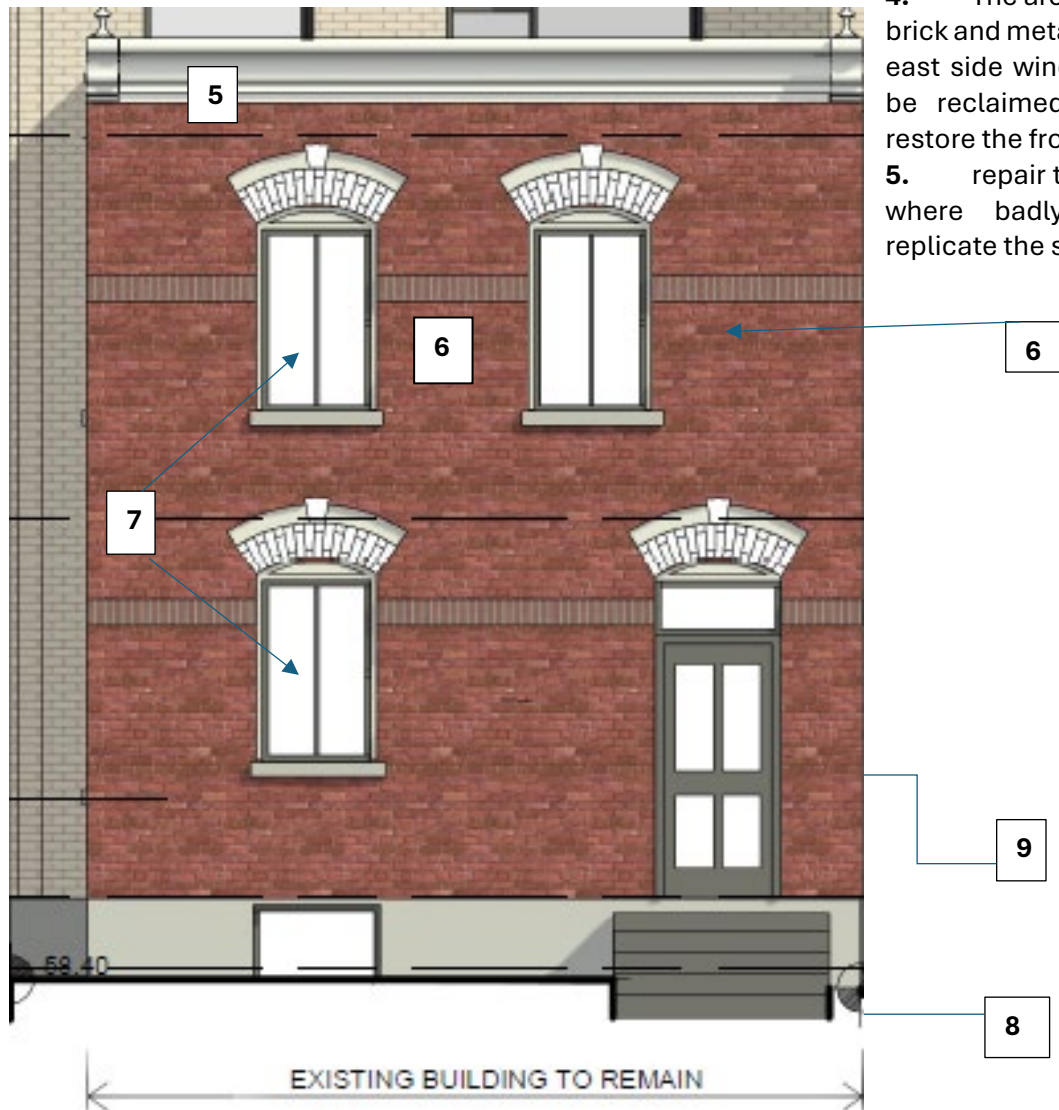
The main elements that will be addressed are on the exterior – the metal cornice, the brick work, repairs to the area on the second floor where it bulges out, the replacement of the brick around the front door including replacement of the transom and metal hood, stabilizing and realigning the foundation, replacing the front porch, and repairing windows. The additions on the rear of the building will be demolished to allow for the construction of a 4-storey addition. Potentially, the brick at the rear can be salvaged for reuse. The metal hood over the window on the west façade could be removed and used over the front door.

1. Undertake a structural assessment of the foundation, realign the foundation at the west corner, undertake jacking for levelling the floors and setting the building on a repaired foundation.
2. Engage a brick mason with expertise in conservation to assess the condition of the brick.
3. Undertake a program of removals followed by an assessment. As part of demolition of the rear additions, salvage brick as matching replacement for masonry at the front.

4. The arched segmented brick and metal hood from the east side window of 174 can be reclaimed and used to restore the front entry.

5. repair the cornice and, where badly deteriorated, replicate the section.

6. Dismantle the section of brick on the second floor where there is bulging and potential separation of brick from the backing wall. Repair and repoint façade as necessary.
7. Casement windows will be retained and painted.
8. Install a new stoop to provide access to the new front door
9. Undertake brick dismantling and replacing the salvaged decorative hood and segmented brick header over the front door, replace the brick between the door and the west corner and repoint as necessary.
