March 19, 2009
File: PG0861-LET.02

Richcraft Homes
2280 St. Laurent Boulevard
Suite 201
Ottawa, Ontario
K1G 4K1

Subject: **Limit of Hazard Lands
Proposed Residential Development
Eden Park - Renaud Road
Ottawa, Ontario**

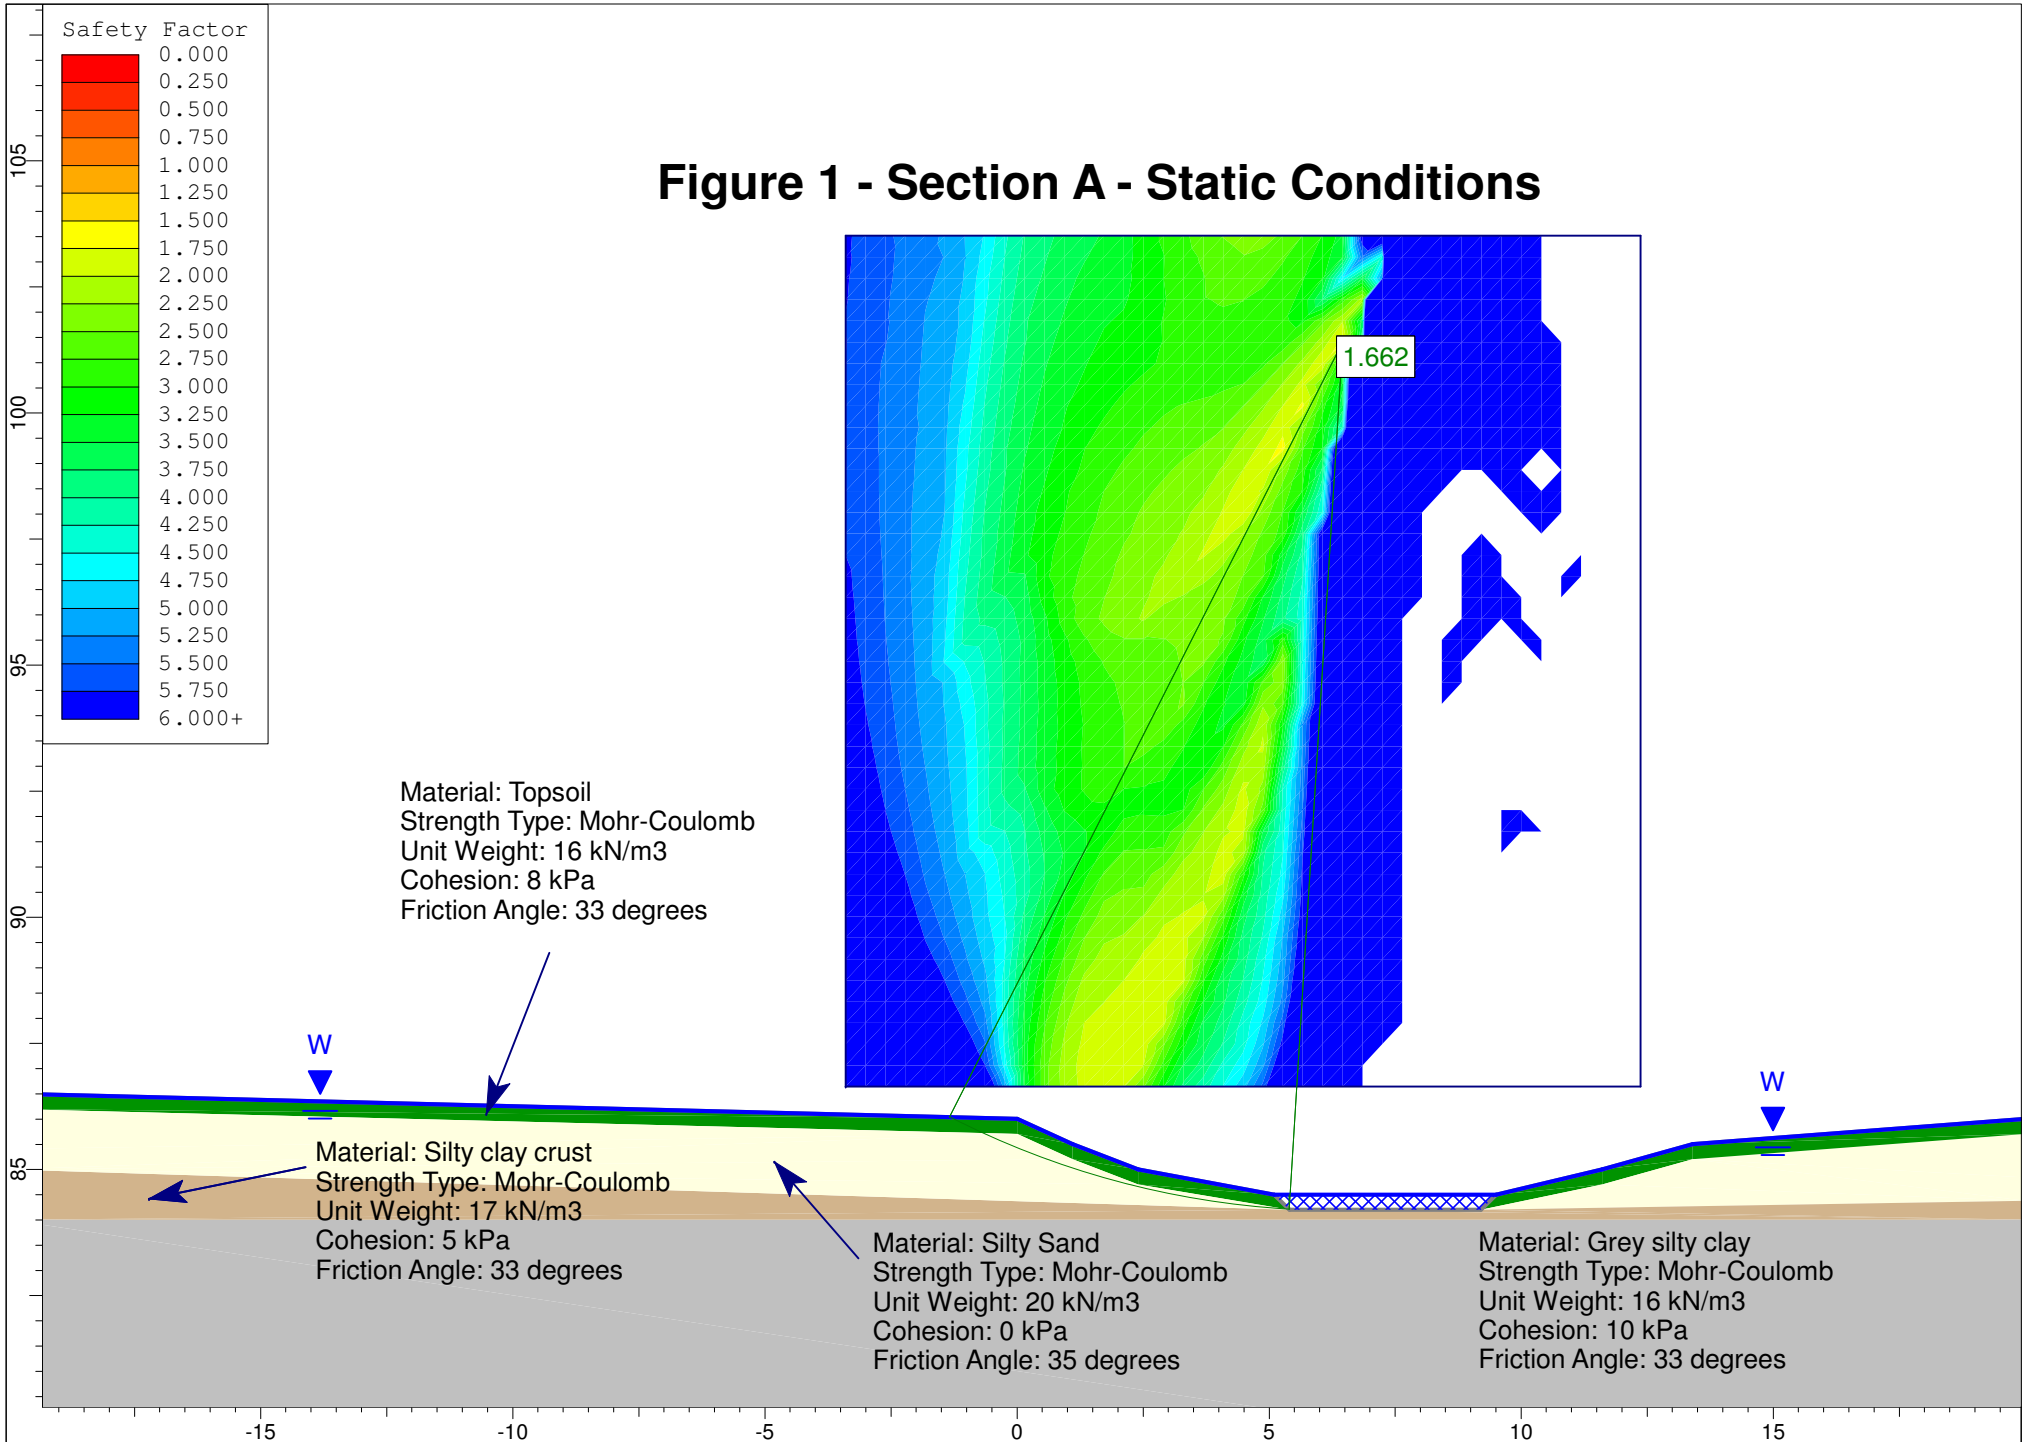
Figure 1 - Section A - Static Conditions

The results for the existing slope conditions at Sections A and B are shown in Figures 1 and 3 attached to the present letter. The factors of safety were found to be greater than 1.5 at both Sections A and B.

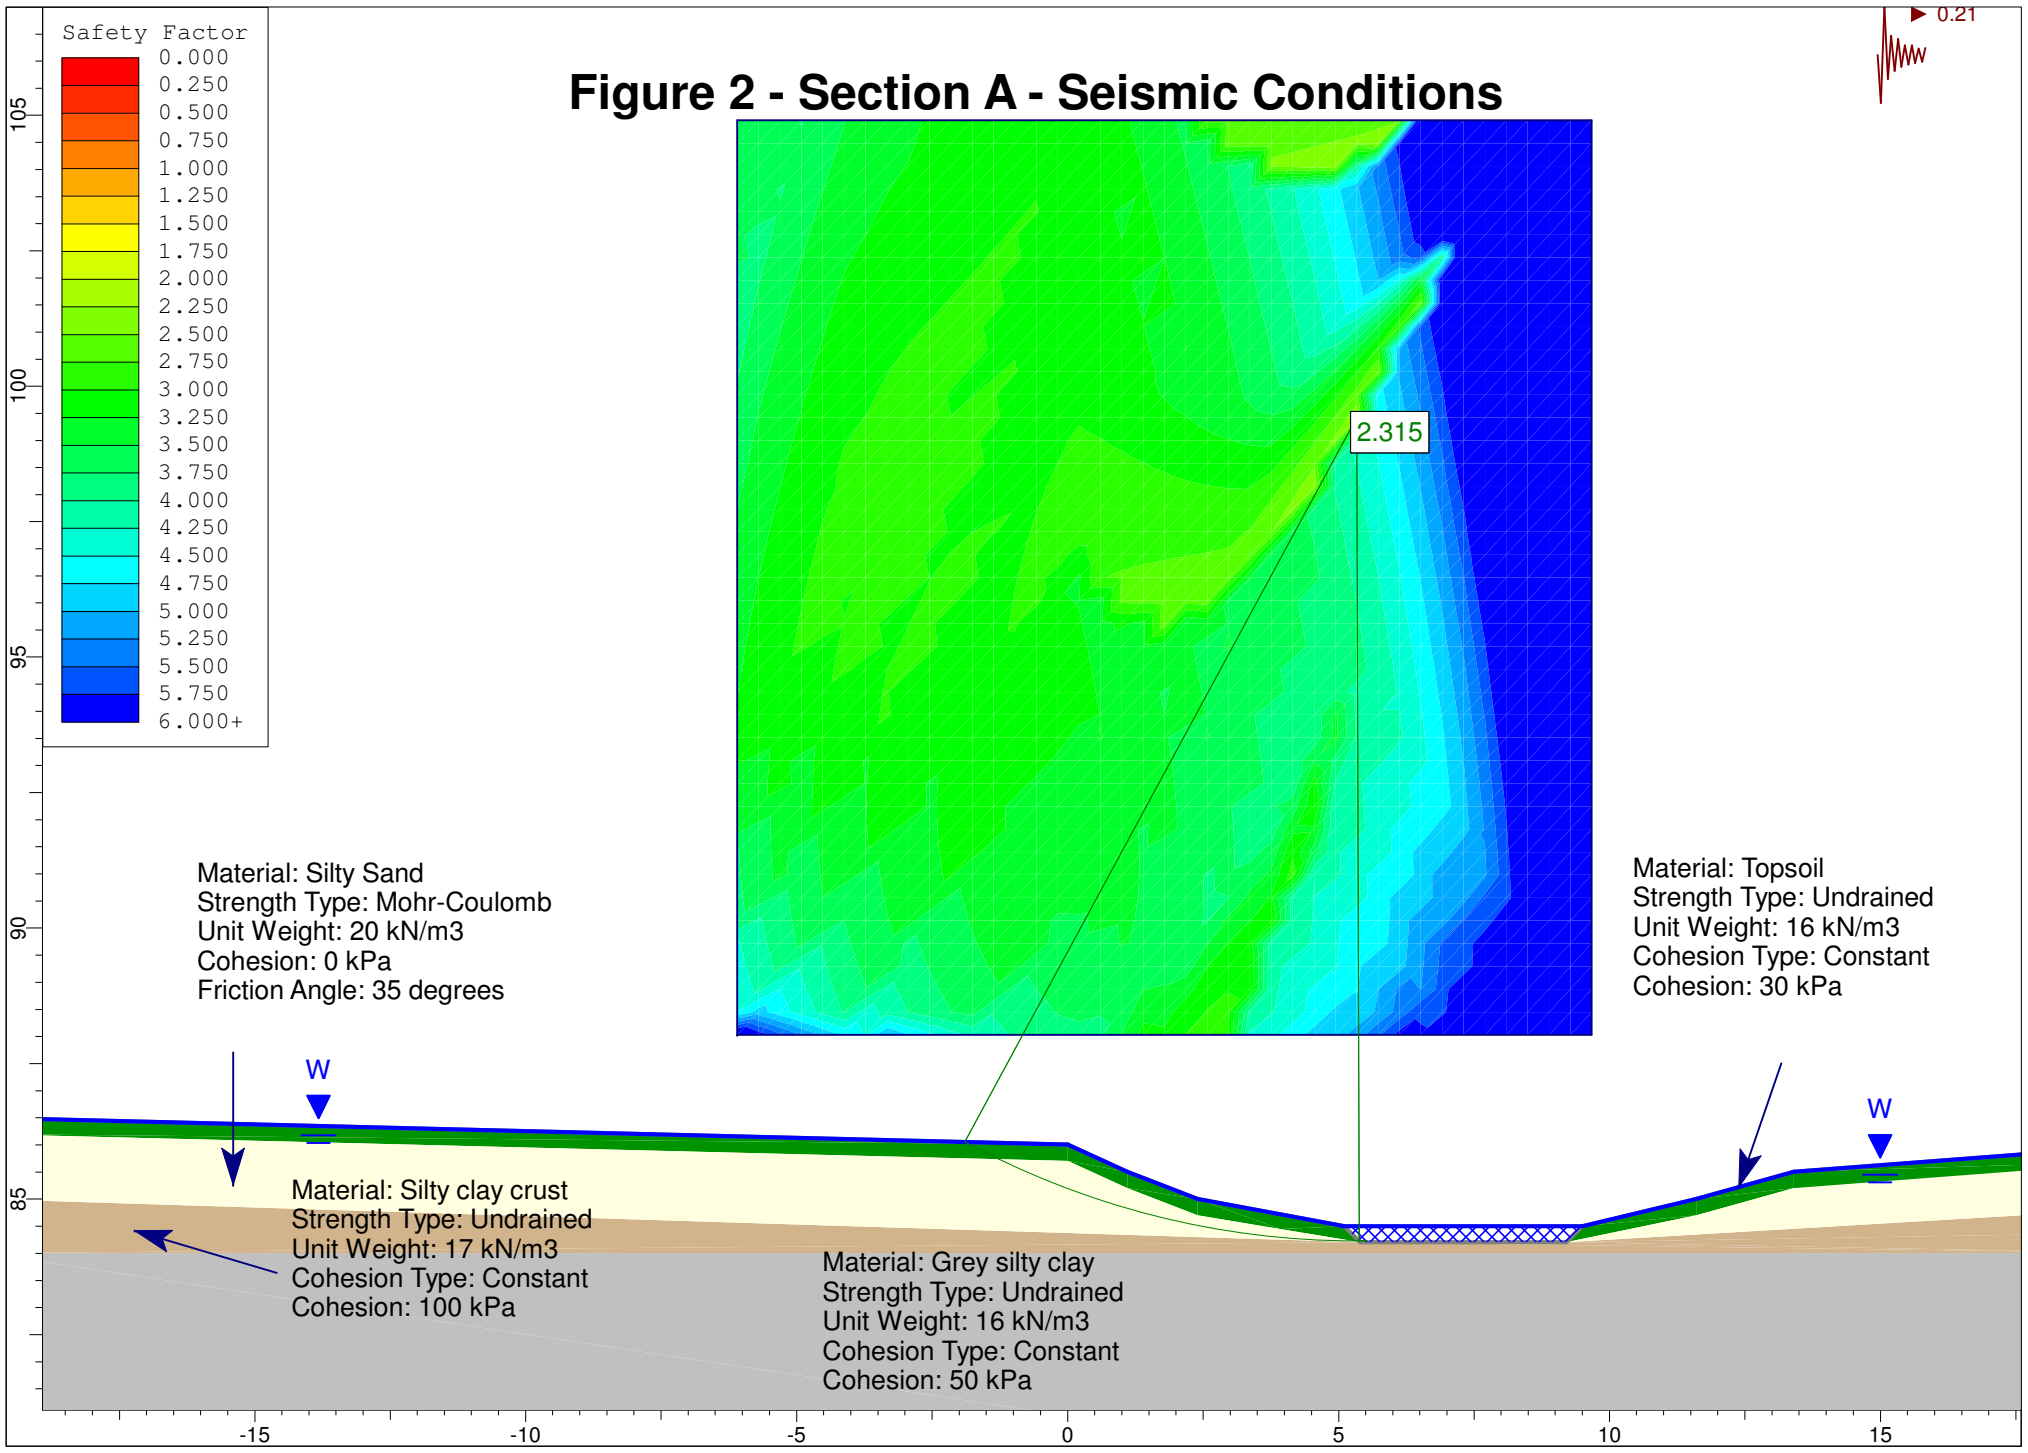
Figure 2 - Section A - Seismic Conditions

An analysis considering seismic loading was also completed. A horizontal seismic acceleration, K_h , of 0.1G was considered for the analyzed sections. A factor of safety of 1.1 is considered to be satisfactory for stability analyses including seismic loading.

The results of the analyses including seismic loading are shown in Figures 2 and 4 for the existing slope conditions. The results indicate that the factors of safety are greater than 1.1. Based on these results, the slopes are considered to be stable under seismic loading.

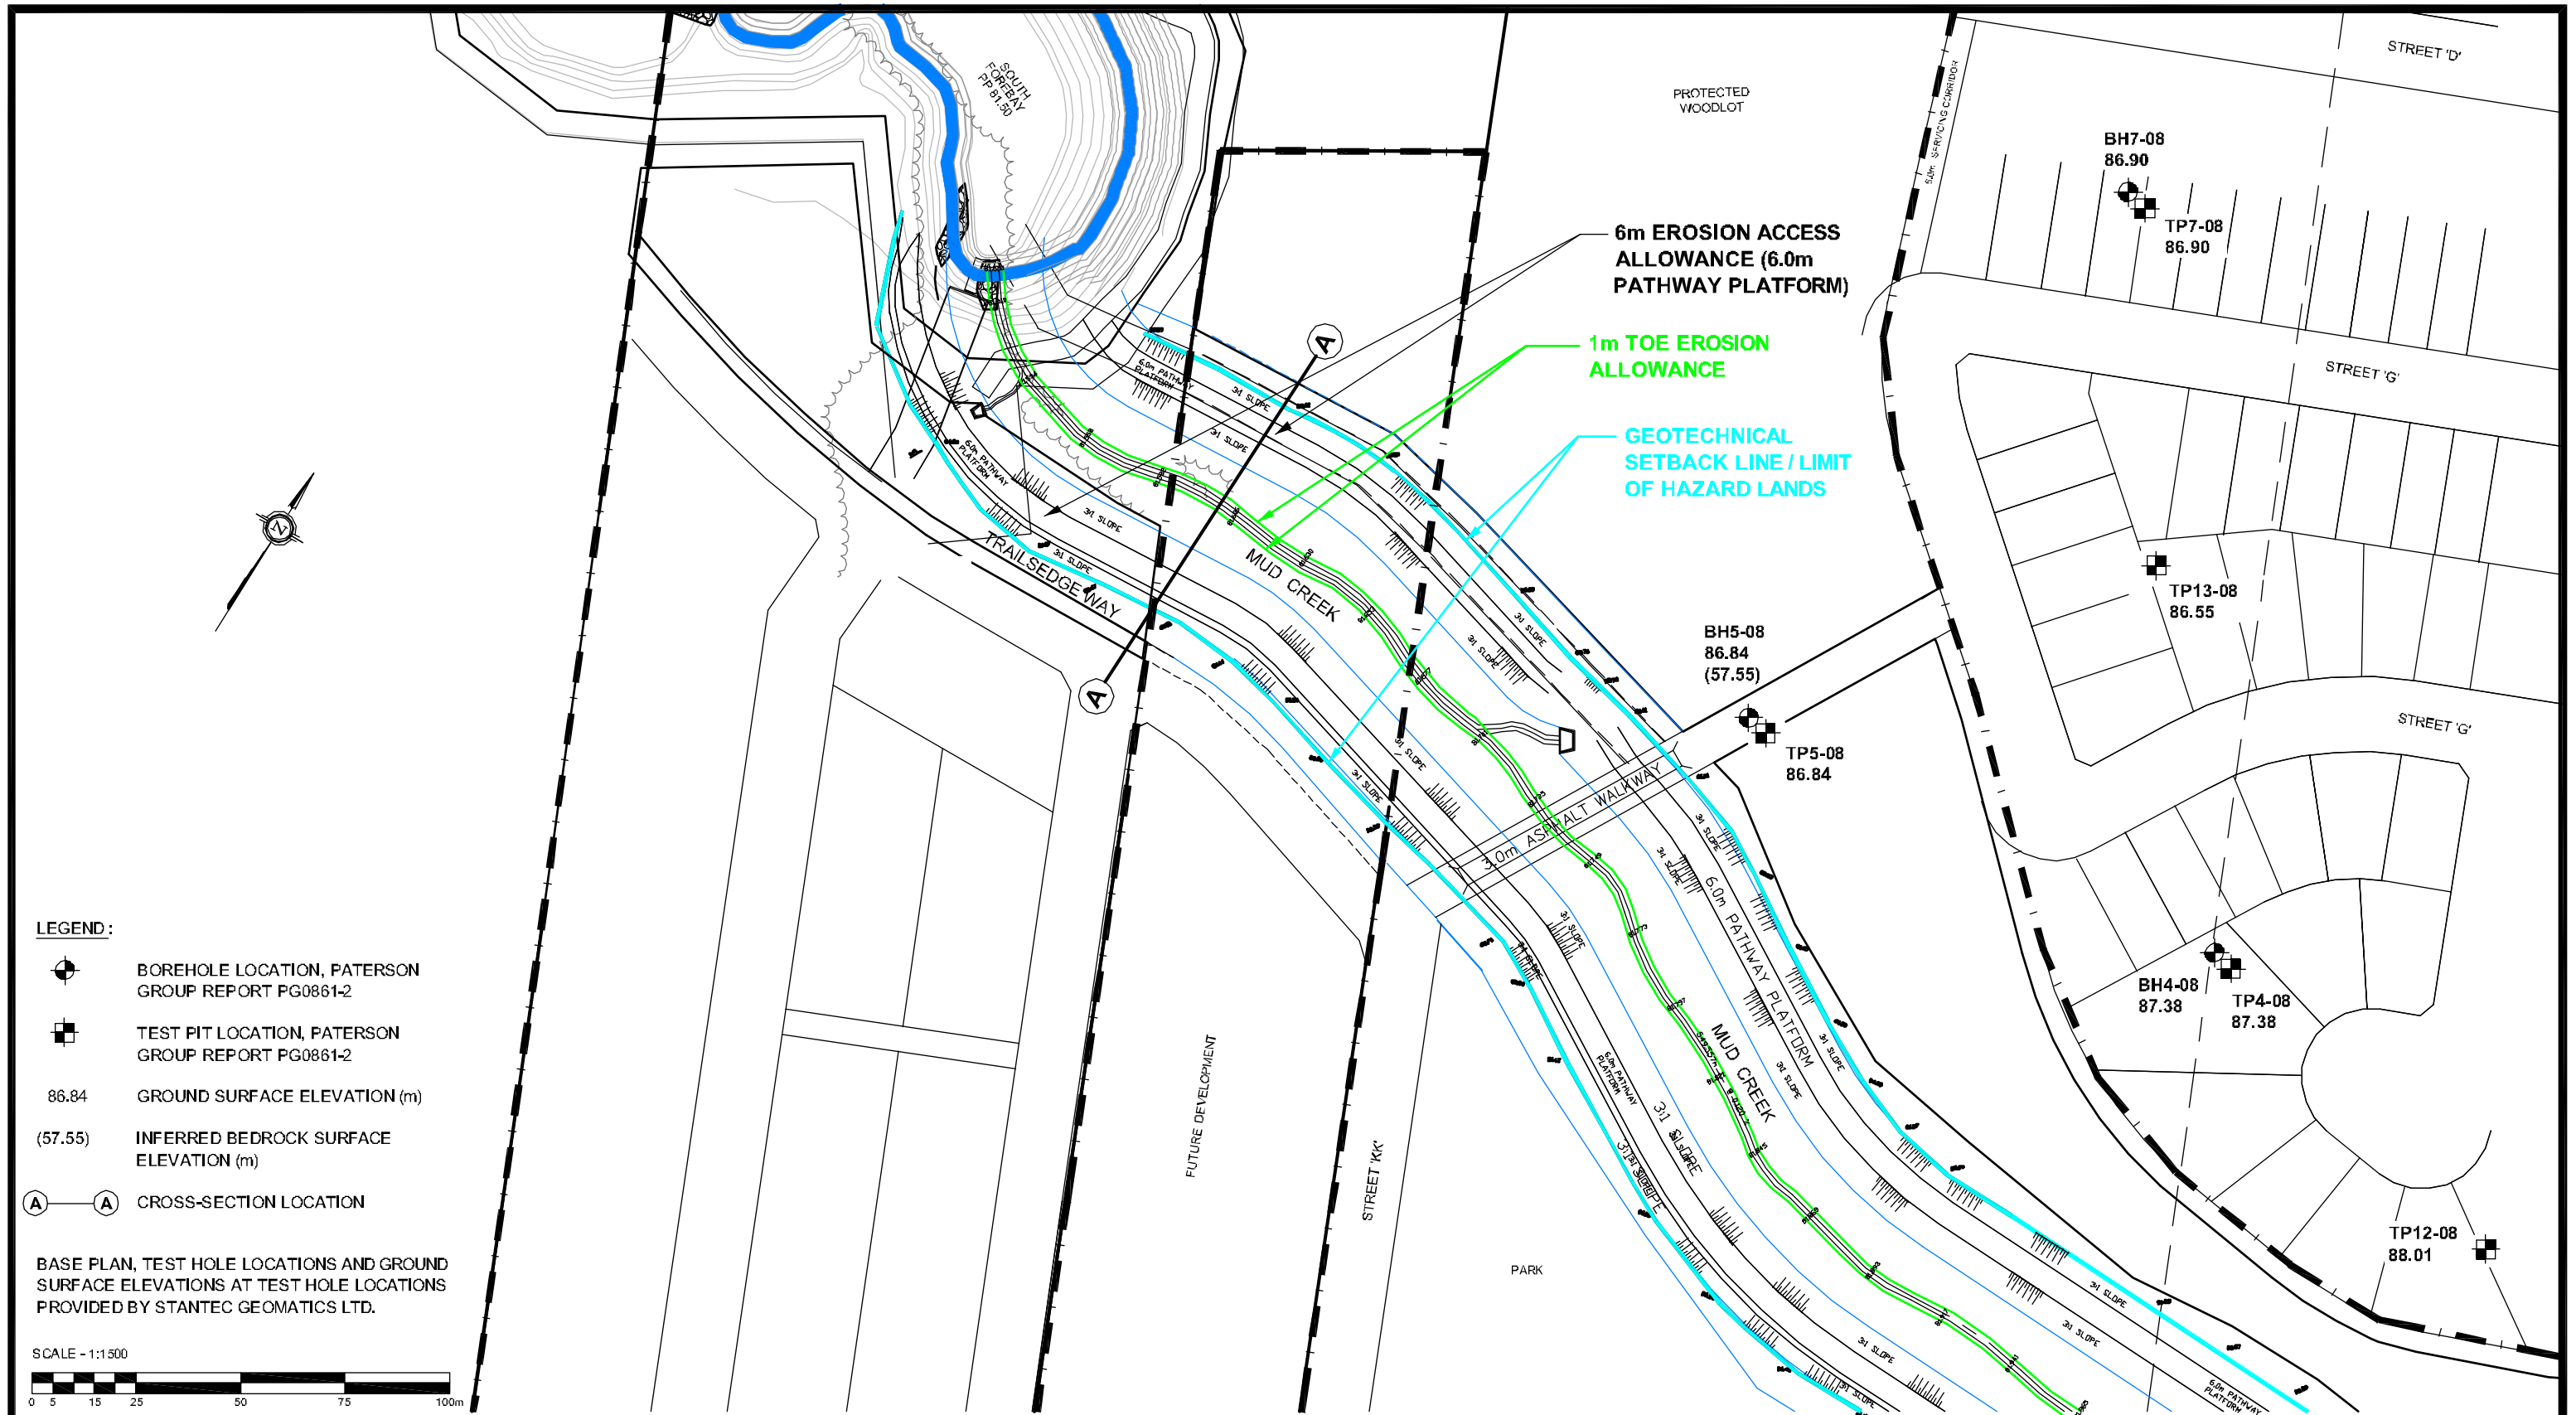
TEST HOLE LOCATION PLAN

The slope condition was reviewed by Paterson field personnel. Two (2) slope cross-sections were studied as the worst case scenarios. The cross section locations are presented on Drawing PG0861-8 attached to the present letter. The existing slope is currently grass and tree covered with little to no signs of erosion within the lower portions of the slope face. The watercourse was also noted to be approximately 150 to 300 mm deep.

No signs of active erosion were noted along the subject section of the existing watercourse. A 1 m toe erosion is deemed appropriate for this slope based on the nature of the soils, the observed erosion areas and the current watercourse width and location. It is considered that a toe erosion allowance of 1 m and an access allowance of 6 m is required from the top of stable slope (ie.- slope with factor of safety greater than 1.5). The limit of hazard lands, which include these allowances, is indicated on Drawing PG0861-8.

The existing vegetation on the slope face should not be removed as it contributes to the stability of the slope and reduces erosion.
