TREE CONSERVATION REPORT

500 Edgeworth Ave

Tree Conservation Report submitted as Partial Requirements for a Site Plan Control and Zoning Bylaw Amendment Application, August 11, 2025

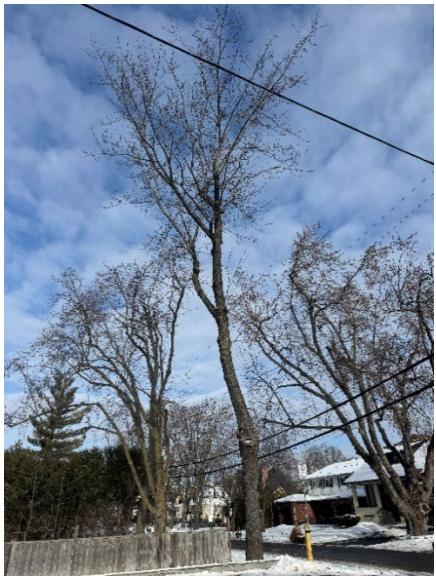
Picture 1: Tree 1, privately owned silver maple

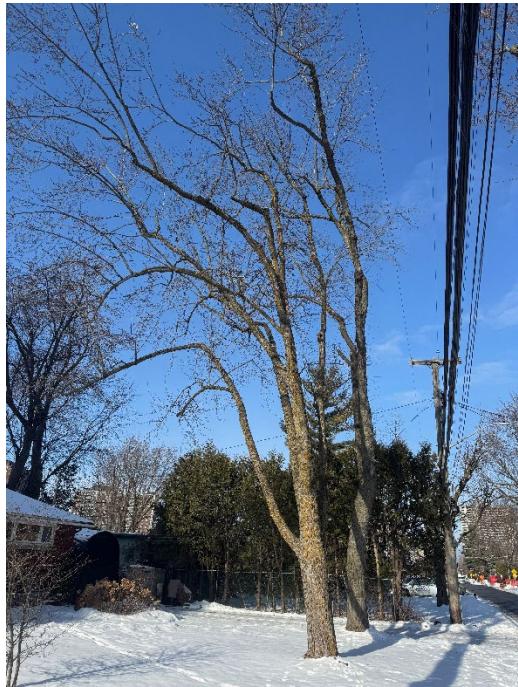
Picture 2: Trees 2 and 3, privately owned silver maples

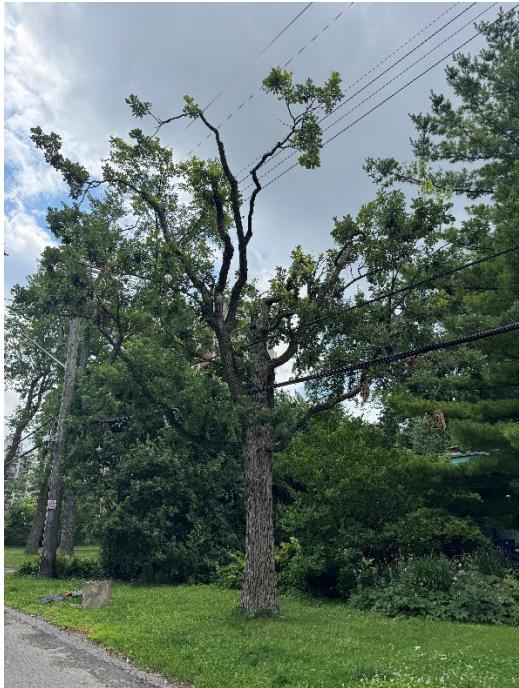
Picture 3: Tree 4, city-owned bur oak

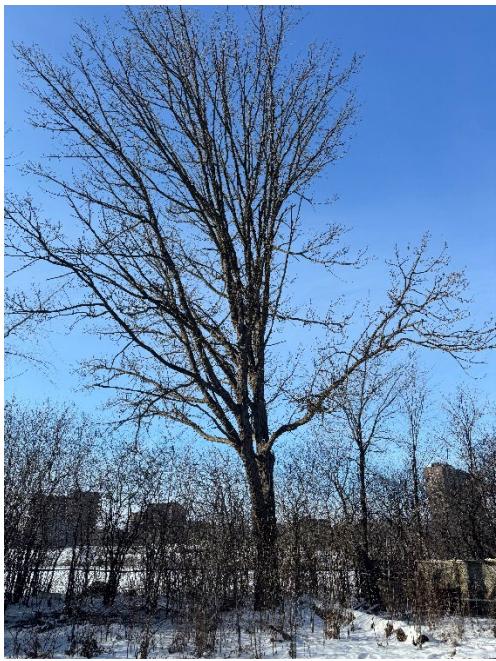
Picture 4: tree 10, bur oak at the rear of 508 Edgeworth

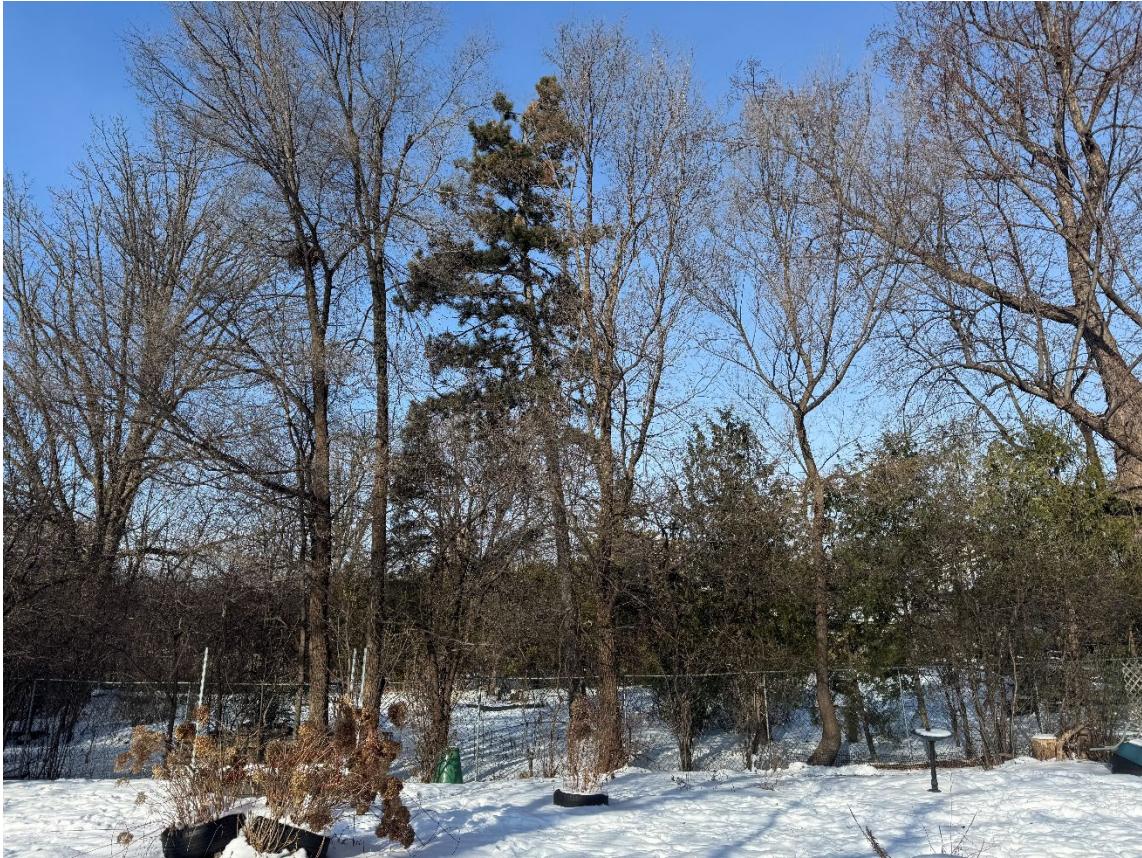
Picture 6: facing northwards from 500 Edgeworth - row of Siberian elms (trees 17-20)

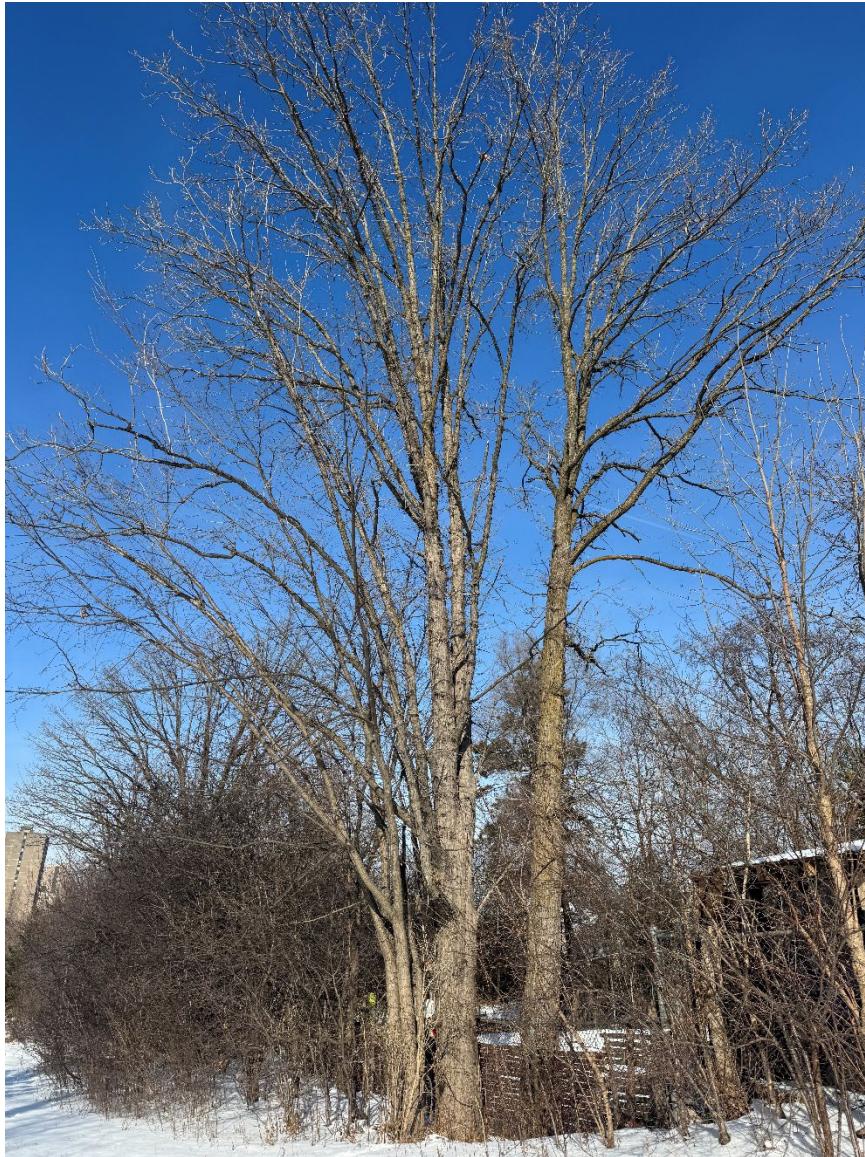
Picture 7: Trees 25 (right), bur oak on subject properties and 26 (left), bur oak on NCC property

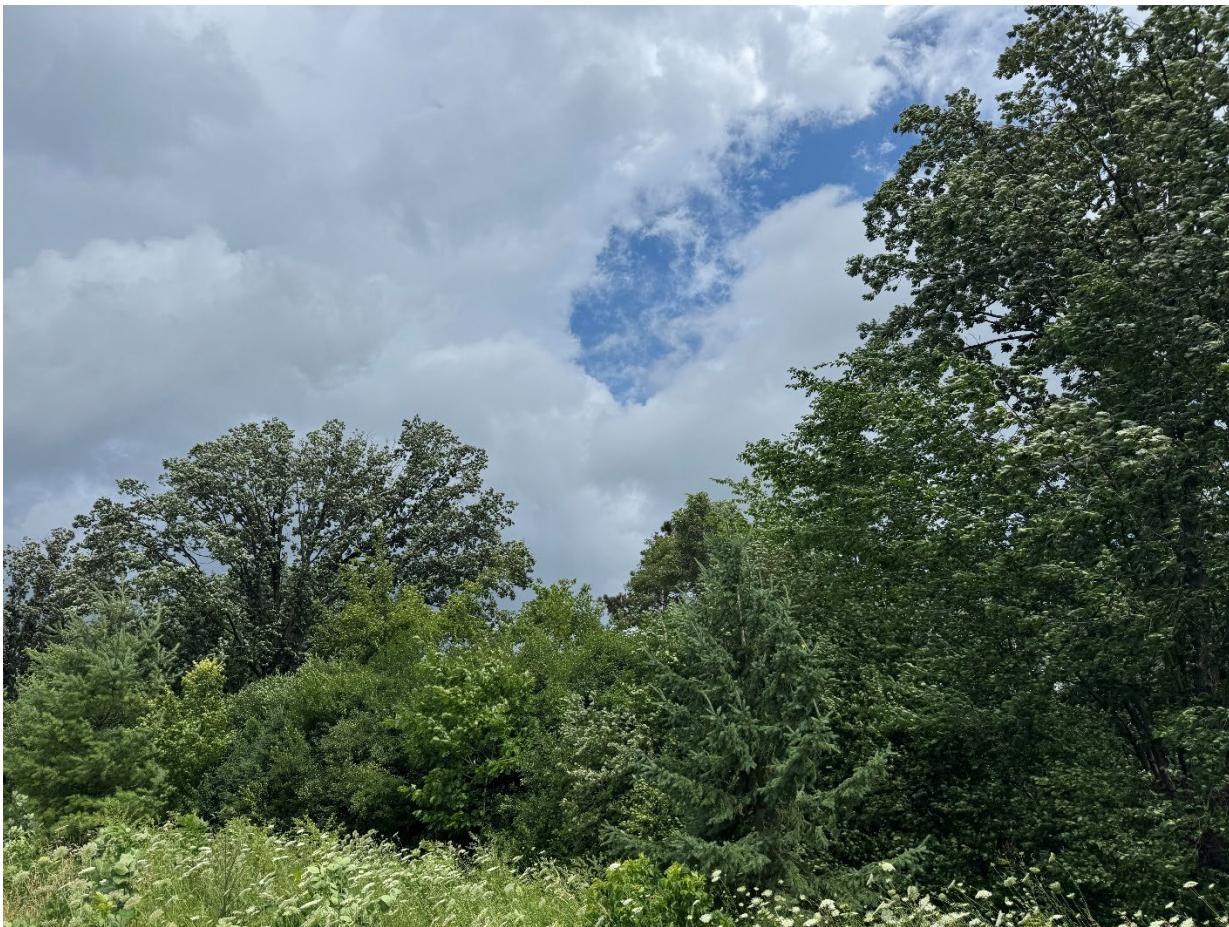
In addition to those trees identified on TCR maps, there is also a line of thick buckthorn shrubs along the edge of the NCC property. Due to their invasive nature, these should all be removed along with the trees that need to be removed to accommodate the excavation and make the area free of any risks of tree failures. During deep excavations such as this, the falling distance increases for those trees along the edge, resulting in higher consequences of failure for the construction crews working below.

Picture 8: Taken from the NCC property, row of buckthorn along the property line interspersed with recently planted trees along the west side

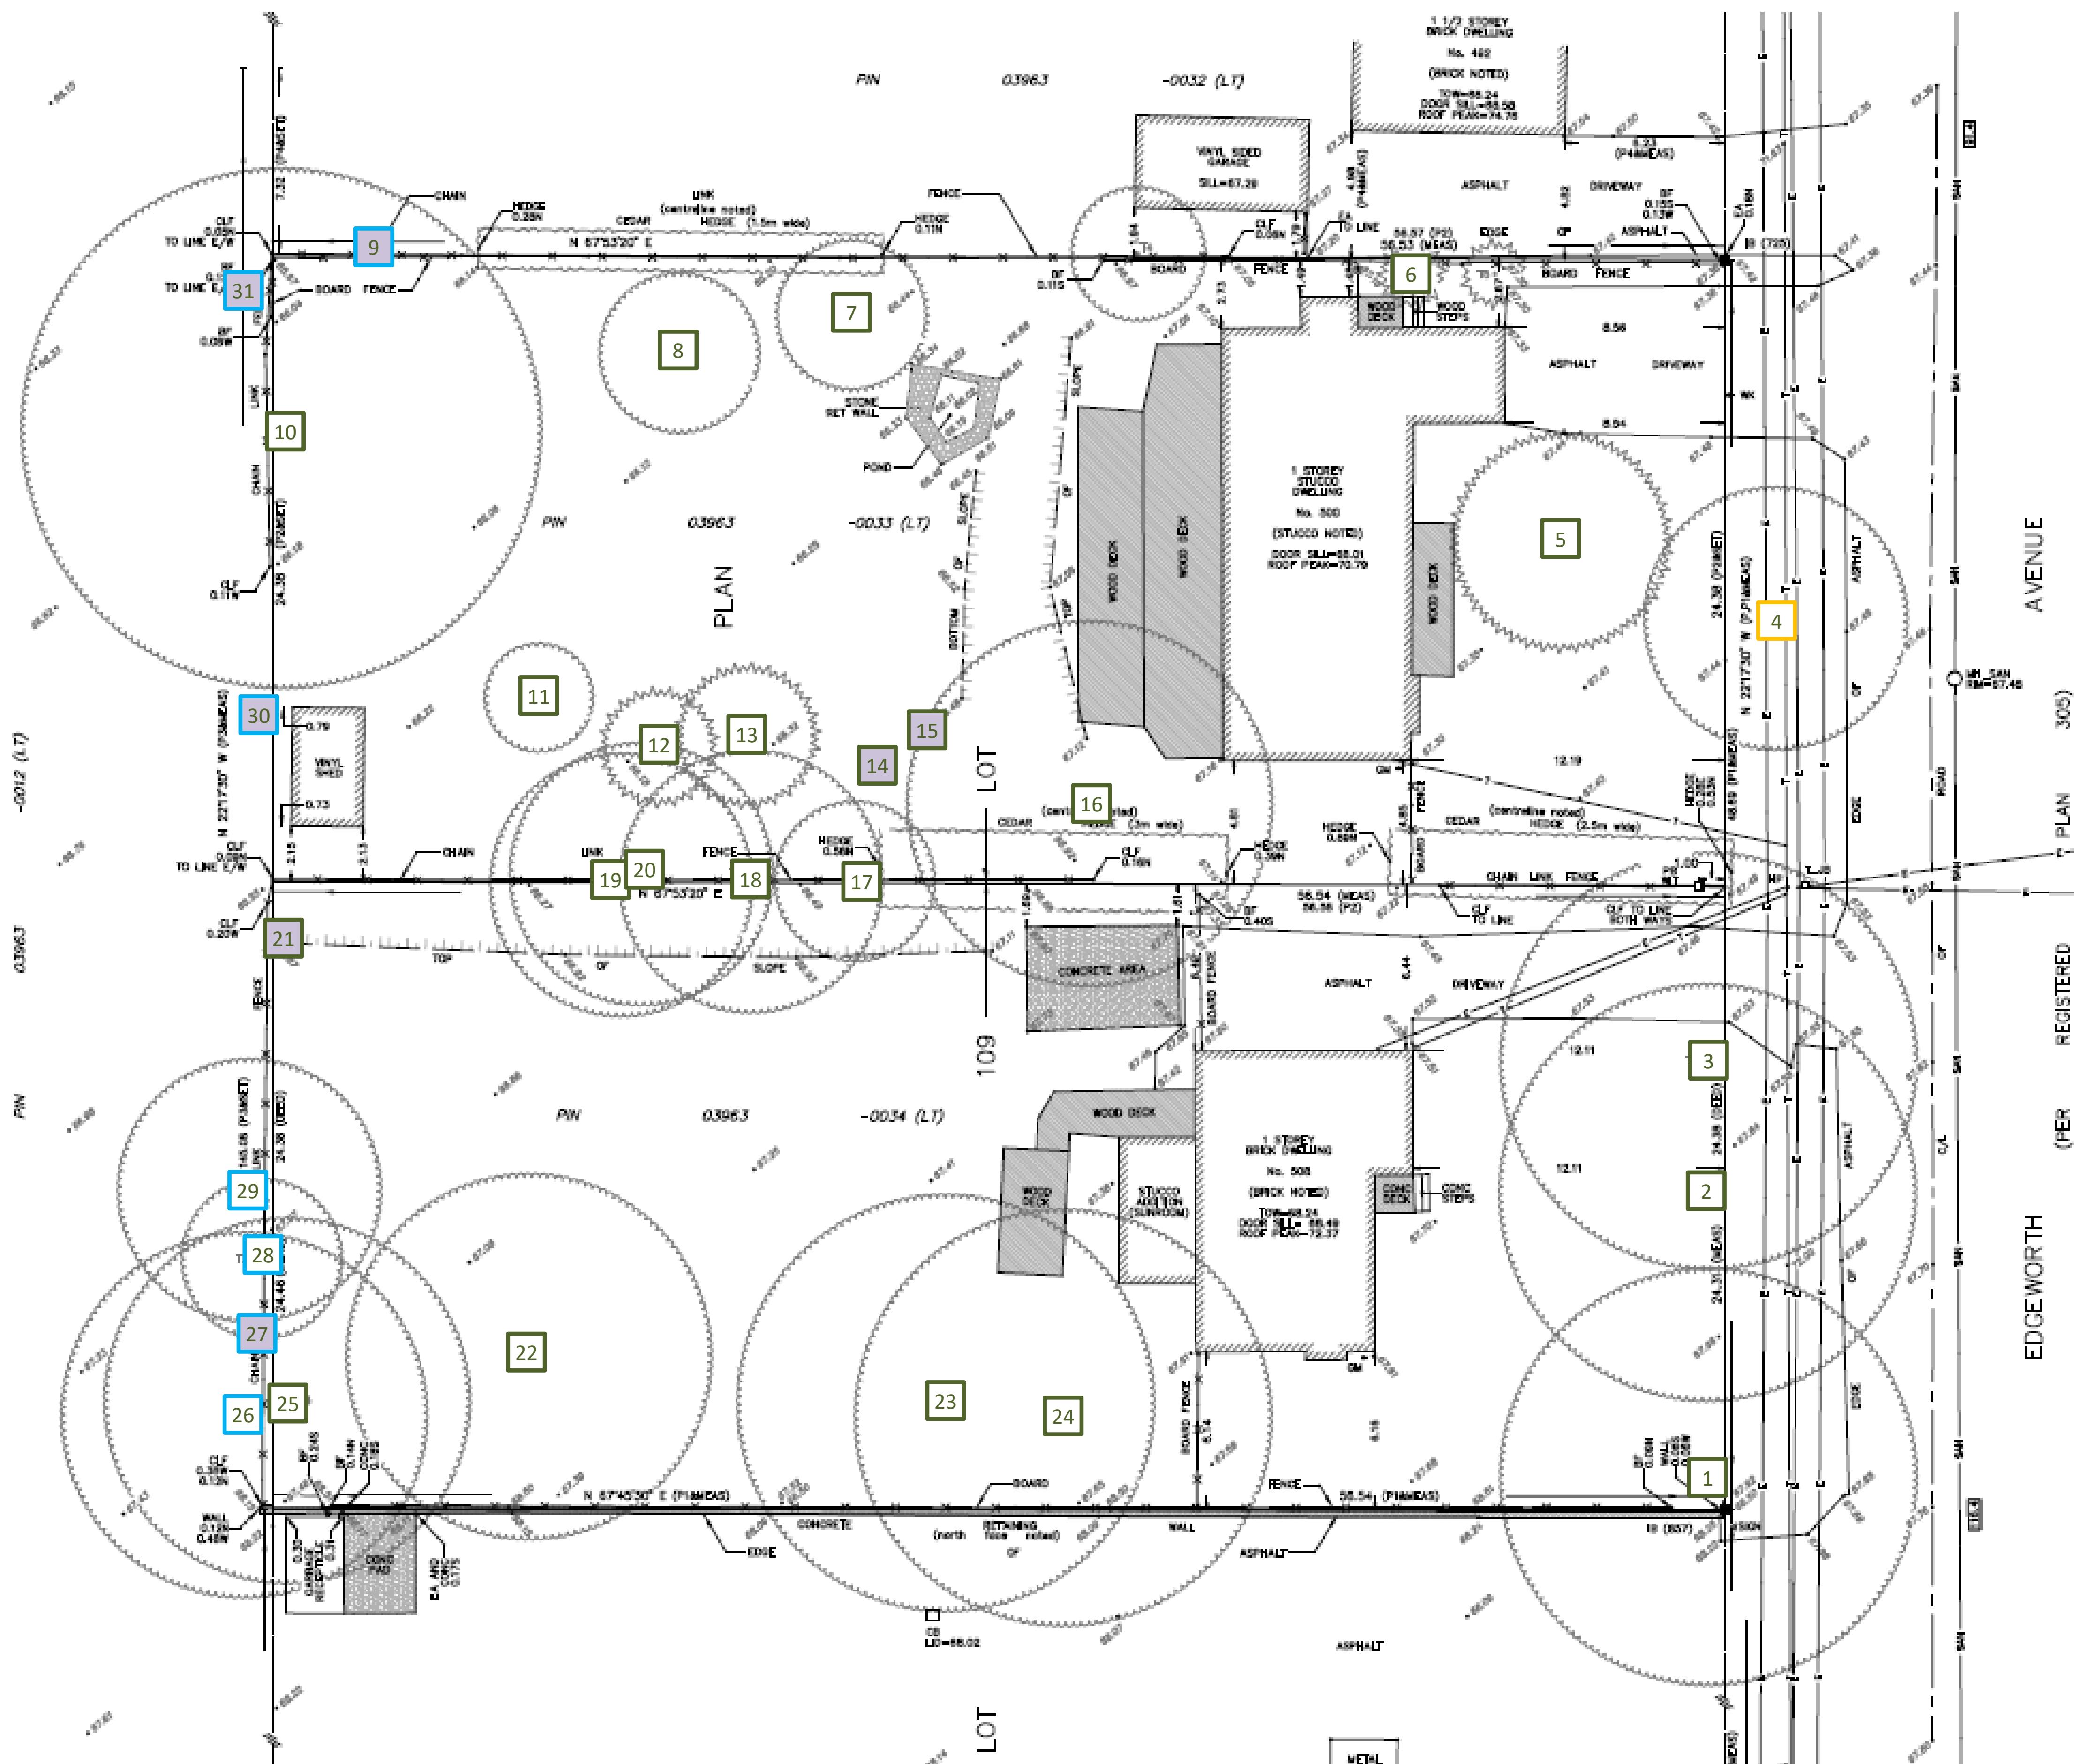
TCR Map#1: Existing Vegetation – 500 Edgeworth Ave

Tree ¹	Species	Diameter at breast height (cm)	Condition
1	Sugar maple (<i>Acer saccharum</i>)	59	Fair; pruned for hydro clearance, epicormic shoots, old branch attachment wound with decay at 4 m grade
2	Sugar maple (<i>Acer saccharum</i>)	55	Fair; pruned for hydro clearance, low vigour, epicormic shoots, decay in upper canopy
3	Sugar maple (<i>Acer saccharum</i>)	57	Fair; asymmetric crown
4	Bur oak (<i>Quercus macrocarpa</i>)	54	Fair/poor; directly under hydro lines, woodpecker holes in centre stem, dieback
5	White pine (<i>Pinus strobus</i>)	43	Good/fair; slight lean at base, minor chlorosis
6	Eastern white cedar (<i>Thuja occidentalis</i>)	17, 19, 14, 15	Good/fair
7	White birch (<i>Betula papyrifera</i>)	18	Good
8	Apple (<i>Malus spp</i>)	24	poor; many epicormic shoots
9 ⁴	Manitoba maple (<i>Acer negundo</i>)	12 (est)	Fair; heavy lean
10	Bur oak (<i>Quercus macrocarpa</i>)	78	Good; asymmetric crown, some deadwood

11	Apple (<i>Malus spp</i>)	16	Poor; epicormic shoots, significant decay
12	Scots pine (<i>Pinus sylvestris</i>)	13	Fair; thin top
13	Austrian pine (<i>Pinus nigra</i>)	41	Fair; thin crown with dieback, sapsucker holes,
14 ⁴	Eastern white cedar (<i>Thuja occidentalis</i>)	13	Good
15 ⁴	Eastern white cedar (<i>Thuja occidentalis</i>)	13	Good
16	Sugar maple (<i>Acer saccharum</i>)	120	Poor/fair; old branch attachment wound, multi-stemmed
17	Siberian elm (<i>Ulmus pumila</i>)	23	Fair/good; vigorous growth, growing within fence
18	Siberian elm (<i>Ulmus pumila</i>)	31	Fair/good; growing within chain link fence
19	Siberian elm (<i>Ulmus pumila</i>)	32	Fair; growing within chain link fence
20	Siberian elm (<i>Ulmus pumila</i>)	10, 29, 16	Fair
21 ⁴	Manitoba maple (<i>Acer negundo</i>)	14	Good
22	Sugar maple (<i>Acer saccharum</i>)	31, 32, 34	Fair/good; lean
23	Sugar maple (<i>Acer saccharum</i>)	29, 44	Fair; lean

24	Sugar maple (<i>Acer saccharum</i>)	43, 68	Fair/poor; topped, decay at base, old branch attachment wounds with decay
25	Bur oak (<i>Quercus macrocarpa</i>)	49	Good; asymmetrical crown
26	Bur oak (<i>Quercus macrocarpa</i>)	52	Good/fair; asymmetric crown, epicormic shoots
27 ⁴	American elm (<i>Ulmus americana</i>)	17, 18, 11, 9	Fair; multi-stemmed, included bark in unions
28	American elm (<i>Ulmus americana</i>)	12	Good
29	American elm (<i>Ulmus americana</i>)	18	Good
30 ⁴	Oakleaf mountain ash (<i>Sorbus Thuringiaca</i>)	26	Poor; high level of decay, heavy lean, woodpecker holes
31 ⁴	American elm (<i>Ulmus americana</i>)	20	Good
