# PATERSON GROUP

February 20, 2026  
PG6557-LET.01 Revision 2

Subject: **Preliminary Geotechnical Investigation  
Proposed Commercial Development  
2175 Prince of Wales Drive – Ottawa, Ontario**

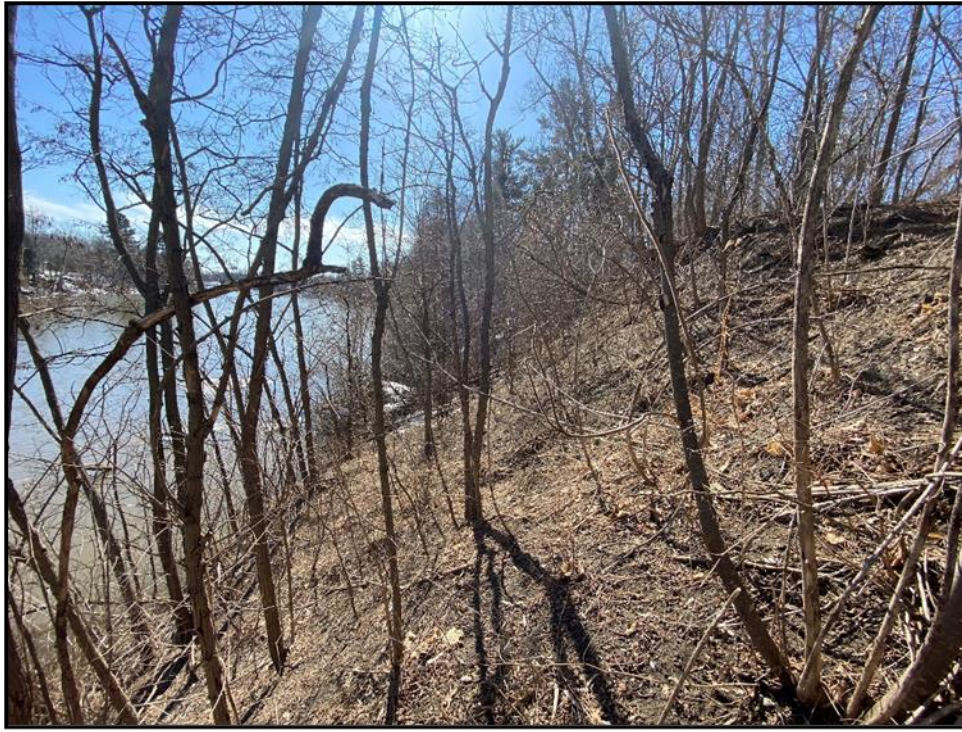
**Photo 1:** Photograph taken in a southeast direction illustrating some evidence of active erosion.

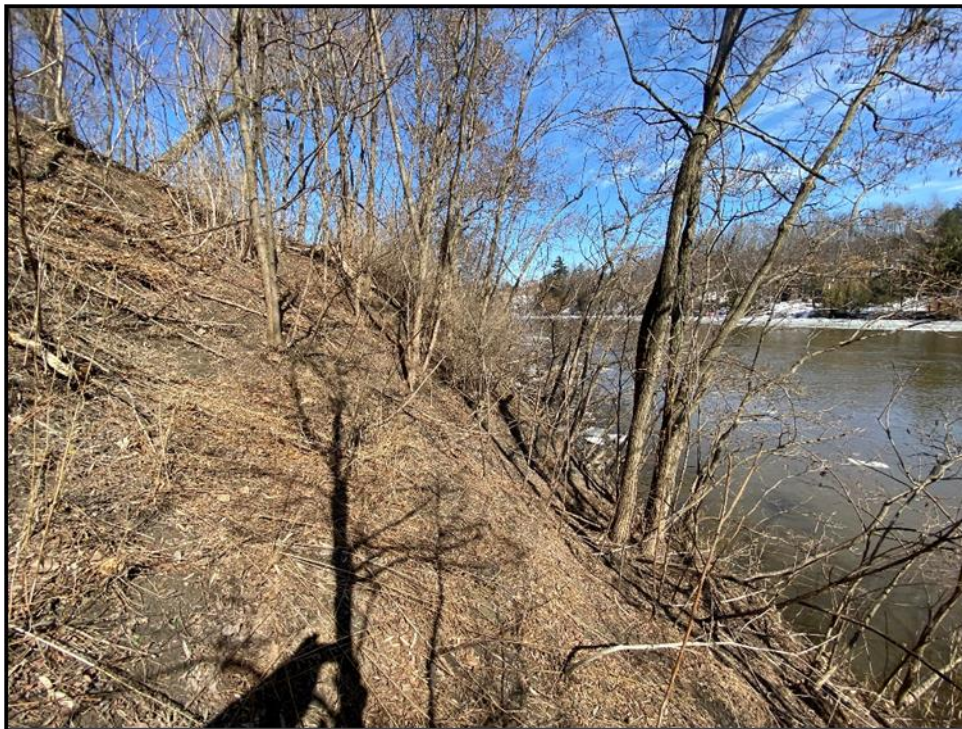
**Photo 2:** Photograph taken in a northeast direction illustrating some evidence of active erosion along the west bank of the Rideau River.

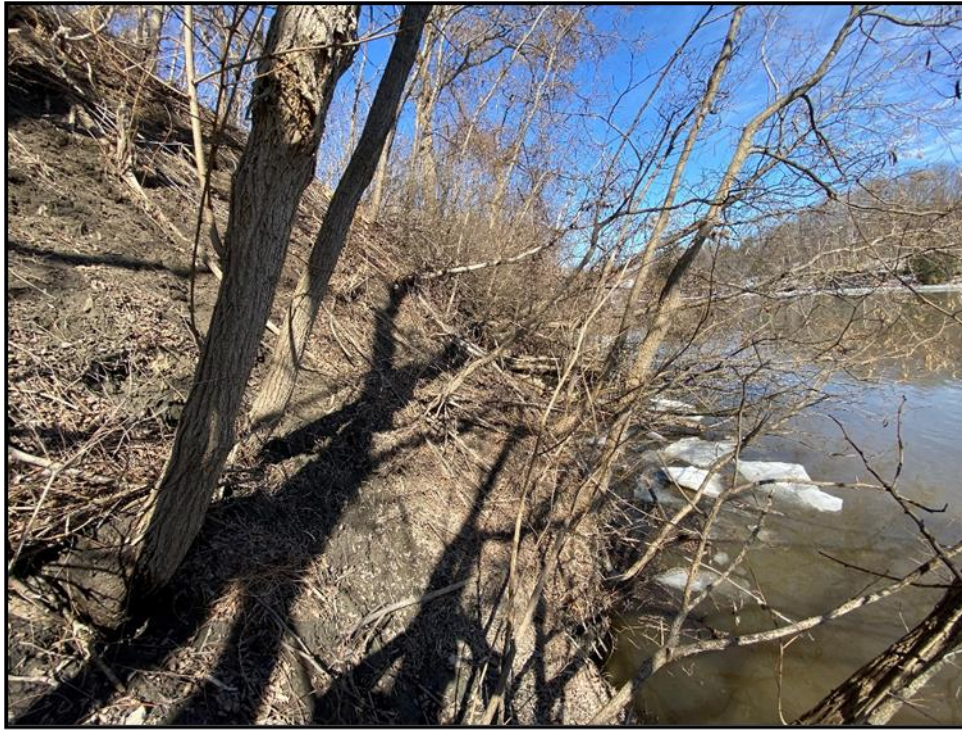
**Photo 3:** Photograph taken in a northeast direction illustrating some evidence of toe erosion along the west bank of the Rideau River.

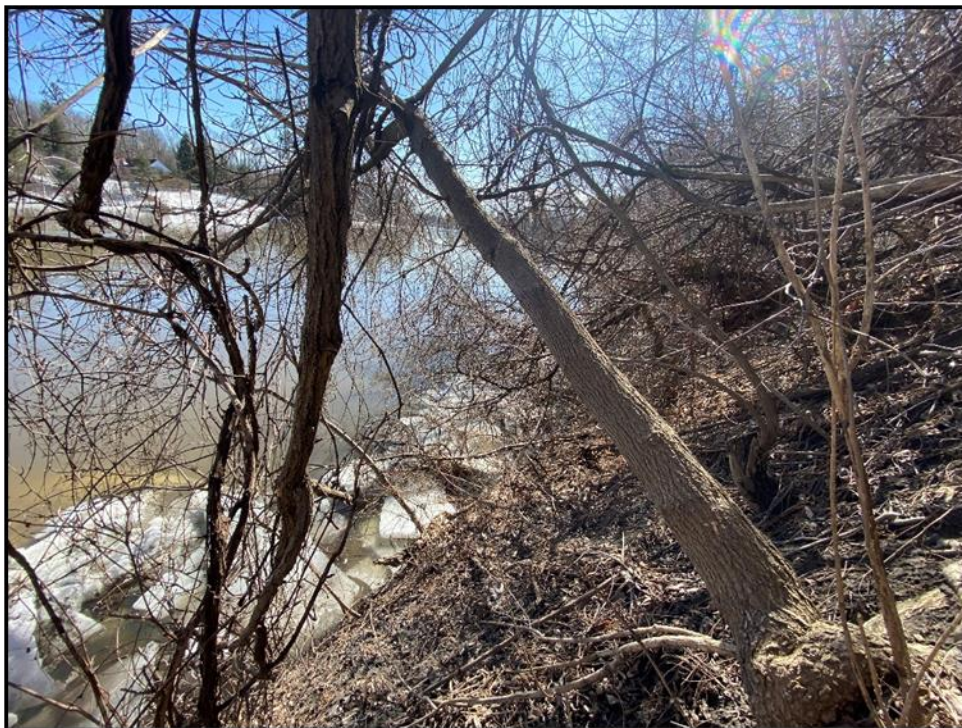
**Photo 4:** Photograph taken in a southwest direction illustrating some evidence of active erosion along the west bank of the Rideau River.

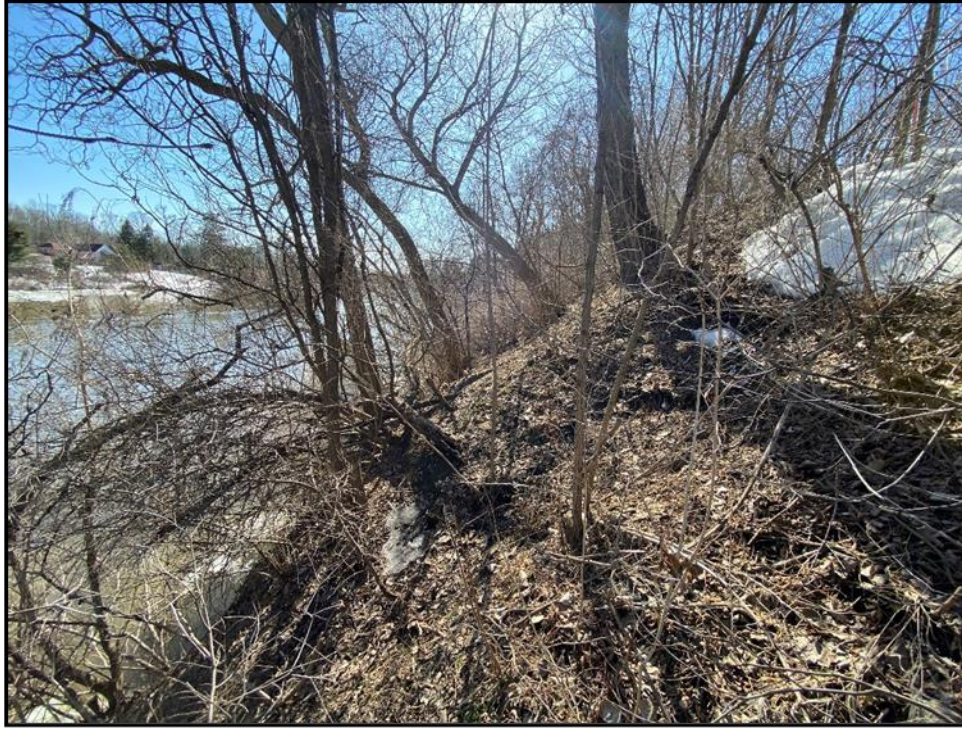
**Photo 5:** Photograph taken in a southwest direction illustrating some evidence of active erosion along the west bank of the Rideau River.

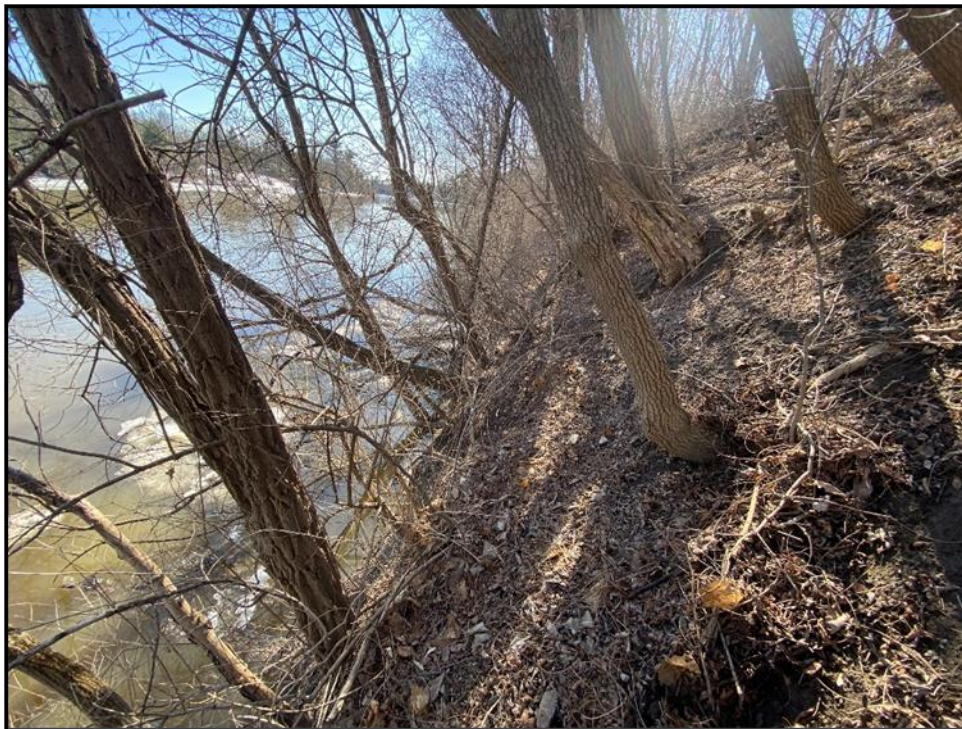
**Photo 6:** Photograph taken in a southwest direction illustrating some evidence of toe erosion along the west bank of the Rideau River.

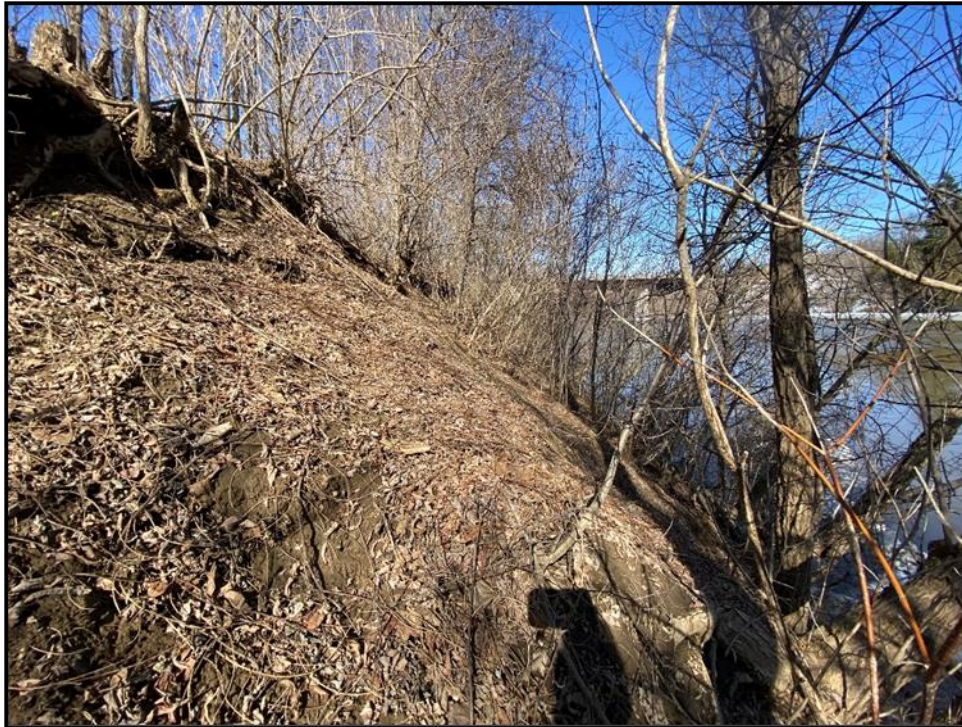
**Photo 7:** Photograph taken in a northeast direction illustrating some evidence of active erosion along the west bank of the Rideau River.

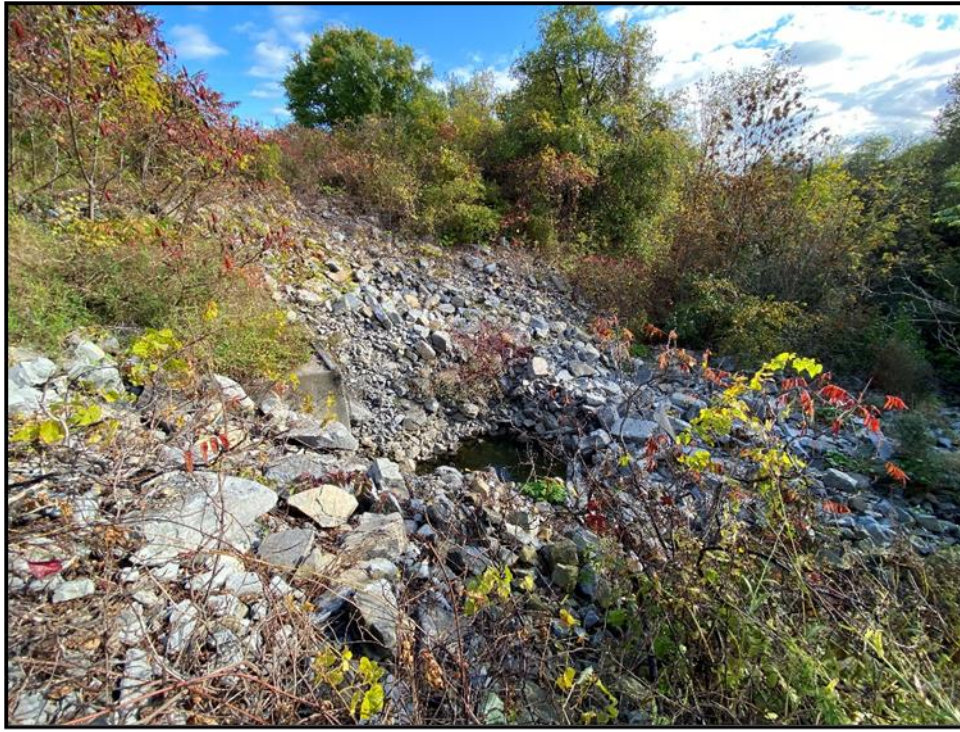
**Photo 8:** Photograph taken in a northeast direction illustrating the placement of riprap stone around the culvert outlet that discharges into the tributary to the Rideau River.

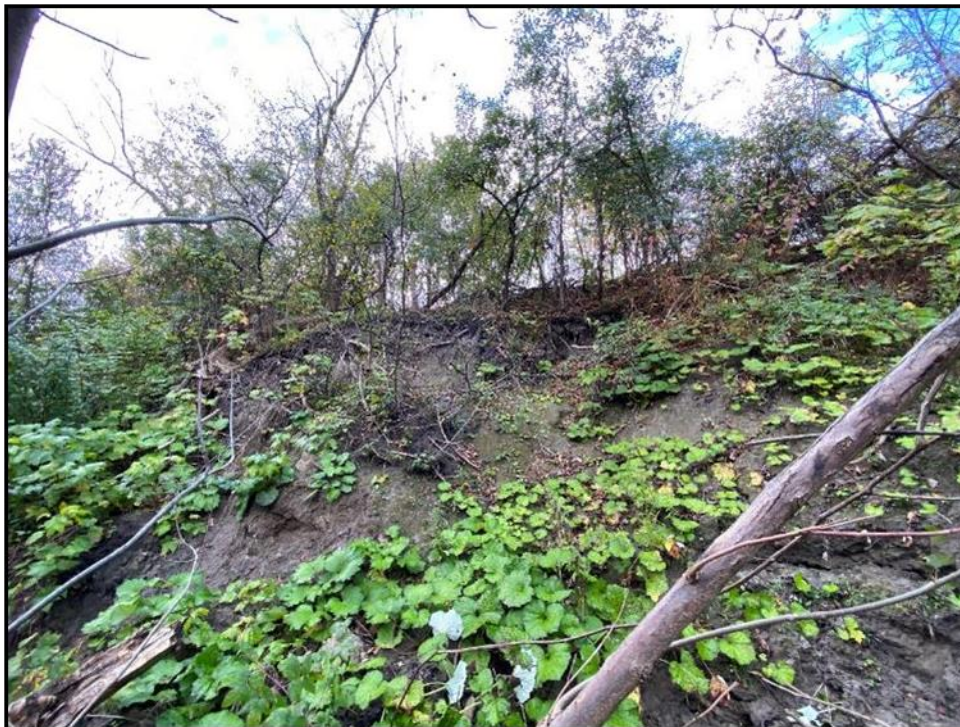
**Photo 9:** Photograph taken in a south direction along the tributary to the Rideau River illustrating some evidence of historical slip failures along the south banks of the valley corridor.

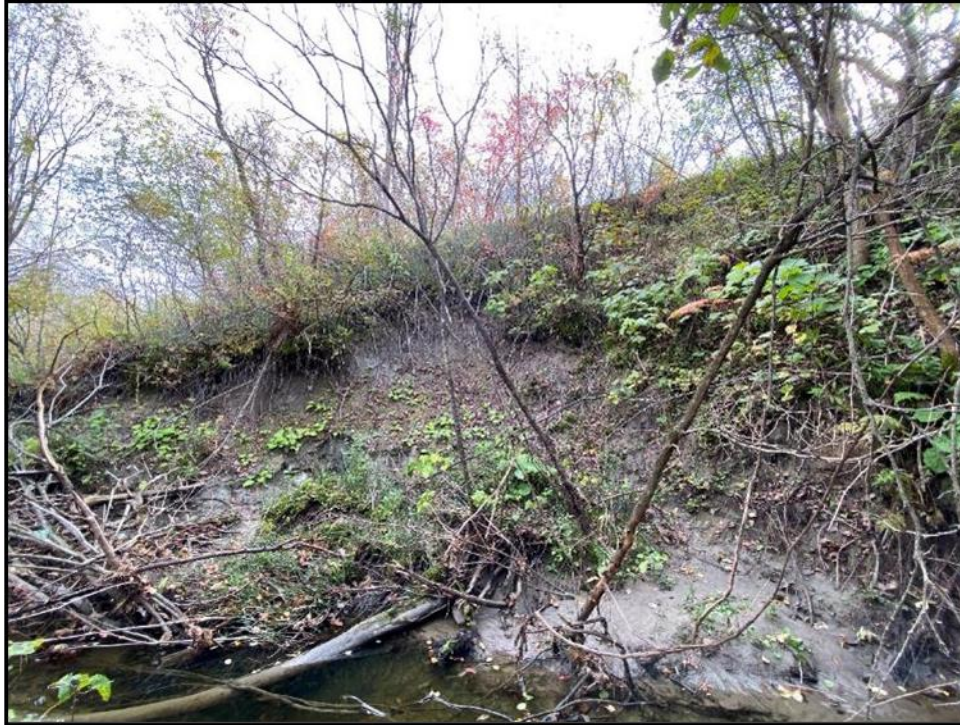
**Photo 10:** Photograph taken in a south direction along the tributary to the Rideau River illustrating some toe erosion along the base of the valley corridor where the watercourse meets the wall of the valley corridor.

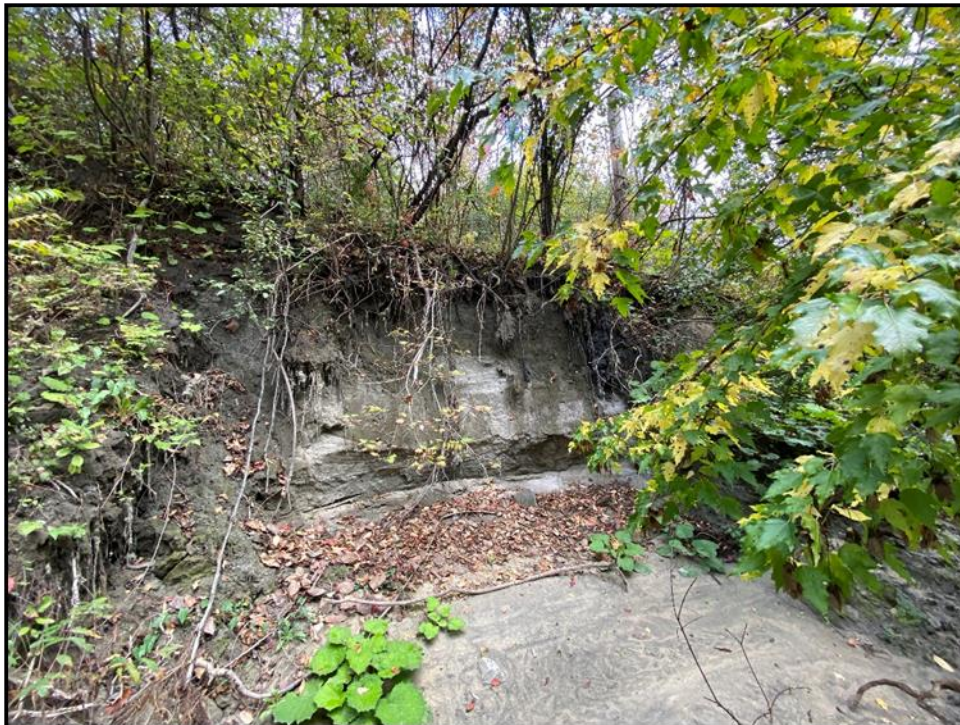
**Photo 11:** Photograph taken in a north direction along the tributary to the Rideau River illustrating evidence of active erosion along the north bank of the valley corridor.

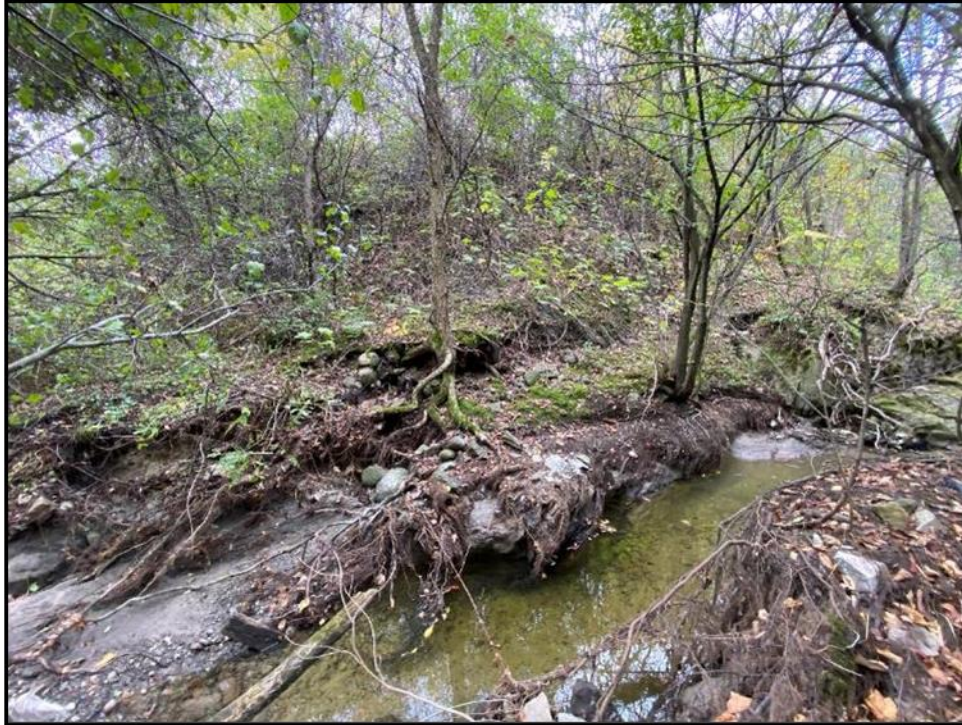
**Photo 12:** Photograph taken in a south direction along the tributary to the Rideau River illustrating evidence of historical slip failures along the south bank of the valley corridor and evidence of active erosion where the watercourse meets the wall of the valley corridor.

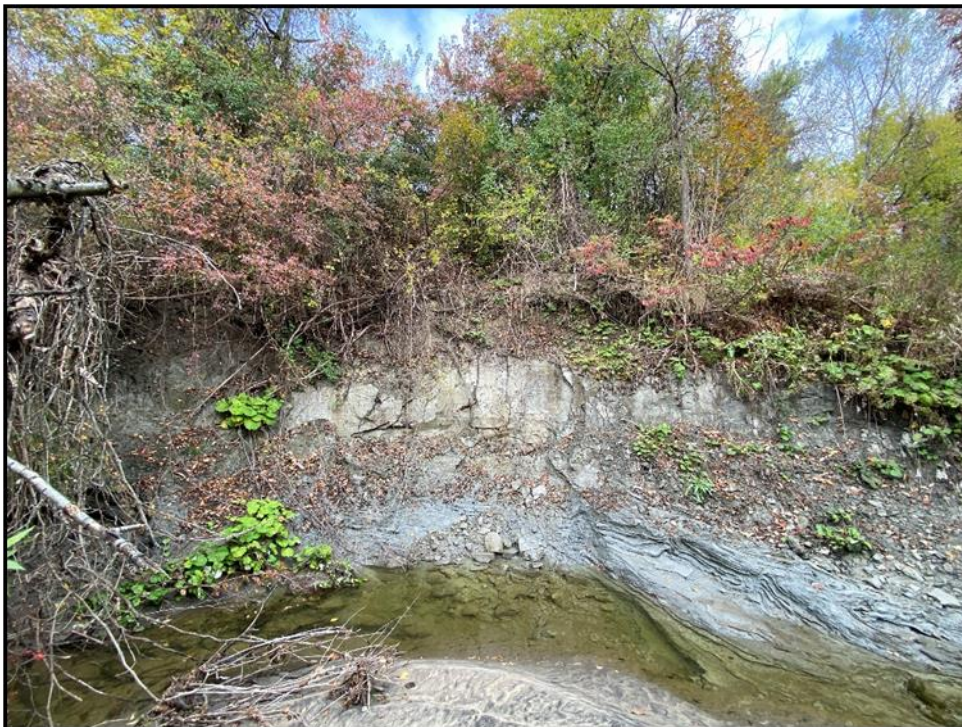
**Photo 13:** Photograph taken in a north direction along the tributary to the Rideau River illustrating evidence of active erosion.

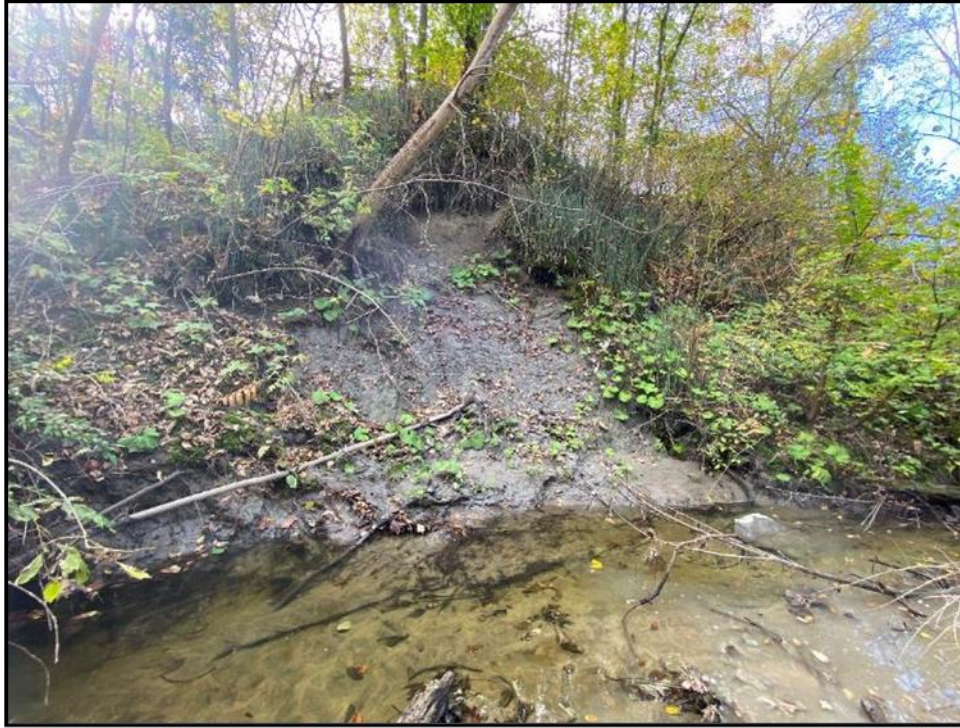
**Photo 14:** Photograph taken in a south direction along the tributary to the Rideau River illustrating evidence of historical slip failures along the south bank of the valley corridor and evidence of active erosion where the watercourse meets the wall of the valley corridor.

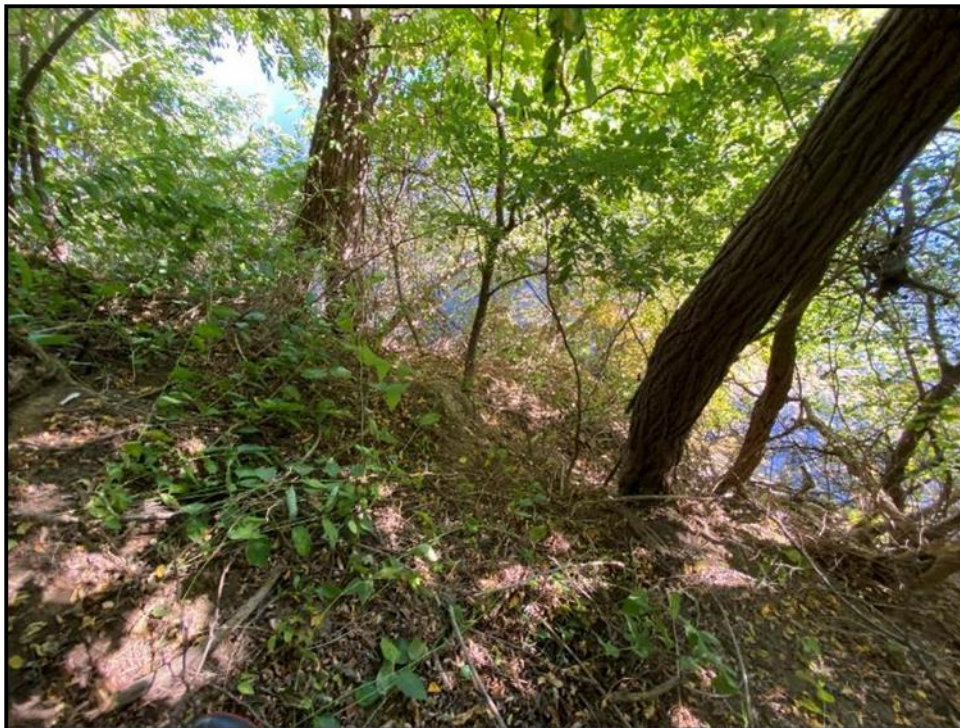
**Photo 15:** Photograph taken in an east direction over the west bank of the Rideau River showing some active erosion.

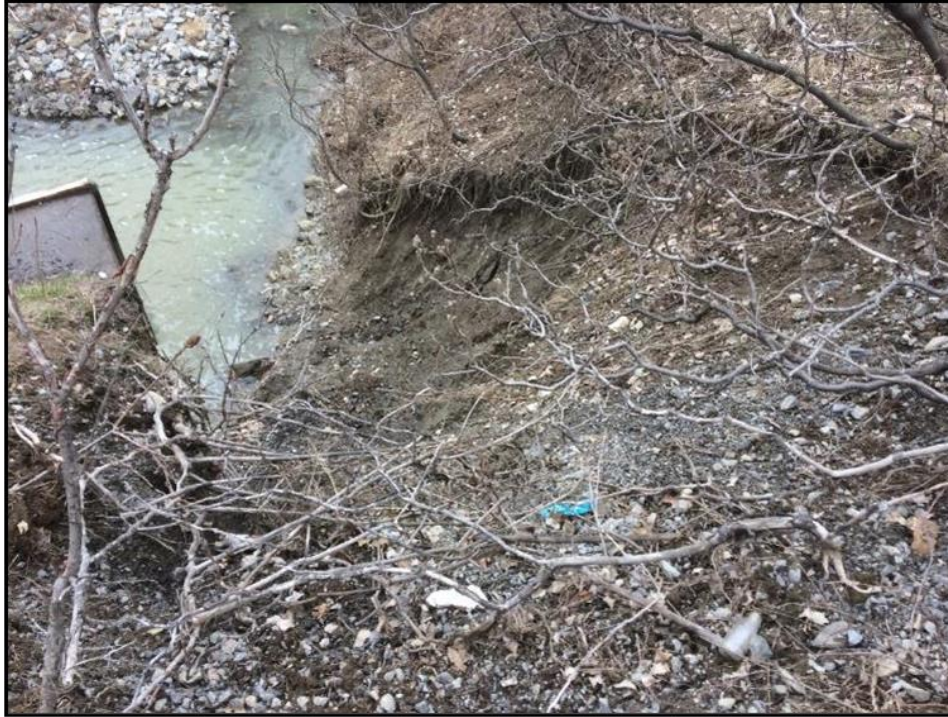
**Photo 16:** Photograph taken in an east direction illustrating the active erosion and subsequent slip failures adjacent to the concrete box culvert.

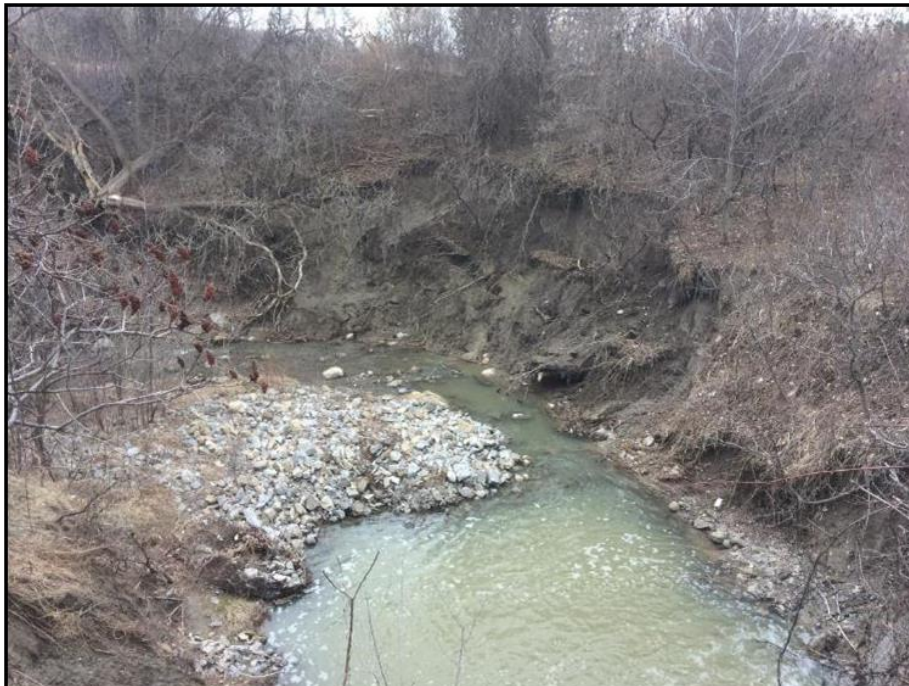
**Photo 17:** Photograph taken in an east direction from the top of the concrete box culvert illustrating the active erosion and subsequent slip failures along the south bank of the tributary to the Rideau River.

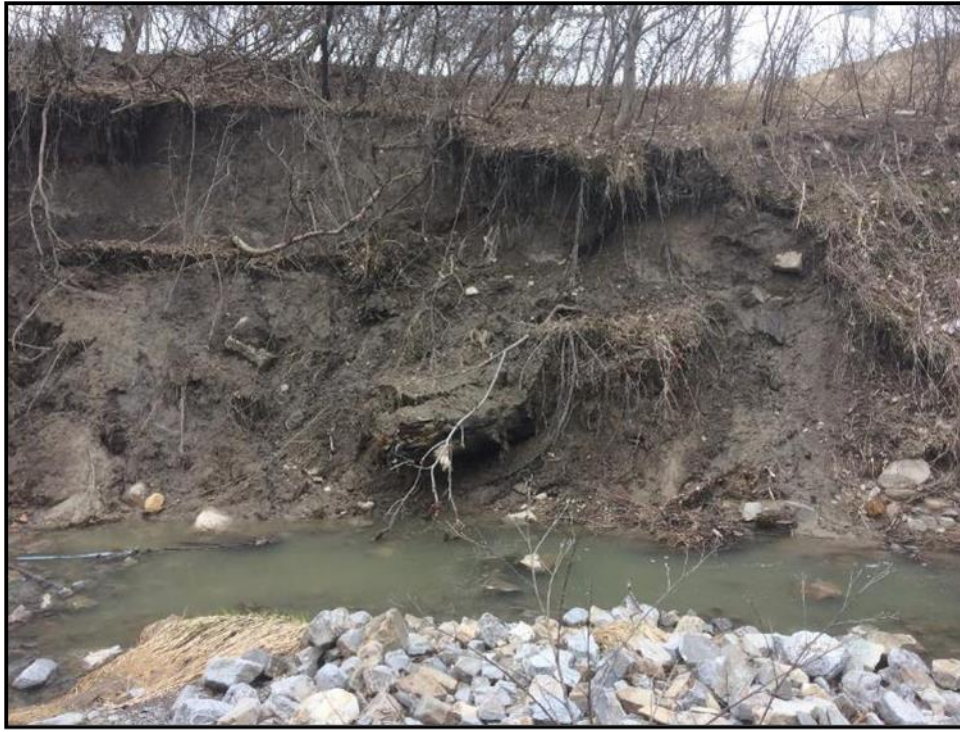
**Photo 18:** Photograph taken in a west direction to further capture the active erosion and subsequently slip failure presented in the previous photograph.

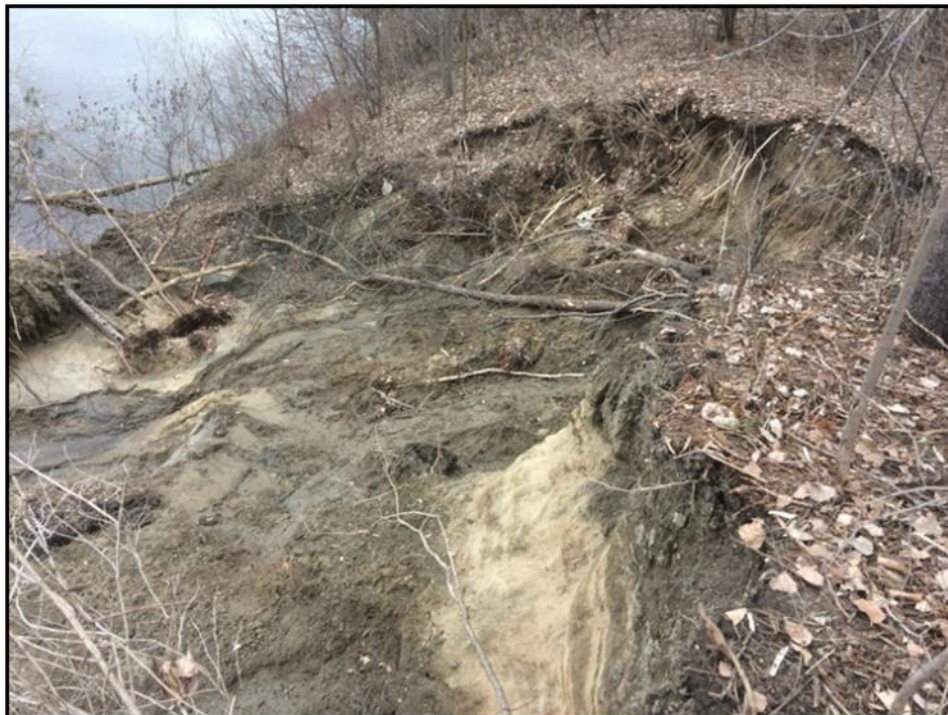
**Photo 19:** Photograph taken in a south direction illustrating a relatively recent slope failure along the west bank of the Rideau River.

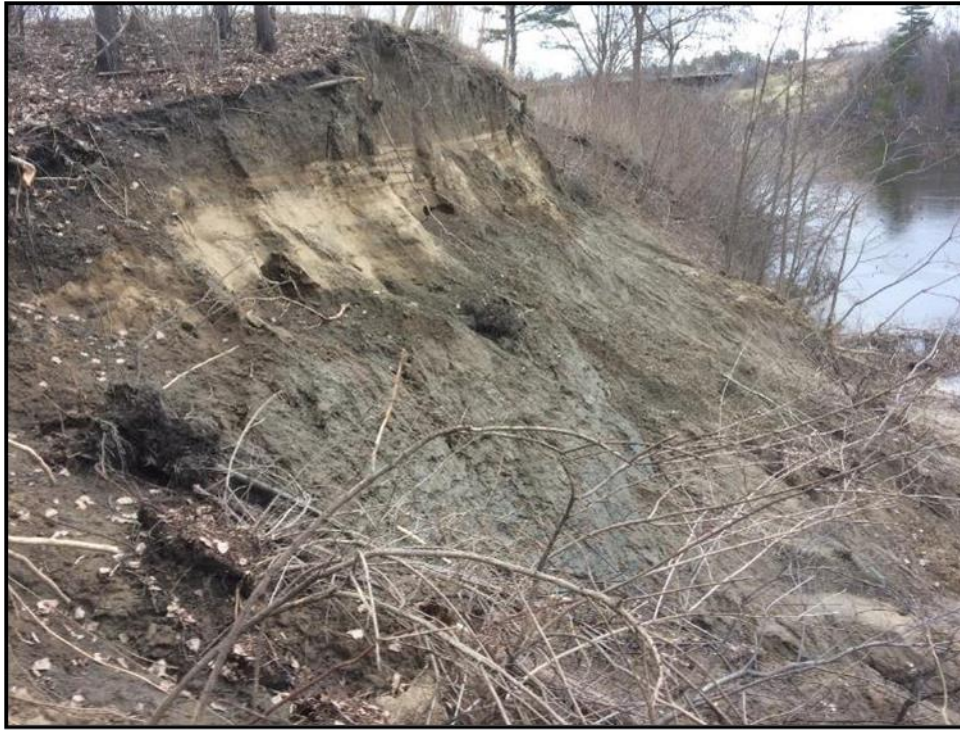
**Photo 20:** Similar to the previous photograph but taken in a north direction further illustrating the relatively recent slip failure along the west bank of the Rideau River.

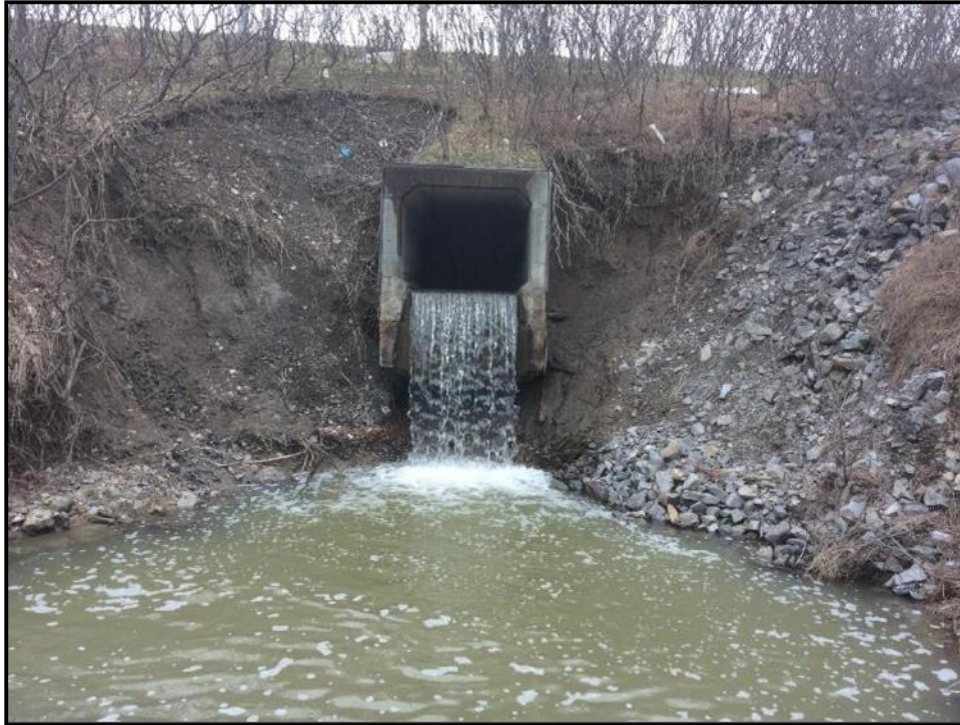
**Photo 21:** Photograph taken in a west direction on April 17, 2017, illustrating the active erosion and subsequent slip failures adjacent to the concrete box culvert.

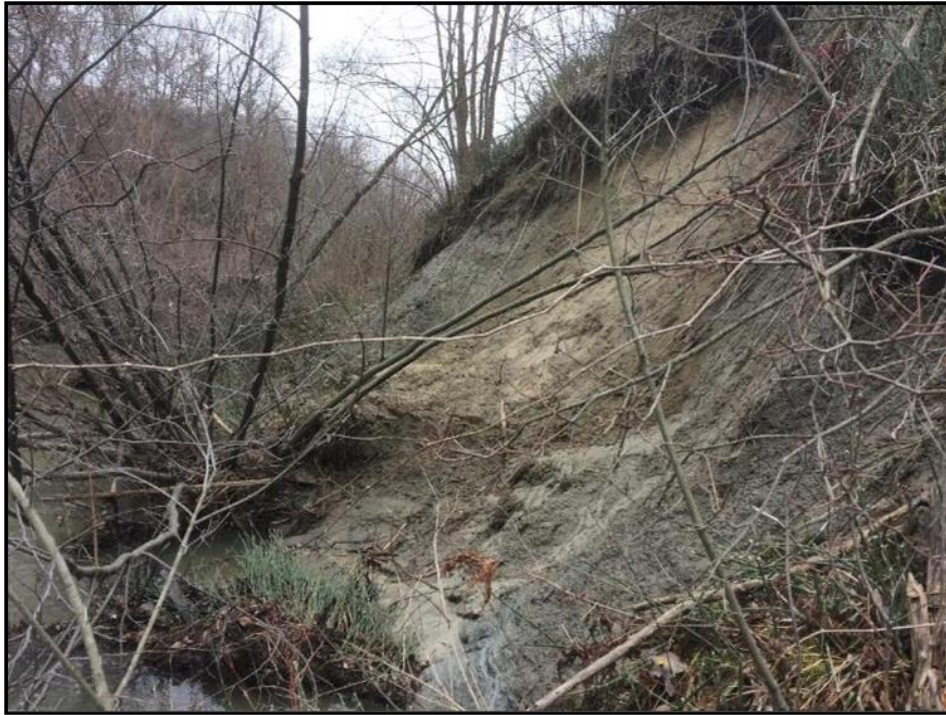
**Photo 23:** Photograph taken in an east direction on April 17, 2017, illustrating the active erosion and subsequent slip failure along the south bank of the Tributary to the Rideau River.

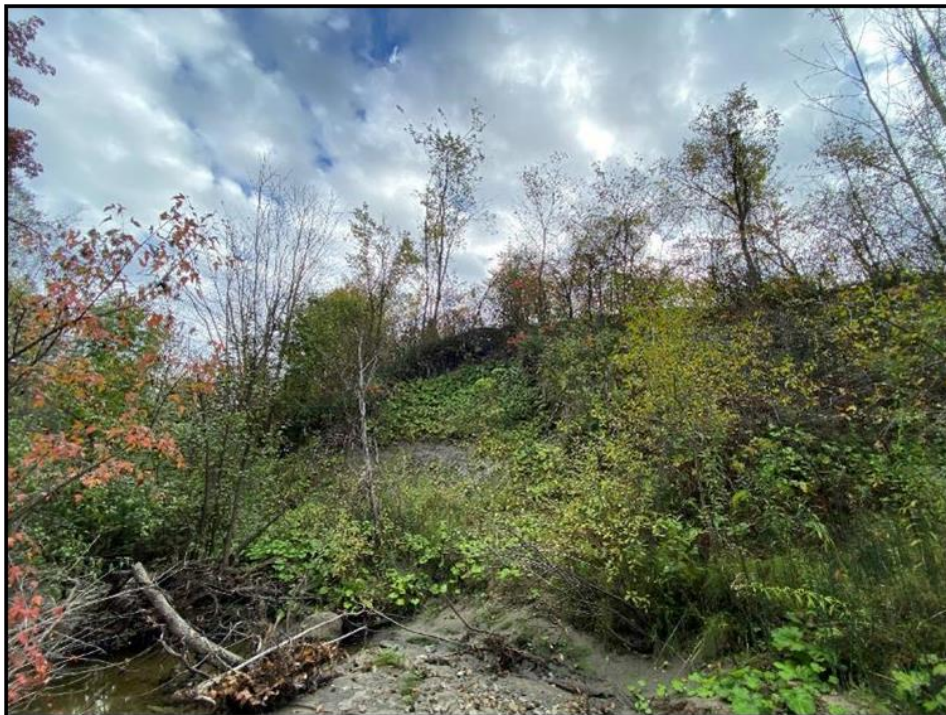
**Photo 24:** Photograph taken in southeast direction on October 8, 2024, illustrating the active erosion at the toe of the slope and the development of vegetation along the previously identified slip failure.

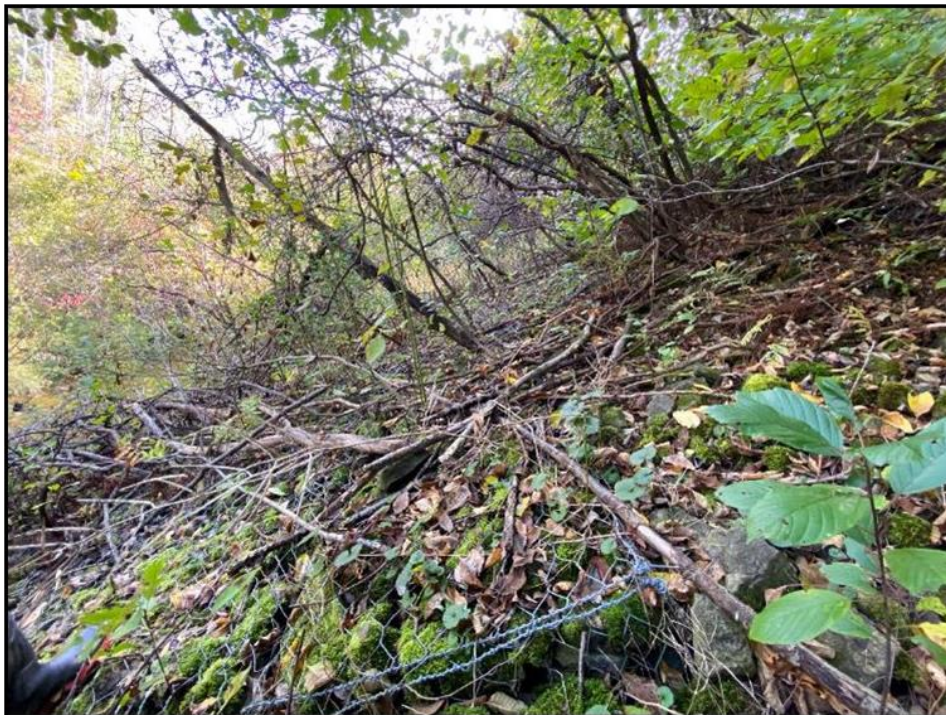
**Photo 26:** Photograph taken in an east direction on October 8, 2024, validating that the gabion baskets that are continuing to perform as designed.

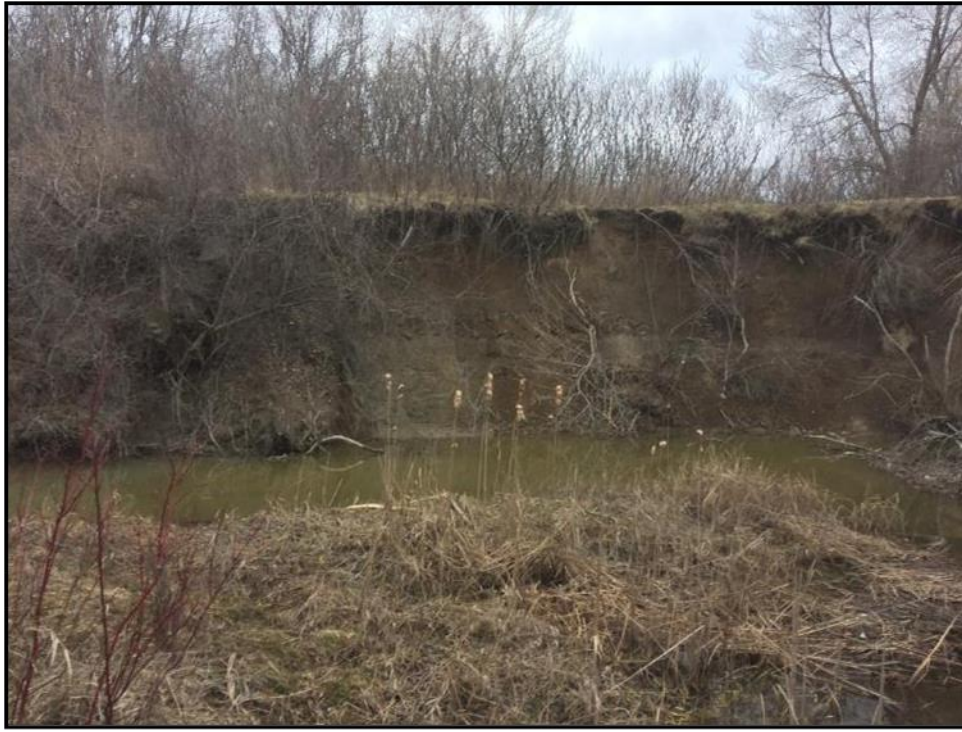
**Photo 27:** Photograph taken on April 17, 2027, in a northeast direction illustrating the active erosion and subsequent slip failures along the north bank of the tributary to the Rideau River.

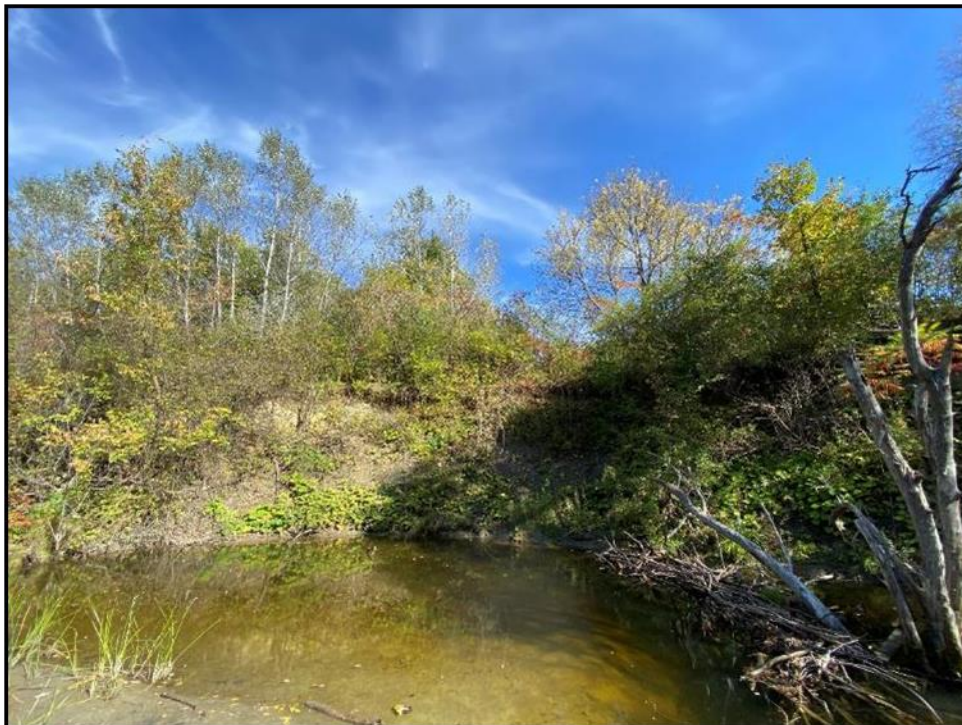
**Photo 28:** Photograph taken on October 8, 2024, in a northeast direction further documenting the active erosion and historic slope failure that occurred along the north bank of the tributary to the Rideau River.
