TREE CONSERVATION REPORT
ADDENDUM
71 Russell Ave

Tree Conservation Report Addendum submitted as
Partial Requirements for a Site Plan Control
Application, April 10, 2026

Address: 71 Russell Ave

Date of Report: April 10th 2026

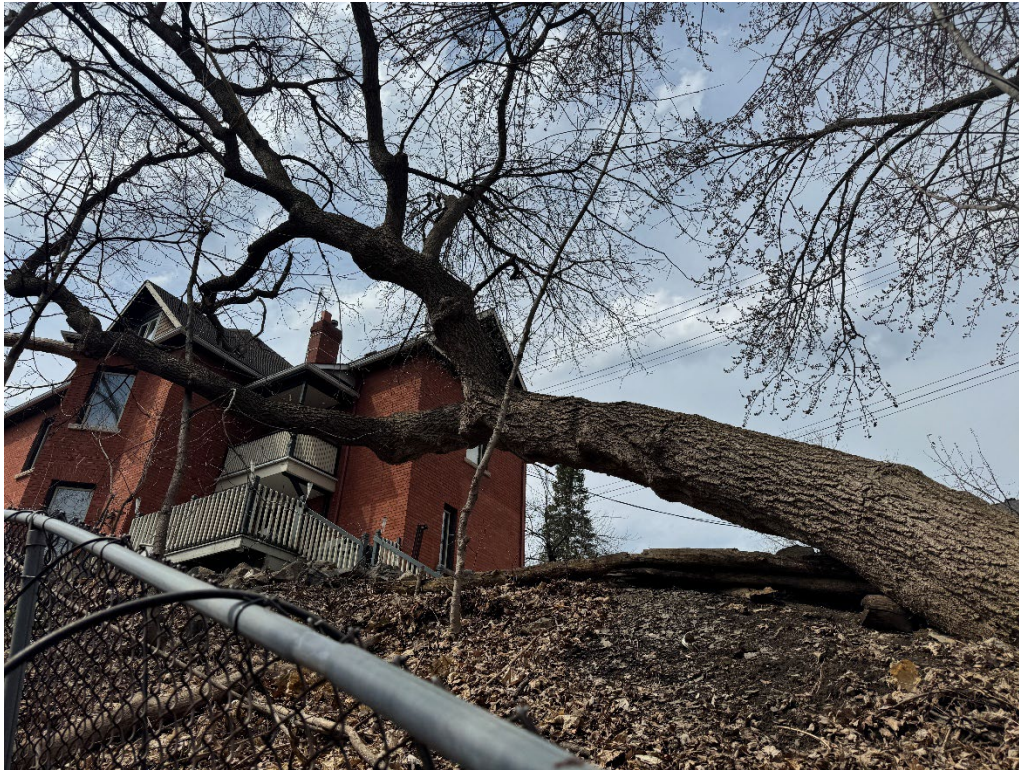
Tree 11: This tree is located on the adjacent property and exhibits a severe structural defect, growing at a nearly horizontal lean. Given its poor condition, the tree may be susceptible to failure triggered by construction-related vibrations. While its removal is not mandatory for the project, it is recommended that the applicant consult with the neighbor to explore this option. At a minimum, any large branches encroaching over the subject property that pose a risk of failure should be pruned.

Photo 2: Tree 11, Manitoba maple with very heavy lean on adjacent property

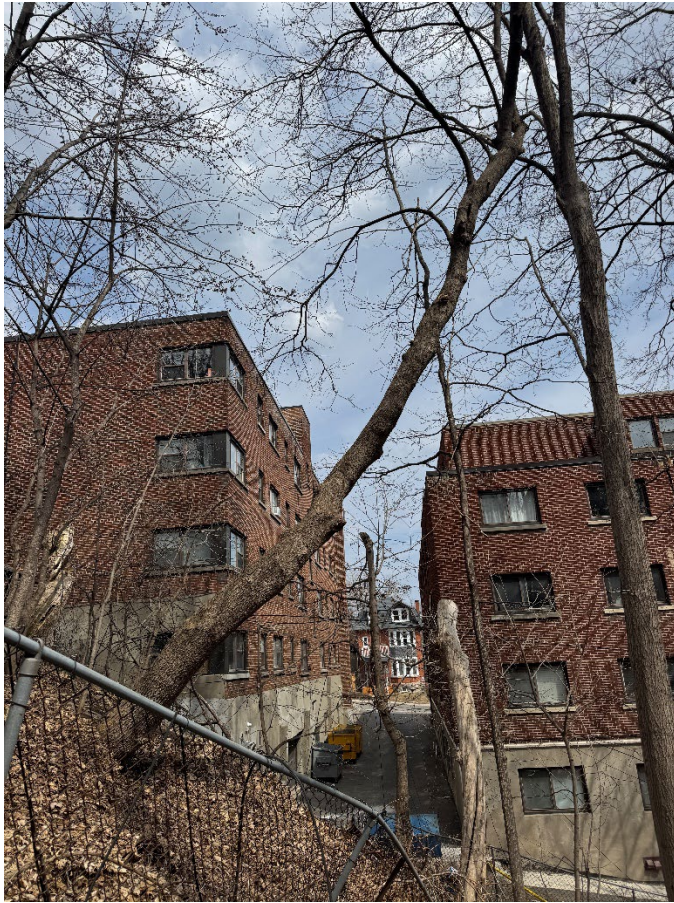
Tree 27: This tree is situated on an adjacent property on a steep slope experiencing active soil creep. Evidence of this movement is visible in the accumulation of soil and organic debris against the boundary fence, which has mostly collapsed under the pressure towards the base of the slope. The tree exhibits a significant lean toward the subject property, presenting a potential safety hazard. While a full assessment was limited by property access, a visual inspection from the property line suggests potential girdling roots on the upslope side of the root flare. Furthermore, the proposed building footprint presents a direct conflict with the tree's crown. Due to these combined factors, removal is recommended; however, this is contingent upon obtaining written permission from the neighboring property owner.

Photo 3: Tree 27, Manitoba maple on adjacent property that should be removed due to the potential for failure on subject property
