TREE CONSERVATION REPORT
ADDENDUM 2.1
71 Russell Ave

Tree Conservation Report Addendum submitted as
Partial Requirements for a Site Plan Control
Application, May 29, 2026

Tree Conservation Report Addendum

Address: 71 Russell Ave
Date of Report: May 29, 2026
Date of Site Visit: April 9, 2026
Prepared by: Astrid Nielsen, RPF, ISA Certified Arborist®
101- 45 Spencer Ave, K1Y 2P5
Astrid.nielsen@dendronforestry.ca
Client: Colin Miller, Colin@pinehillbuilders.ca

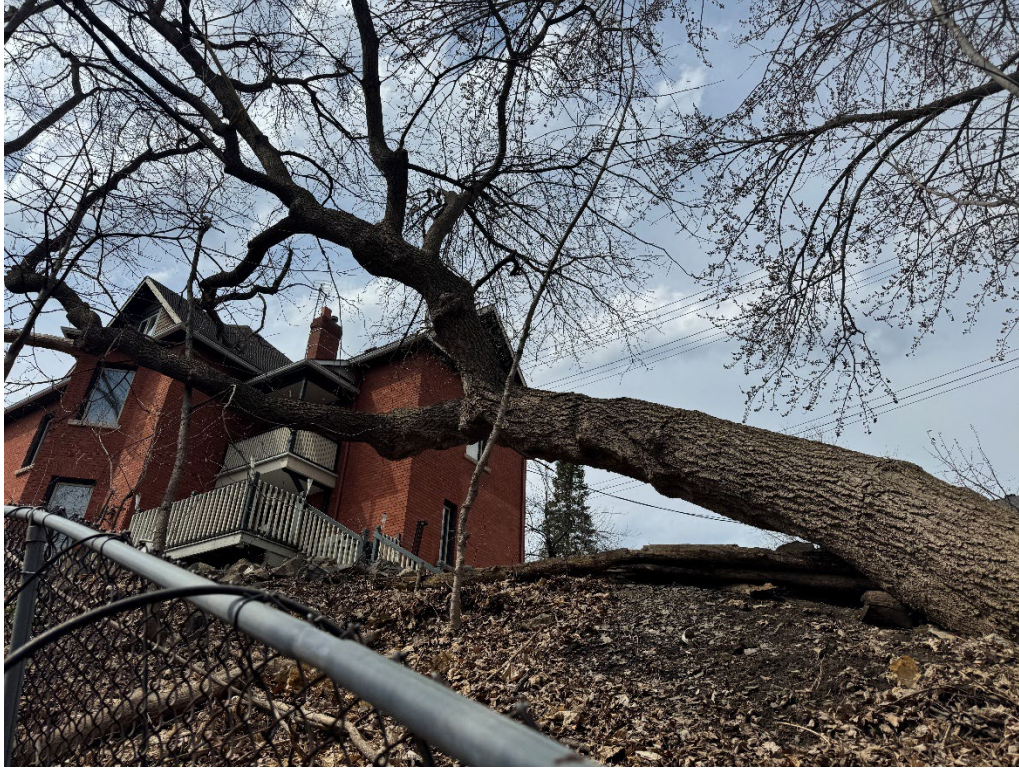
Tree 11: This tree is located on the adjacent property and exhibits a severe structural defect, growing at a nearly horizontal lean. Given its poor condition, the tree may be susceptible to failure triggered by construction-related vibrations. While its removal is not mandatory for the project, it is recommended that the applicant consult with the neighbor to explore this option. At a minimum, any large branches encroaching over the subject property that pose a risk of failure should be pruned.

Photo 2: Tree 11, Manitoba maple with very heavy lean on adjacent property
