June 19, 2026  
PG6557-LET.01 Revision 4

Subject: **Preliminary Geotechnical Investigation  
Proposed Commercial Development  
2175 Prince of Wales Drive – Ottawa, Ontario**

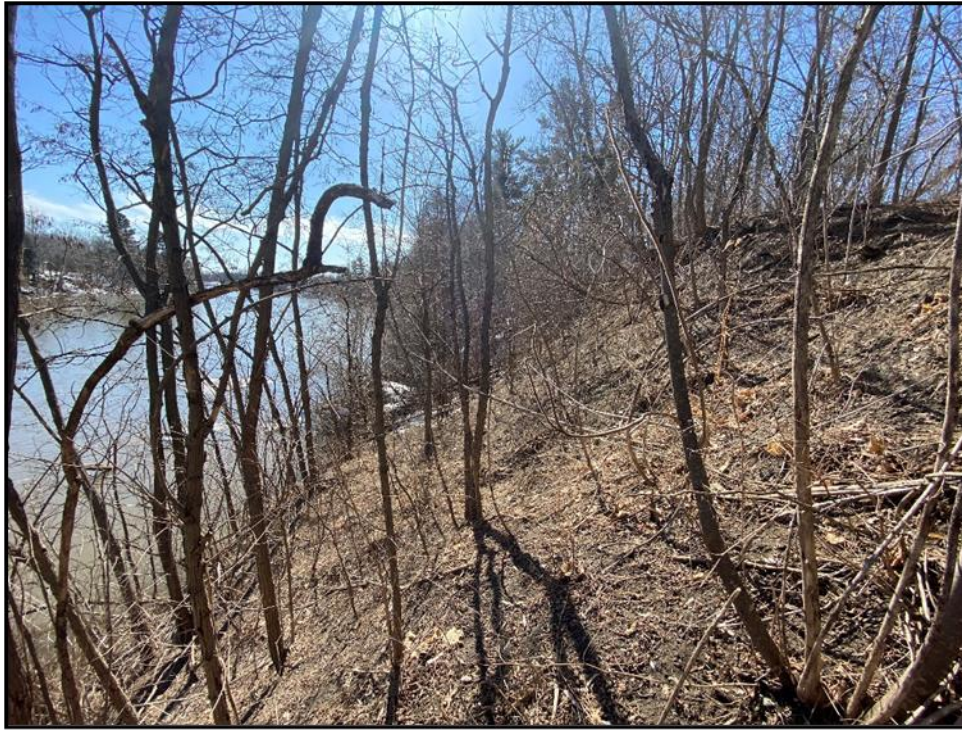
**Photo 1:** Photograph taken in a southeast direction illustrating some evidence of active erosion.

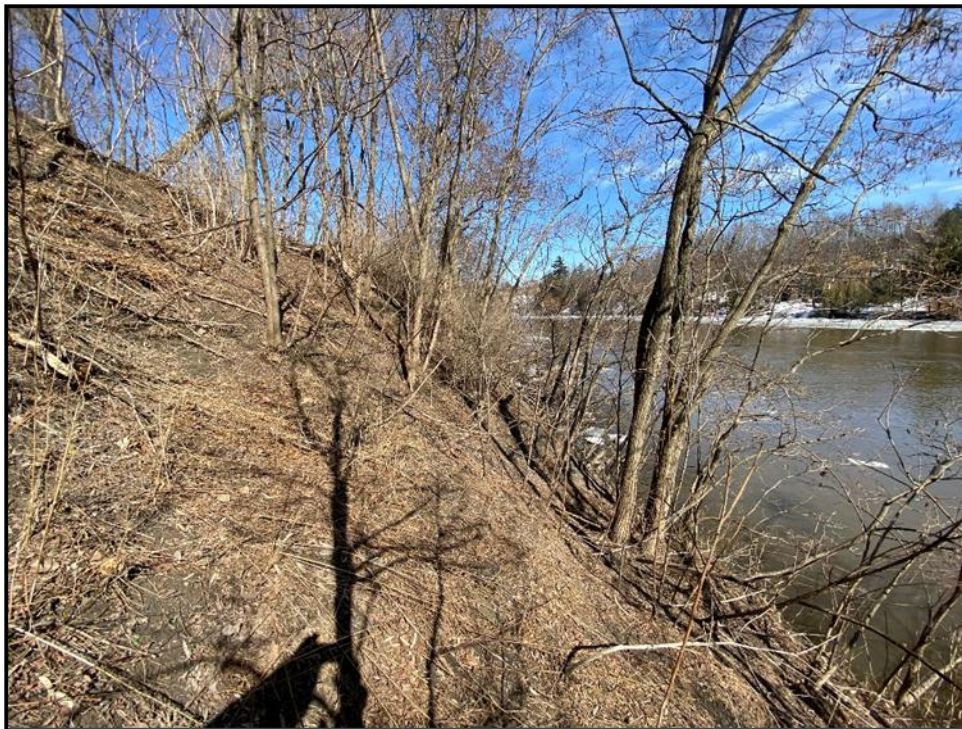
**Photo 2:** Photograph taken in a northeast direction illustrating some evidence of active erosion along the west bank of the Rideau River.

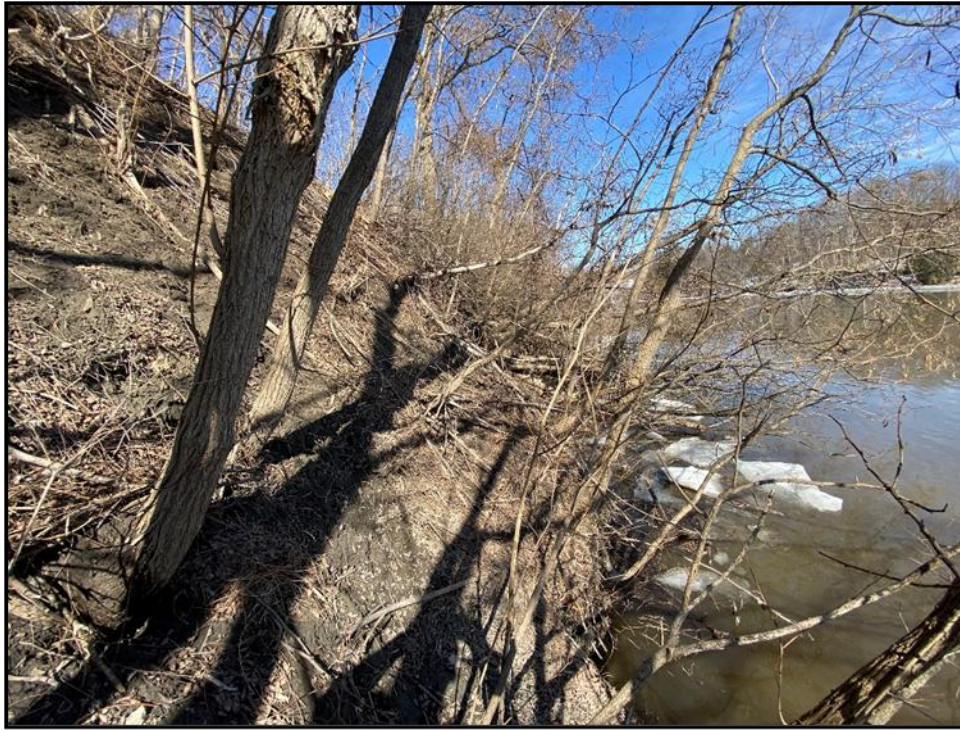
**Photo 3:** Photograph taken in a northeast direction illustrating some evidence of toe erosion along the west bank of the Rideau River.

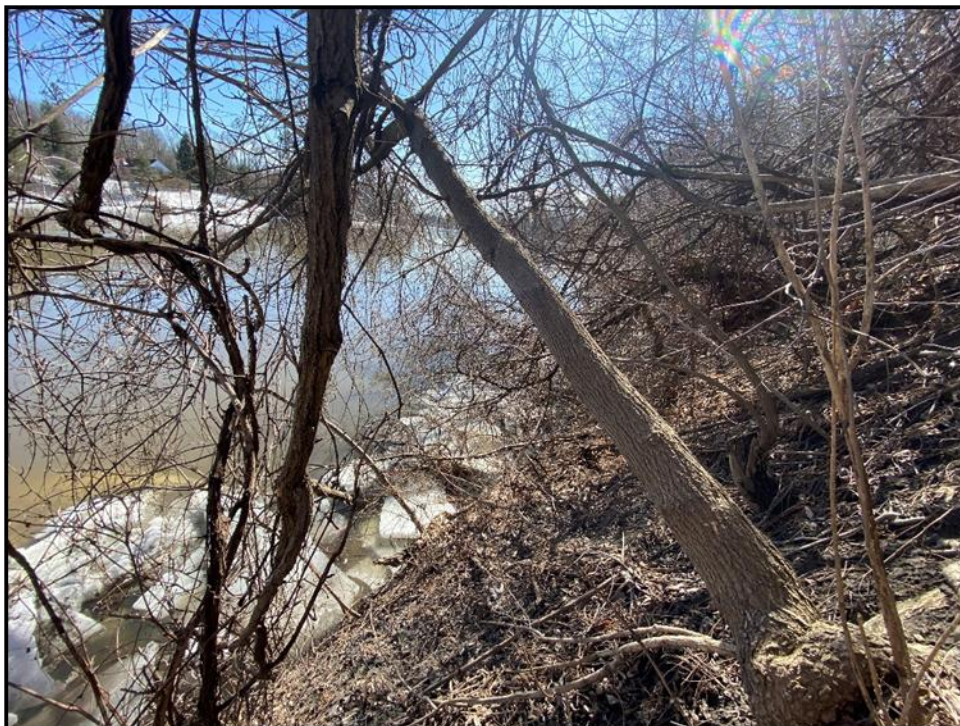
**Photo 4:** Photograph taken in a southwest direction illustrating some evidence of active erosion along the west bank of the Rideau River.

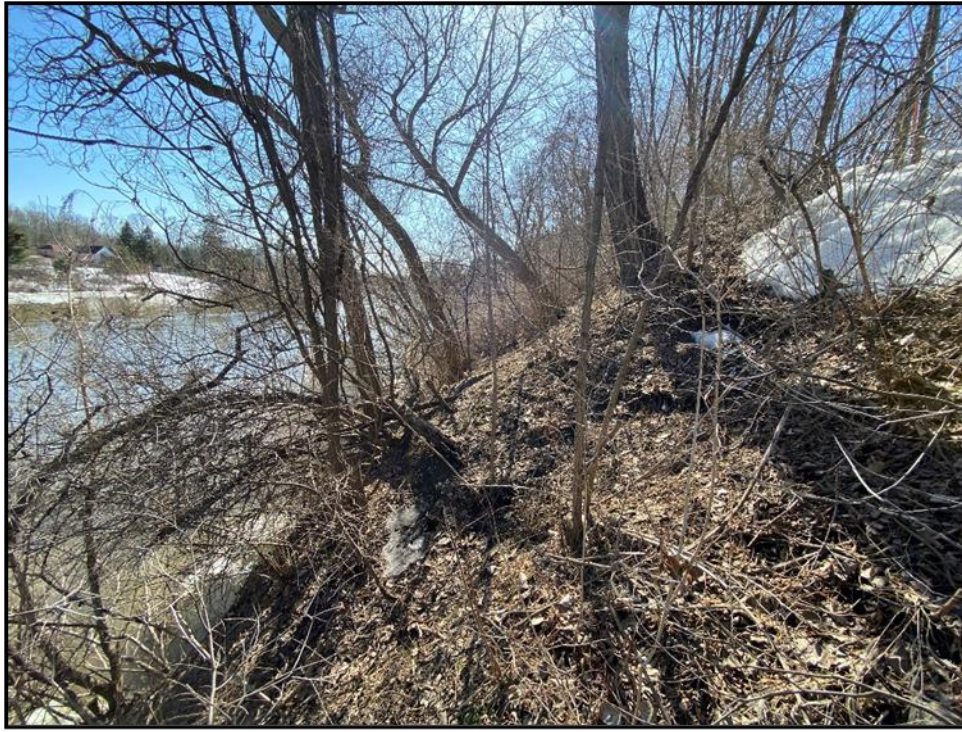
**Photo 5:** Photograph taken in a southwest direction illustrating some evidence of active erosion along the west bank of the Rideau River.

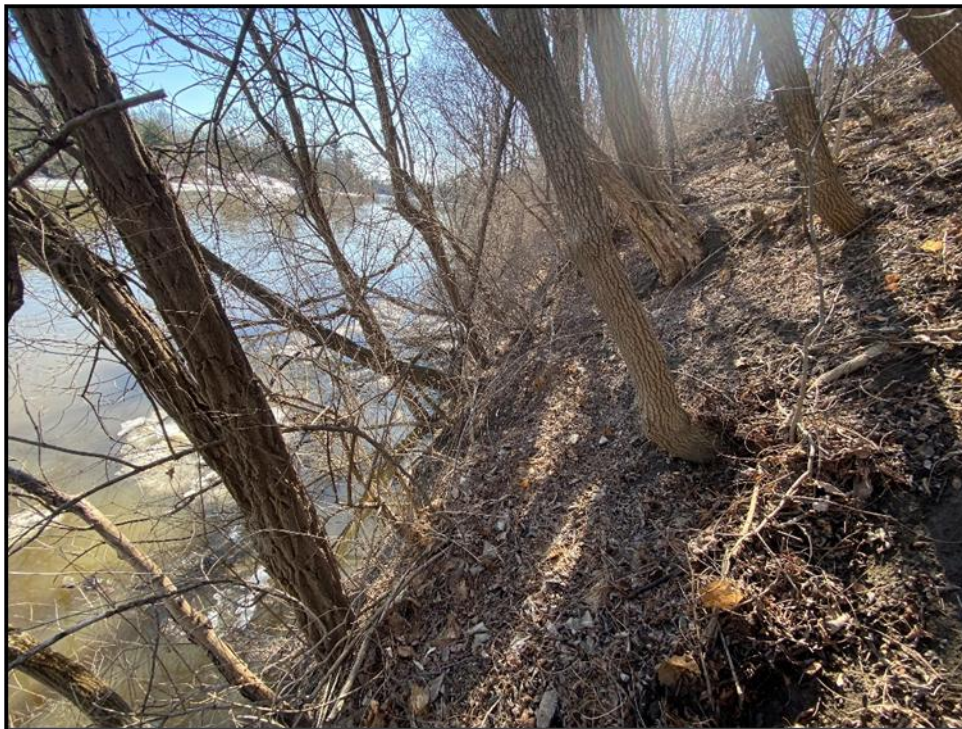
**Photo 6:** Photograph taken in a southwest direction illustrating some evidence of toe erosion along the west bank of the Rideau River.

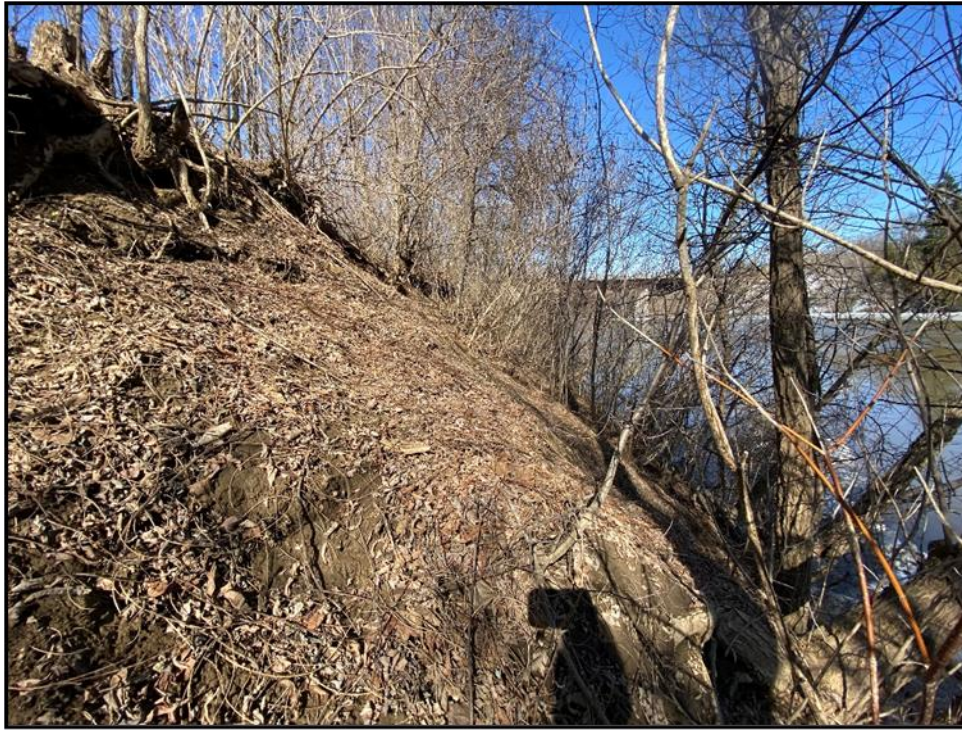
**Photo 7:** Photograph taken in a northeast direction illustrating some evidence of active erosion along the west bank of the Rideau River.

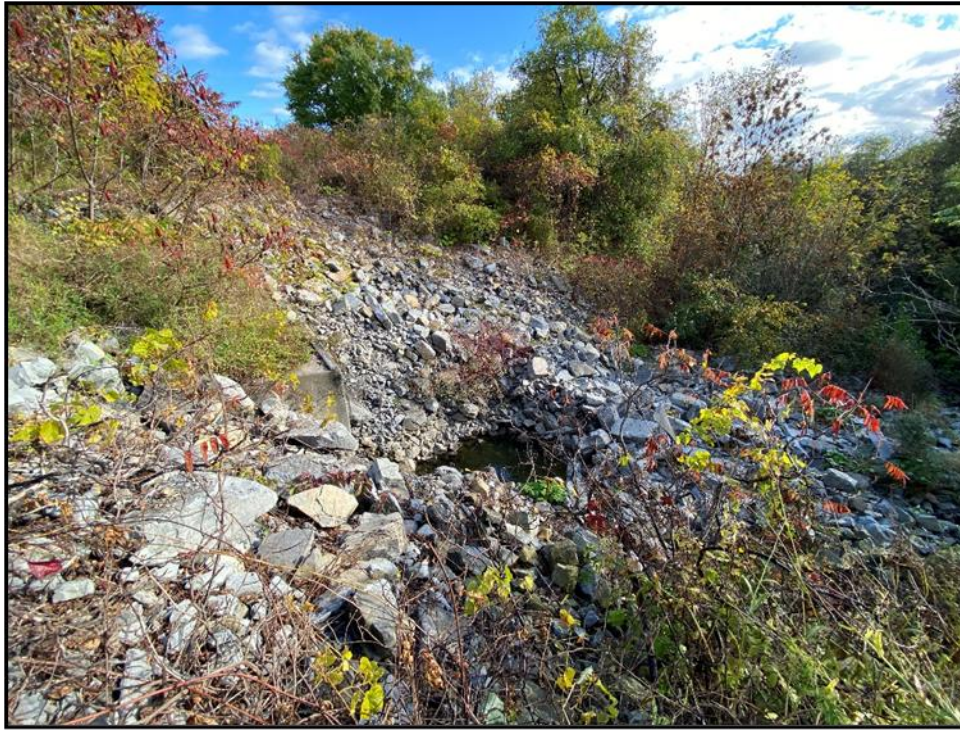
Surface water discharging from the stormwater sewer to the tributary contributes significantly to the existing and on-going active erosion. The area immediately beyond the headwall structure had been enhanced with erosion protection consisting of constructing rock protection in either 2018 or 2019 (and as recommended to be undertaken by Paterson under separate cover in 2017). However, the remainder of the area between the headwall and Rideau River remains similar to the historical condition and continues to be subject to erosion along the length of the tributary. Paterson completed several rounds of field reviews amongst the subject slopes, including April 2026, May 2025, October 2024, April 2017 and June 2009. Findings from these reviews do not indicate major alterations to the slopes with the exception of the erosion protection enhancement efforts in 2017/2018 at the headwall structure.

**Photo 8:** Photograph taken in a northeast direction illustrating the placement of riprap stone around the culvert outlet that discharges into the tributary to the Rideau River.

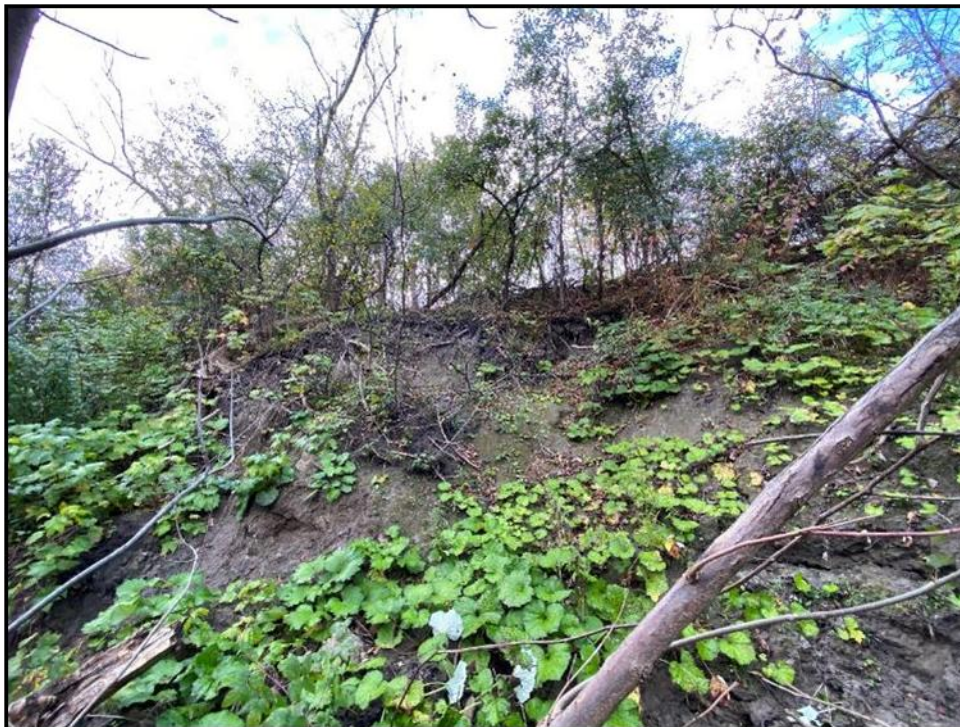
**Photo 9:** Photograph taken in a south direction along the tributary to the Rideau River illustrating some evidence of historical slip failures along the south banks of the valley corridor.

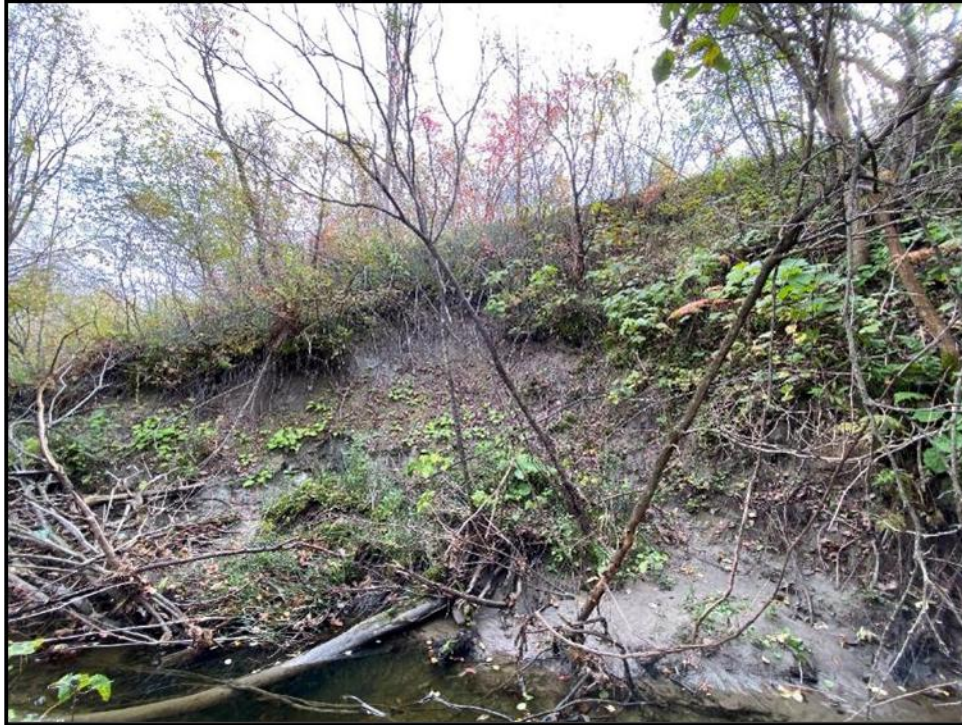
**Photo 10:** Photograph taken in a south direction along the tributary to the Rideau River illustrating some toe erosion along the base of the valley corridor where the watercourse meets the wall of the valley corridor.

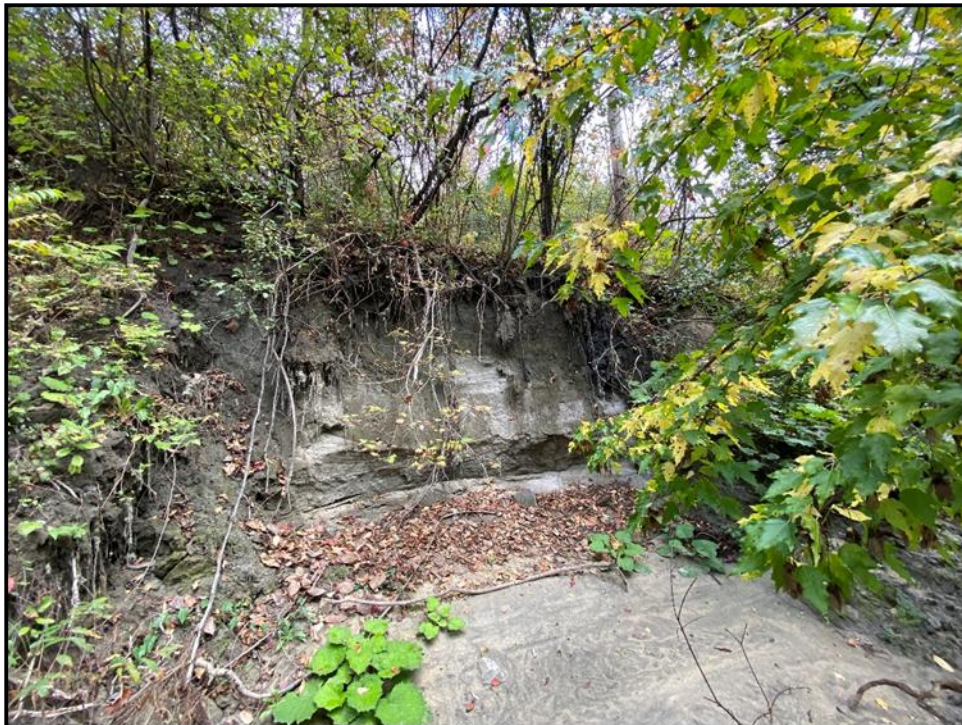
**Photo 11:** Photograph taken in a north direction along the tributary to the Rideau River illustrating evidence of active erosion along the north bank of the valley corridor.

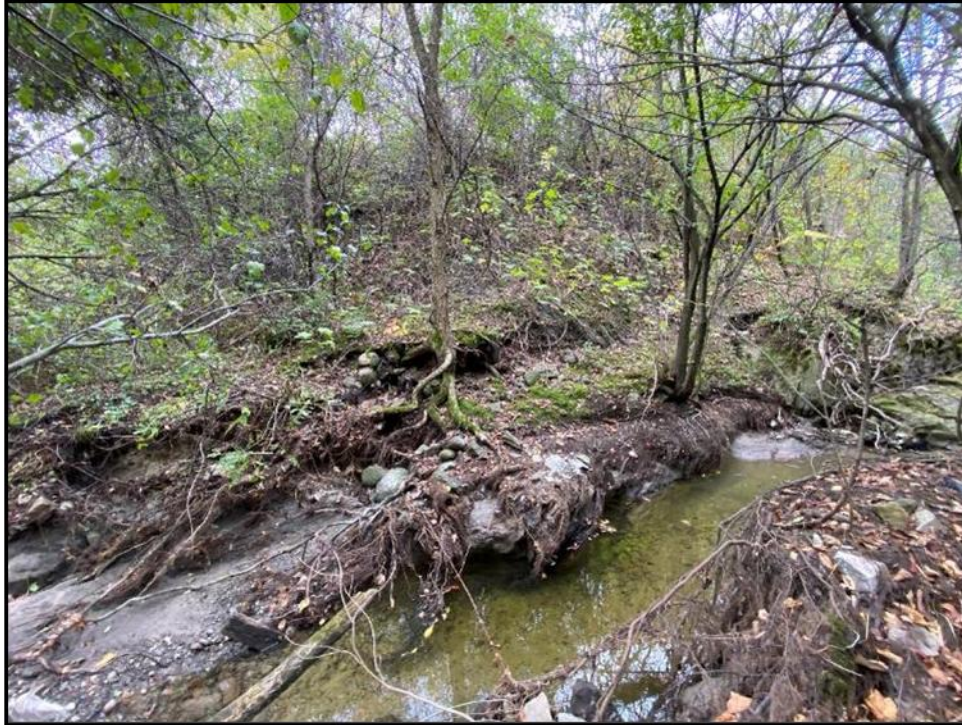
**Photo 12:** Photograph taken in a south direction along the tributary to the Rideau River illustrating evidence of historical slip failures along the south bank of the valley corridor and evidence of active erosion where the watercourse meets the wall of the valley corridor.

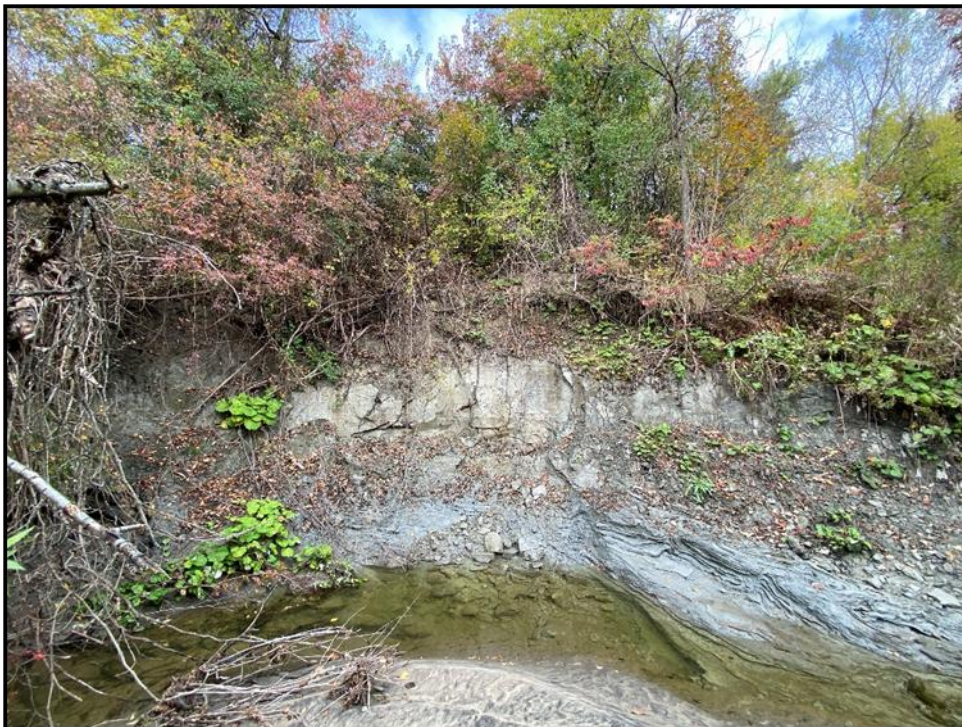
**Photo 13:** Photograph taken in a north direction along the tributary to the Rideau River illustrating evidence of active erosion.

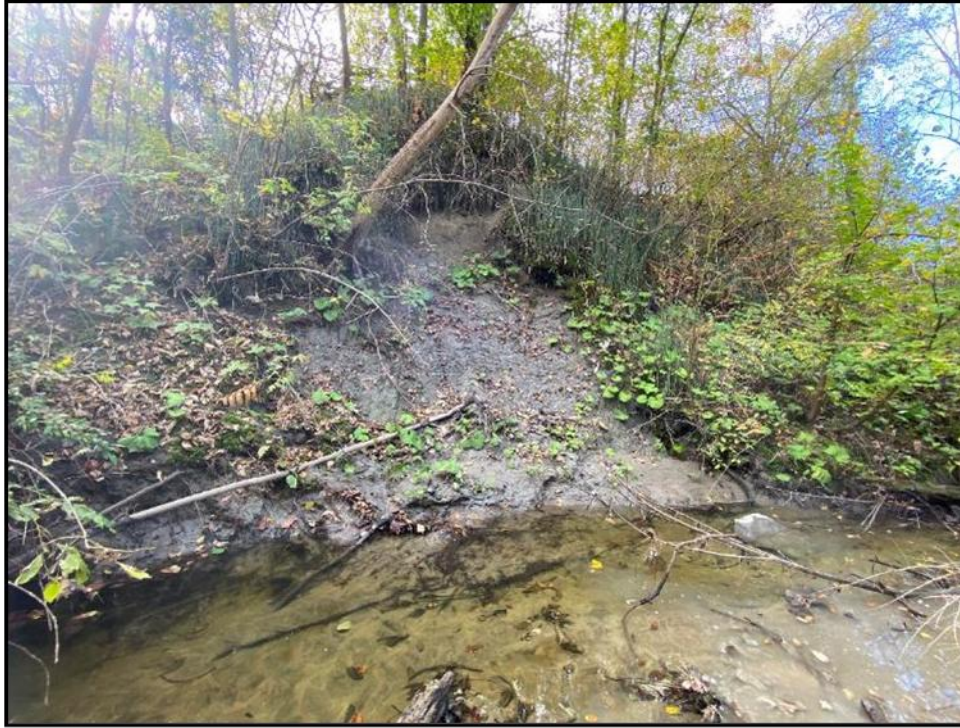
**Photo 14:** Photograph taken in a south direction along the tributary to the Rideau River illustrating evidence of historical slip failures along the south bank of the valley corridor and evidence of active erosion where the watercourse meets the wall of the valley corridor.

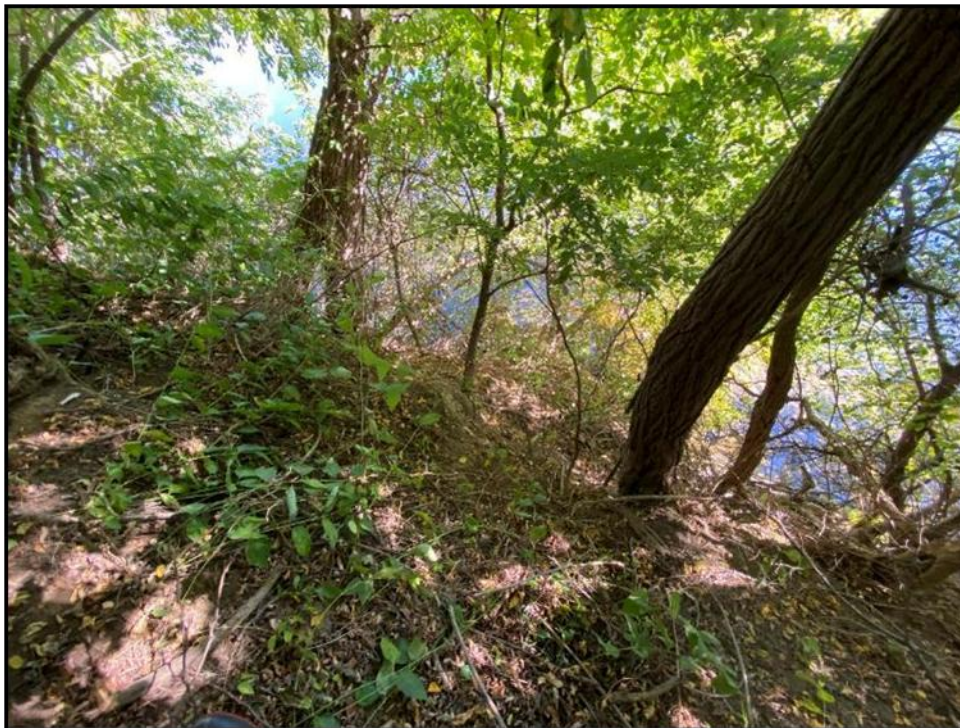
**Photo 15:** Photograph taken in an east direction over the west bank of the Rideau River showing some active erosion.

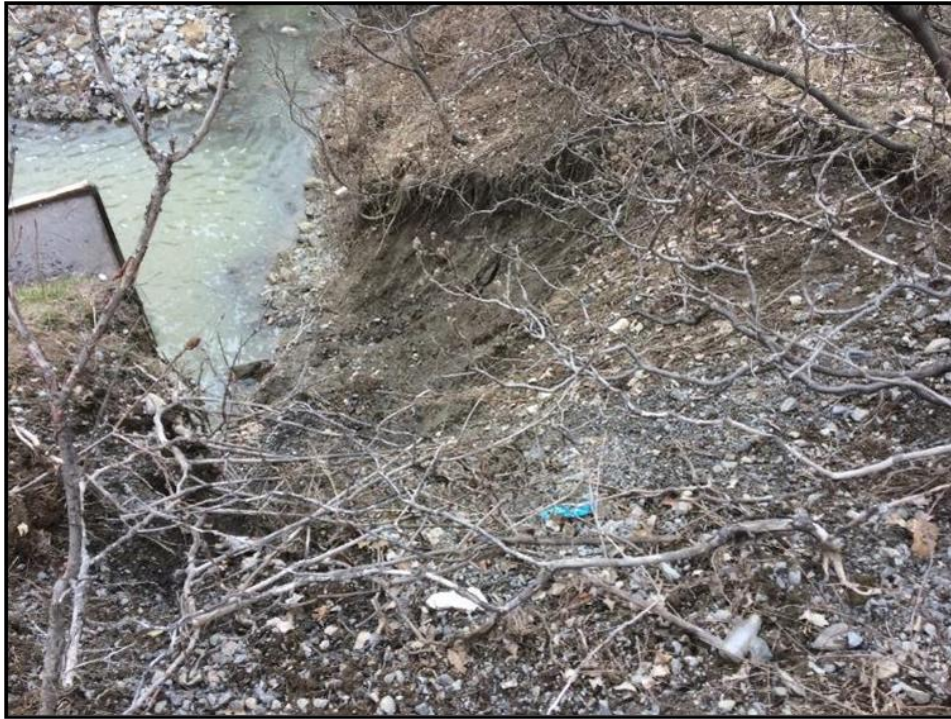
**Photo 16:** Photograph taken in an east direction illustrating the active erosion and subsequent slip failures adjacent to the concrete box culvert.

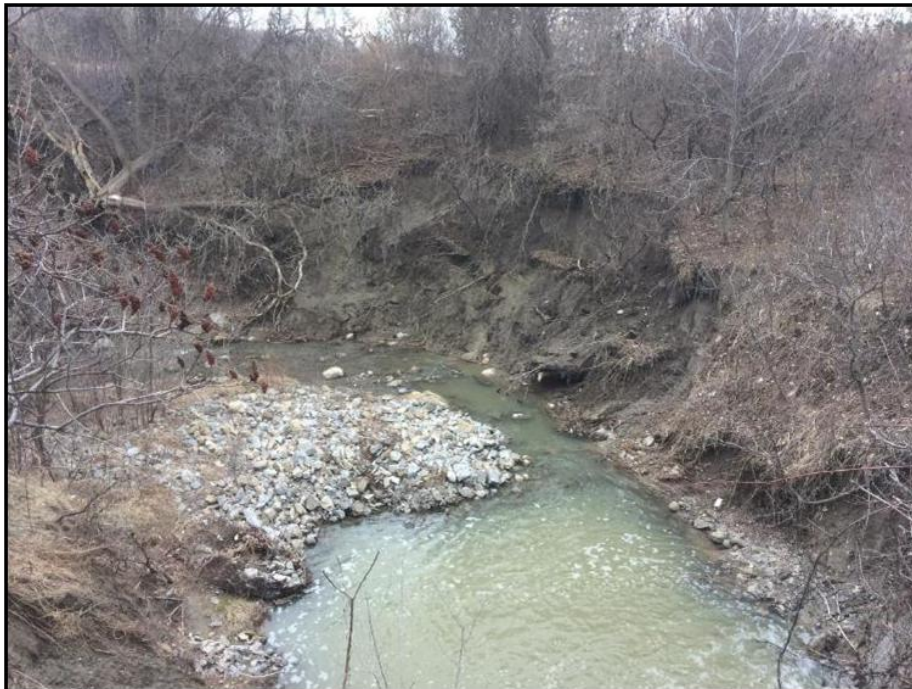
**Photo 17:** Photograph taken in an east direction from the top of the concrete box culvert illustrating the active erosion and subsequent slip failures along the south bank of the tributary to the Rideau River.

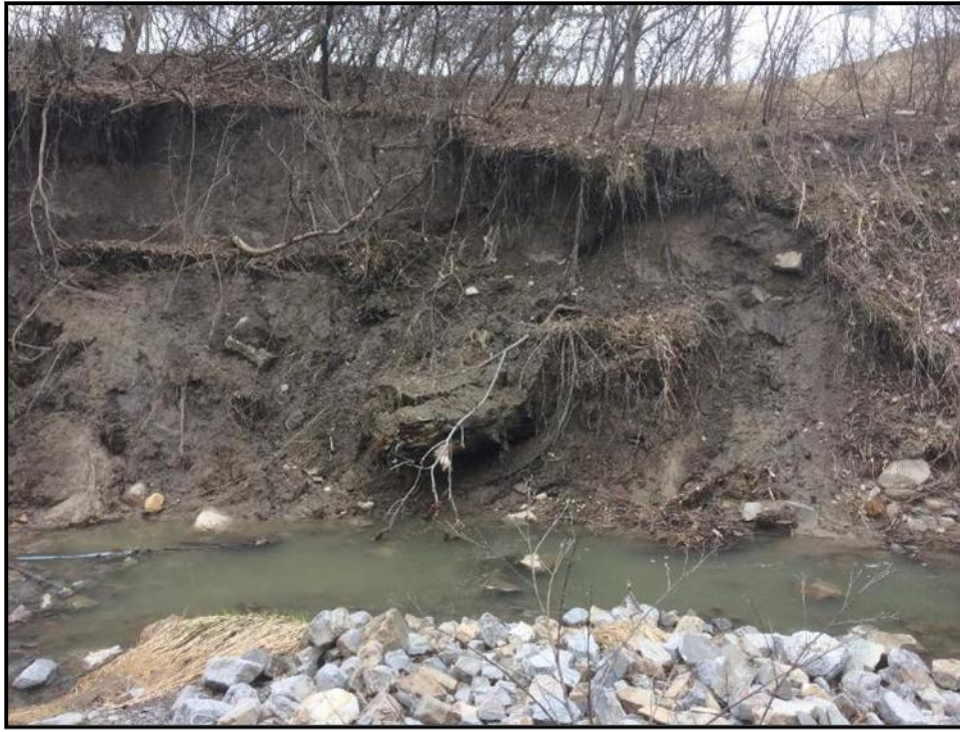
**Photo 18:** Photograph taken in a west direction to further capture the active erosion and subsequently slip failure presented in the previous photograph.

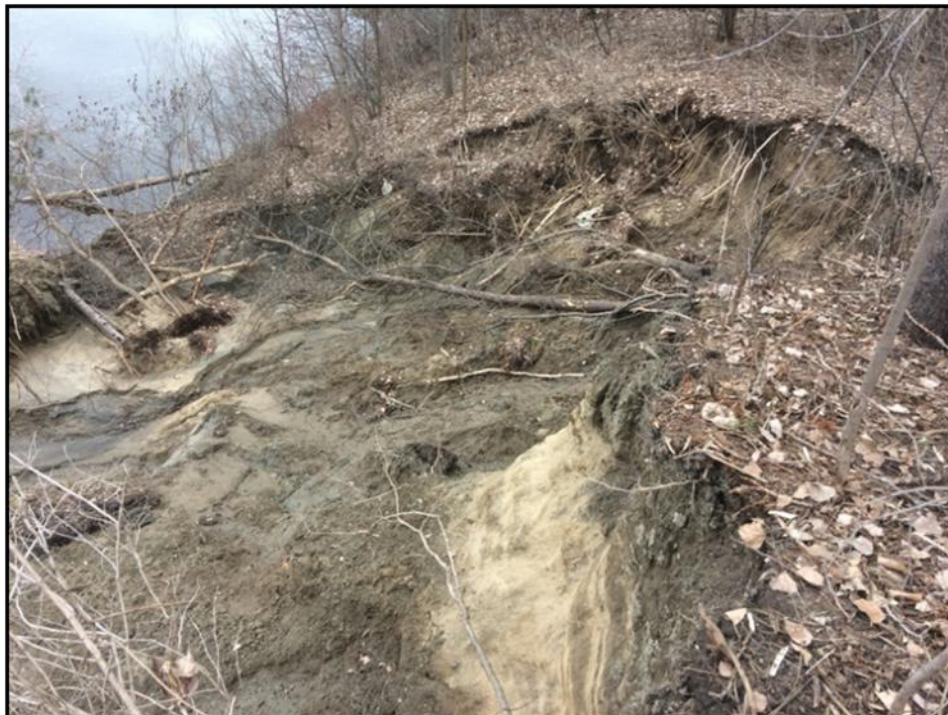
**Photo 19:** Photograph taken in a south direction illustrating a relatively recent slope failure along the west bank of the Rideau River.

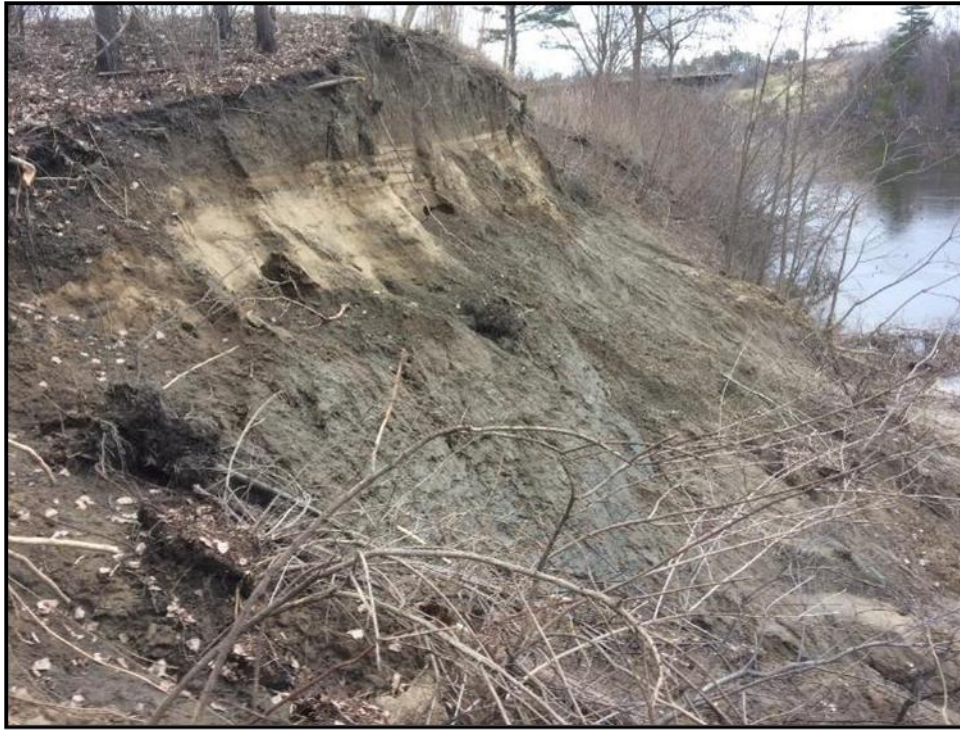
**Photo 20:** Similar to the previous photograph but taken in a north direction further illustrating the relatively recent slip failure along the west bank of the Rideau River.

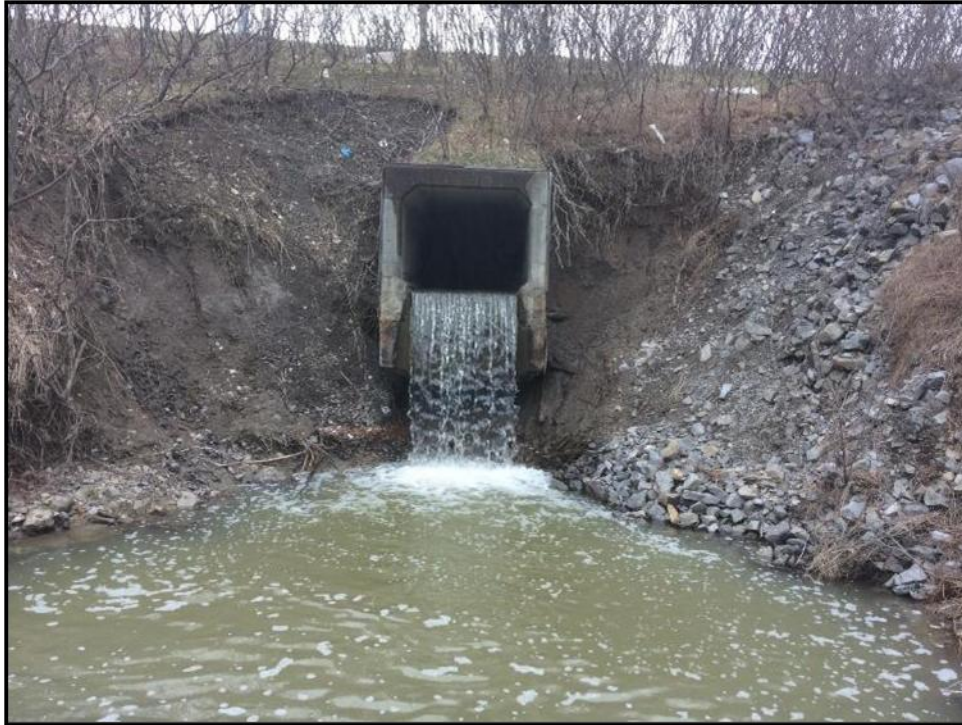
**Photo 21:** Photograph taken in a west direction on April 17, 2017, illustrating the active erosion and subsequent slip failures adjacent to the concrete box culvert.

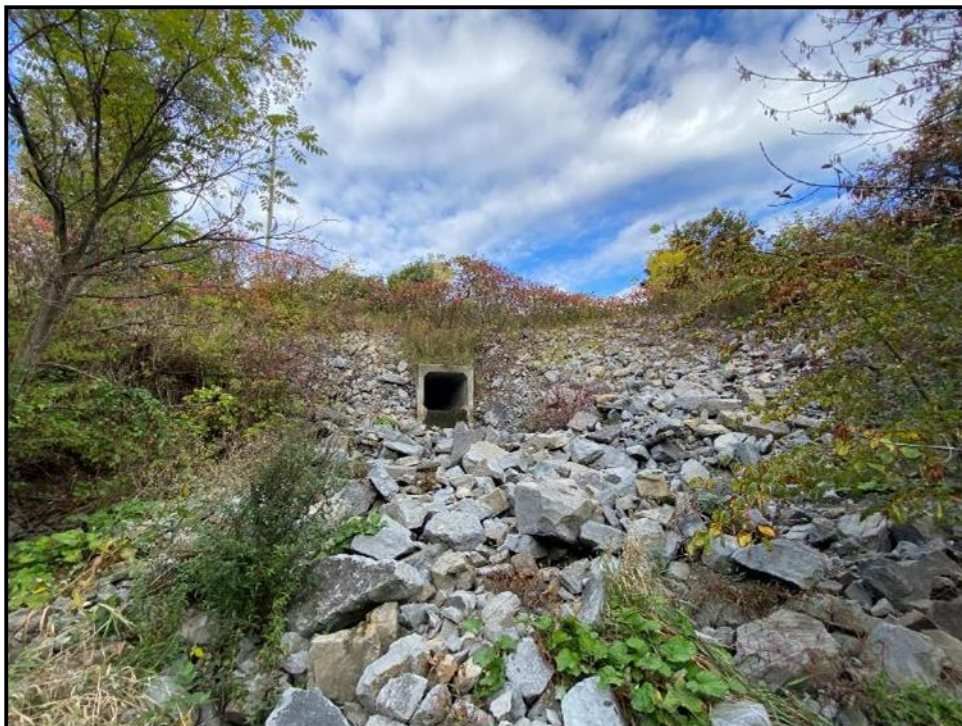
**Photo 22:** Photograph taken in a west direction on October 8, 2024, illustrating the placement of blast rock fill to mitigate the active erosion near the outlet of the concrete box culvert.

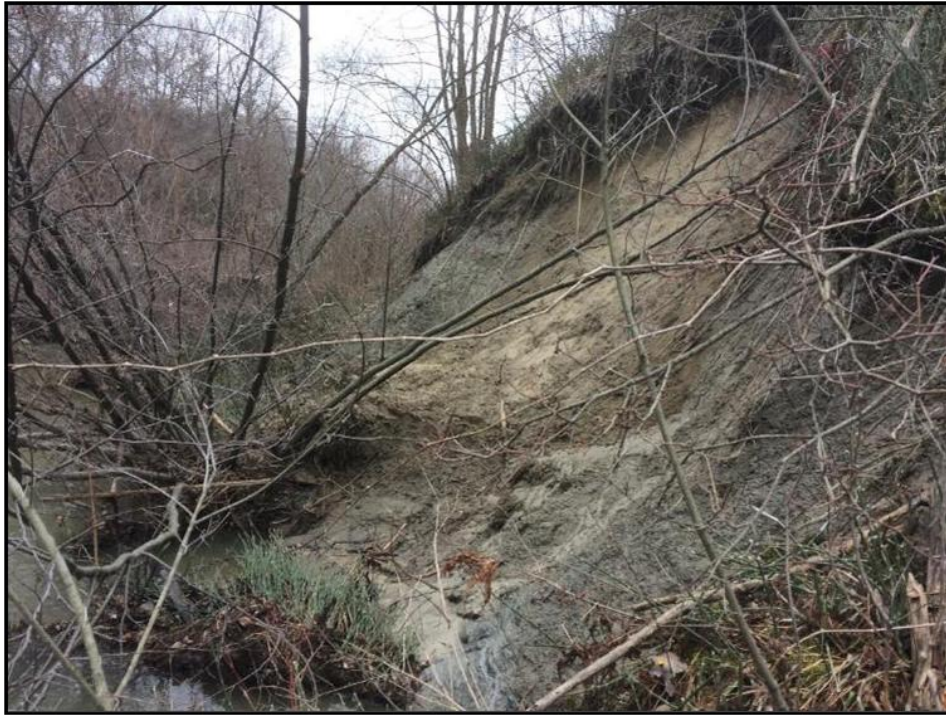
**Photo 23:** Photograph taken in an east direction on April 17, 2017, illustrating the active erosion and subsequent slip failure along the south bank of the Tributary to the Rideau River.

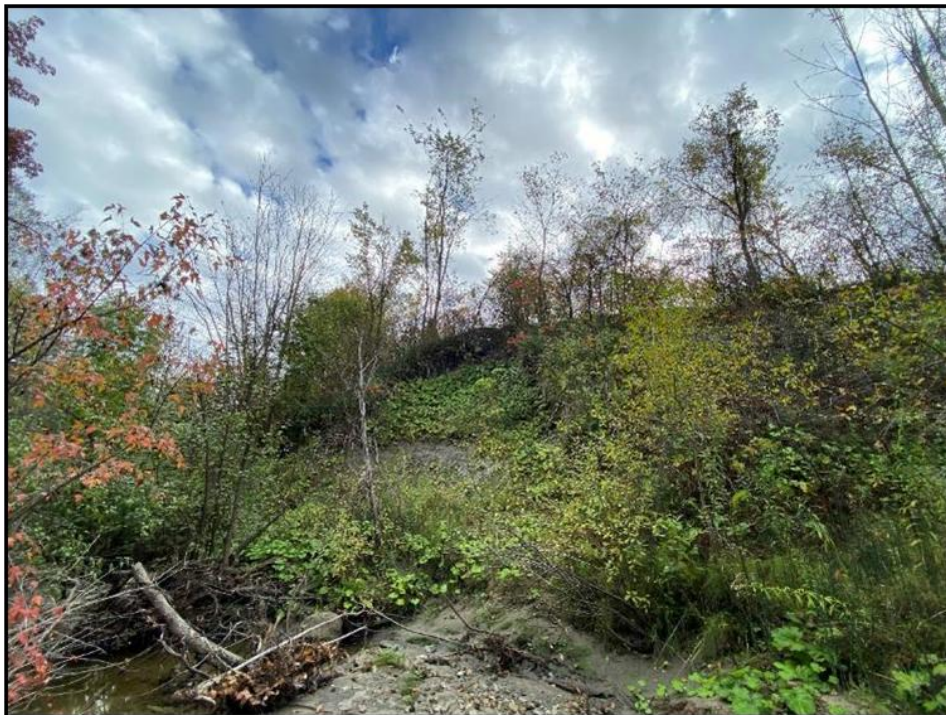
**Photo 24:** Photograph taken in southeast direction on October 8, 2024, illustrating the active erosion at the toe of the slope and the development of vegetation along the previously identified slip failure.

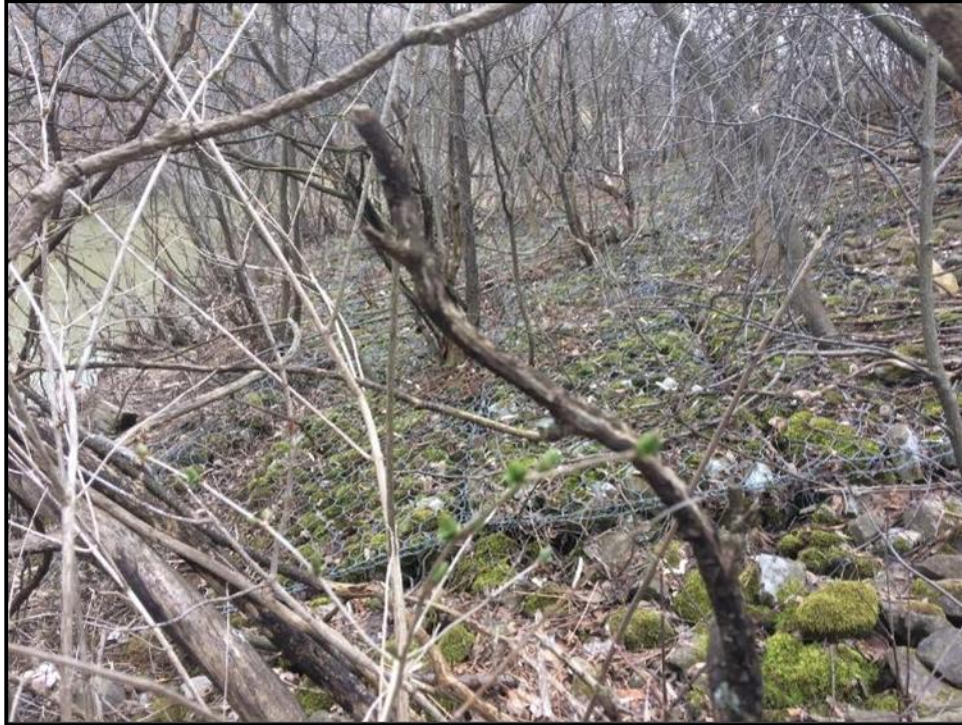
**Photo 25:** Photograph taken in an east direction on April 17, 2017, illustrating some gabion baskets used to mitigate the active erosion along the south bank of the tributary to the Rideau River.

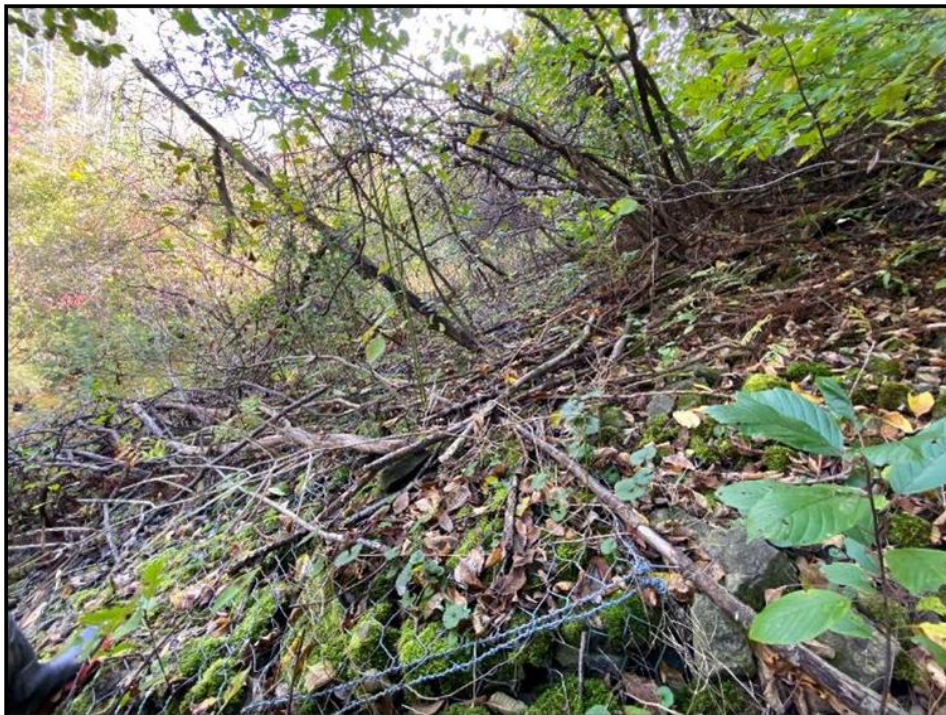
**Photo 26:** Photograph taken in an east direction on October 8, 2024, validating that the gabion baskets that are continuing to perform as designed.

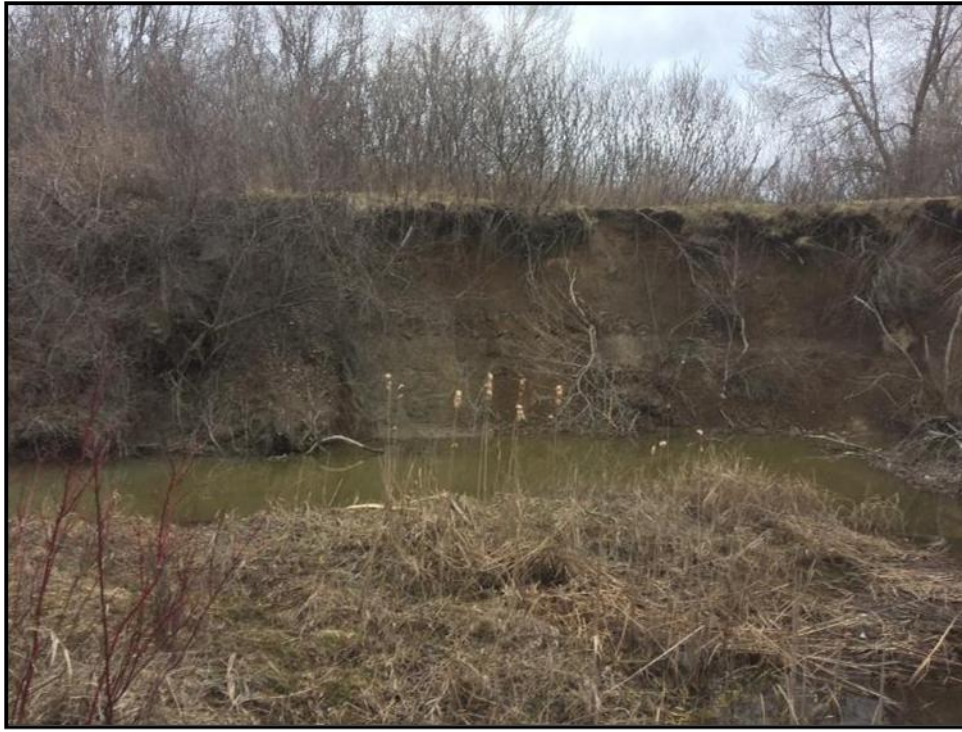
**Photo 27:** Photograph taken on April 17, 2017, in a northeast direction illustrating the active erosion and subsequent slip failures along the north bank of the tributary to the Rideau River.

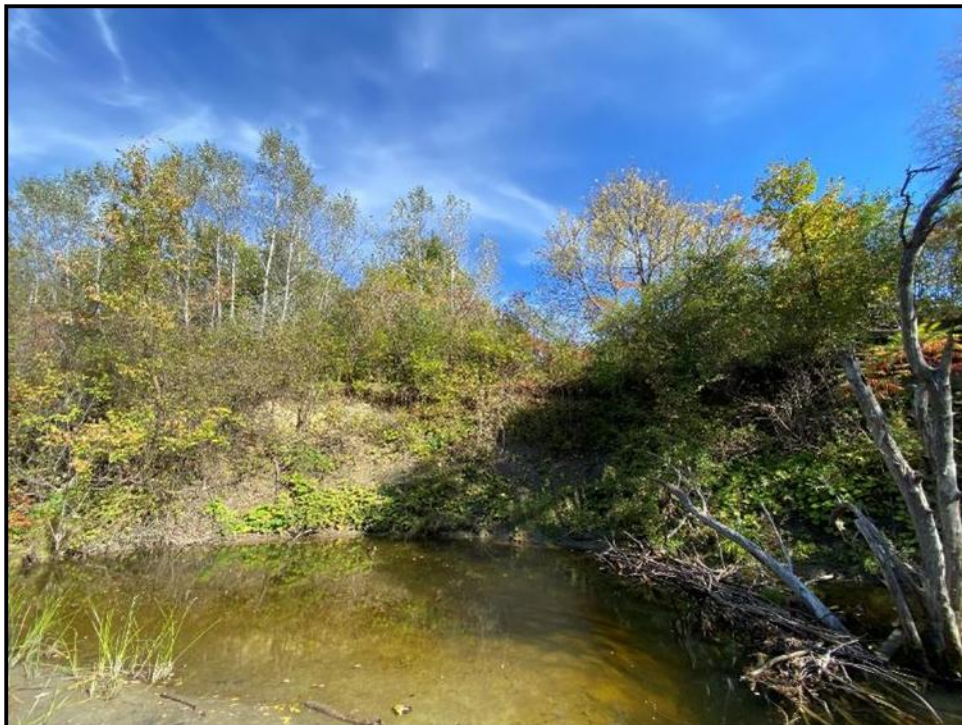
**Photo 28:** Photograph taken on October 8, 2024, in a northeast direction further documenting the active erosion and historic slope failure that occurred along the north bank of the tributary to the Rideau River.

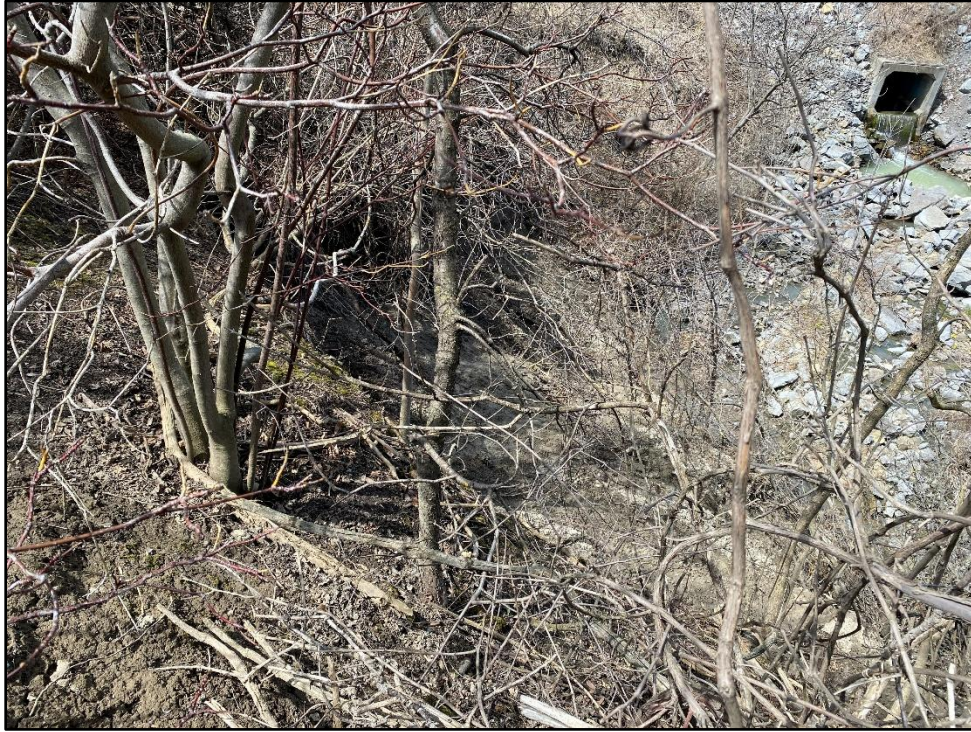
**Photo 29:** Photograph taken in a north direction illustrating the current state of the slope adjacent to the previously placed blast rock fill near the outlet of the concrete box culvert along the north bank of the tributary to the Rideau River.

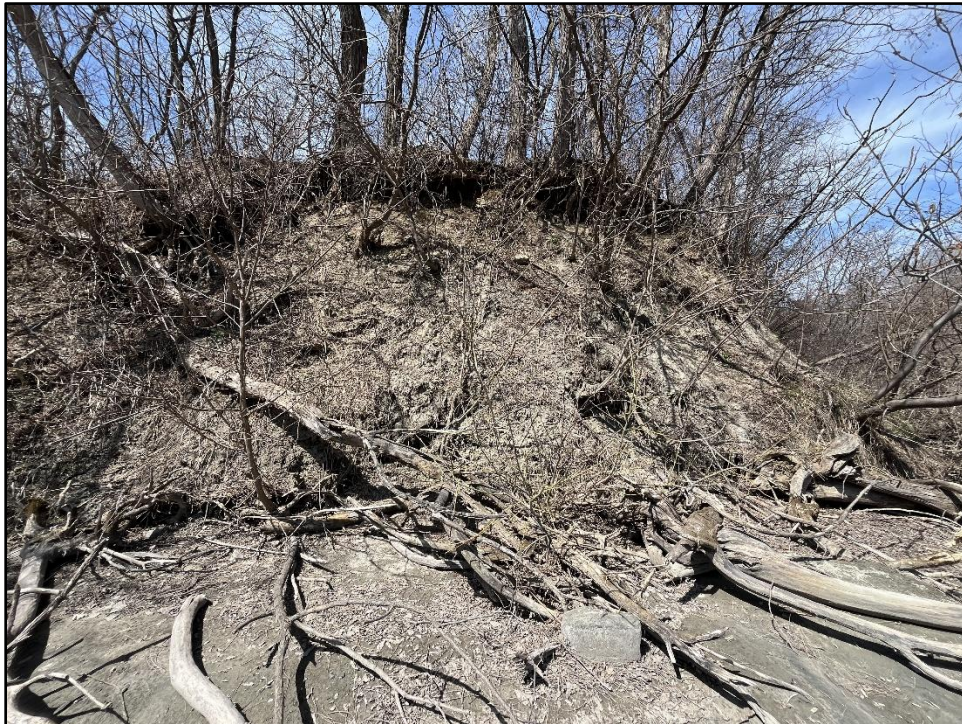
**Photo 30:** Photograph taken in a west direction from where the tributary connects to the Rideau River, illustrating the active erosion along the northeastern corner slope face.
