June 19, 2026  
PG6557-LET.01 Revision 4

Subject: **Preliminary Geotechnical Investigation  
Proposed Commercial Development  
2175 Prince of Wales Drive – Ottawa, Ontario**

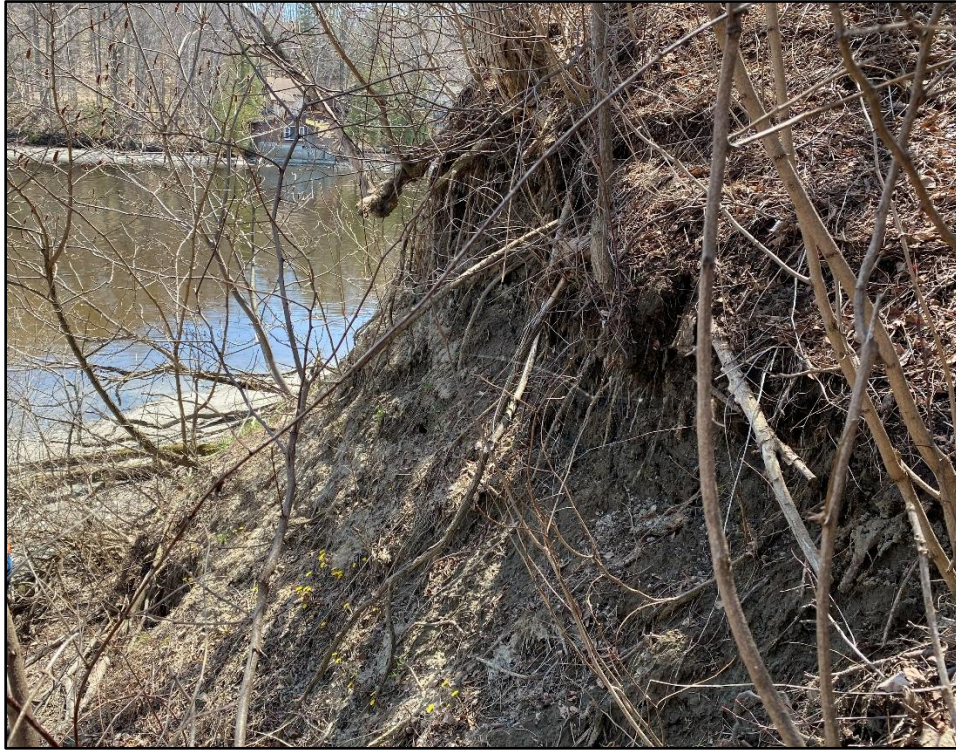
**Photo 31:** Photograph taken in an east direction illustrating the active erosion along the northeastern corner slope face (Rideau River beyond).

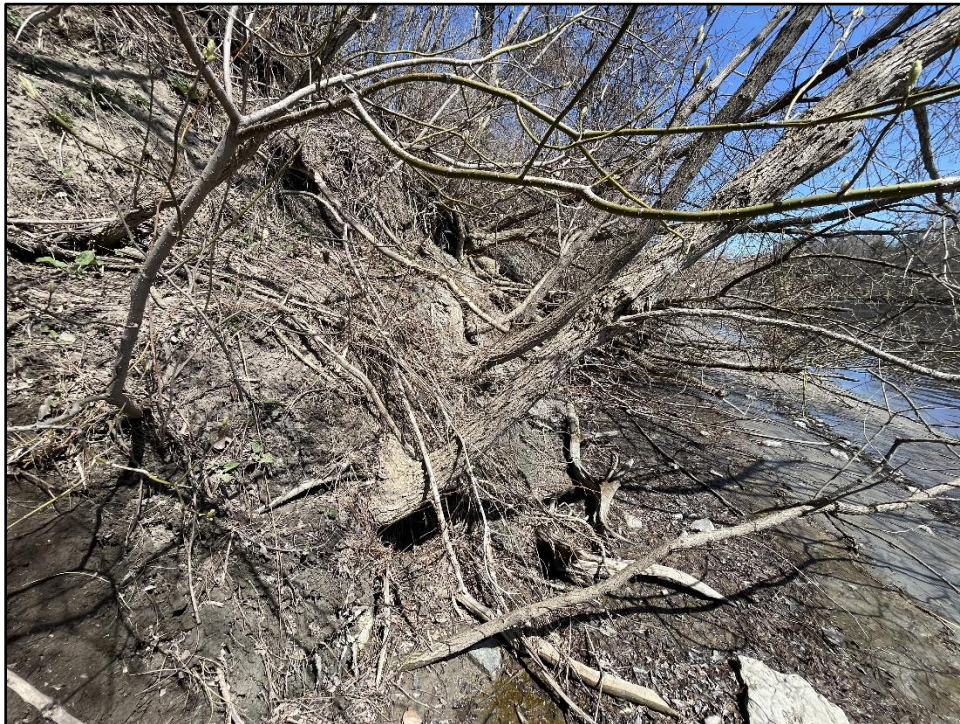
**Photo 32:** Photograph taken in a north direction at the base of the slope along the Rideau River, illustrating evidence of active erosion along the lower sections of the slope face.

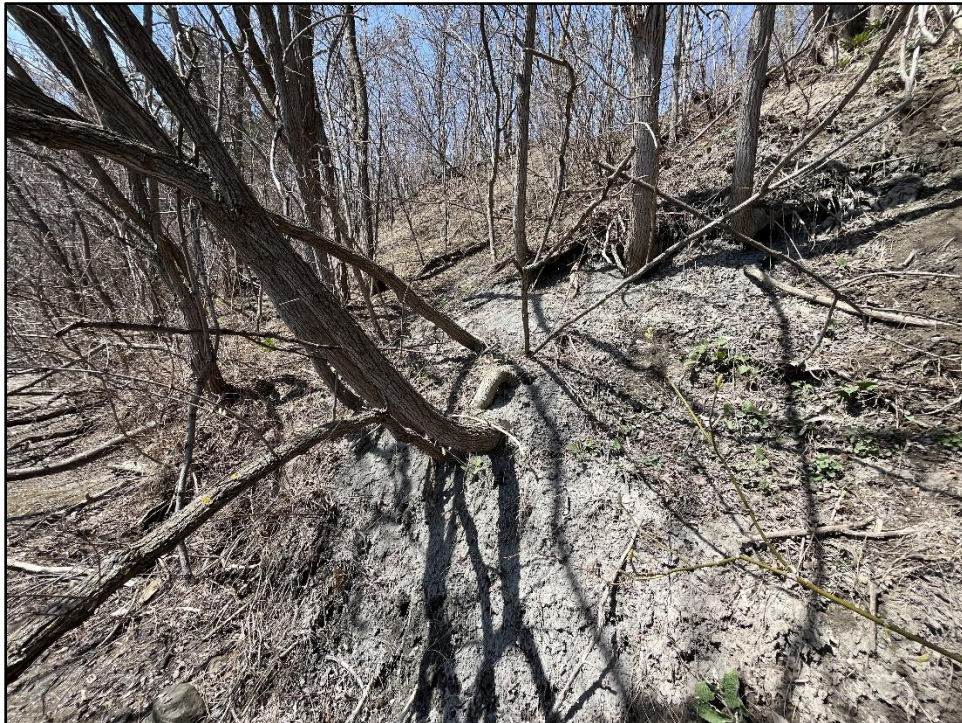
**Photo 34:** Photograph taken in a southwest direction midway up the slope along the Rideau River, illustrating evidence of active erosion along the lower sections and localized higher sections of the slope face.
