TREE CONSERVATION REPORT

1110 Fisher

Tree Conservation Report submitted as Partial Requirements for a Zoning Application

Date: October 28, 2019

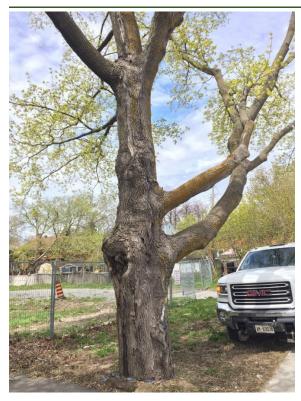
Tree no. 1 is a Norway maple in relatively poor health and is directly in the path of the new laneway, therefore, removal is recommended. Tree no.2 and 3 are also city-owned Norway maple and provided there is no major trenching of their critical roots, these trees should be retainable. The location for the protective fencing has been included for these trees.

Figure 1: Tree no. 1 - Norway maple in fair/poor condition on City property

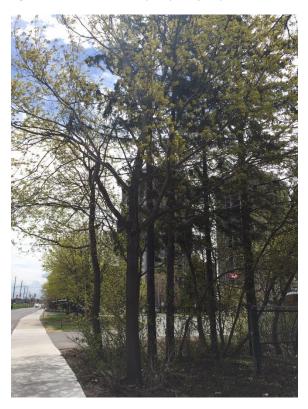
Figure 2: Trees no. 2 and 3 - City-owned Norway maples

Prior to any site works, protective fencing should be installed around the trees as indicated in the attached *Proposed Development and Conserved Vegetation Map* and maintained until all construction on site has been completed as per the **City of Ottawa Tree Protection Specifications (April 2019)**. Within the fenced area, the following tree protection guidelines should be applied:

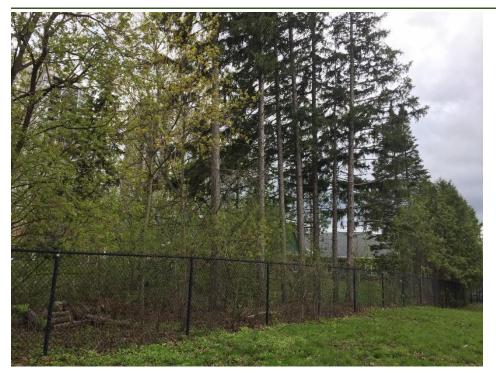
Tree nos. 4-11 are Norway spruce growing together in a clump. For the most part, there will be little damage to the roots of these trees except for tree no. 4 which is only 1.9 m from the fence. Given the scope of this project, it is assumed that excavation will come right to the fence line. Spruce are shallow rooted, and the majority of root mass is likely in the top 1 m of soil. If there is flexibility with the excavation, it is recommended that as much root mass be left in the top metre of soil for this tree as possible. Because these trees grown in a clump, their roots are intertwined and support one another. With the loss of some of the critical root mass for tree no. 4, it should remain supported by the remaining trees. Any exposed roots should be kept moist with organic material such as burlap until they are re-buried. In addition, any roots that are torn should be pruned back with a clean cut to allow for proper sealing.

Figure 3: Southern property line – clump of Norway spruce (tree nos. 4-11)

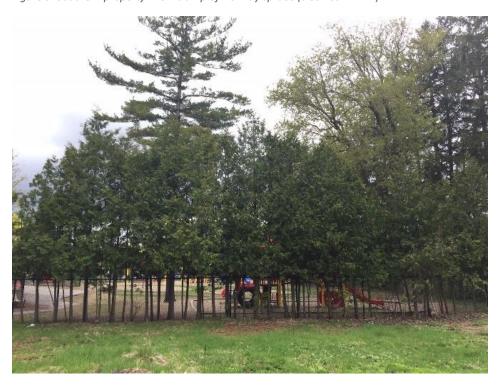
In addition to the above, there are also two cedar hedges running close to the property line, on the neighbouring school property (see map) The diameters of these cedars range from 5-20 cm and are within approximately 20 cm from the property line.

Figure 4: Cedar hedge along western property line

The cedar hedge running along the southern property line may be impacted by the excavation as well. The same recommended mitigation measures would apply here whereby the excavation in the top metre of soil be kept to a minimum, and the roots be kept moist while being exposed.

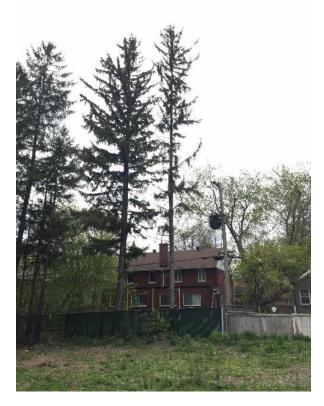
Tree no. 12 is in good health and far enough away from the development, that it should be retainable with proper protection measures. Tree no. 13 is in fair condition that has undergone significant hydro pruning along the north side. The crown is also thin on the south side as is a large stump (perhaps an ash) close to the base indicating that it was likely shaded out by a large tree. The roots have also been damaged through some recent compaction and grade changes. The proposed excavation will come to approximately 1 metre to the base of the tree resulting in a loss of approximately 20% of the root mass, possibly including some stabilizing roots. Given the poor health combined with the proposed excavation, removal of this tree is recommended. Note that because this is a jointly owned tree, approval for removal with the neighbouring owner is required.

Figure 5: Norway spruce along the northern property line (tree nos. 12 -13)

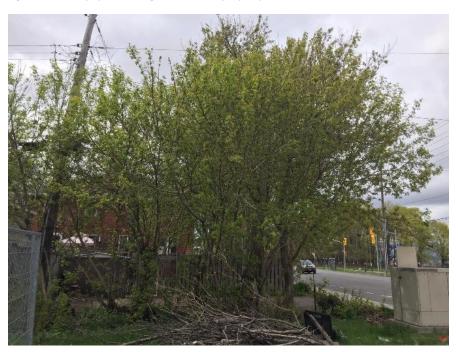
16³	Manitoba maple (Acer negundo)	20 cm	2 m	Jointly owned with neighbour at 1120 Trent St and/or City	Fair/poor	Either removal for poor health or retention to provide for screening
17³	Manitoba maple (Acer negundo)	36, 10, 10 cm	4 m	Jointly owned with City	Fair	Either removal for poor health or retention to provide for screening

Tree no. 14 is a clump of Manitoba maple that will be exposed to significant grading. Combined with being an invasive species, removal is recommended. The remaining Manitoba maple are very close to, or on the property line with the abutting neighbour and the city. For the most part, these trees are in poor/fair condition, however, they do provide screening. Removal and replacement with more desirable species are recommended. However, they could be retained if screening is a priority. Permission with the abutting owners is required for removal.

Figure 6: Manitoba maple along the northern property line (tree nos. 15-17)

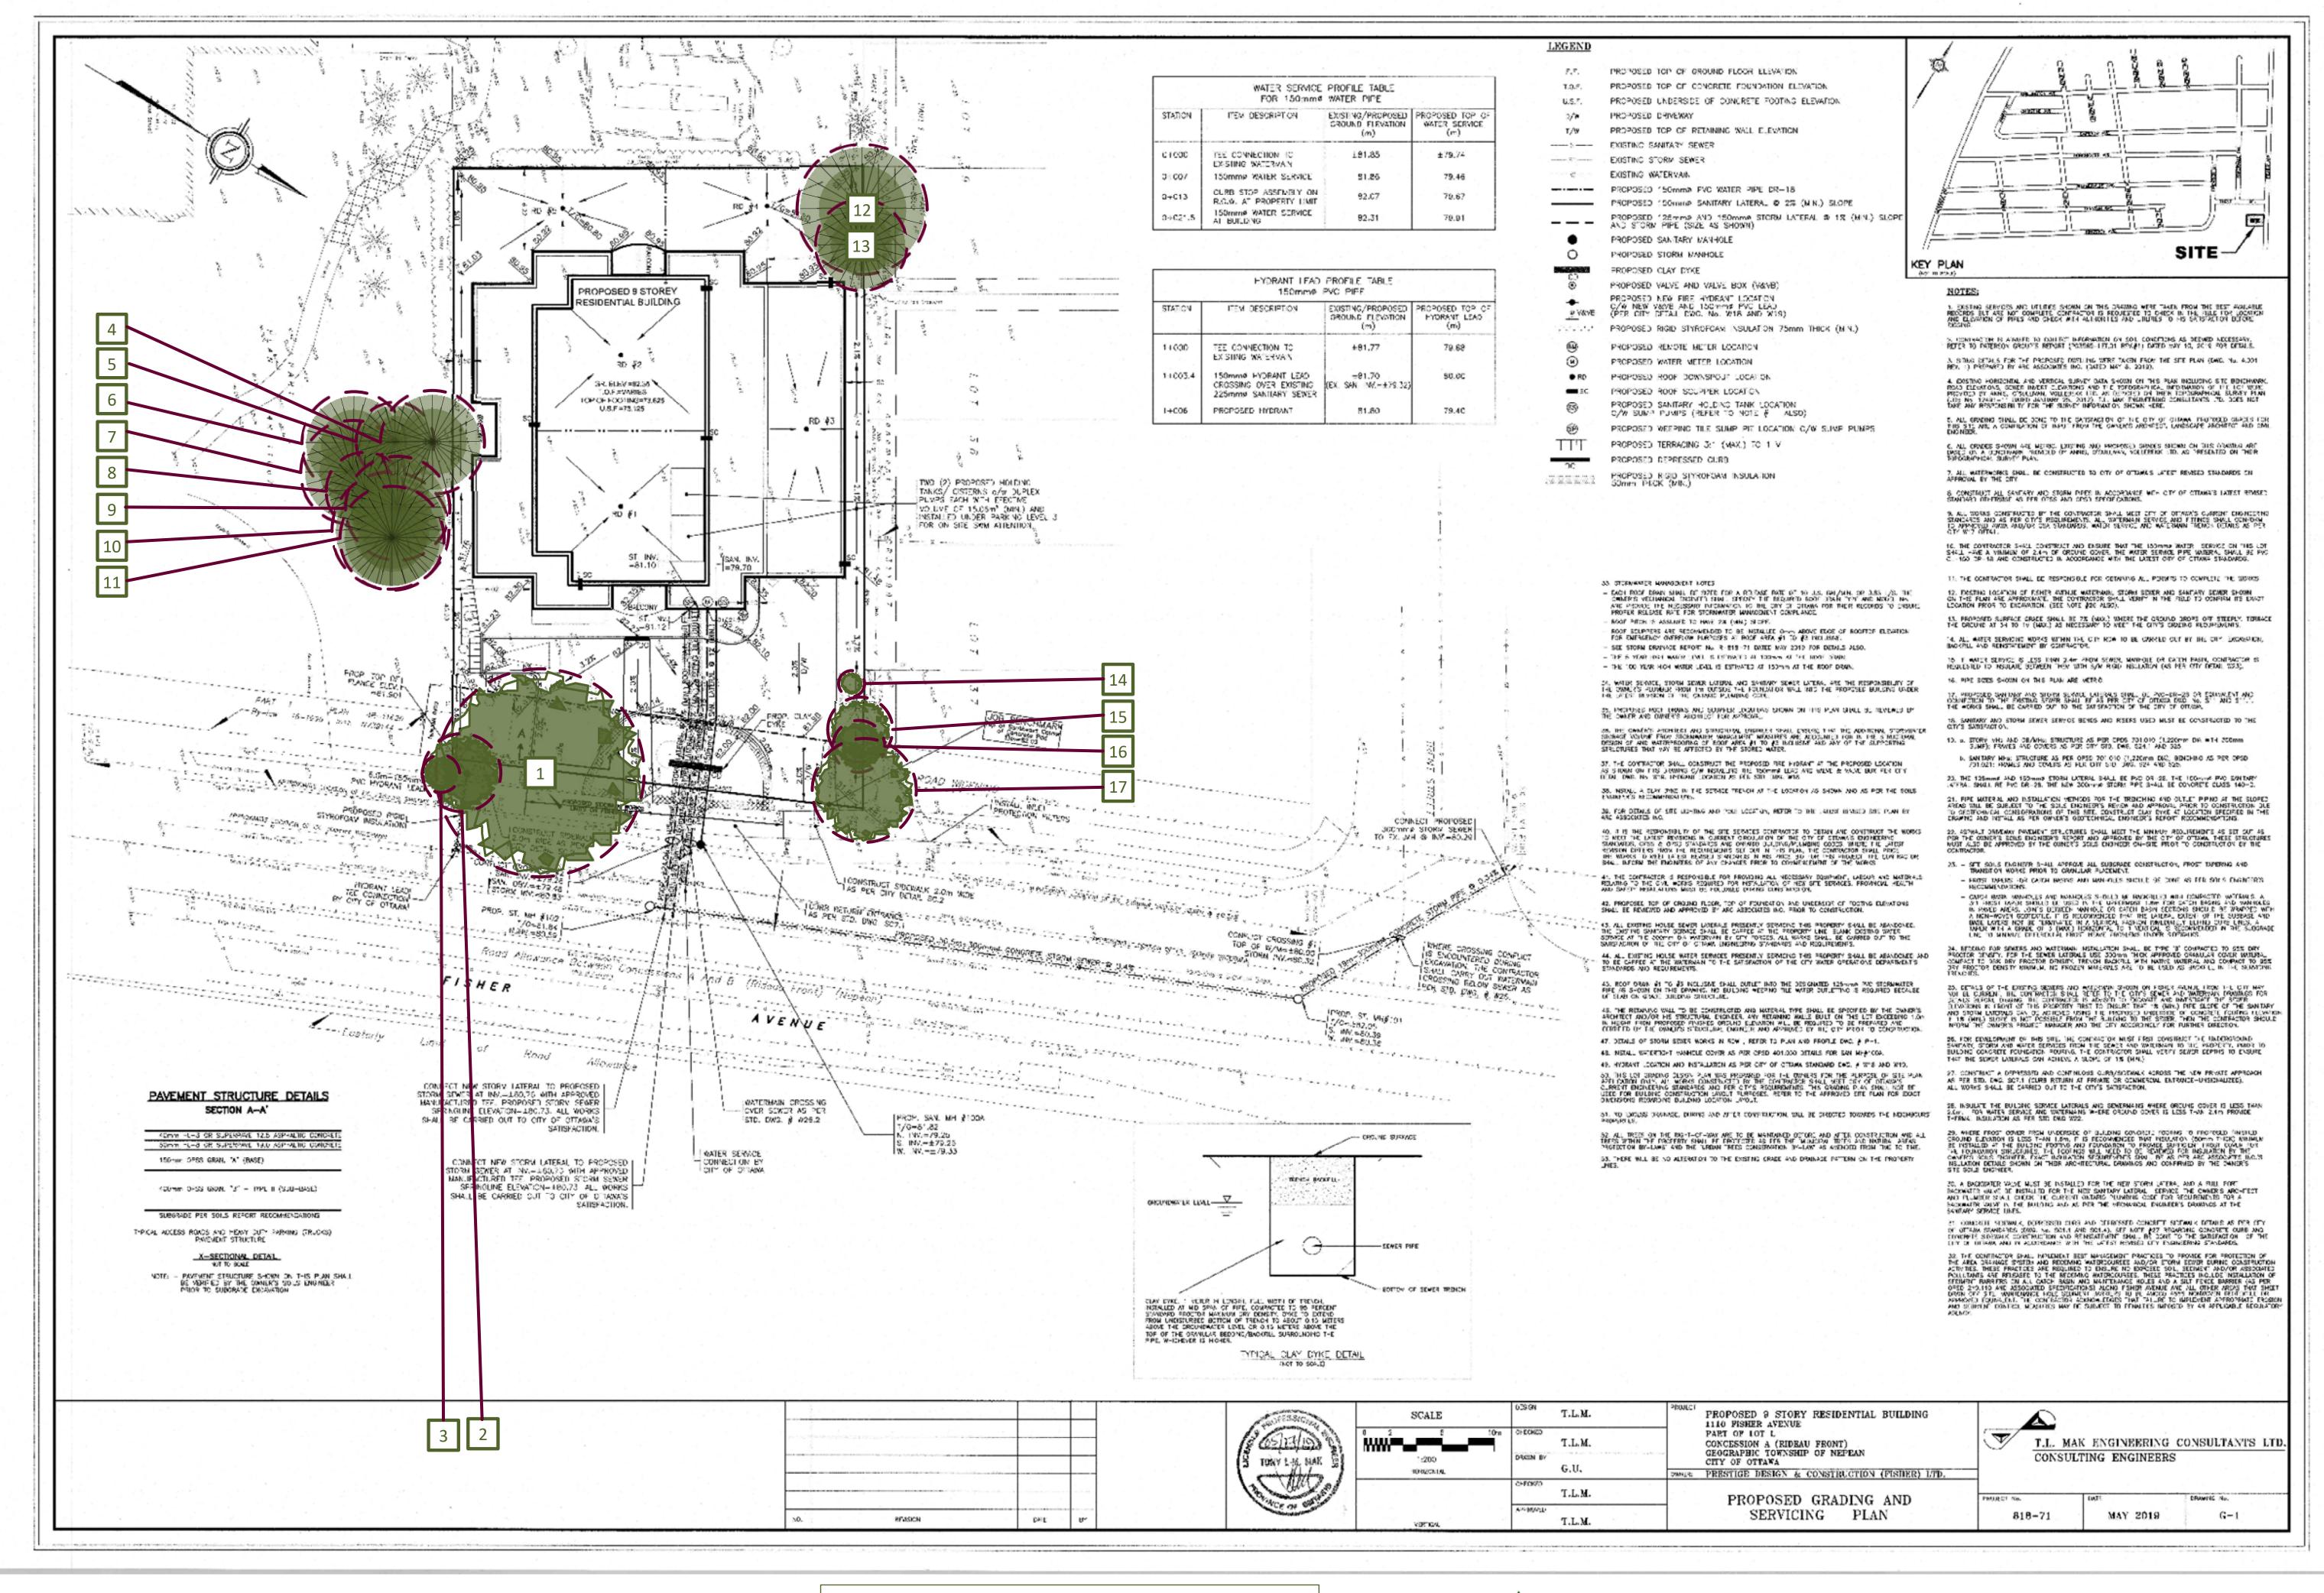
Tree Conservation Report – Current Vegetation

Tree ¹	Species	Diameter at breast height (dbh)	Critical Root Zone (m)	Ownership	Condition	Action
1	Norway maple (Acer platanoides)	78 cm	8 m	Jointly owned with City	Fair/poor	Proposed removal; conflict with new laneway and poor health
2	Norway maple (Acer platanoides)	30 cm	3 m	City	Good	Retain provided there is no excavation planned within the critical root zone
3	Norway maple (Acer platanoides)	8 cm	1 m	City	Good	Retain provided there is no excavation planned within the critical root zone
43	Norway spruce (<i>Picea abies</i>)	38 cm	4 m	Neighbouring school property	Good; 1.9 m from the property line	Retain; minimize excavation of critical root zone
5³	Norway spruce (Picea abies)	28 cm	3 m	Neighbouring school property	Good	Retain
63	Norway spruce (Picea abies)	38 cm	4 m	Neighbouring school property	Good; 10% lean towards road	Retain
7 ³	Norway spruce (Picea abies)	37 cm	4 m	Neighbouring school property	Good	Retain

83	Norway spruce (Picea abies)	31 cm	3 m	Neighbouring school property	Good; supressed	Retain
93	Norway spruce (Picea abies)	37 cm	4 m	Neighbouring school property	Fair; 3.9 m from property line	Retain
10³	Norway spruce (<i>Picea abies</i>)	43 cm	4.5 m	Neighbouring school property	Good; 4.0 m from property line	Retain

11³	Norway spruce (Picea abies)	39 cm	4 m	Neighbouring school property	Good	Retain
12	Norway spruce (<i>Picea abies</i>)	50 cm (estimate only)	5 m	Jointly owned with neighbour at 1130 Trent St	Good	Retain and protect
13	Norway spruce (Picea abies)	35 cm (estimate only)	3.5 m	Jointly owned with neighbour at 1130 Trent St	Fair; pruned by hydro, roots have been damaged by soil excavation and compaction	Removal recommended as excavation will come within approximately 1 m from the tree and tree is in fair health; approval by abutting neighbour is required
143	Manitoba maple (Acer negundo)	10, 10, 11 cm	1 m	Private	Good/fair	Removal recommended due to site grading and paving
15³	Manitoba maple (Acer negundo)	24, 7 cm	2.5 m	Jointly owned with neighbour at 1120 Trent St	Fair; heavy lean and decay at base; small nest located in smaller tree	Either removal for poor health or retention to provide for screen

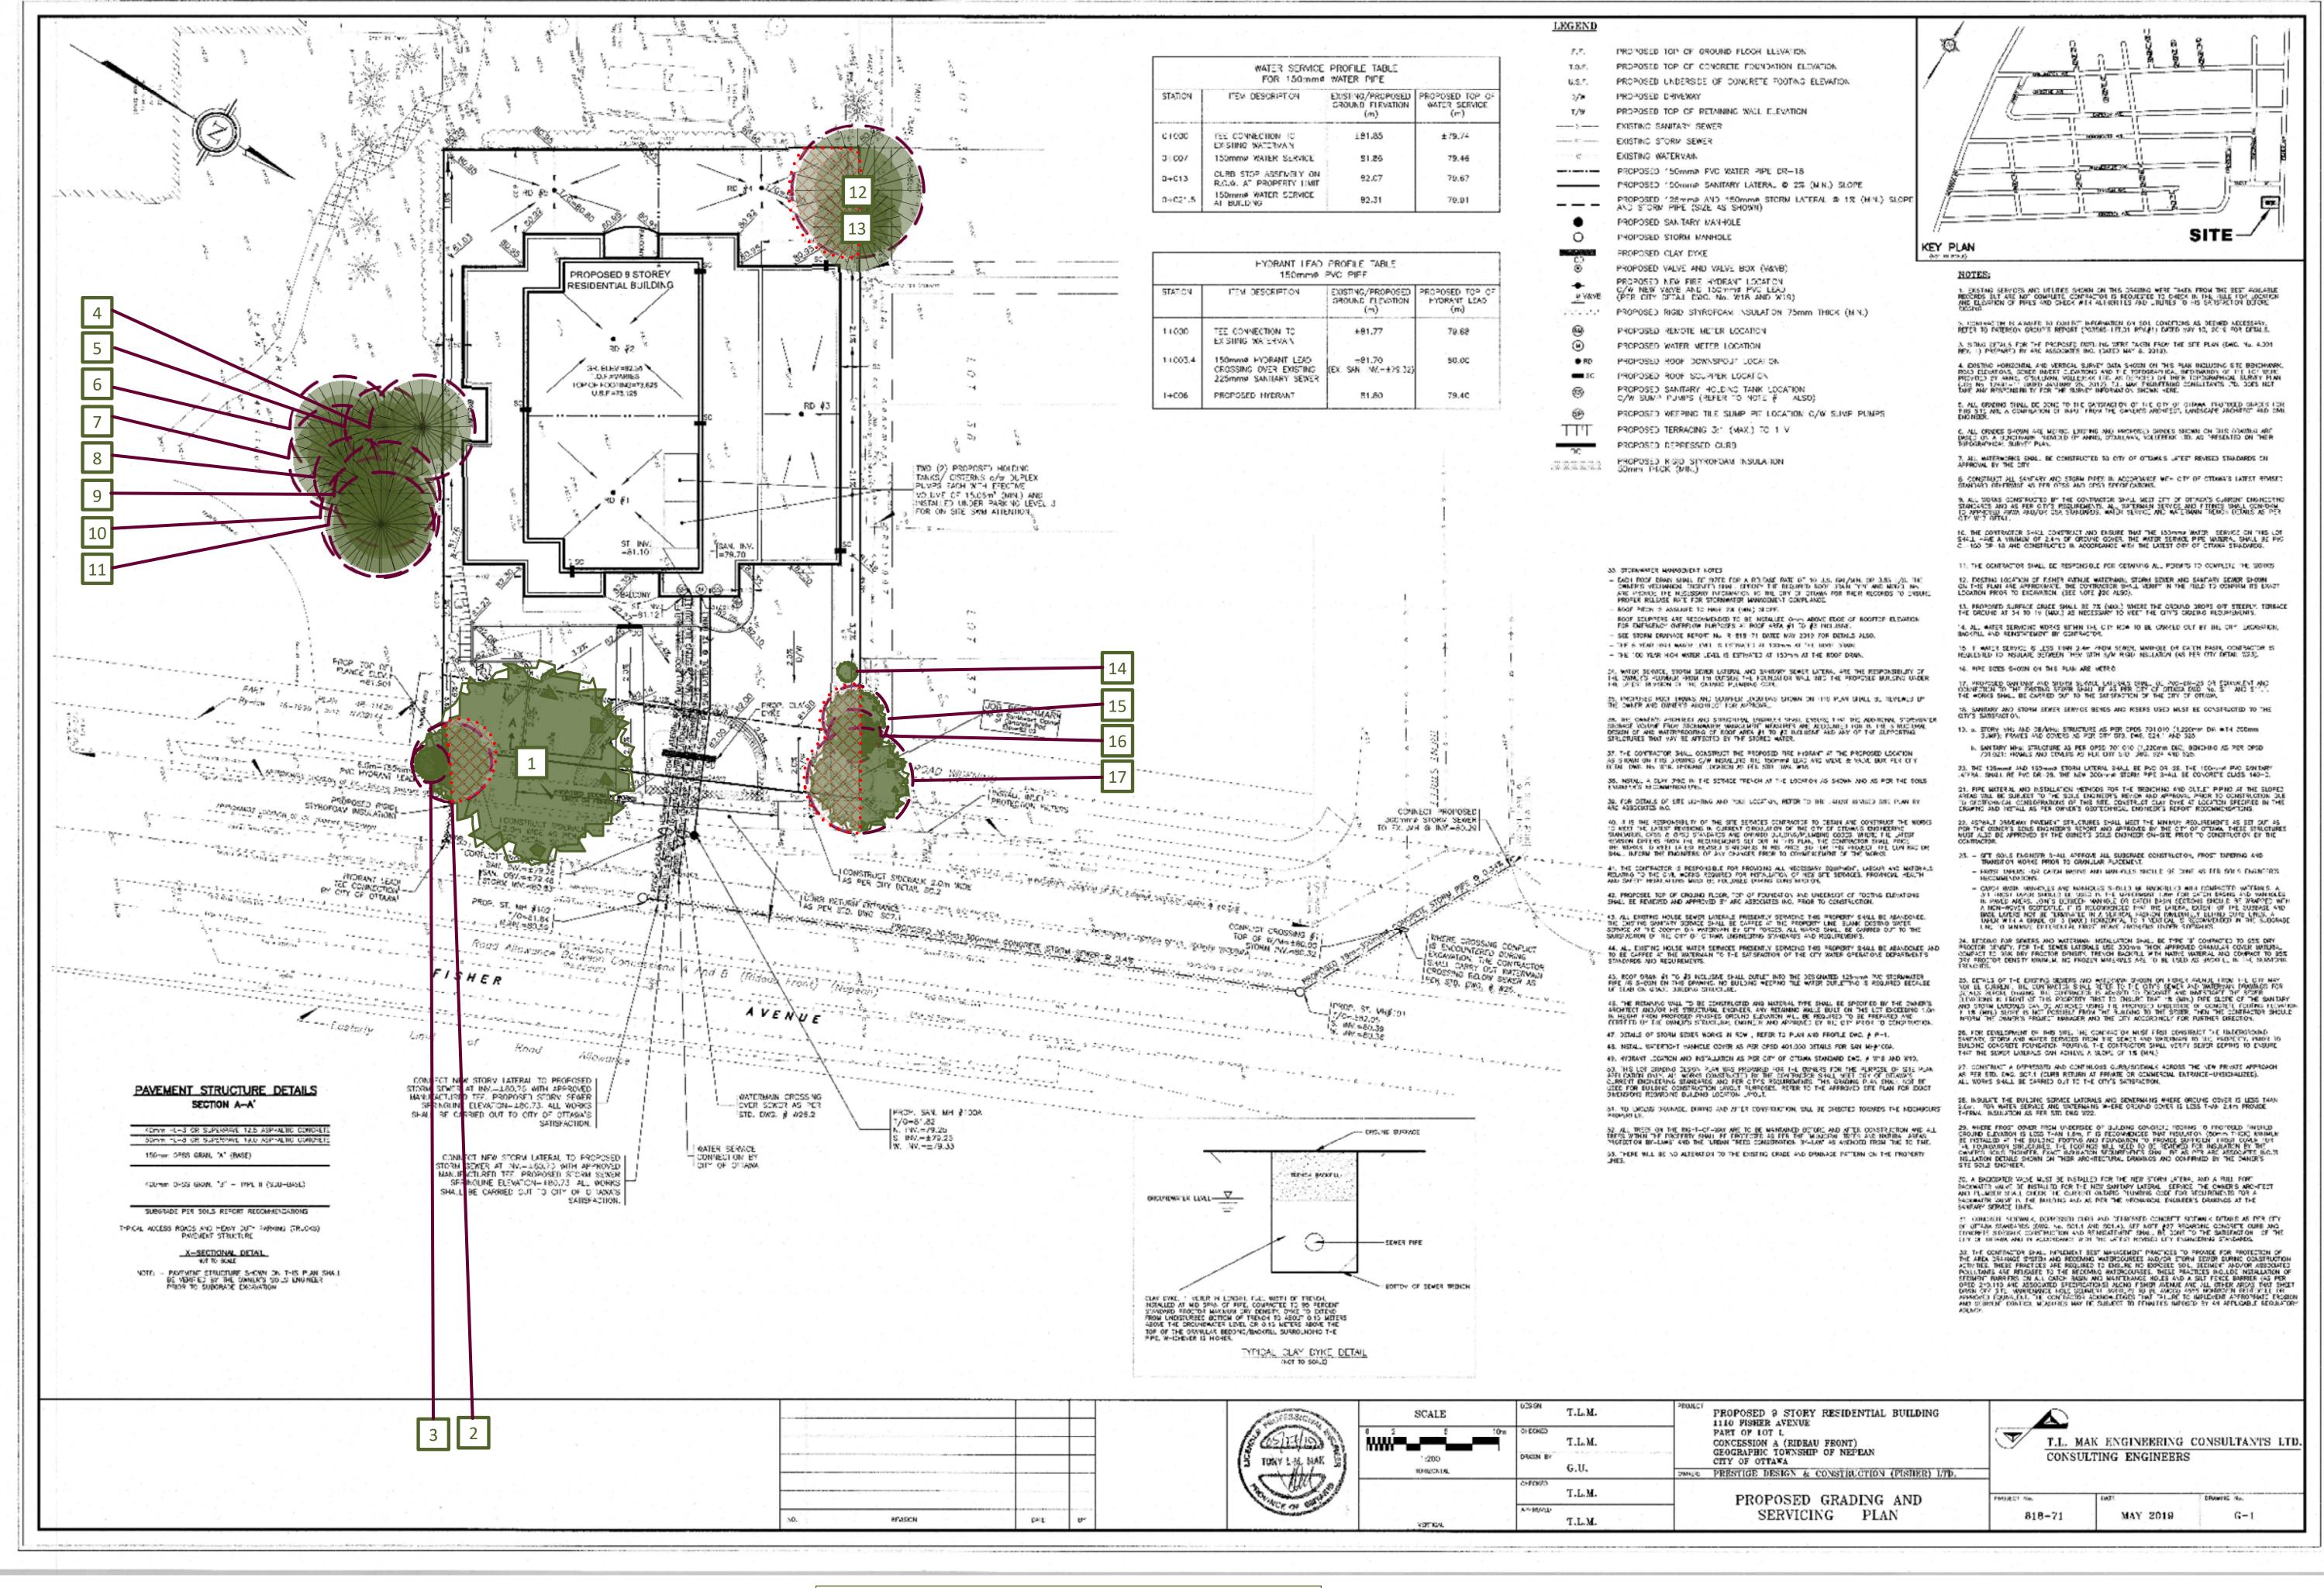
Tree Conservation Report – Proposed Developmet and Conserved Vegetation

The proposed development is shown in the *Proposed Development and Conserved Vegetation Map*. This map shows a tree layer created by Dendron Forestry Services overlaying the Grading Plan provided by Prestige Design & Construction.

The tree protection fencing must be 1.2 m in height and constructed of a rigid or framed material (e.g. modulus – steel, plywood hoarding, or snow fence on a 2"X4" wood frame) with posts 2.4 m apart such that the fence location cannot be altered.
