June 1, 2017
File: PG1887-LET.02 Revision 1

Subject: **Addendum to Slope Stability Analysis**
2175 Prince of Wales Drive
Ottawa, Ontario

1.0 Current Slope Conditions Review

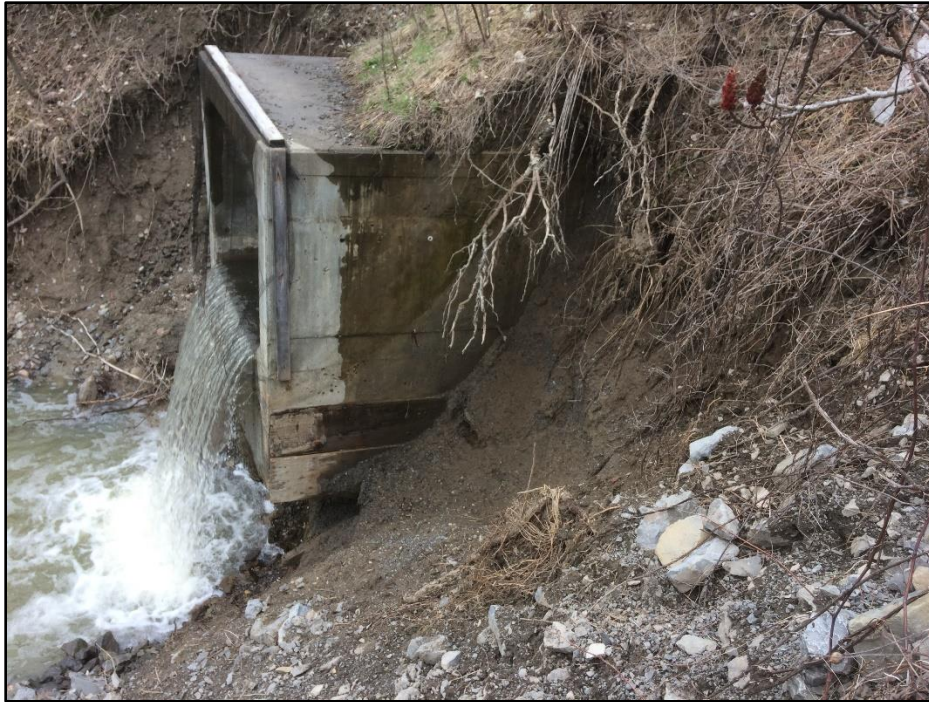
At that time, several areas along the watercourse tributary to the east of the site exhibited signs of active erosion. The stormwater outlet pipe at the Prince of Wales Drive crossing was noted to be severely undermined and remedial work is recommended to limit further erosion action along the roadway embankment. Several sections of the tributary valley wall were noted to have minor slip failures due to the active erosion. However, the overall slope face and top of slope have not been significantly altered since our original review in 2010. Photographs of the current slope conditions are attached to the present letter report.

Photo 1: Significant erosion below stormwater outlet structure adjacent to Prince of Wales Drive.

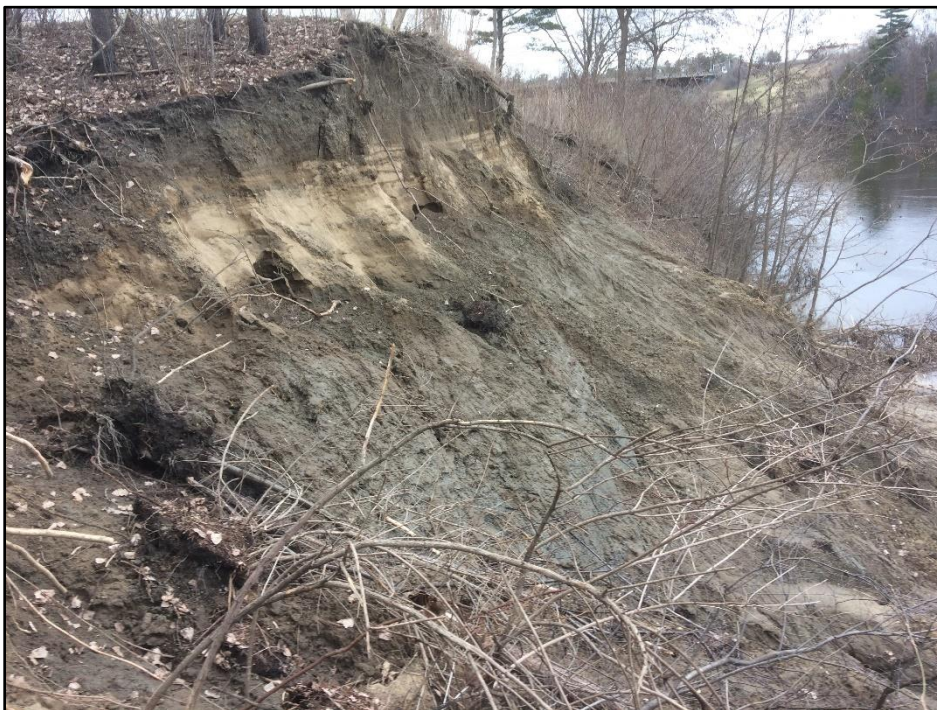
The riverbank and valley corridor wall along the Rideau River adjacent to the subject site is relatively unchanged since our original review in 2010. A recent large slope failure within the City of Ottawa Right-of-Way was noted along the Rideau River to the southwest of the subject site. A slope stability section based on our cursory review of the existing slope conditions was analyzed by Paterson (Section C). The cross-section location is presented in Drawing PG1887-2 - Site Plan attached.

Photo 2: Existing slope conditions along slope located to the southwest of the subject site. Recent slip failure has occurred and left steep backscarp.

- A legal surveyor should provide topographic information along current top of slope and along toe of the failure area, where access is possible.
- Failed slope material should be removed and a remedial slope program should be designed by a geotechnical consultant to re-establish the original top of slope along the impacted area and provide a stable slope.
- The slope toe should be protected against further toe erosion activities.

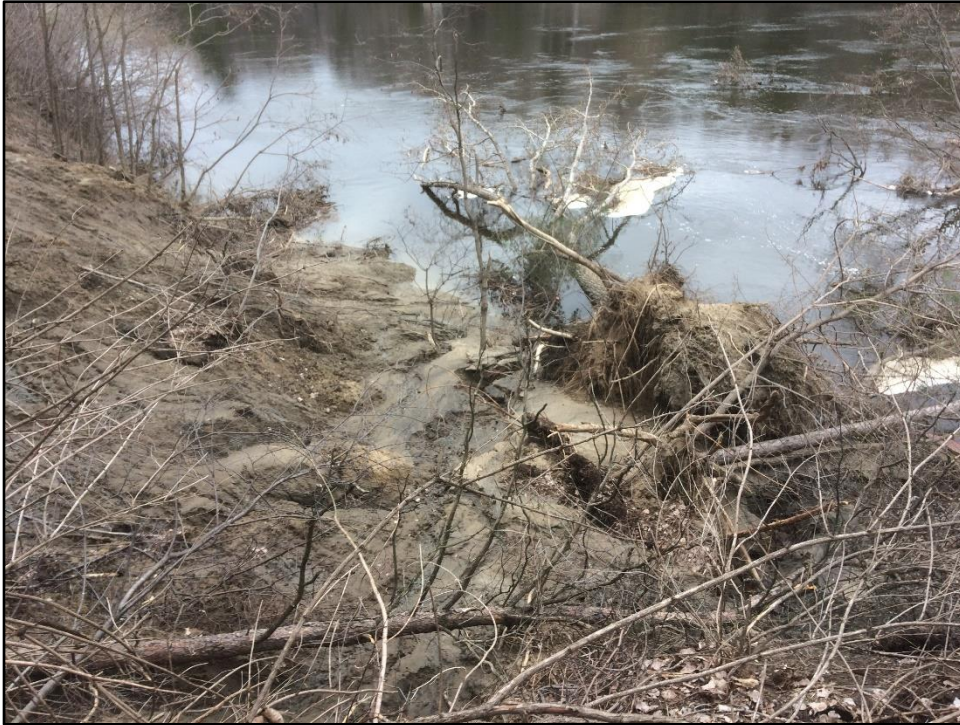
Photo 3: Slope toe in failure area along Rideau River at same location as noted in Photo 2.

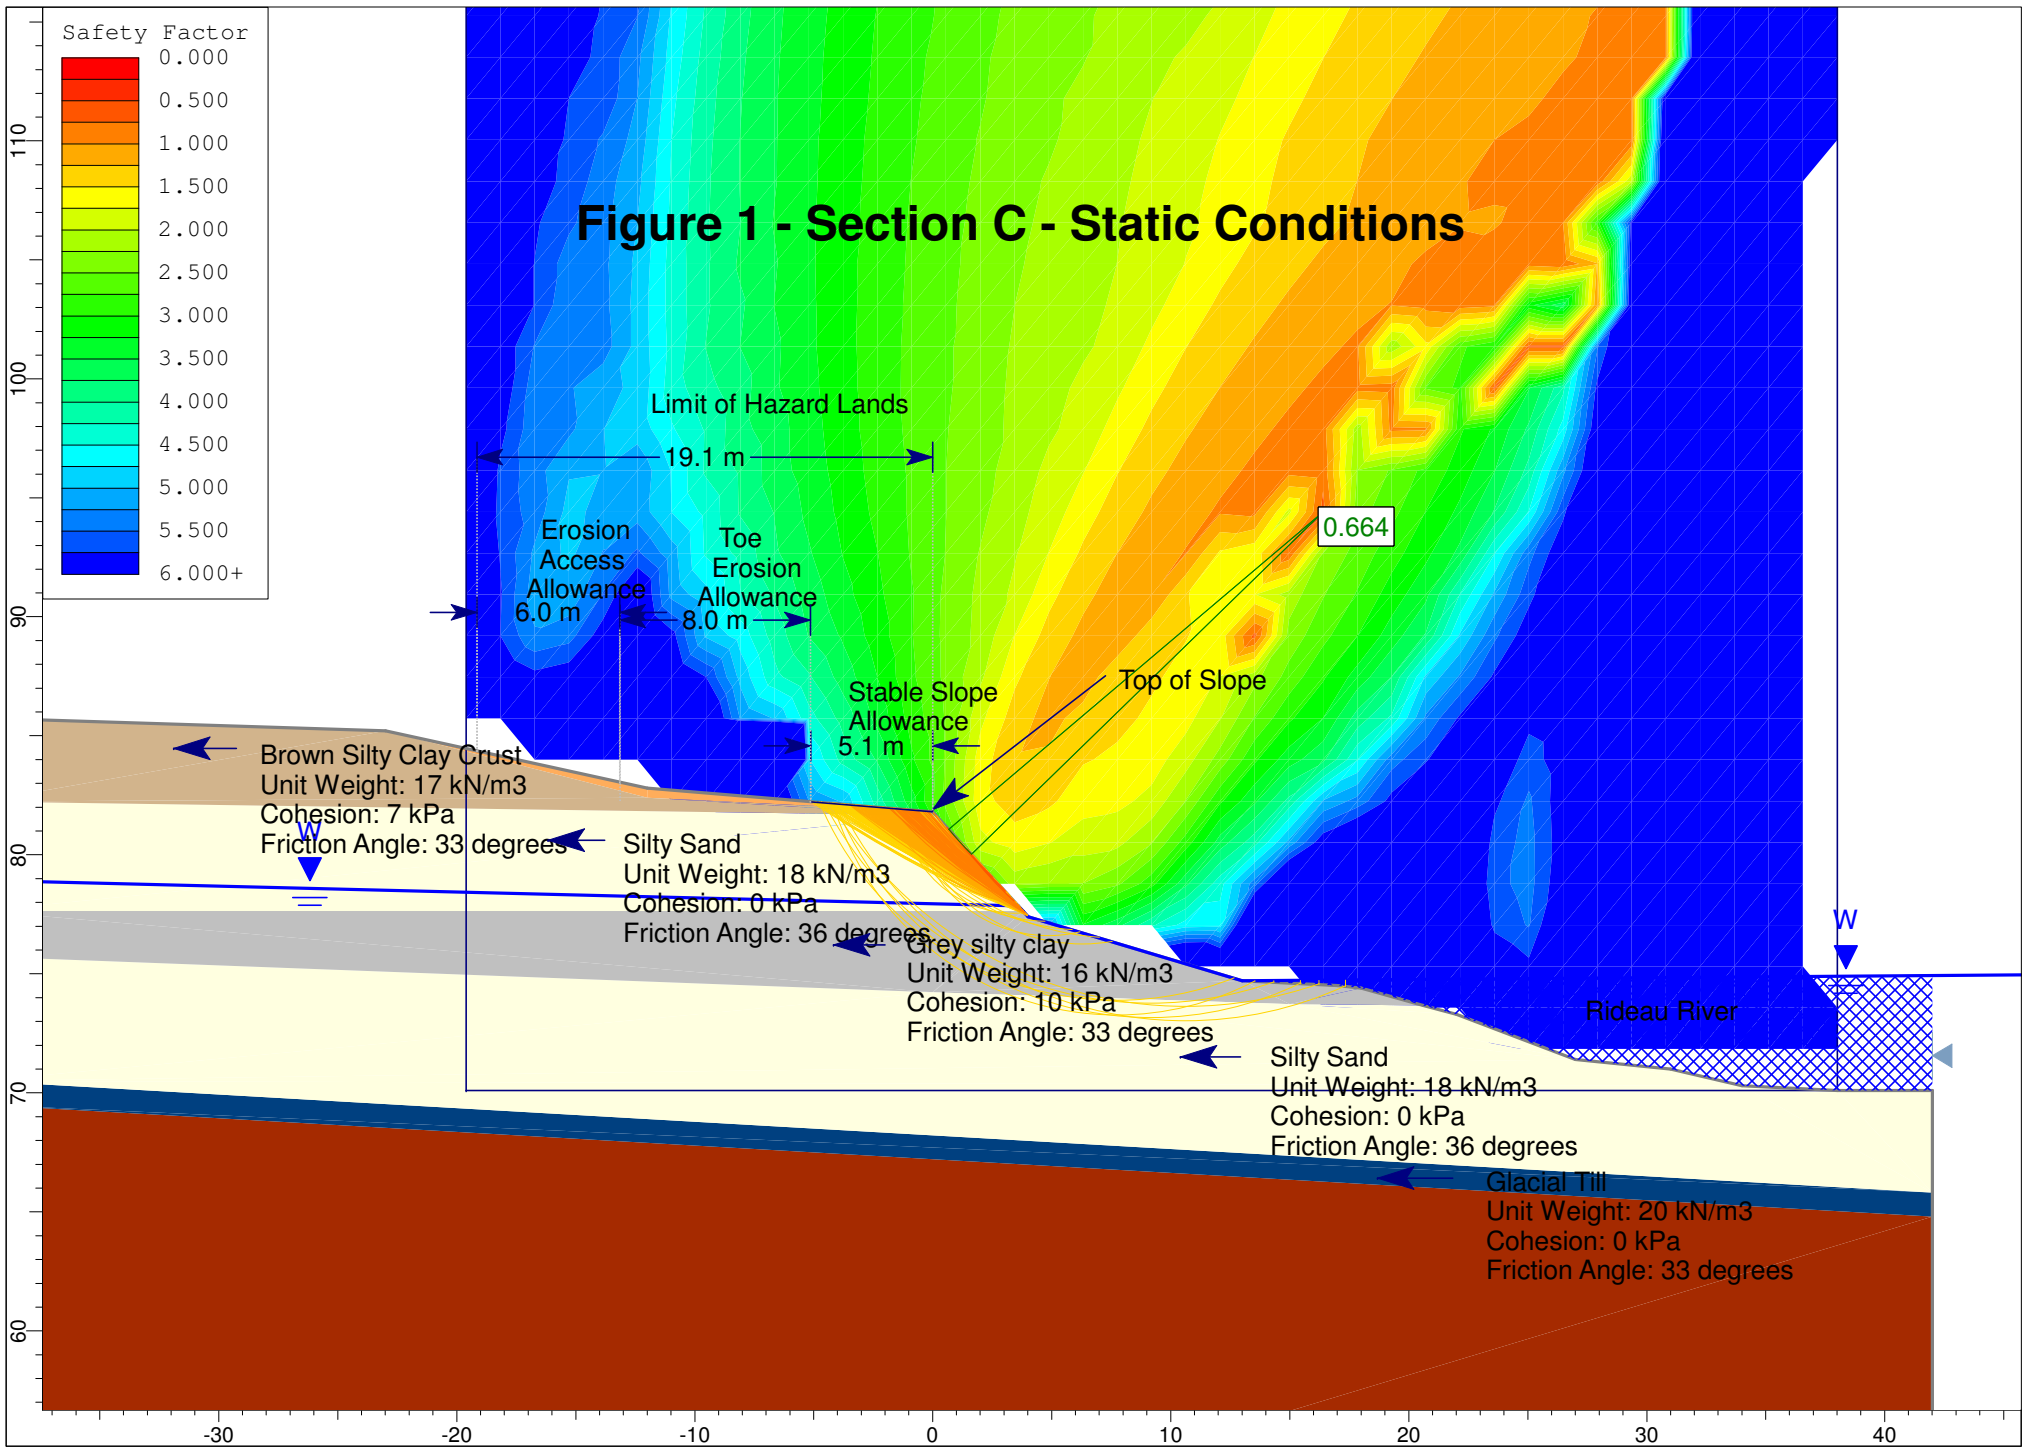
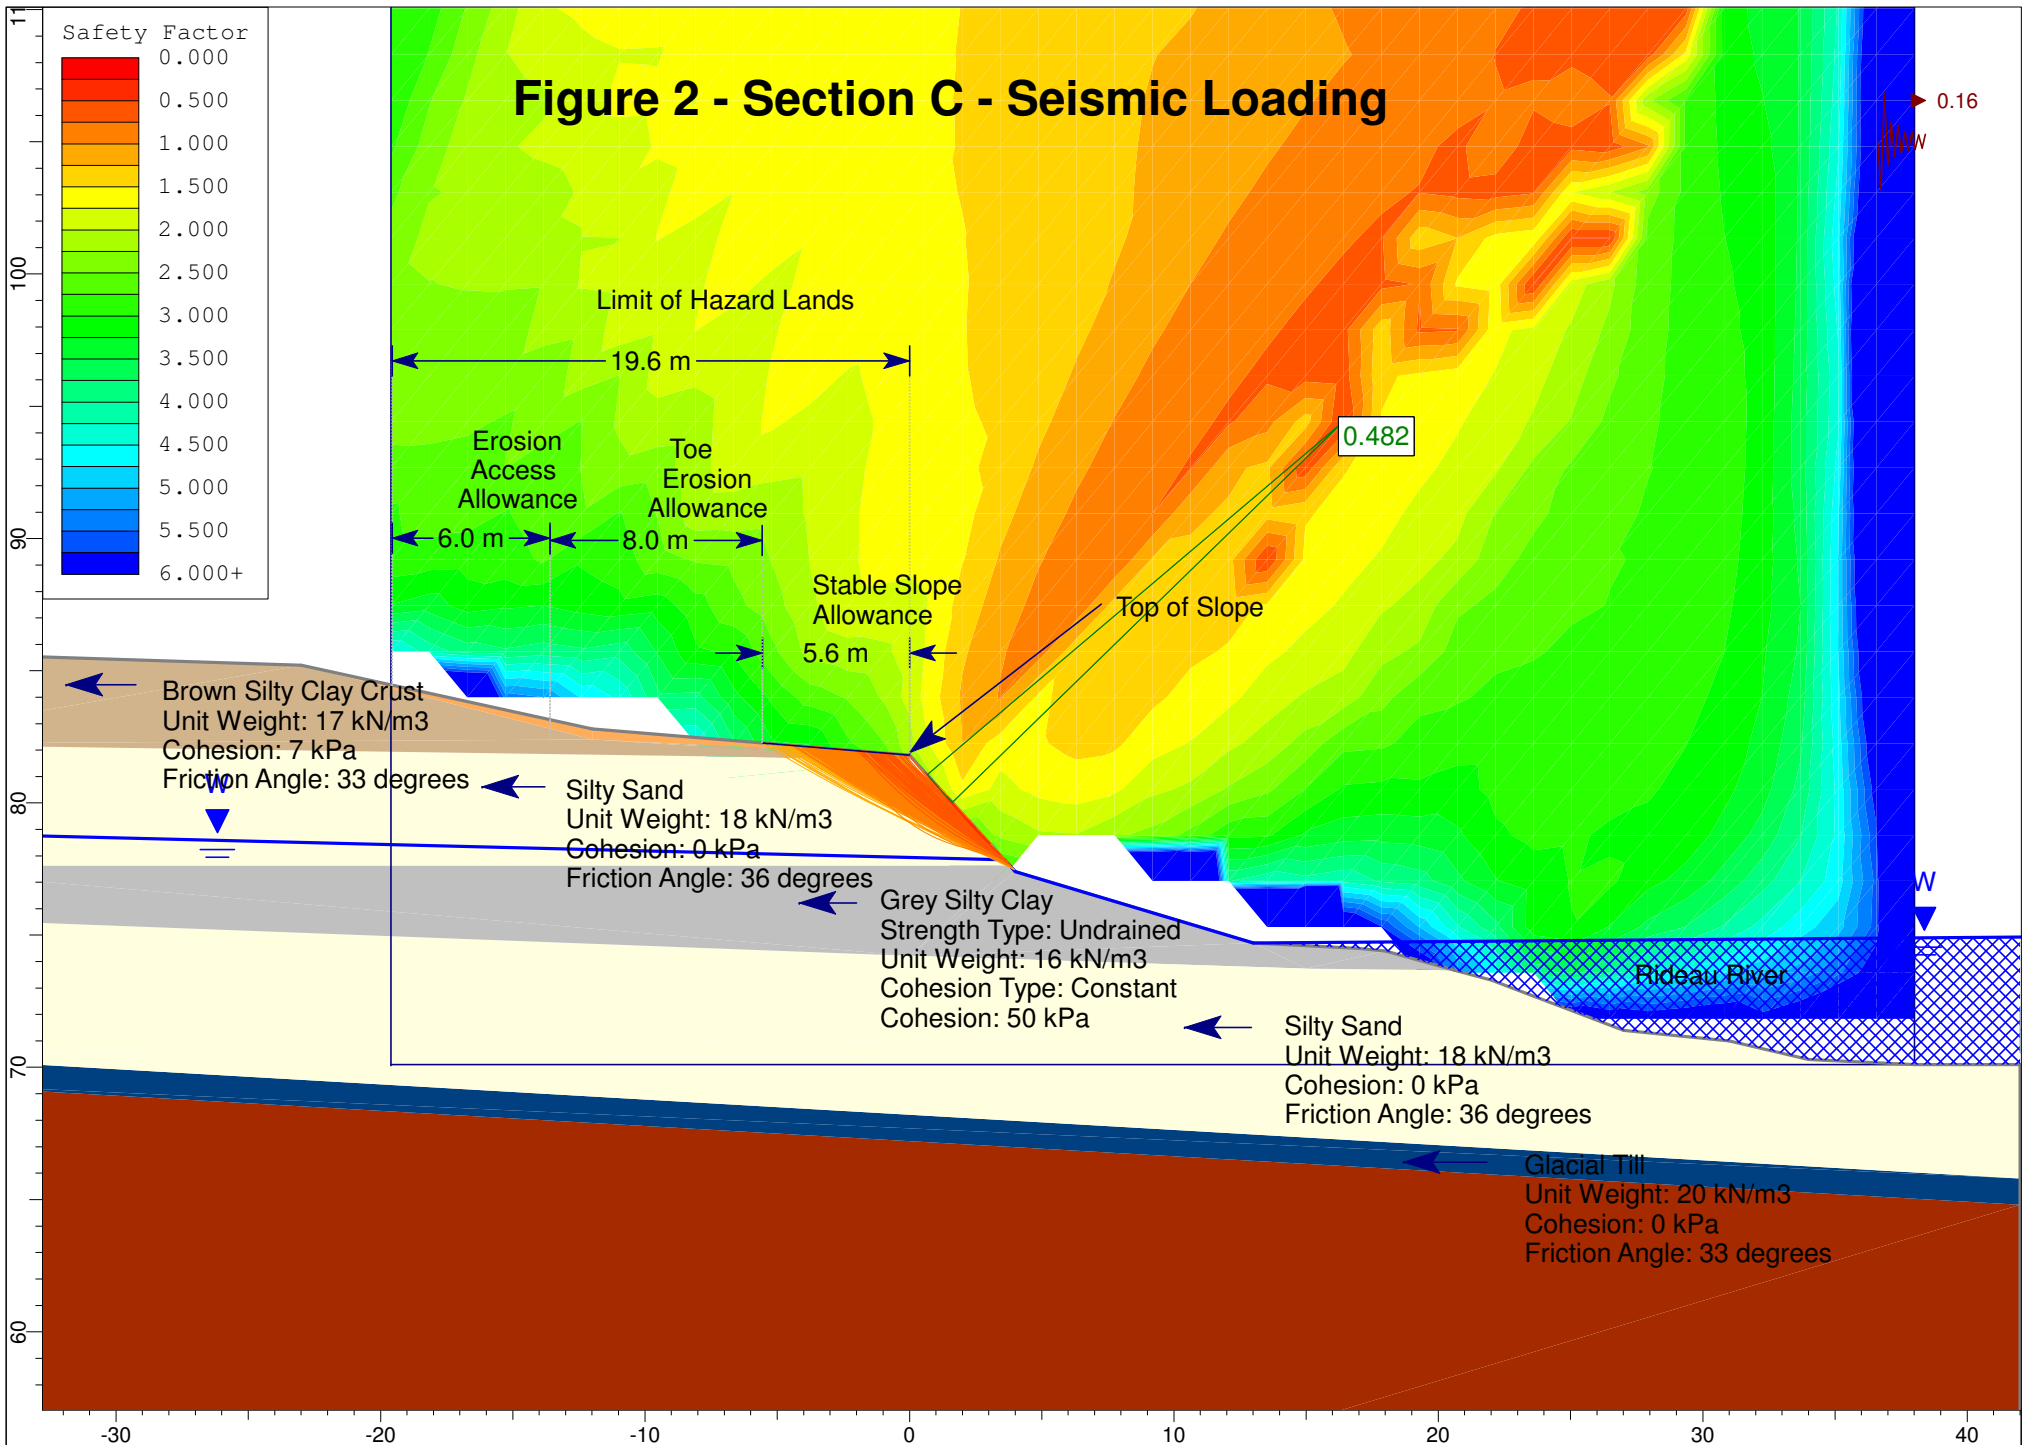
Figure 1 - Section C - Static Conditions

Based on our analysis, a setback from the top of the existing slope (stable slope allowance) is required in the area of the observed slope failure. However, the stable slope allowance recommended at Section C is still in compliance with our previous stable slope allowance for the area. The results of our analysis are presented in Figures 1 and 2 attached. **It should be noted that the limit of hazard lands line established by Paterson in 2010 does not have to be altered due to the slope failure observed in the City of Ottawa Right-of-Way. It should be further noted that our slope stability analysis and limit of hazard lands designation presented in our 2010 report adequately represent the current slope conditions for the subject site based on our analysis and site review.**

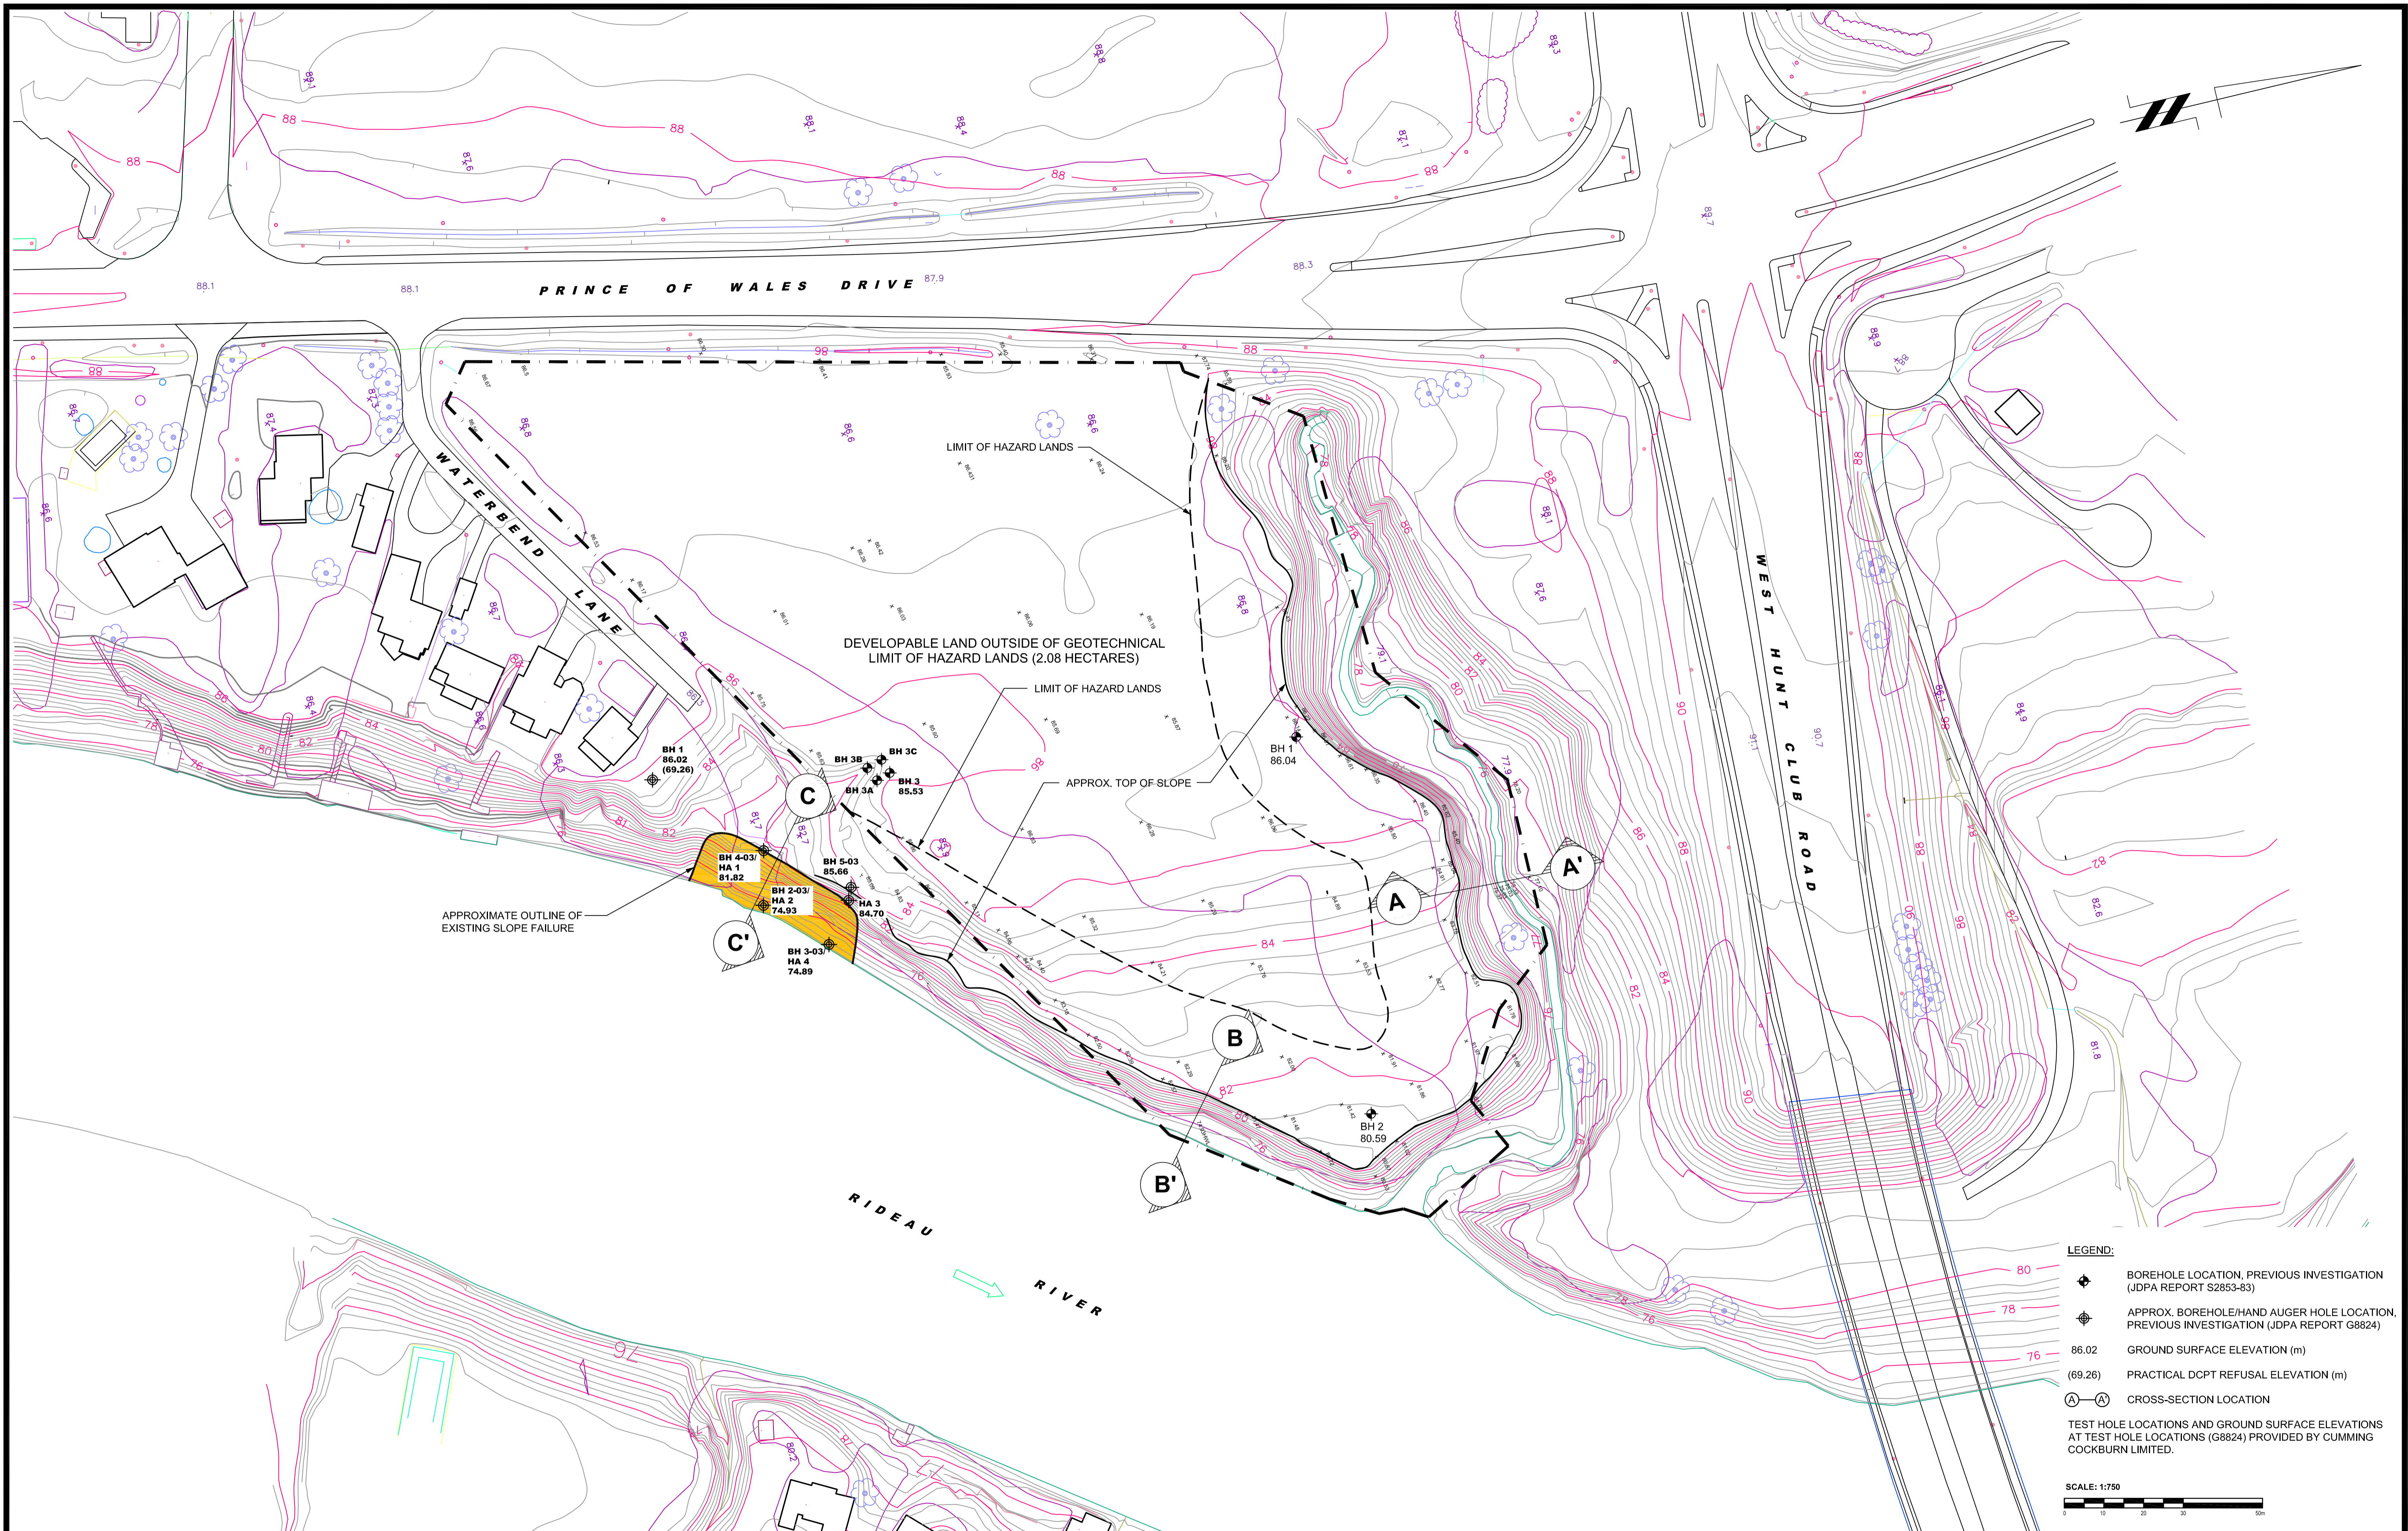
SITE PLAN

The observed slope failure which is located along the slope face within the City easement, which abuts the Rideau River to the southwest of the subject site. The approximate failure area is presented in Drawing PG1887-2 - Site Plan attached. General details for a remedial slope repair program are presented below.
