April 20, 2010  
File: PG1887-LET.01R

Subject: **Slope Stability Analysis**  
**2175 Prince of Wales Drive**  
**Ottawa, Ontario**

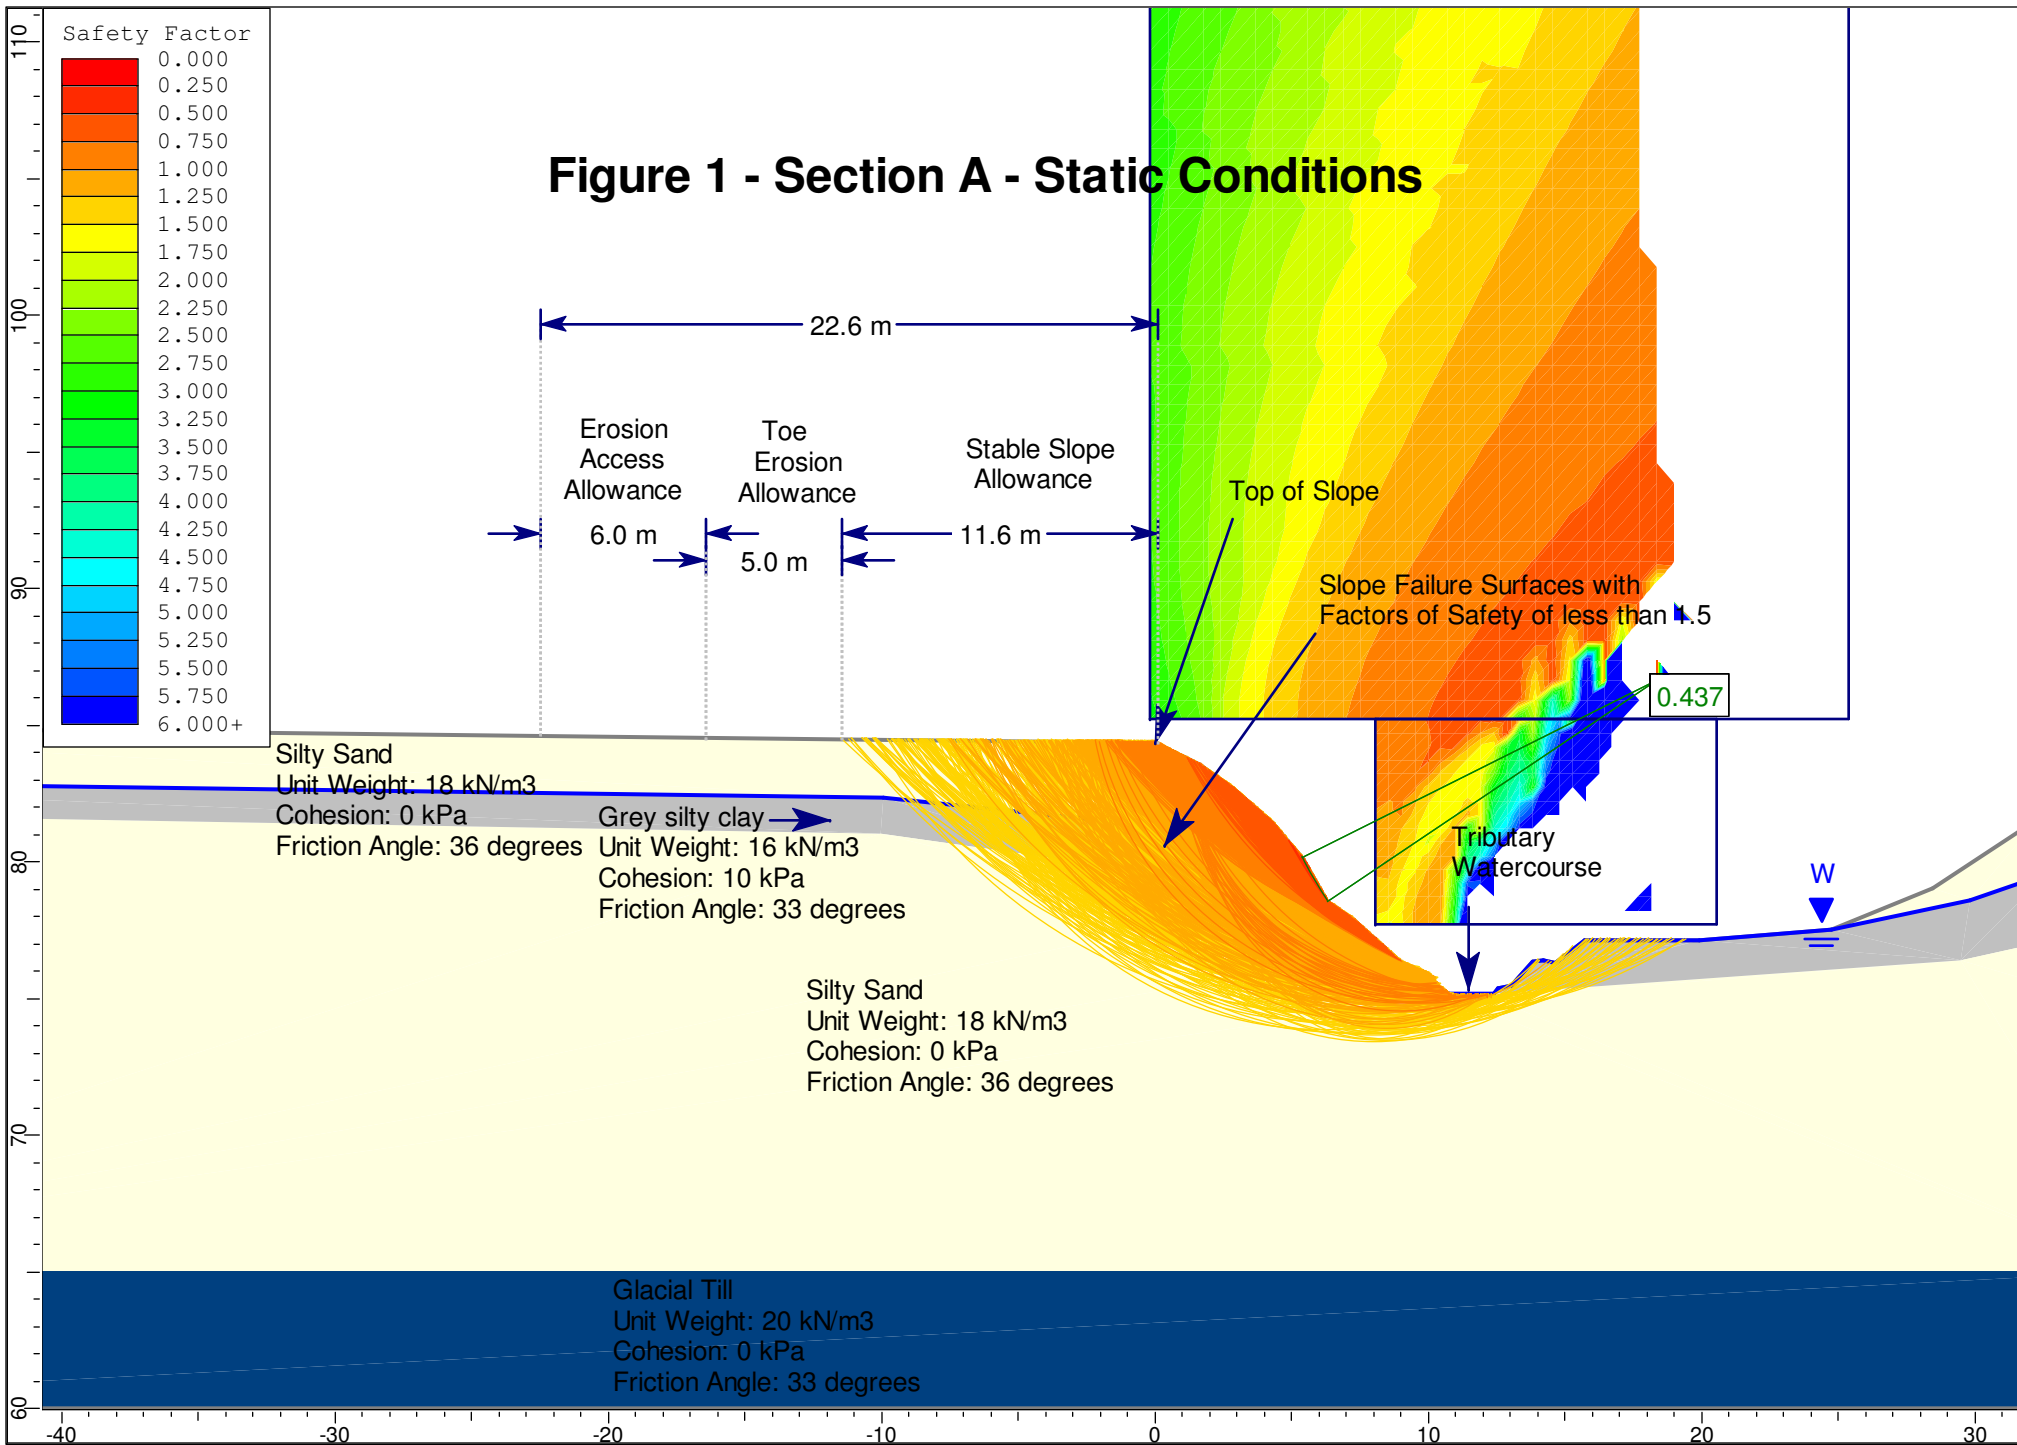
# Figure 1 - Section A - Static Conditions

The results for the existing slope conditions under static loading at Sections A and B are shown in Figures 1 and 3, respectively, attached to the present letter. The overall slope stability factors of safety for the subject sections were found to be less than 1.5. The stable slope allowance from top of slope required for a slope with a minimum factor of safety of 1.5 is identified for each profile in the attached figures.

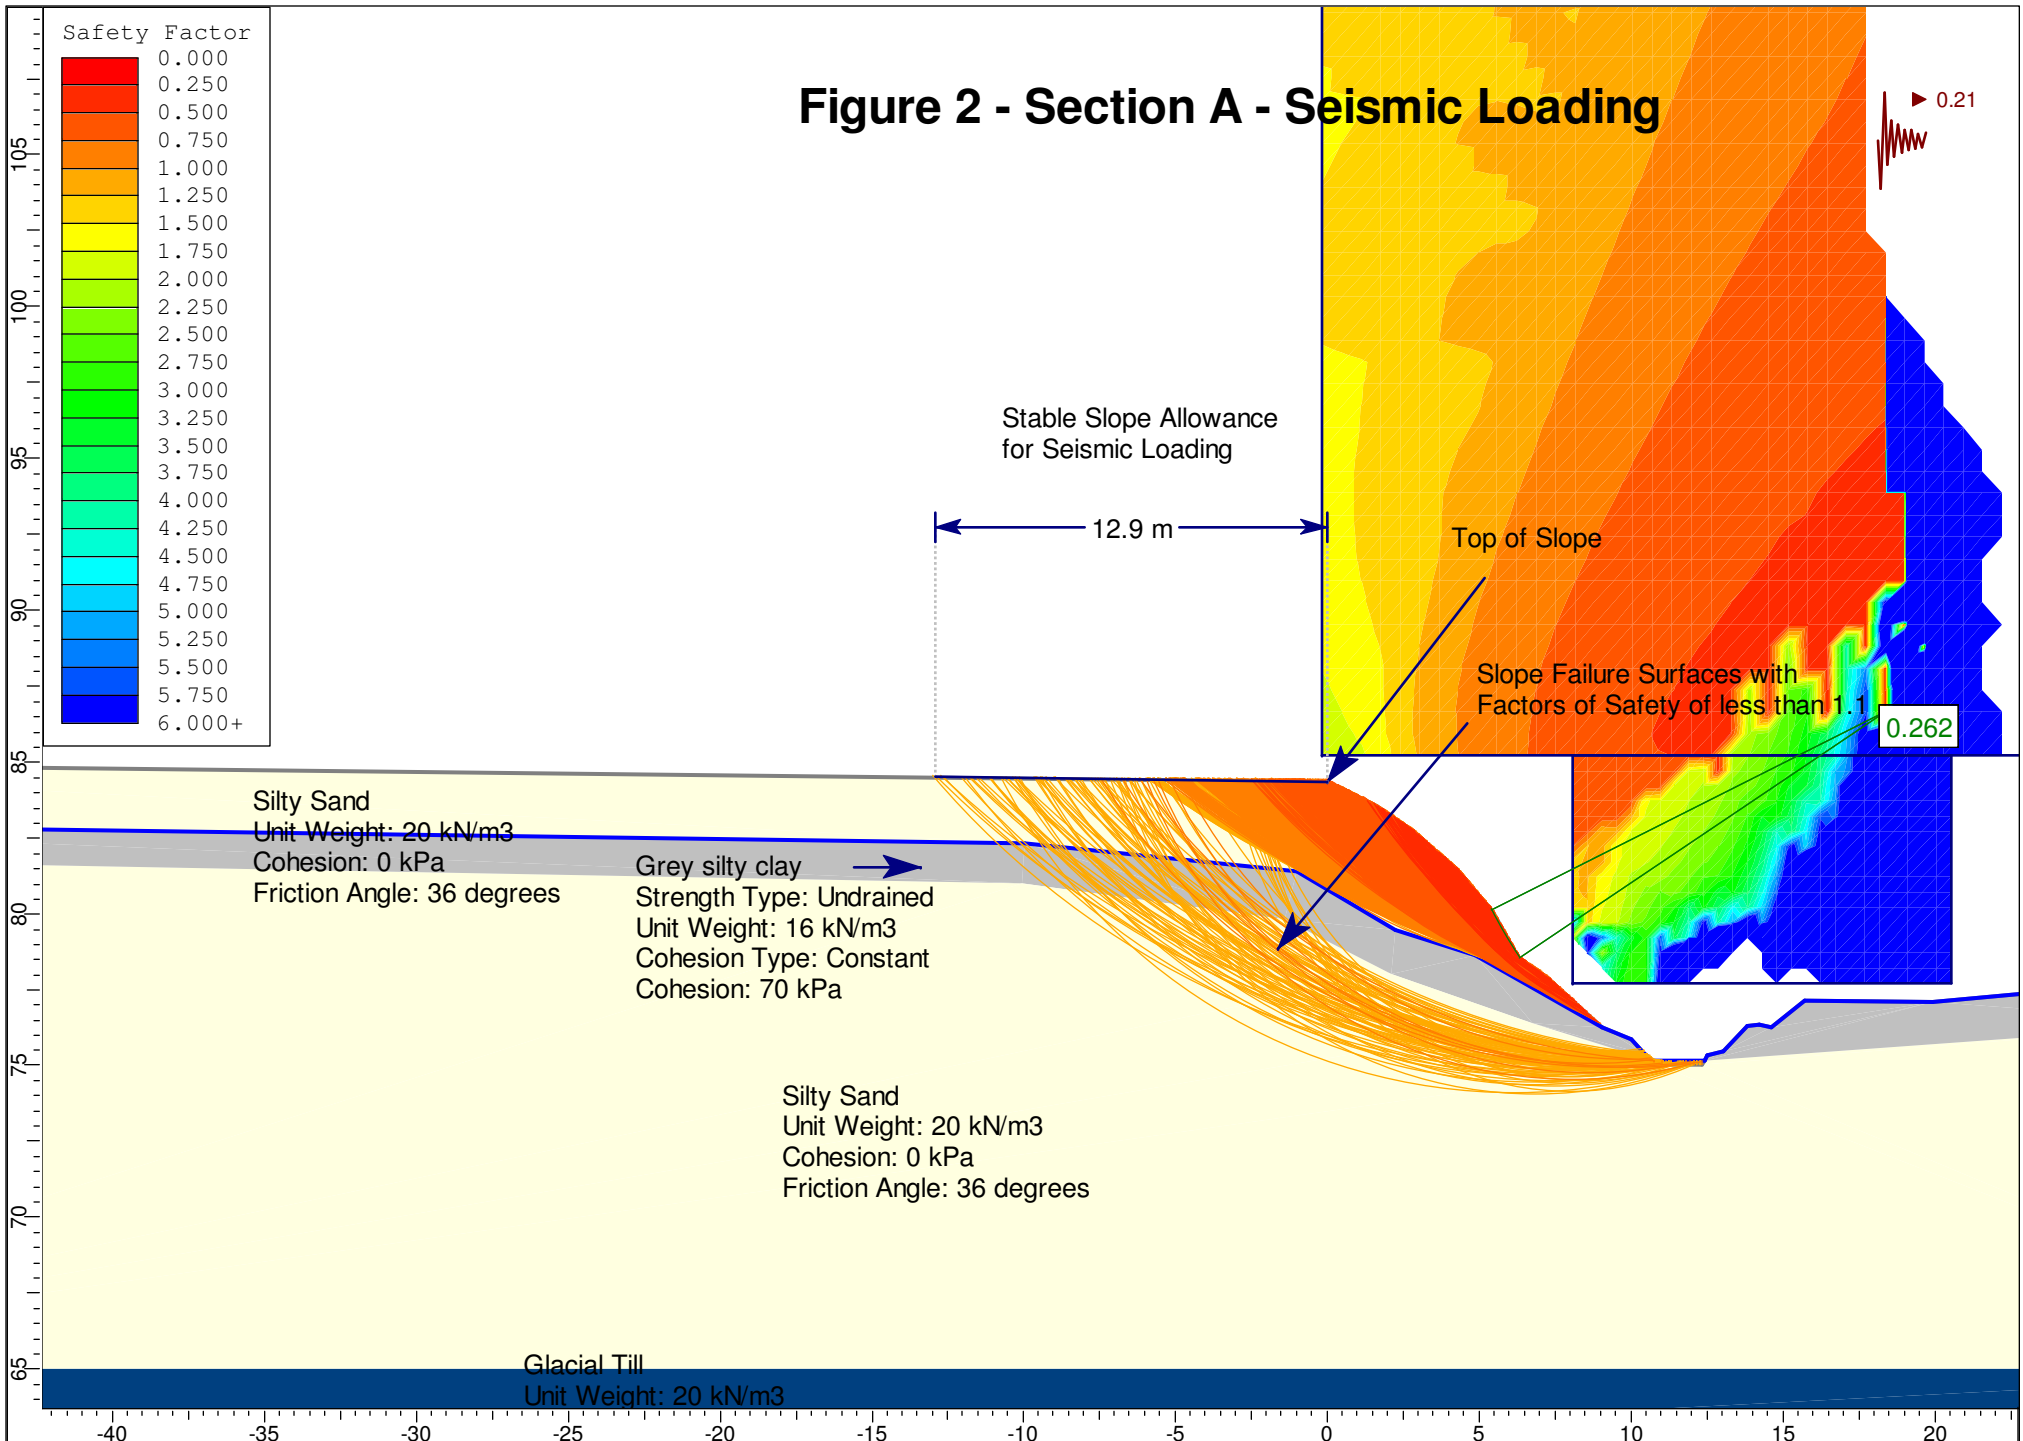
# Figure 2 - Section A - Seismic Loading

The results of the analyses including seismic loading are shown in Figures 2 and 4 for the slope sections. Where the minimum factor of safety is less than 1.1, the stable slope allowance from top of slope required for the slope section is identified in the attached figures.
