# Memo

**To:** Michel Kearney, P.Geo. – City of Ottawa  
**From:** Rob Kell, M.A.Sc., P.Eng., P.Geo., Dillon Consulting Limited  
**cc:** Brent Loney, M.Sc., P.Geo., Dillon Consulting Limited  
**Date:** May 15, 2020  
**Subject:** Review of Caivan - ABIC - Groundwater Field Investigation Memo  
**Our File:** 20-2859

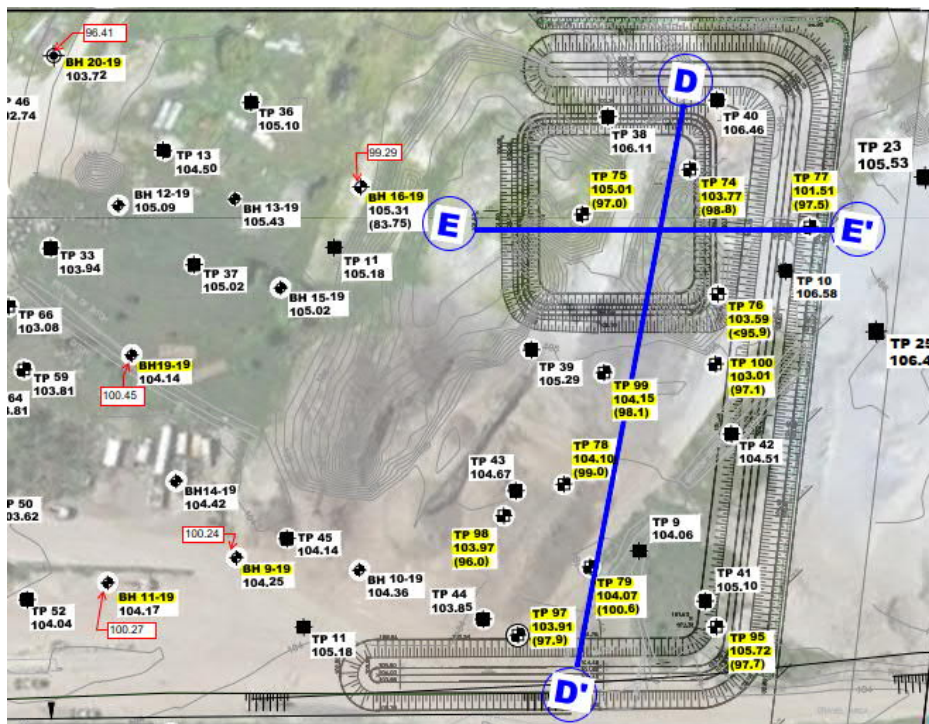
Figure 1 - Site Plan (Plan is from the Paterson Memo with water levels at the monitoring wells / piezometers recorded in November 2019)

Eleven test holes were excavated to approximately 96 to 99 masl on May 6-8, 2020. Four test pits (TP74, TP75, TP76 and TP77) were excavated in the area of the proposed infiltration gallery and one test pit (TP78) excavated in the area of the proposed septic tank to a depth of 5.1 m (99.0 masl). The remaining test pits were located south of the proposed infiltration gallery. Water levels were recorded in the test pits which were left open for about 48 hours. The use of test pits to assess groundwater conditions, while not as technically appropriate as monitoring wells, can be useful to provide a qualitative assessment of near-surface groundwater conditions. Monitoring wells / piezometers were installed in November 2019 west of the proposed and groundwater elevations measured in November 2019 in those installations were generally higher than those measured in the test pits (these levels are tabulated below and are shown on Figure 1 derived from the Paterson Site Plan figure).

With the exception of one test pit (TP74), inferred groundwater levels in the test pits were at or below the bottom elevation of the proposed infiltration gallery 97.5 masl. The water level at TP74 was at 98.8 masl, 1.3 m above the bottom excavation of the proposed infiltration gallery. The higher water level at this test pit was attributed by Paterson to lower hydraulic conductivity fill material noted within the test hole. Paterson states that the lower hydraulic conductivity fill material in the area " ... contains limited groundwater" and concludes that construction dewatering is not expected to be required when constructing the infiltration gallery. We assume that Paterson meant that these materials would conduct less groundwater, such that construction dewatering requirements would be minimal. Dillon has reviewed the groundwater conditions in this general area which indicate that interpolated groundwater levels are generally at an elevation of 97.5 masl (corresponding to the bottom elevation of the proposed Infiltration Gallery). As such, we have no information that would contradict the Paterson conclusion that construction dewatering is not expected to be required.

Test pit TP78 was excavated to a depth corresponding to the proposed bottom of the tank (99.0 masl). The test pit was dry and, as such, Patterson concludes that construction dewatering will not be required during the installation of the septic tanks. It is noted that the water level at TP79 (located approximately 25 m south of TP78) was at an elevation of 100.6 masl. Water levels at other test pits excavated nearby support a groundwater elevation less than 99.0 masl. As stated above, Dillon's review of the groundwater levels in this general area indicates levels less than 99.0 masl, and we have no information that would contradict the Patterson conclusion that construction dewatering is not expected to be required in the area of the septic tank.
