TREE CONSERVATION REPORT

1110 Fisher

Tree Conservation Report submitted as Partial
Requirements for a Zoning Application

Date: May 21, 2019

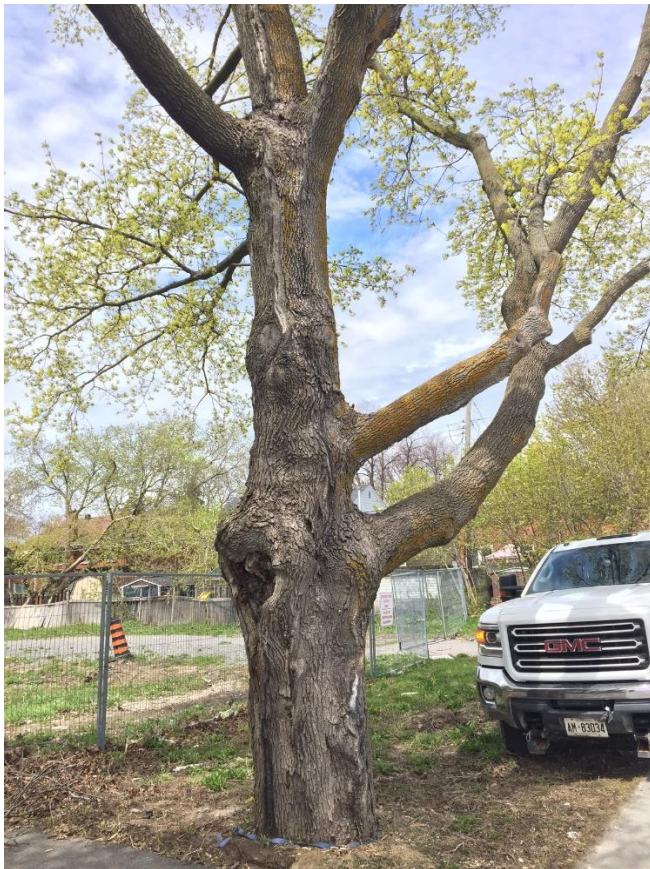
Tree ¹	Species	Diameter at breast height (dbh)	Critical Root Zone (m)	Ownership	Condition	Action
1	Norway maple (Acer platanoides)	78 cm	8 m	City (to be confirmed)	Fair/poor	Proposed removal
2	Norway maple (Acer platanoides)	30 cm	3 m	City (to be confirmed)	Good	Proposed removal
3	Norway maple (Acer platanoides)	8 cm	1 m	City (to be confirmed)	Good	Proposed removal

Figure 1: Tree no. 1 - Norway maple in fair/poor condition on City property

Based on the level of construction proposed at this site, it is recommended that the Norway maples at the front of the property be removed and replaced once construction is complete. Trees no.2 and 3 have been naturally seeded and were most likely not planted by the City.

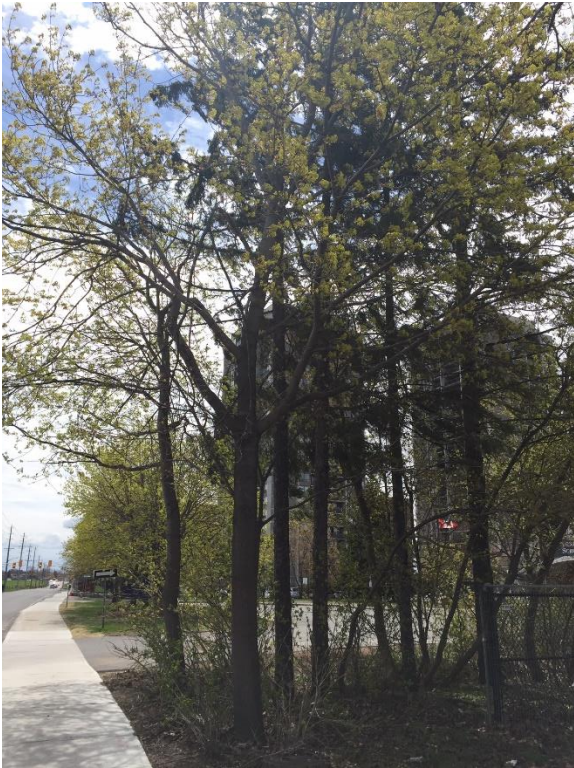
Figure 2: Trees no. 2 and 3 - City-owned Norway maples

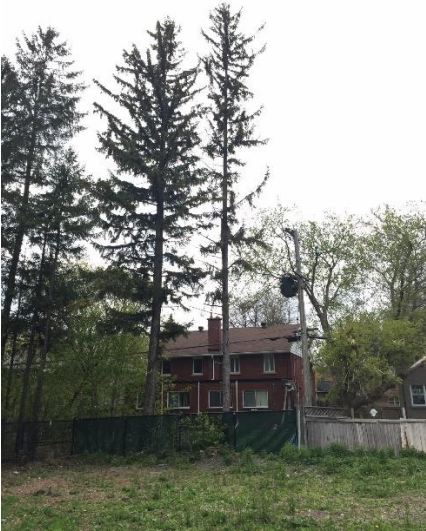
Figure 5: White spruce along the northern property line

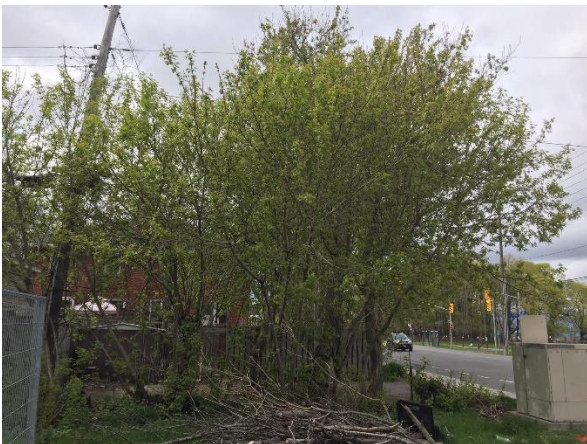
In addition to the above, there are also trees and vegetation located close to the property line on neighbouring property. These have been identified in the Existing Conditions Map provided in this report. This map used the 2015 imagery from geoOttawa. Note that the locations of the vegetation are approximate only. Along the southern property line, there are trees along the east side that range from 25-45 cm in diameter. Along the same southern line, there is a cedar hedge along the west side that is hanging over the property line. A cedar hedge also extends along the west property line. On the northern property line, there are two white spruce on the west side that are close (within a metre) of the property line whose roots may be impacted by work done on the site. Some soil within the root zone has already been disturbed from previous activity. Along the east side, there are some Manitoba maples along the neighbouring property that may require pruning over the property line.

Figure 6: Manitoba maple along the northern property line

In addition, any pruning that is required for trees hanging over the property line should be completed according to good arboricultural practices.
