BLANCHARD LETENDRE ENG

**2490 Orient Park
Ottawa, Ontario**

SEWER CCTV INSPECTION REPORT

Report ID
120475ST1

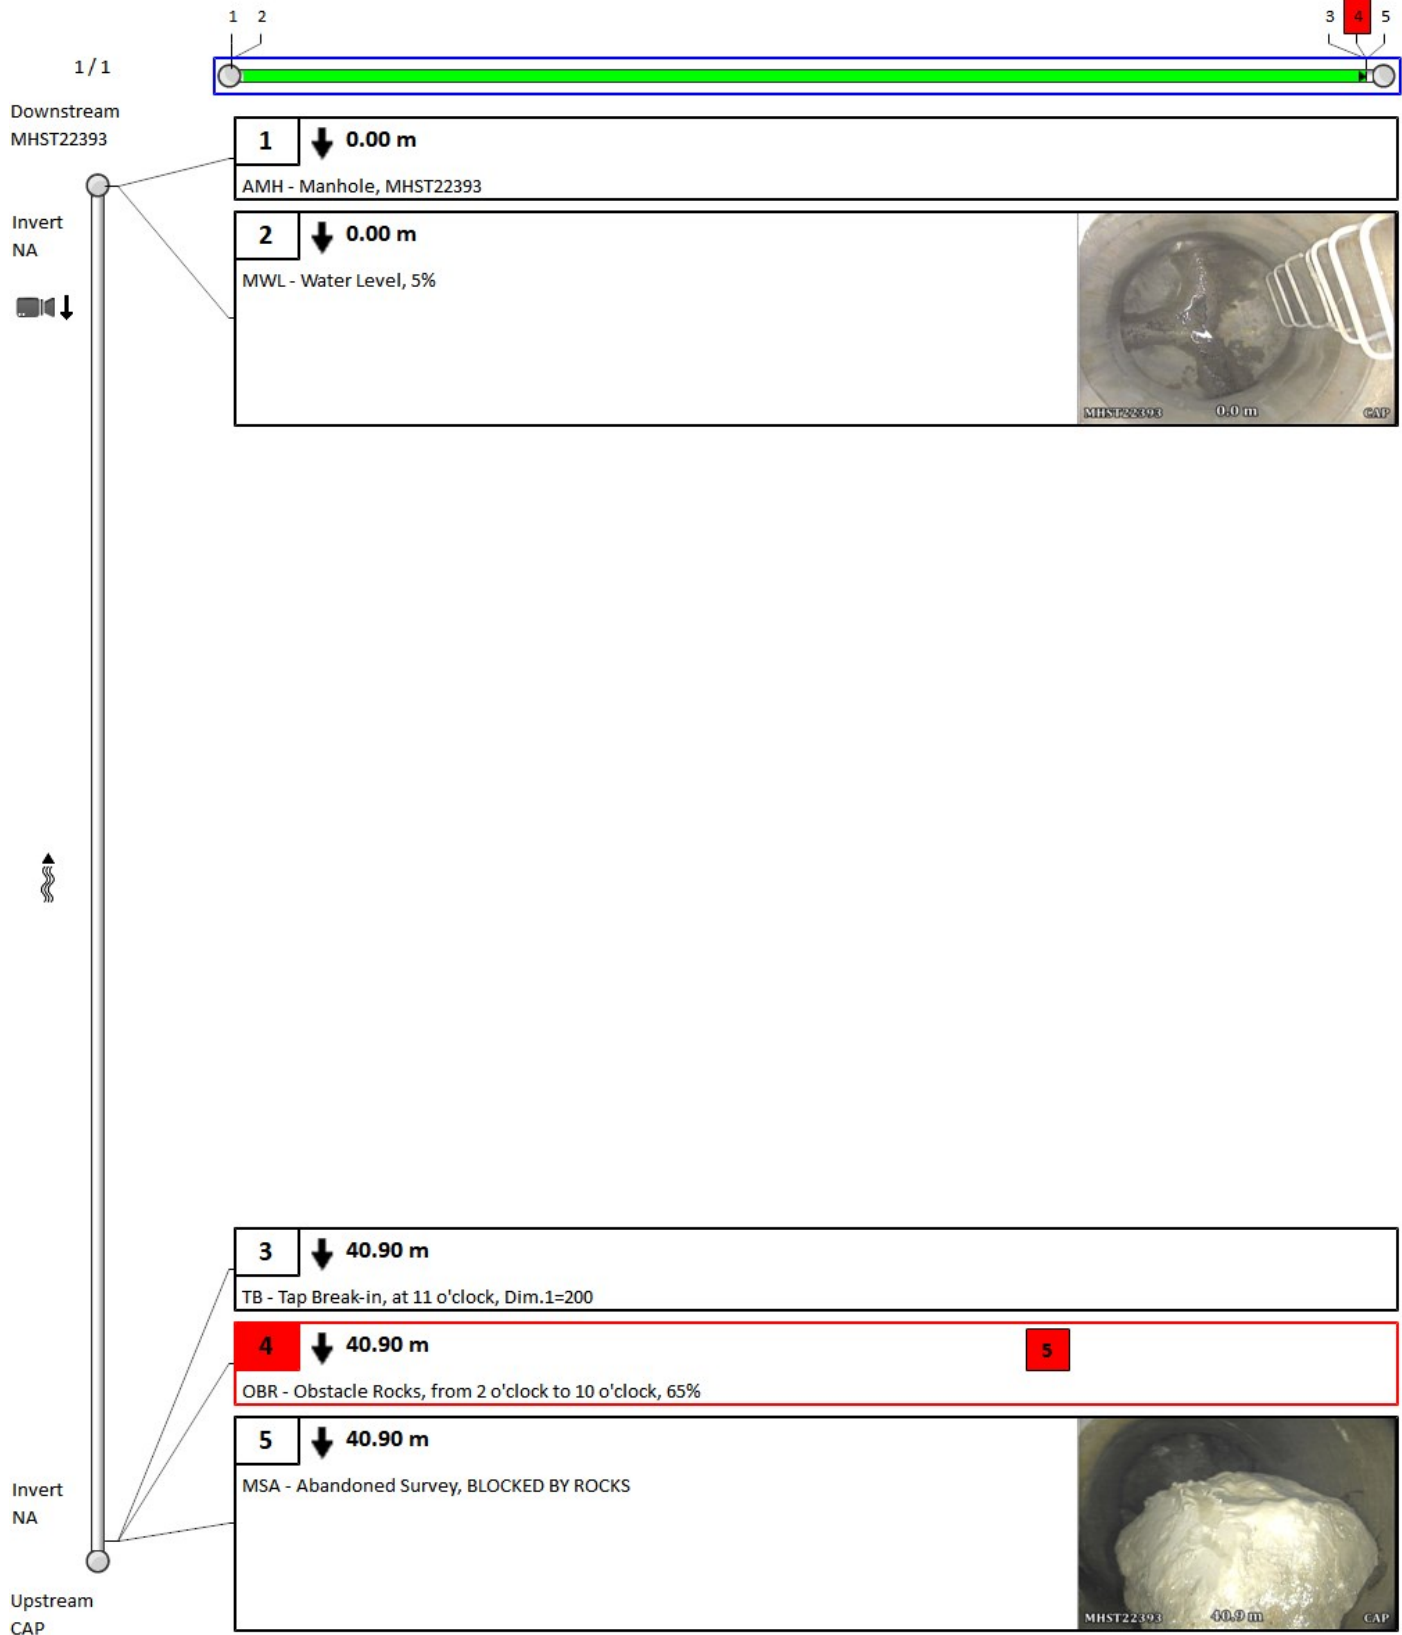
LINE IS AROUND 41.5m BLOCKED BY ROCK
