# TREE CONSERVATION REPORT

2506 Innes Road

## Tree Conservation Report v3.0

**Address:** 2506 Innes Road  
**Date of Report:** September 16, 2024  
**Date of Site Visit:** November 10, 2023  
**Prepared by:** Kevin Myers, ISA Certified Arborist; kevin.myers@dendronforestry.ca  
**Client:** Concorde Properties c/o Jordan Tannis; jt@concorde-properties.ca

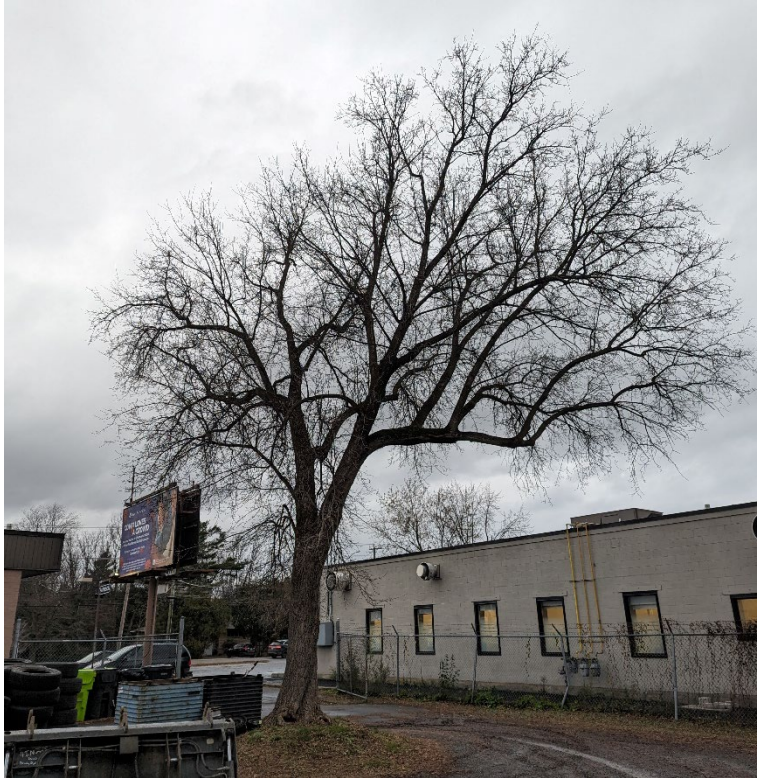
Above: Tree 1 - private manitoba maple to be removed.

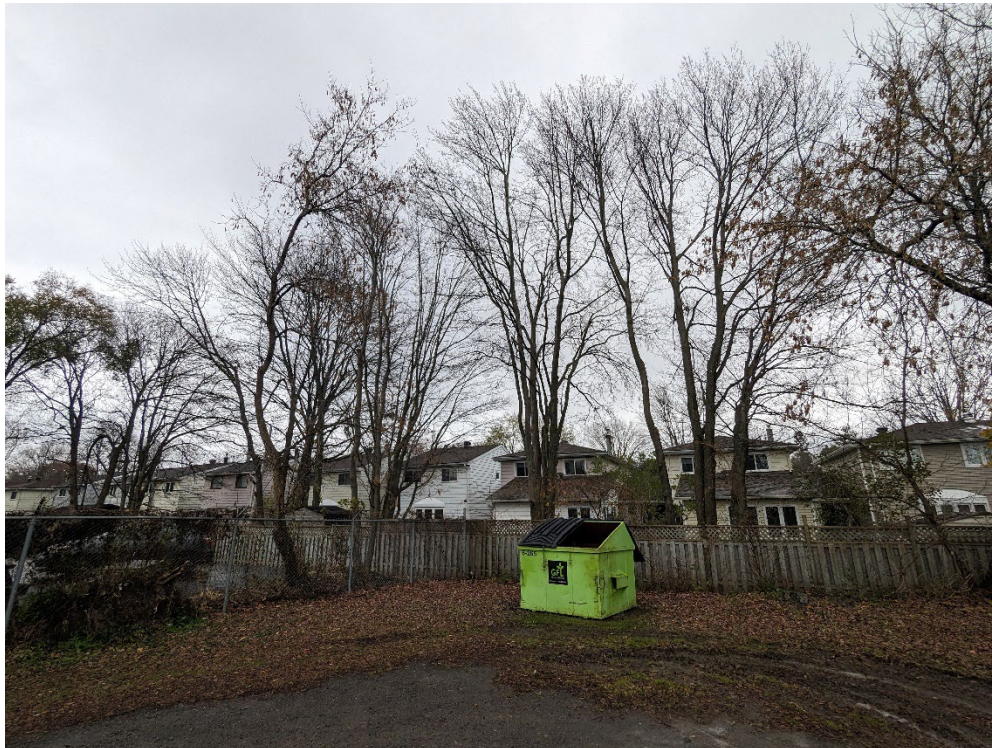
**Trees 4-6** are adjacent maples of varying health and distance from the property line. Due to excavation for the proposed retaining wall and the 75cm grade change, some of these trees are expected to decline quickly and are therefore recommended for removal. However there may be a possibility to retain some stems from the groupings. To accomplish this, the following steps are recommended: that the proposed retaining wall be marked out along the ground, the DBH of each trunk be measured (they were estimated during the site visit) as well as the distance between each trunk and the line for the retaining wall; those that are further than 3x their diameter from the wall can be marked for retention. Then, when it comes time for excavation, the roots can be revealed along the line of excavation and a certified arborist can be on site to ensure that roots are properly severed and no stability concerns remain.

Below: East corner of the property, including Trees 2-6

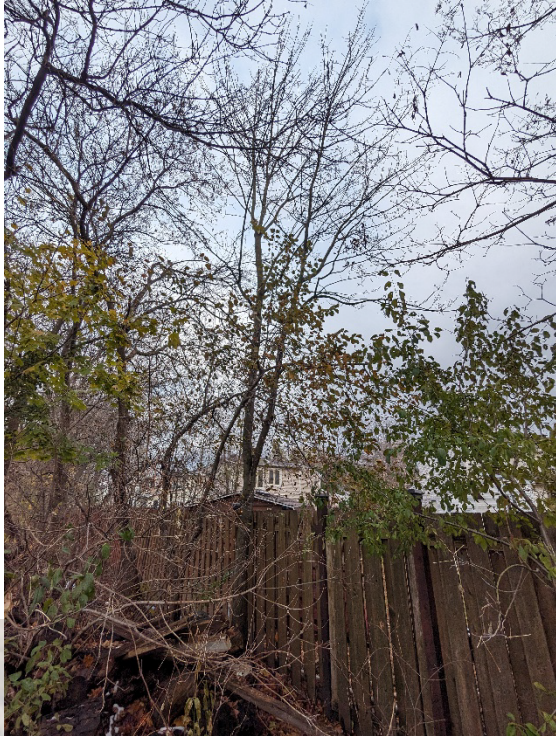
Left: Tree 22 – private maple to be removed.

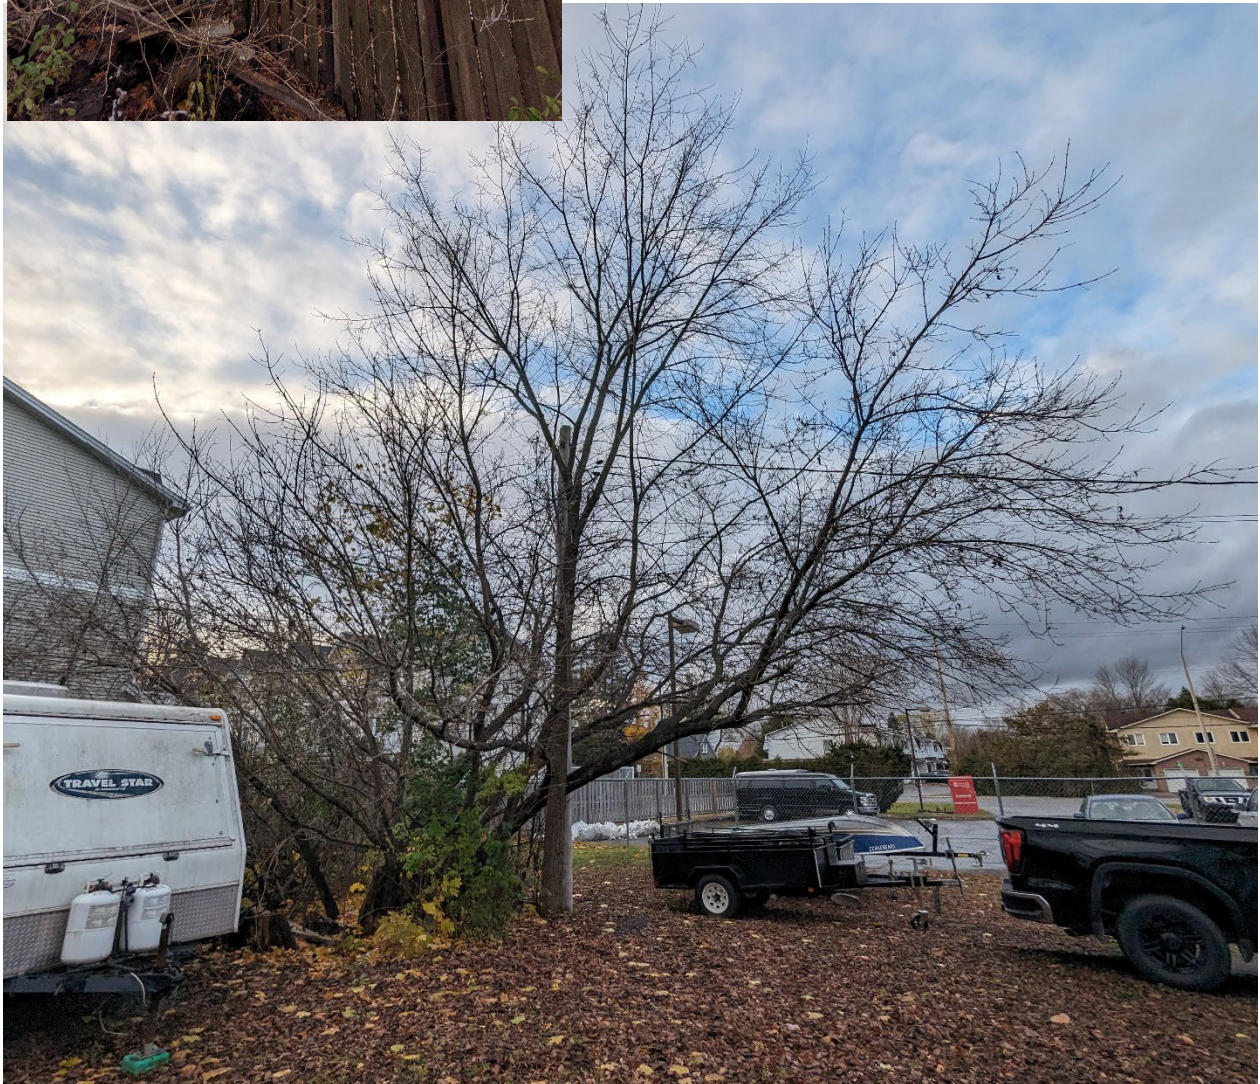
Below: Trees 34-36 - to be removed
