March 27, 2026
CO680.02

**Subject: Test Pits Excavation Report
Elmwood Senior School Addition Project
261 Buena Vista Road, Ottawa, ON, K1M 0V9**

Terrapex Environmental Ltd. (Terrapex) has been retained by Farrow Partners Architect (FPA) to carry out test pit investigation in support of the proposed addition to the existing Elmwood Senior School Building (the Project) located at 261 Buena Vista Road (Site) in Ottawa, Ontario.

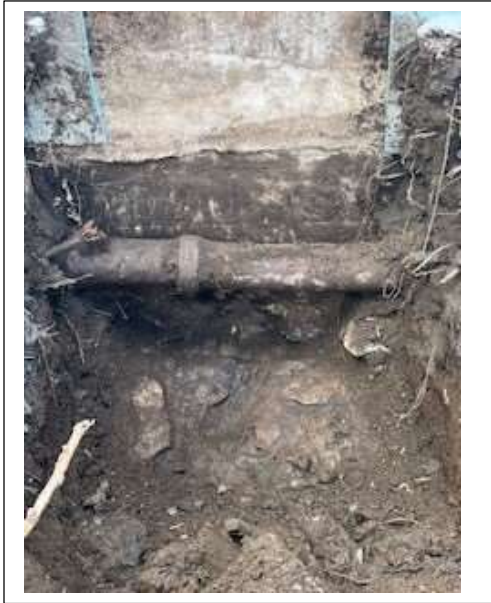
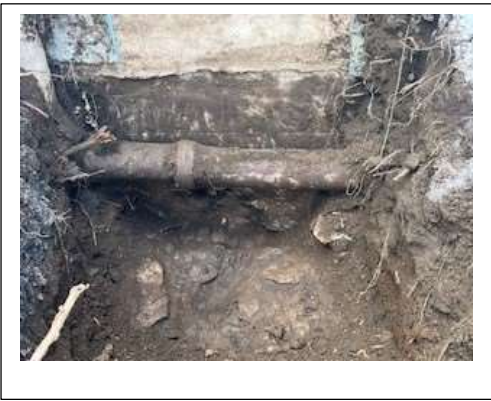
Test Pit No. 1

- Exposed Shallow Bedrock Surface and Footing
- Sanitary pipe

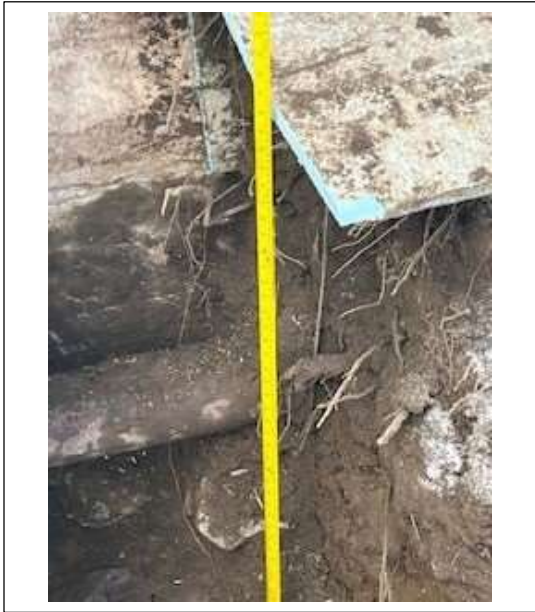
Description	TP-1	TP-2		TP-3	
		North-South Wall		East-West Wall	
Foundation Type	Rubble foundation mixed with concrete founded on bedrock	Concrete footing founded on bedrock	No Foundation observed under the wall		Concrete footing founded on bedrock
Footing thickness	0.13 (rubble footing)	0.35	N/A		0.35
Depth to Top of Footing (*mbgs)	0.95	1.61	N/A		1.56
Footing Width (**m)	-	0.25 m (approximate)	N/A		0.25 m (approximate)
Depth – Bedrock Surface *(mbgs)	1.08	1.96	N/A		1.91

Depth from bedrock surface to existing grade

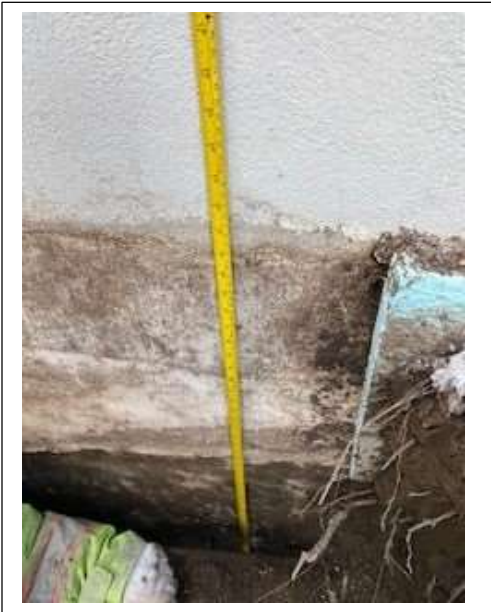
Depth from top of footing to existing grade

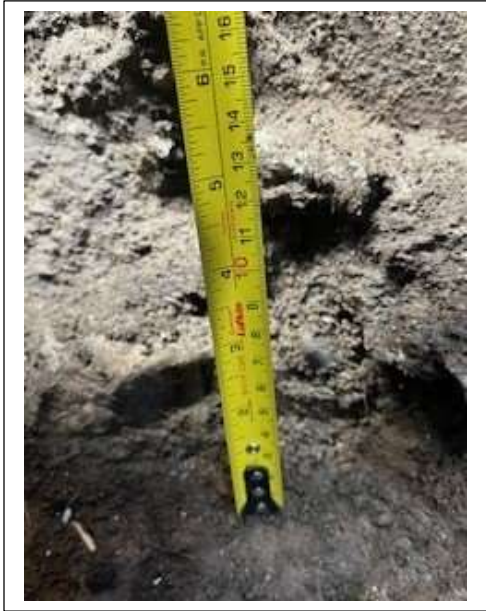
Underside of footing to top of footing (rubble footing)

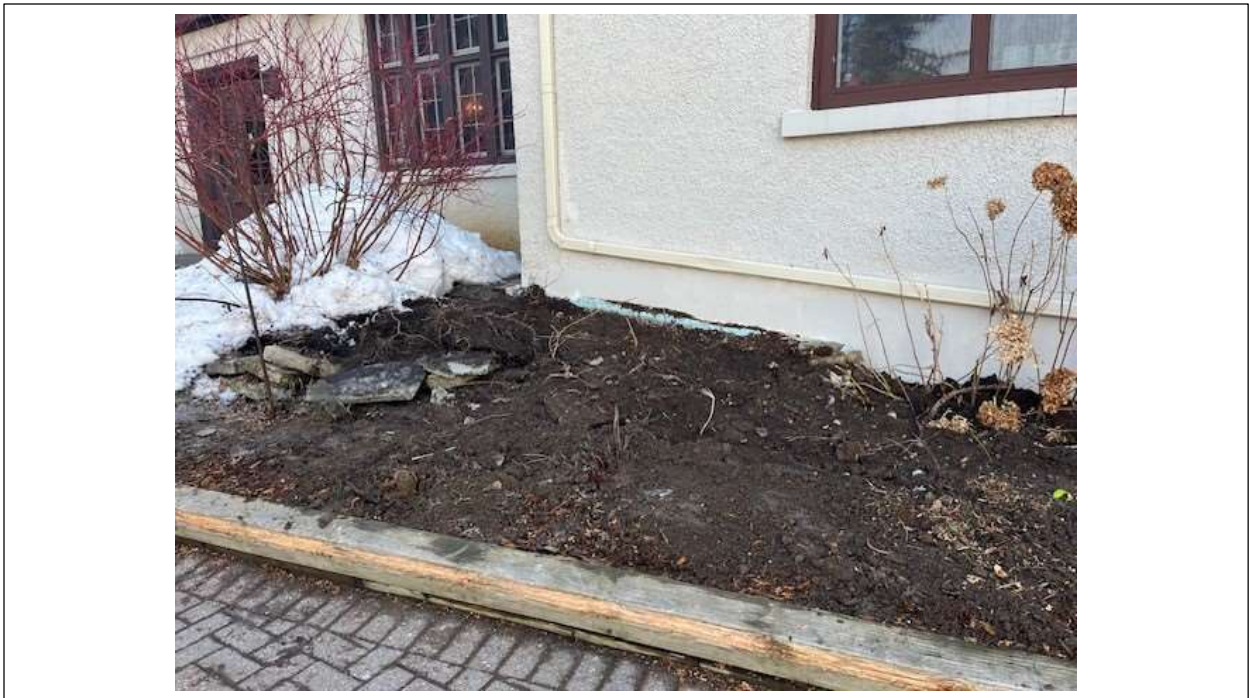
Backfilled pit location

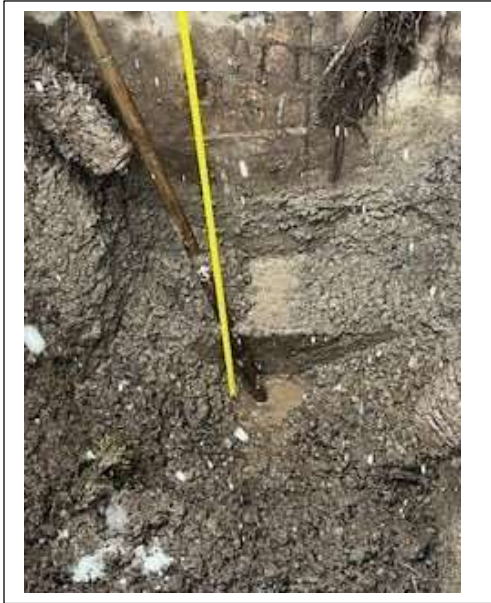
Test Pit No. 2

Exposed footing & bedrock surface (ponding water at the bedrock surface)

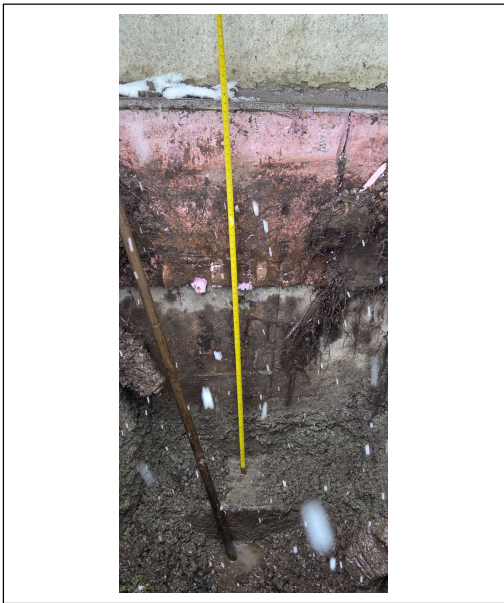
Depth from top of footing to surface

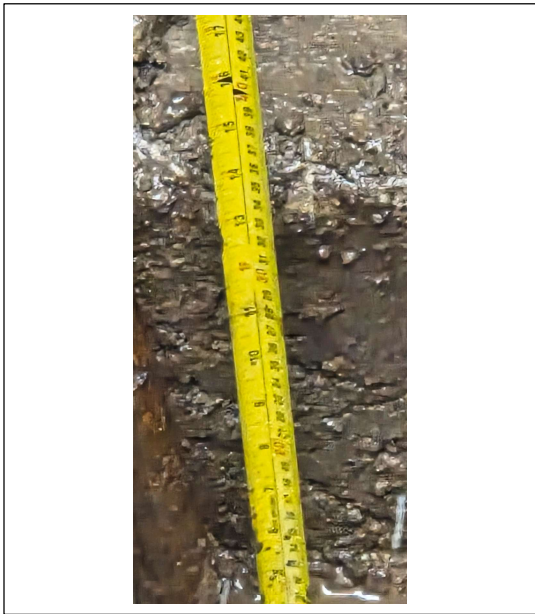
Depth from underside footing to top of footing

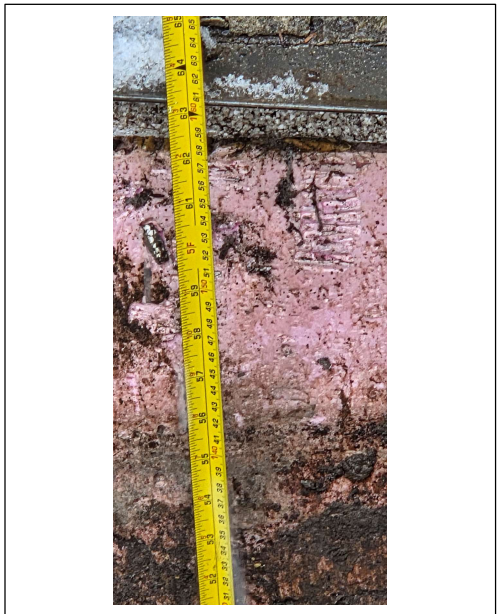
Depth from top of footing to existing grade

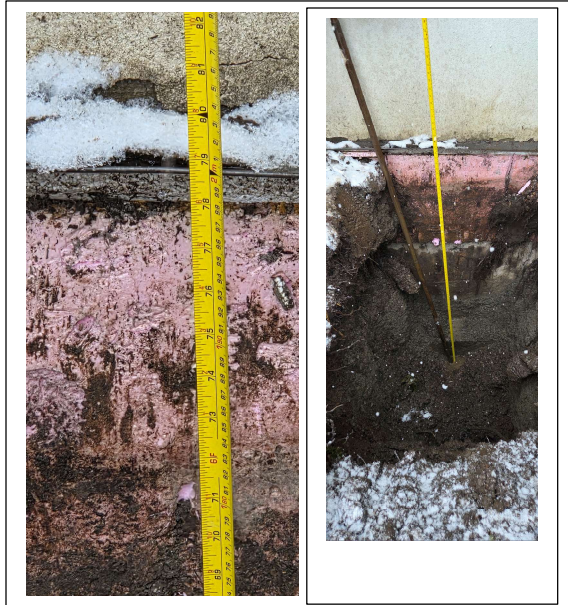
Depth from Bedrock Surface to existing grade

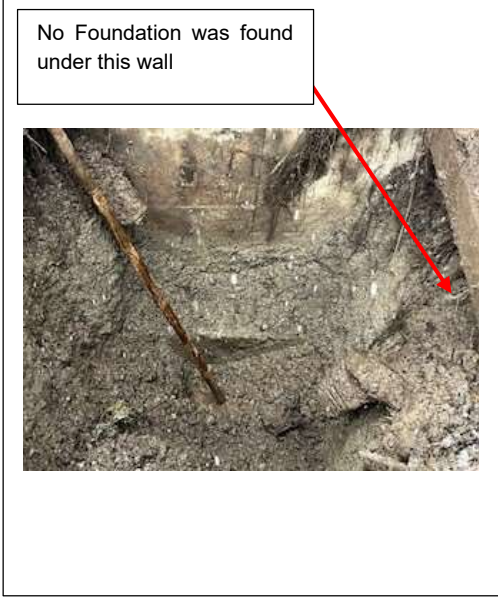
Exposed Bedrock Surface.
No Foundation was observed under the adjoining wall

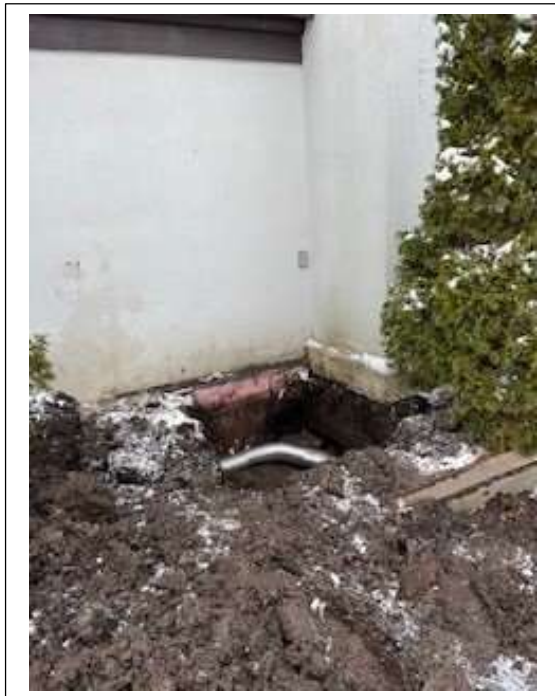
Pit Backfilled – Drain Tile Reinstated

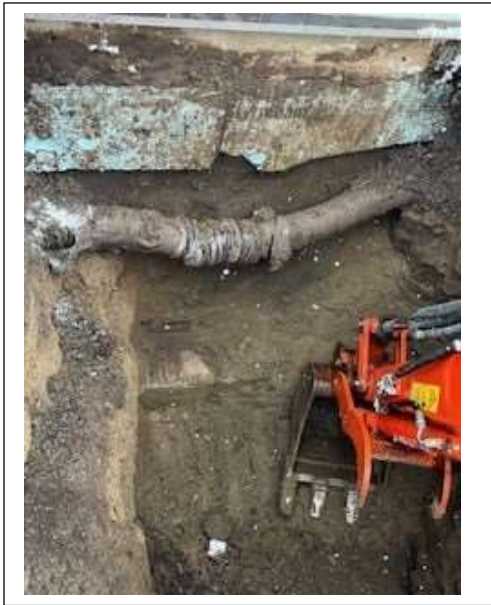
Test Pit No. 3

Exposed Footing

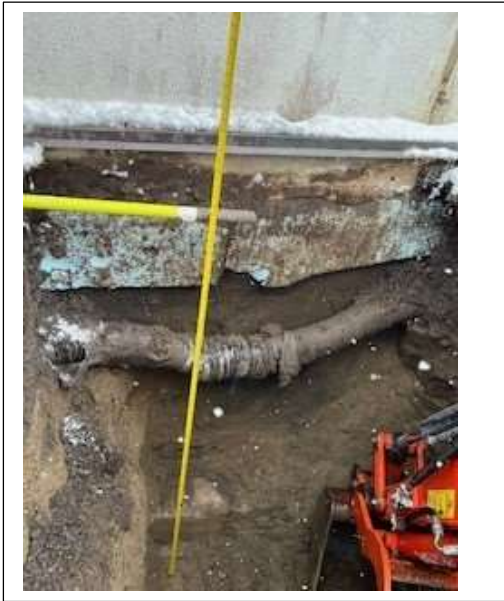
Depth from underside footing to existing grade

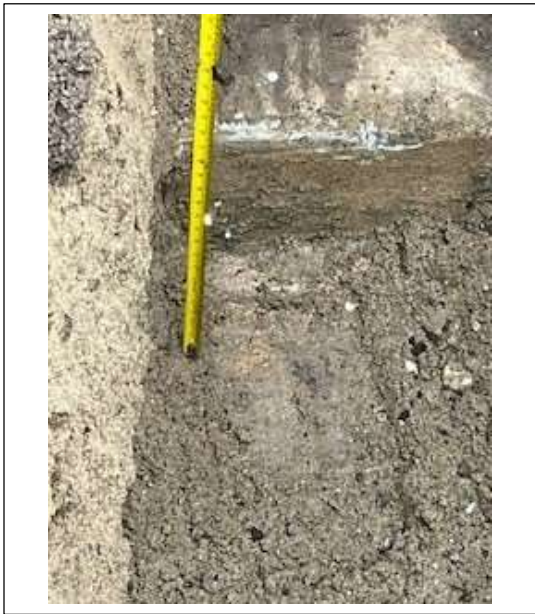
Exposed Bedrock Surface

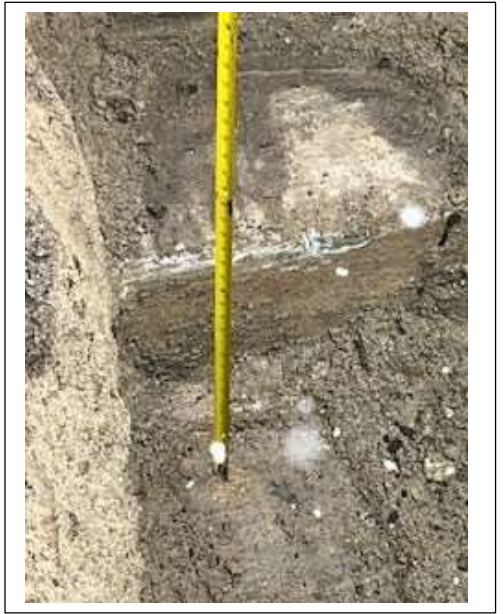
Exposed Footing & Bedrock surface
