March 24, 2021

File: 64913.01 – R01

**Re: Slope Stability Assessment
5497 Manotick Main Street
Manotick (Ottawa), Ontario**

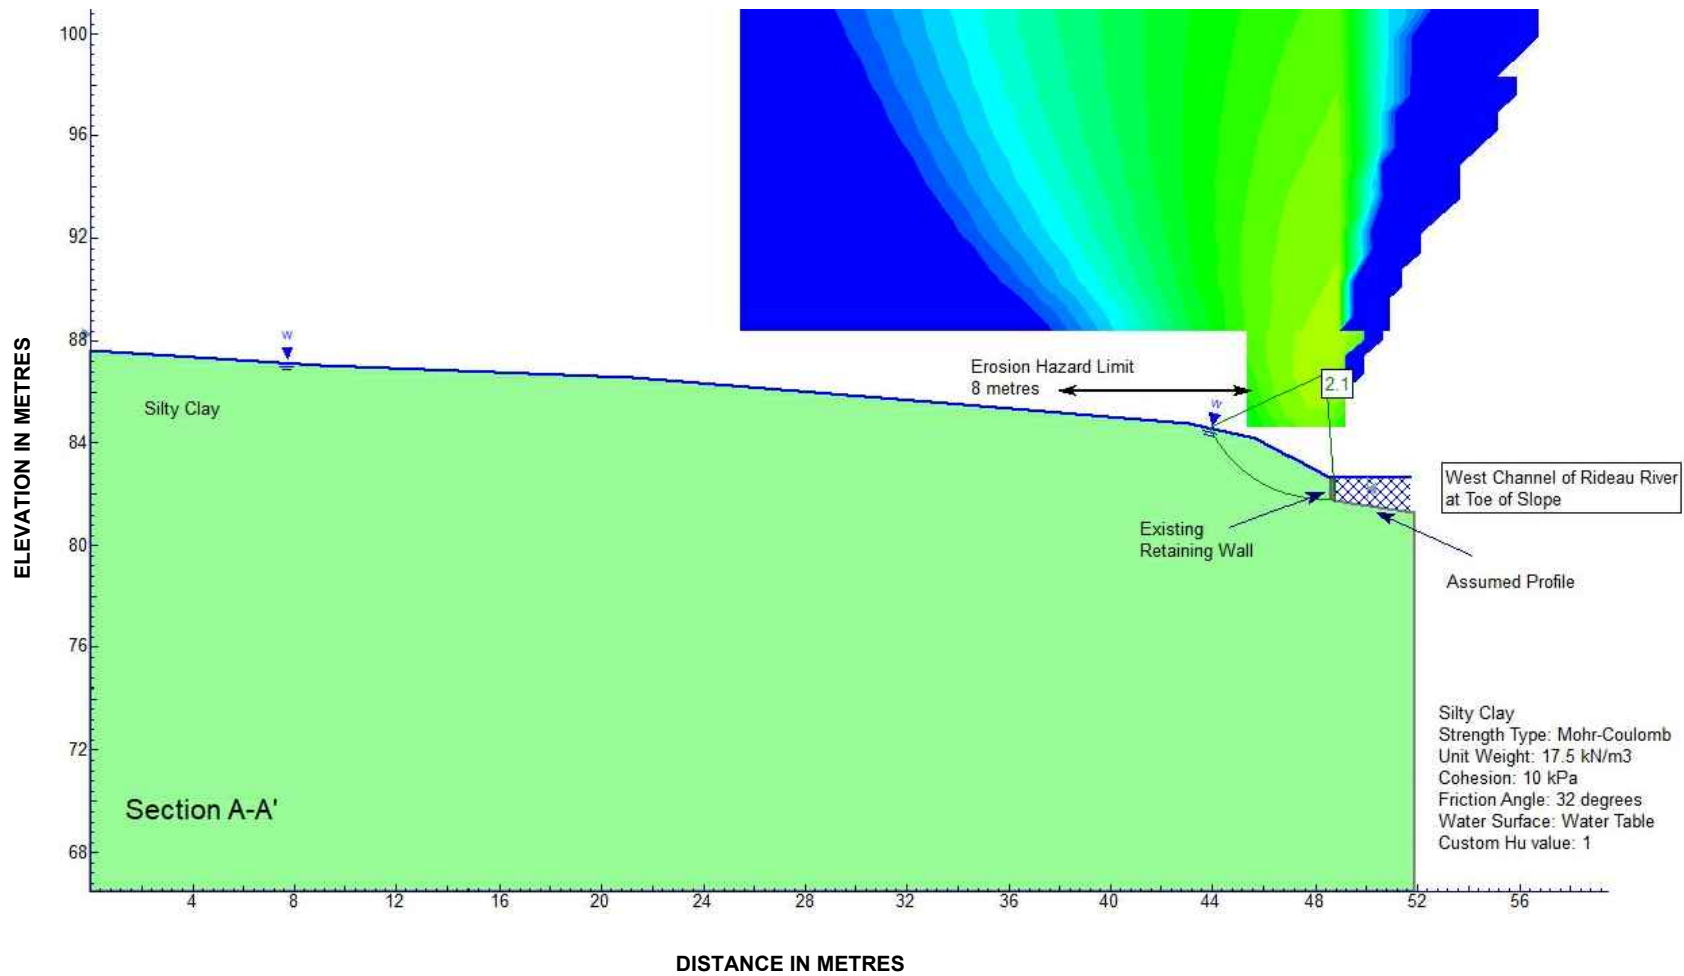
The slope stability analyses indicate that the existing slope, in its current configuration, has a factor of safety against overall rotational failure of about 2.1 and 3.1 for Sections A-A' and B-B', respectively. Based on the slope stability analyses, the factors of safety against overall rotational failure for static loading conditions are considered to indicate adequate long term stability. The results of the stability analyses are provided on Figures A1 and A2 in Attachment A.

- The Stable Slope Allowance, as described in the MNR procedures, is the area where a factor of safety of less than 1.5 against overall rotational failure is calculated. The slope stability analyses indicate that the slope has a factor of safety against failure of greater than 1.5 (refer to Figures A1 and A2 in Attachment A). Therefore, the Stable Slope Allowance described in the MNR procedures is not required.

Therefore, the Erosion Hazard Limit for the slope at this site is located about 8 metres from the crest of the existing slopes at Sections A-A' and B-B' (refer to figures A1 and A2). It may be possible to reduce the Toe Erosion Allowance if an additional site visit is carried out when the water levels have receded in order to confirm the state of erosion along the slope toe at the base of the existing retaining wall.

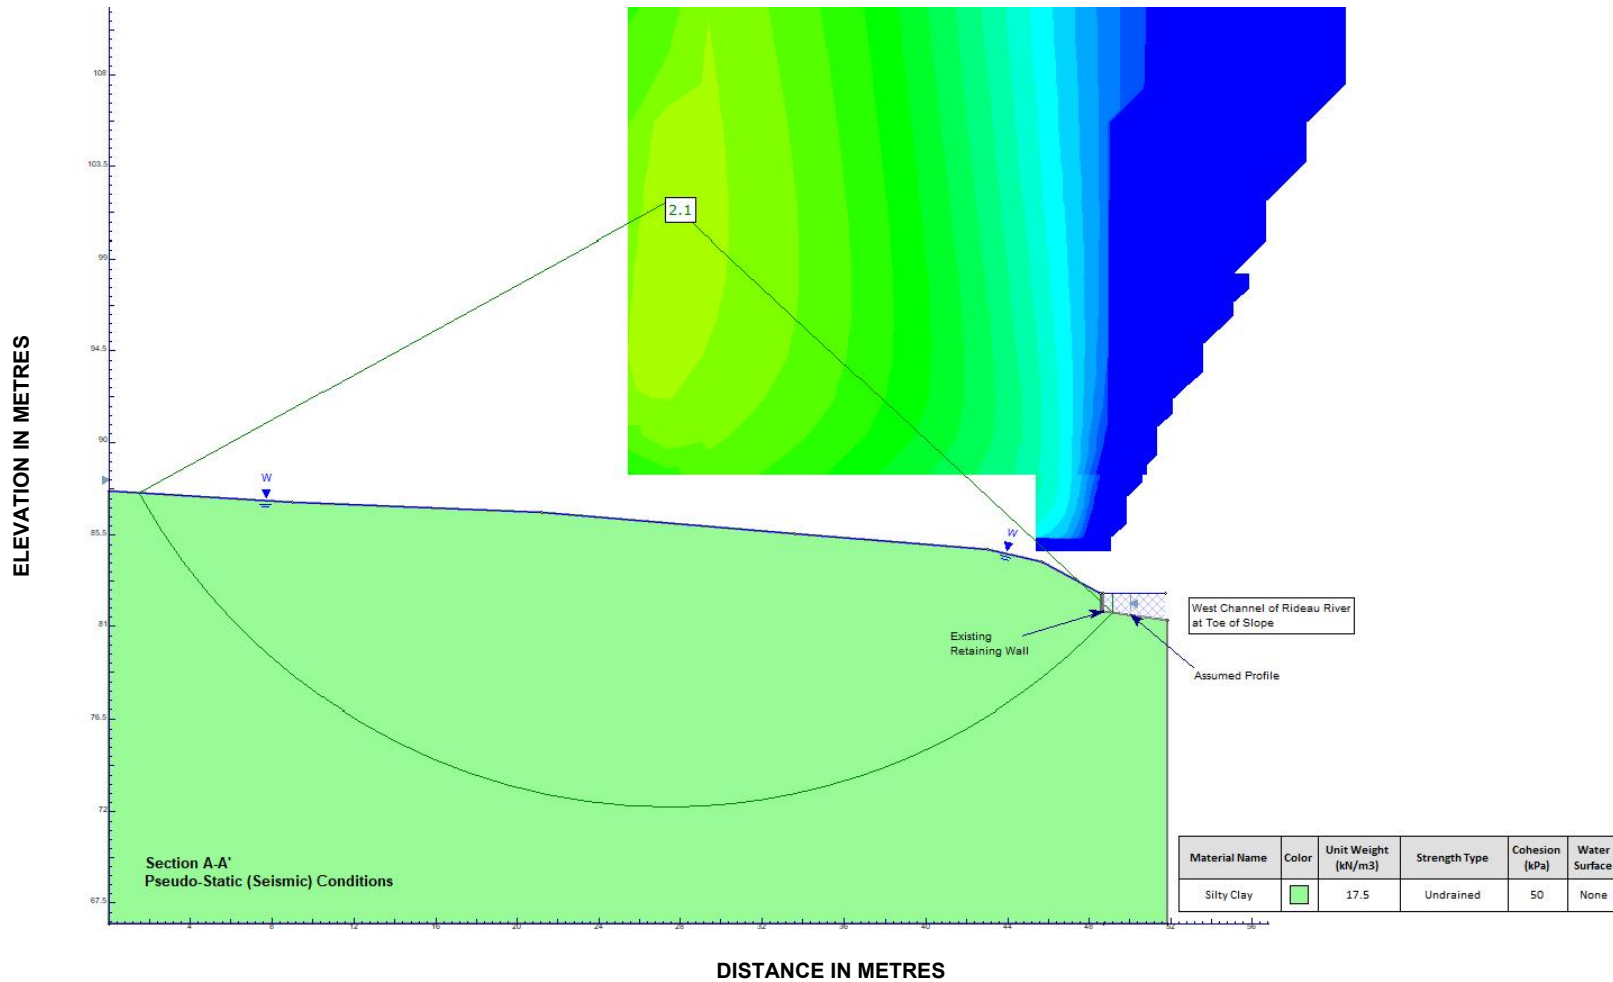
The slopes at Sections A-A' and B-B' were analysed for pseudo-static (seismic) conditions using the undrained silty clay strength parameters. A seismic coefficient of 0.14 was used in the pseudo-static analyses (i.e., half of the Peak Ground Acceleration for Ottawa (Barrhaven) according to the Ontario Building Code 2015). The slope stability analyses indicate that the existing slopes, in their current configurations, have a factor of safety against failure of greater than 1.1 for pseudo-static (seismic) conditions, which is considered acceptable. The results of the pseudo-static stability analyses are provided on Figures A3 and A4 in Attachment A.

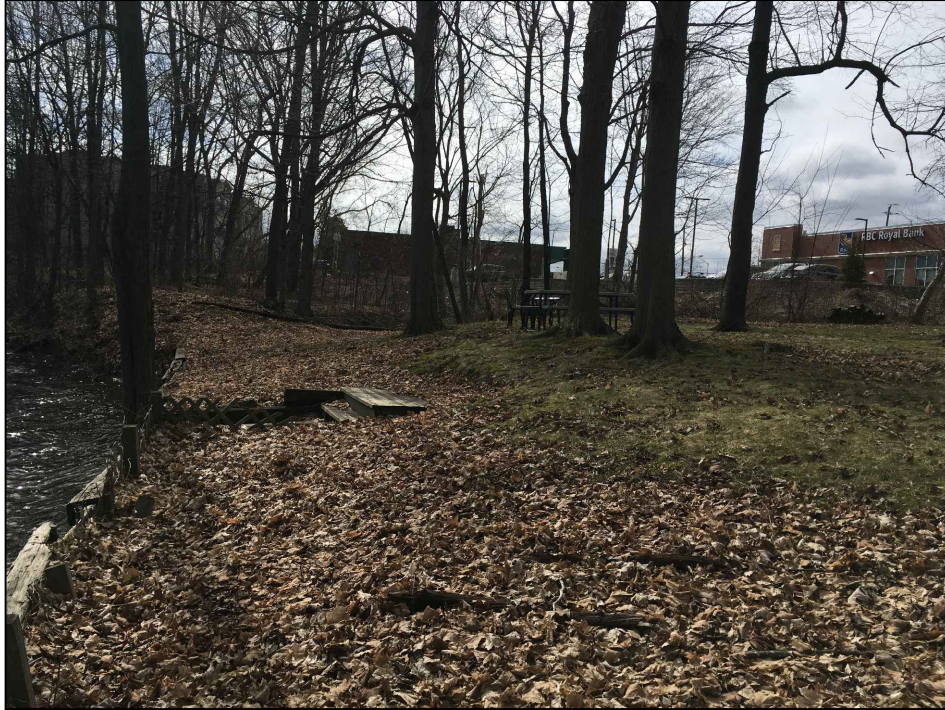
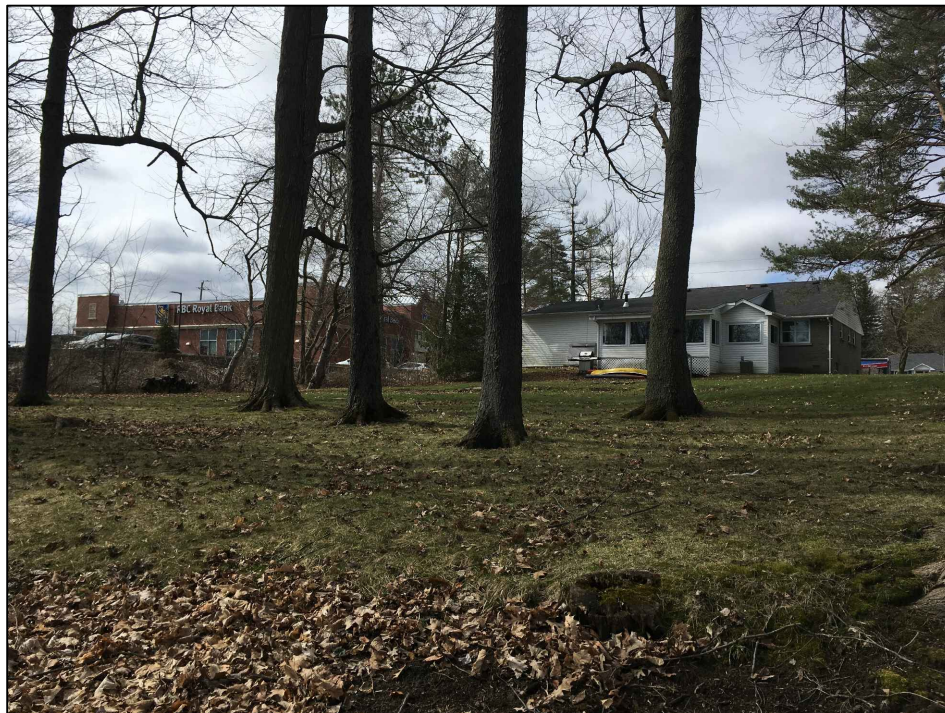
FIGURE B1

- The slopes at the property are relatively flat and are vegetated with grass and large trees.
- An existing timber retaining wall is located at the toe of the slope.
- The river's edge was located at the retaining wall at the time of the site reconnaissance and, as a result, the conditions at the toe of the retaining wall could not be observed.
- Based on visual observations, the height of the retaining wall appears to be less than 1 metre.
- No signs of active erosion or instability were observed at the subject site (i.e., tension cracks, rotational failures, etc.) at the time of the site reconnaissance.

GEMTEC recommends that the existing vegetation and trees along the slope be maintained, to ensure the stability of the slope is not affected.
