February 7, 2023

File: 64913.01 – R03

**Re: Slope Stability Assessment  
5497 Manotick Main Street  
Manotick (Ottawa), Ontario**

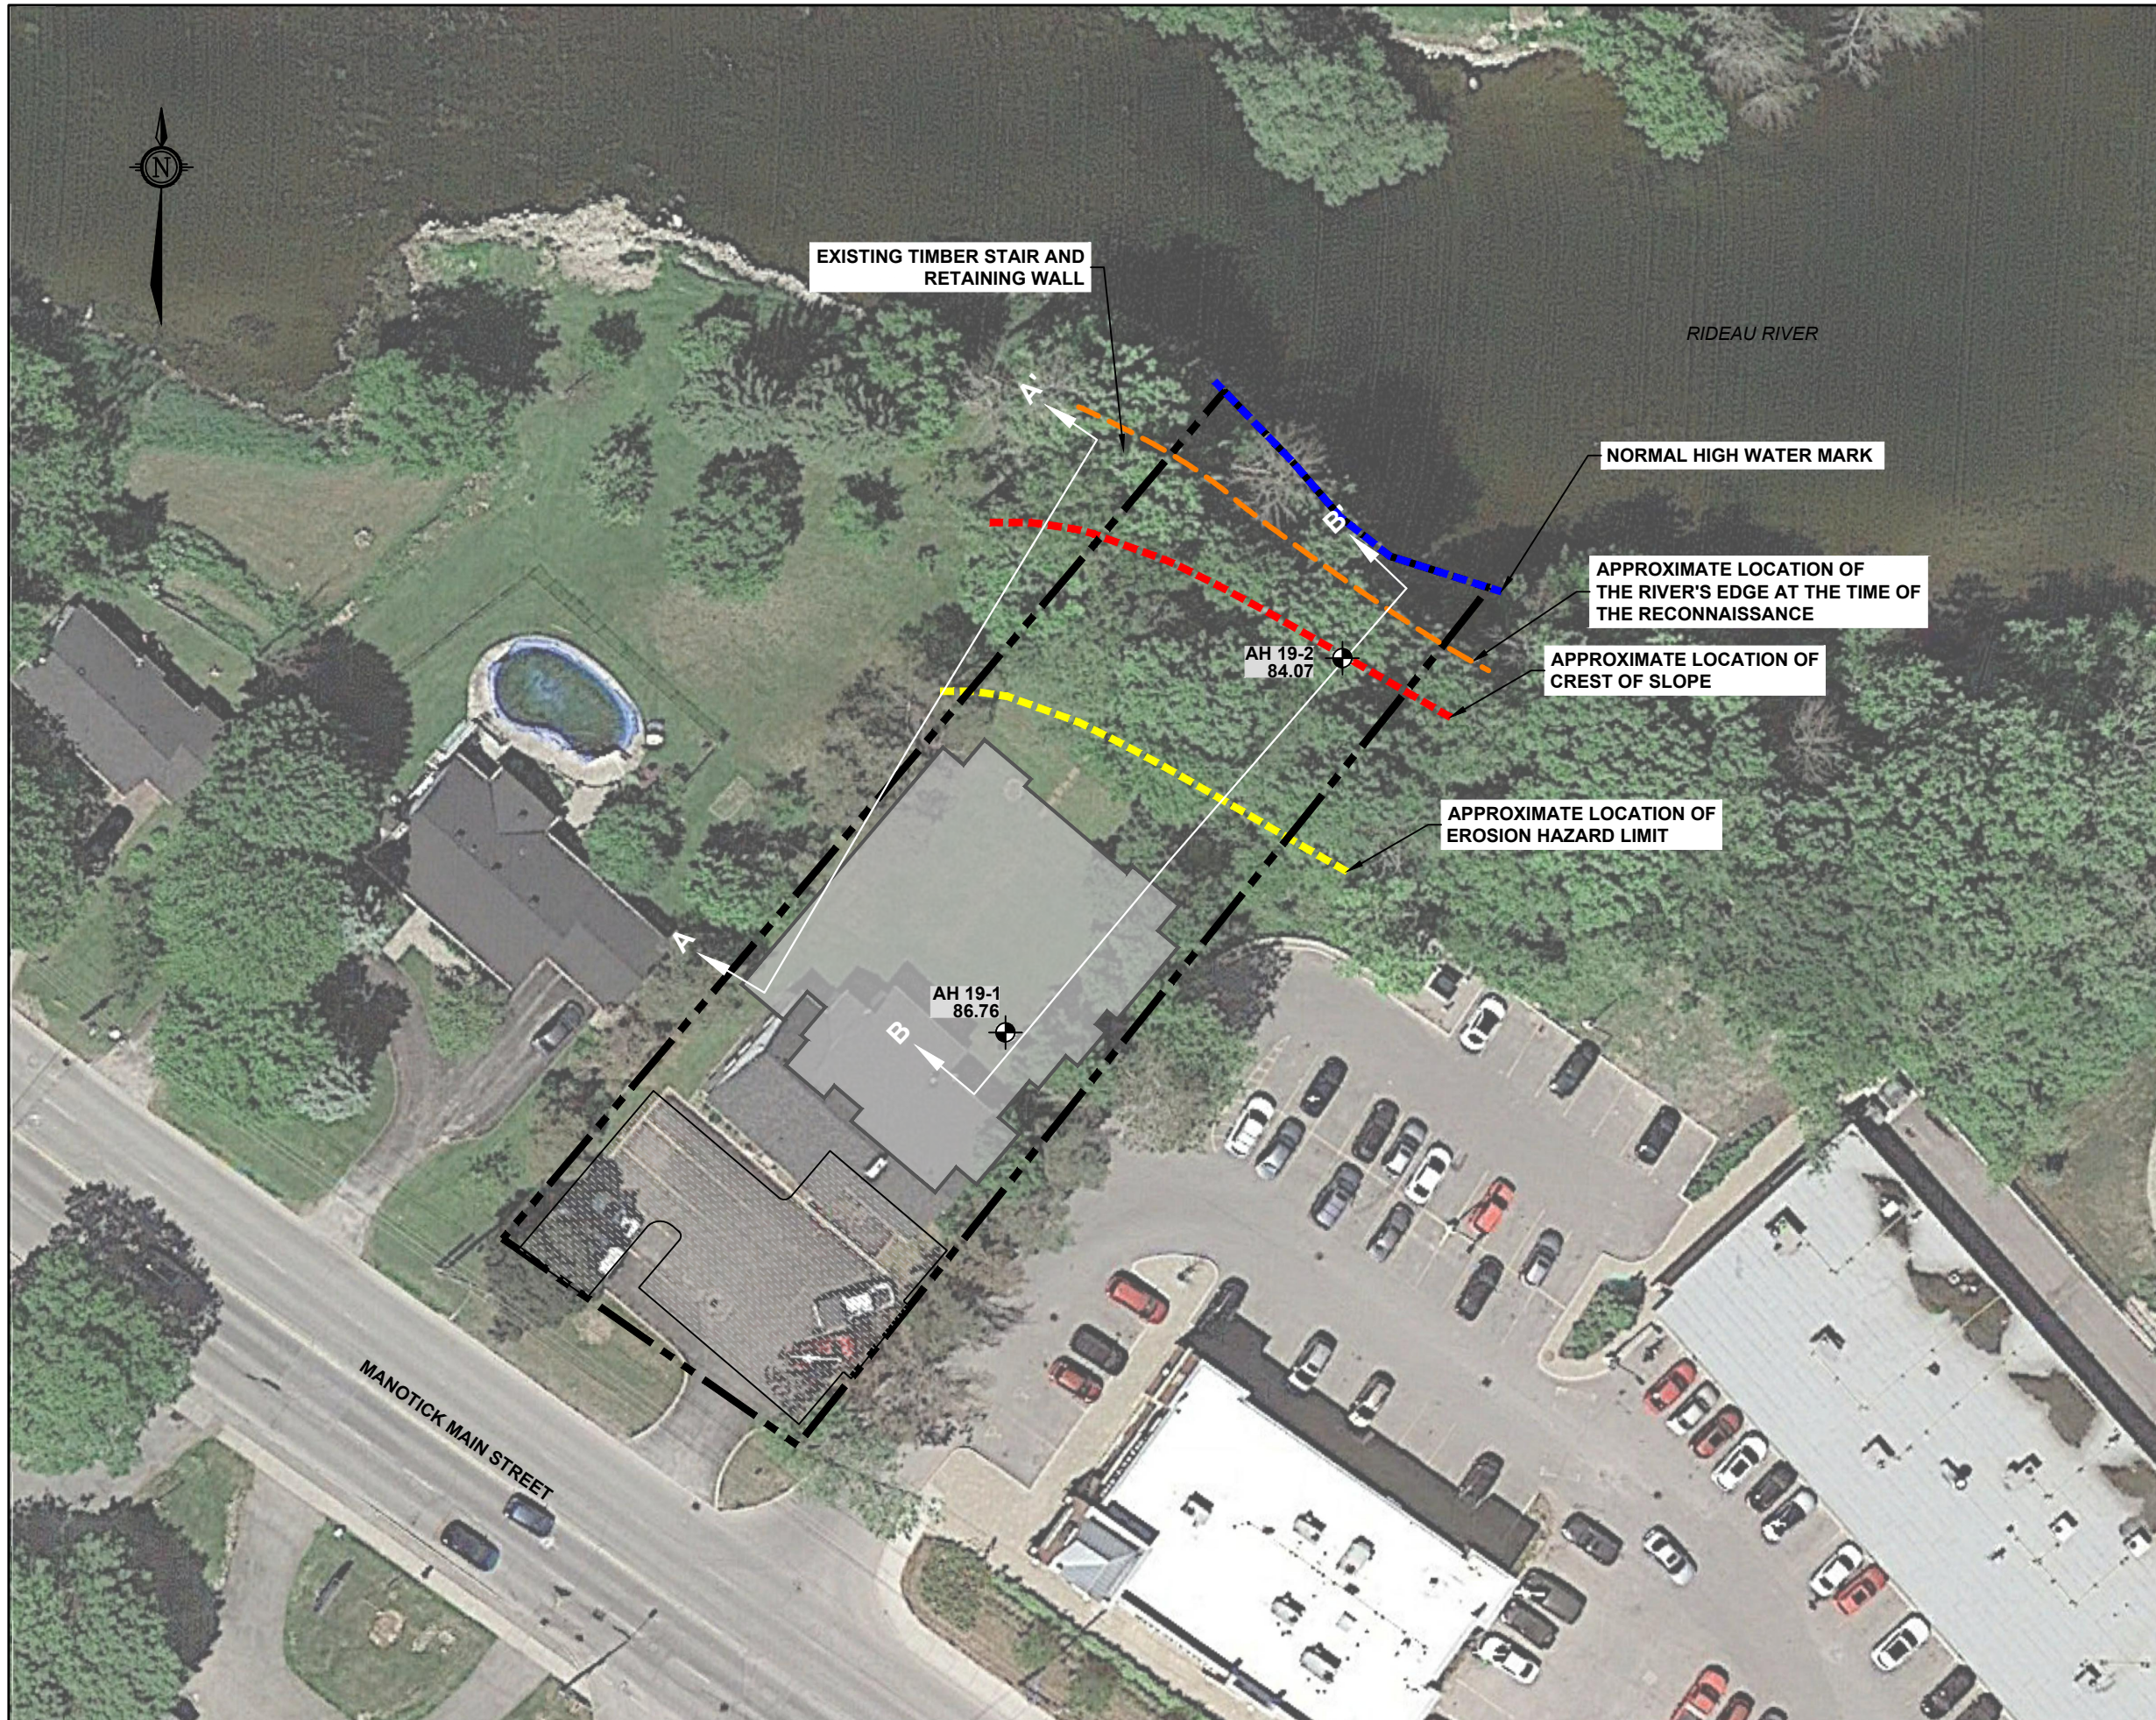
Client		OLIGO GROUP	Project	64913.01
Location		5497 MANOTICK MAIN STREET MANOTICK, ON		
Drwn by	Chkd by	SITE PLAN		
S.L.	D.C.			
Date	FEBRUARY, 2023	Rev.	2	<b>FIGURE 1</b>

It is noted that at the time of the site reconnaissance the Rideau River was experiencing high water levels and based on a review of aerial photographs, the river's edge had advanced up the toe of the slope. The approximate location of the river's edge at the time of the site reconnaissance is shown on Figure 1. Also shown on Figure 1 are the main components of the proposed development based on the Site Plan prepared by P2 concepts dated May 2022 (which was not available to GEMTEC at the time of initial submission of this letter).

The proposed position of the Erosion Hazard Limit is shown on Figure 1, as well as an estimate of the location of the crest of slope line. The location of the crest of slope was not readily identifiable on site during GEMTEC's site visit due to the relatively shallow slopes (refer to the site photographs in Appendix B). A top of slope line is identified on P2 concepts Site Plan south of the existing retaining wall which may be used for reference.

Therefore, the Erosion Hazard Limit for the slope at this site is located about 14 metres from the crest of the existing slopes at Sections A-A' and B-B' (refer to Figures A1 and A2). It may be possible to reduce the Toe Erosion Allowance if an additional site visit is carried out when the water levels have receded in order to confirm the state of erosion along the slope toe at the base of the existing retaining wall. However, this may not be warranted, should the proposed development not be impacted by the proposed (conservatively estimated) Erosion Hazard Limit.

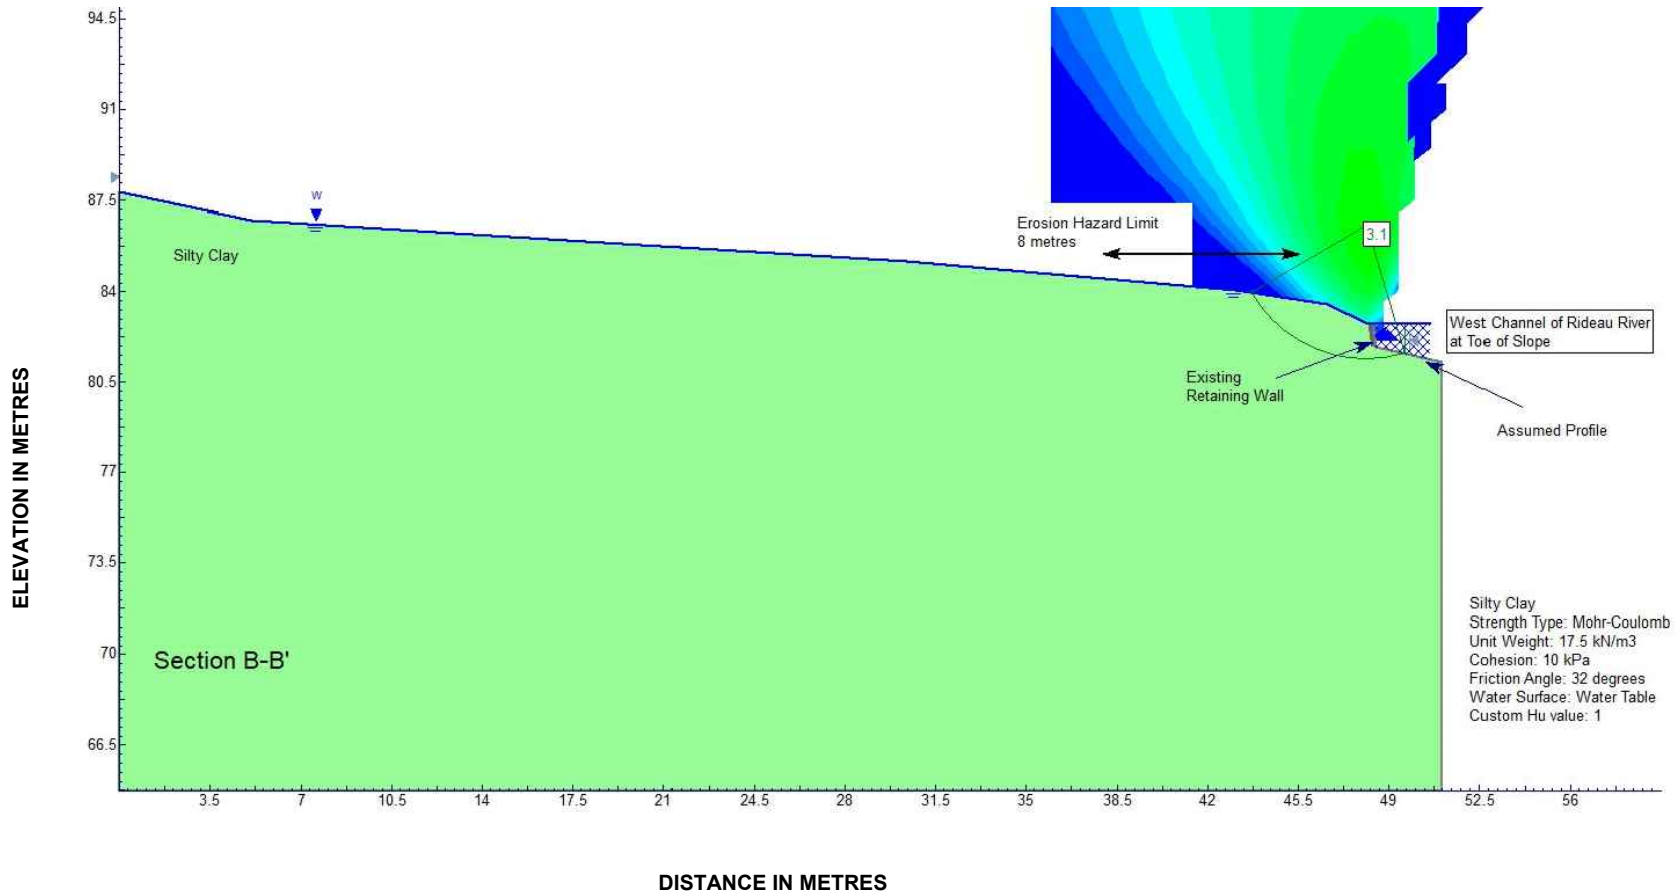
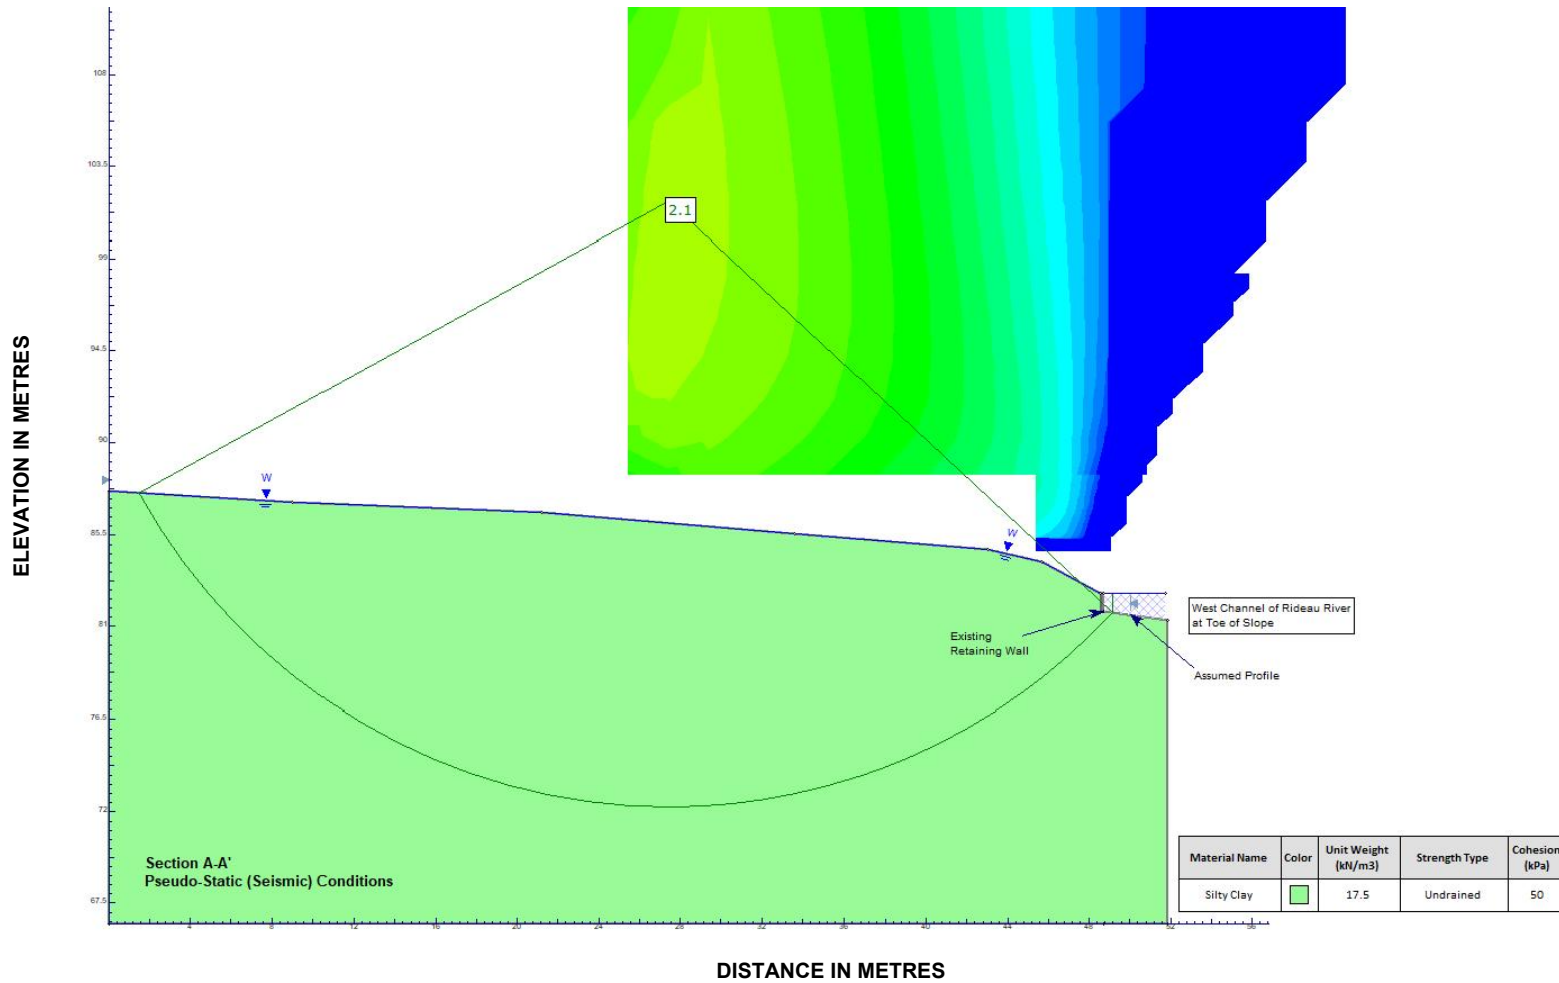
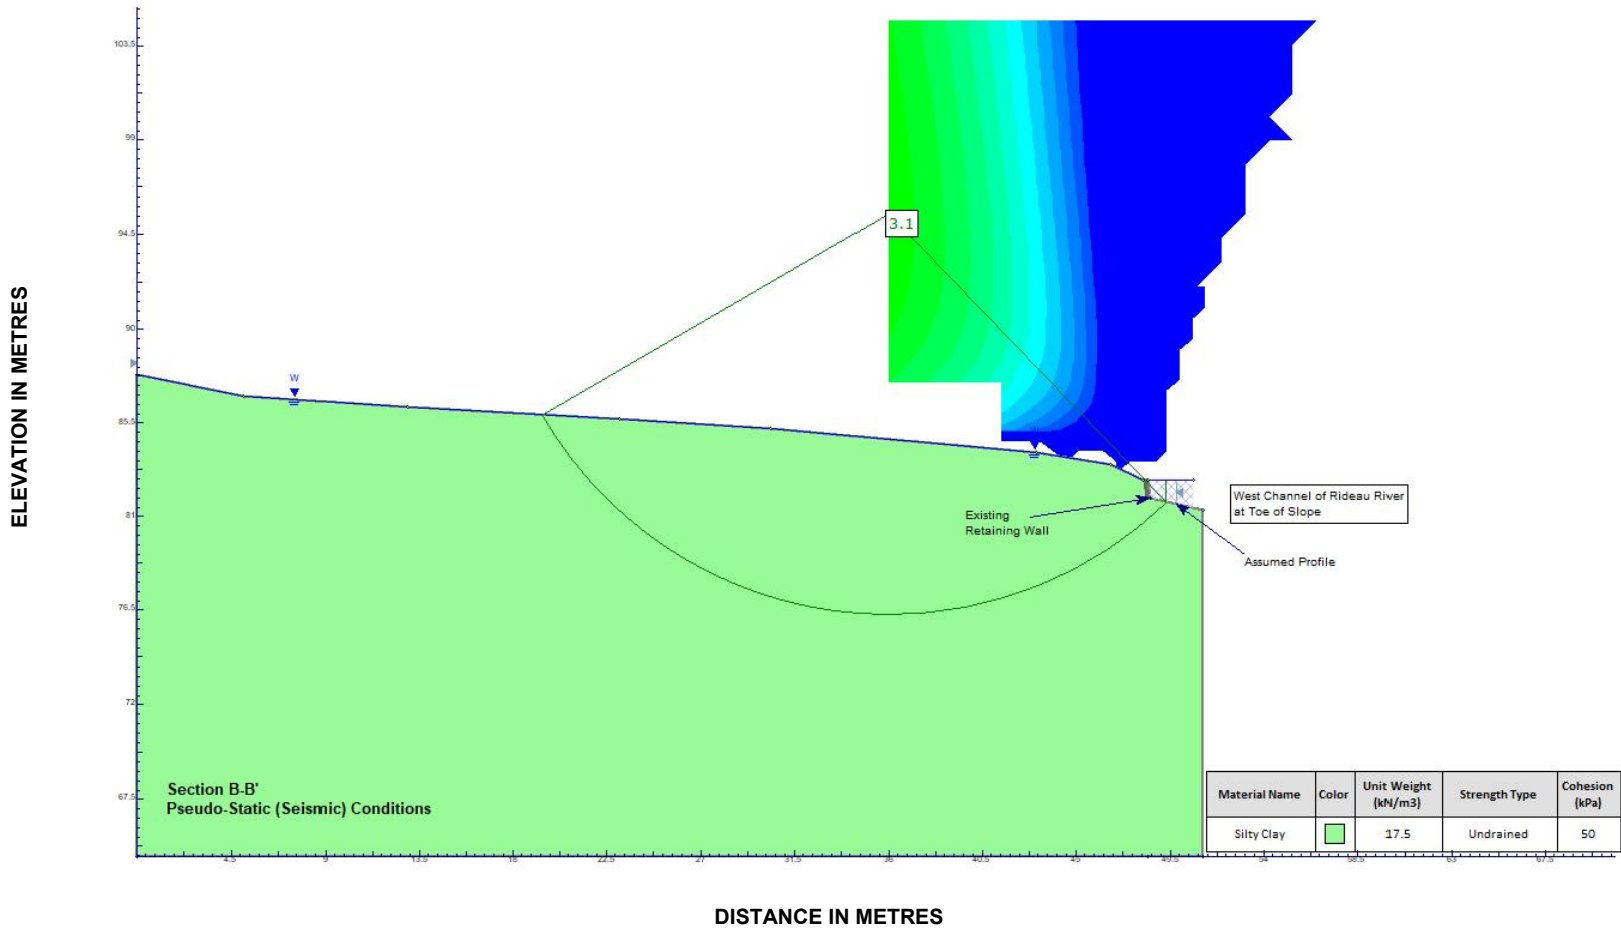
The slope stability analyses indicate that the existing slope, in its current configuration, has a factor of safety against overall rotational failure of about 2.1 and 3.1 for Sections A-A' and B-B', respectively. Based on the slope stability analyses, the factors of safety against overall rotational failure for static loading conditions are considered to indicate adequate long-term stability. The results of the stability analyses are provided on Figures A1 and A2 in Attachment A.

The slopes at Sections A-A' and B-B' were analysed for pseudo-static (seismic) conditions using the undrained silty clay strength parameters. A seismic coefficient of 0.14 was used in the pseudo-static analyses (i.e., half of the Peak Ground Acceleration for Ottawa (Barrhaven) according to the Ontario Building Code 2015). The slope stability analyses indicate that the existing slopes, in their current configurations, have a factor of safety against failure of greater than 1.1 for pseudo-static (seismic) conditions, which is considered acceptable. The results of the pseudo-static stability analyses are provided on Figures A3 and A4 in Attachment A.
