October 1, 2021

RE: TREE CONSERVATION REPORT FOR 100 VARLEY DRIVE, OTTAWA

This report details a pre-construction tree conservation report (TCR) for the above-noted property in Ottawa. The need for this TCR is related to the proposed redevelopment of the subject property to include a 9-storey residential building with surrounding amenity areas, surface parking and one level of below ground parking.

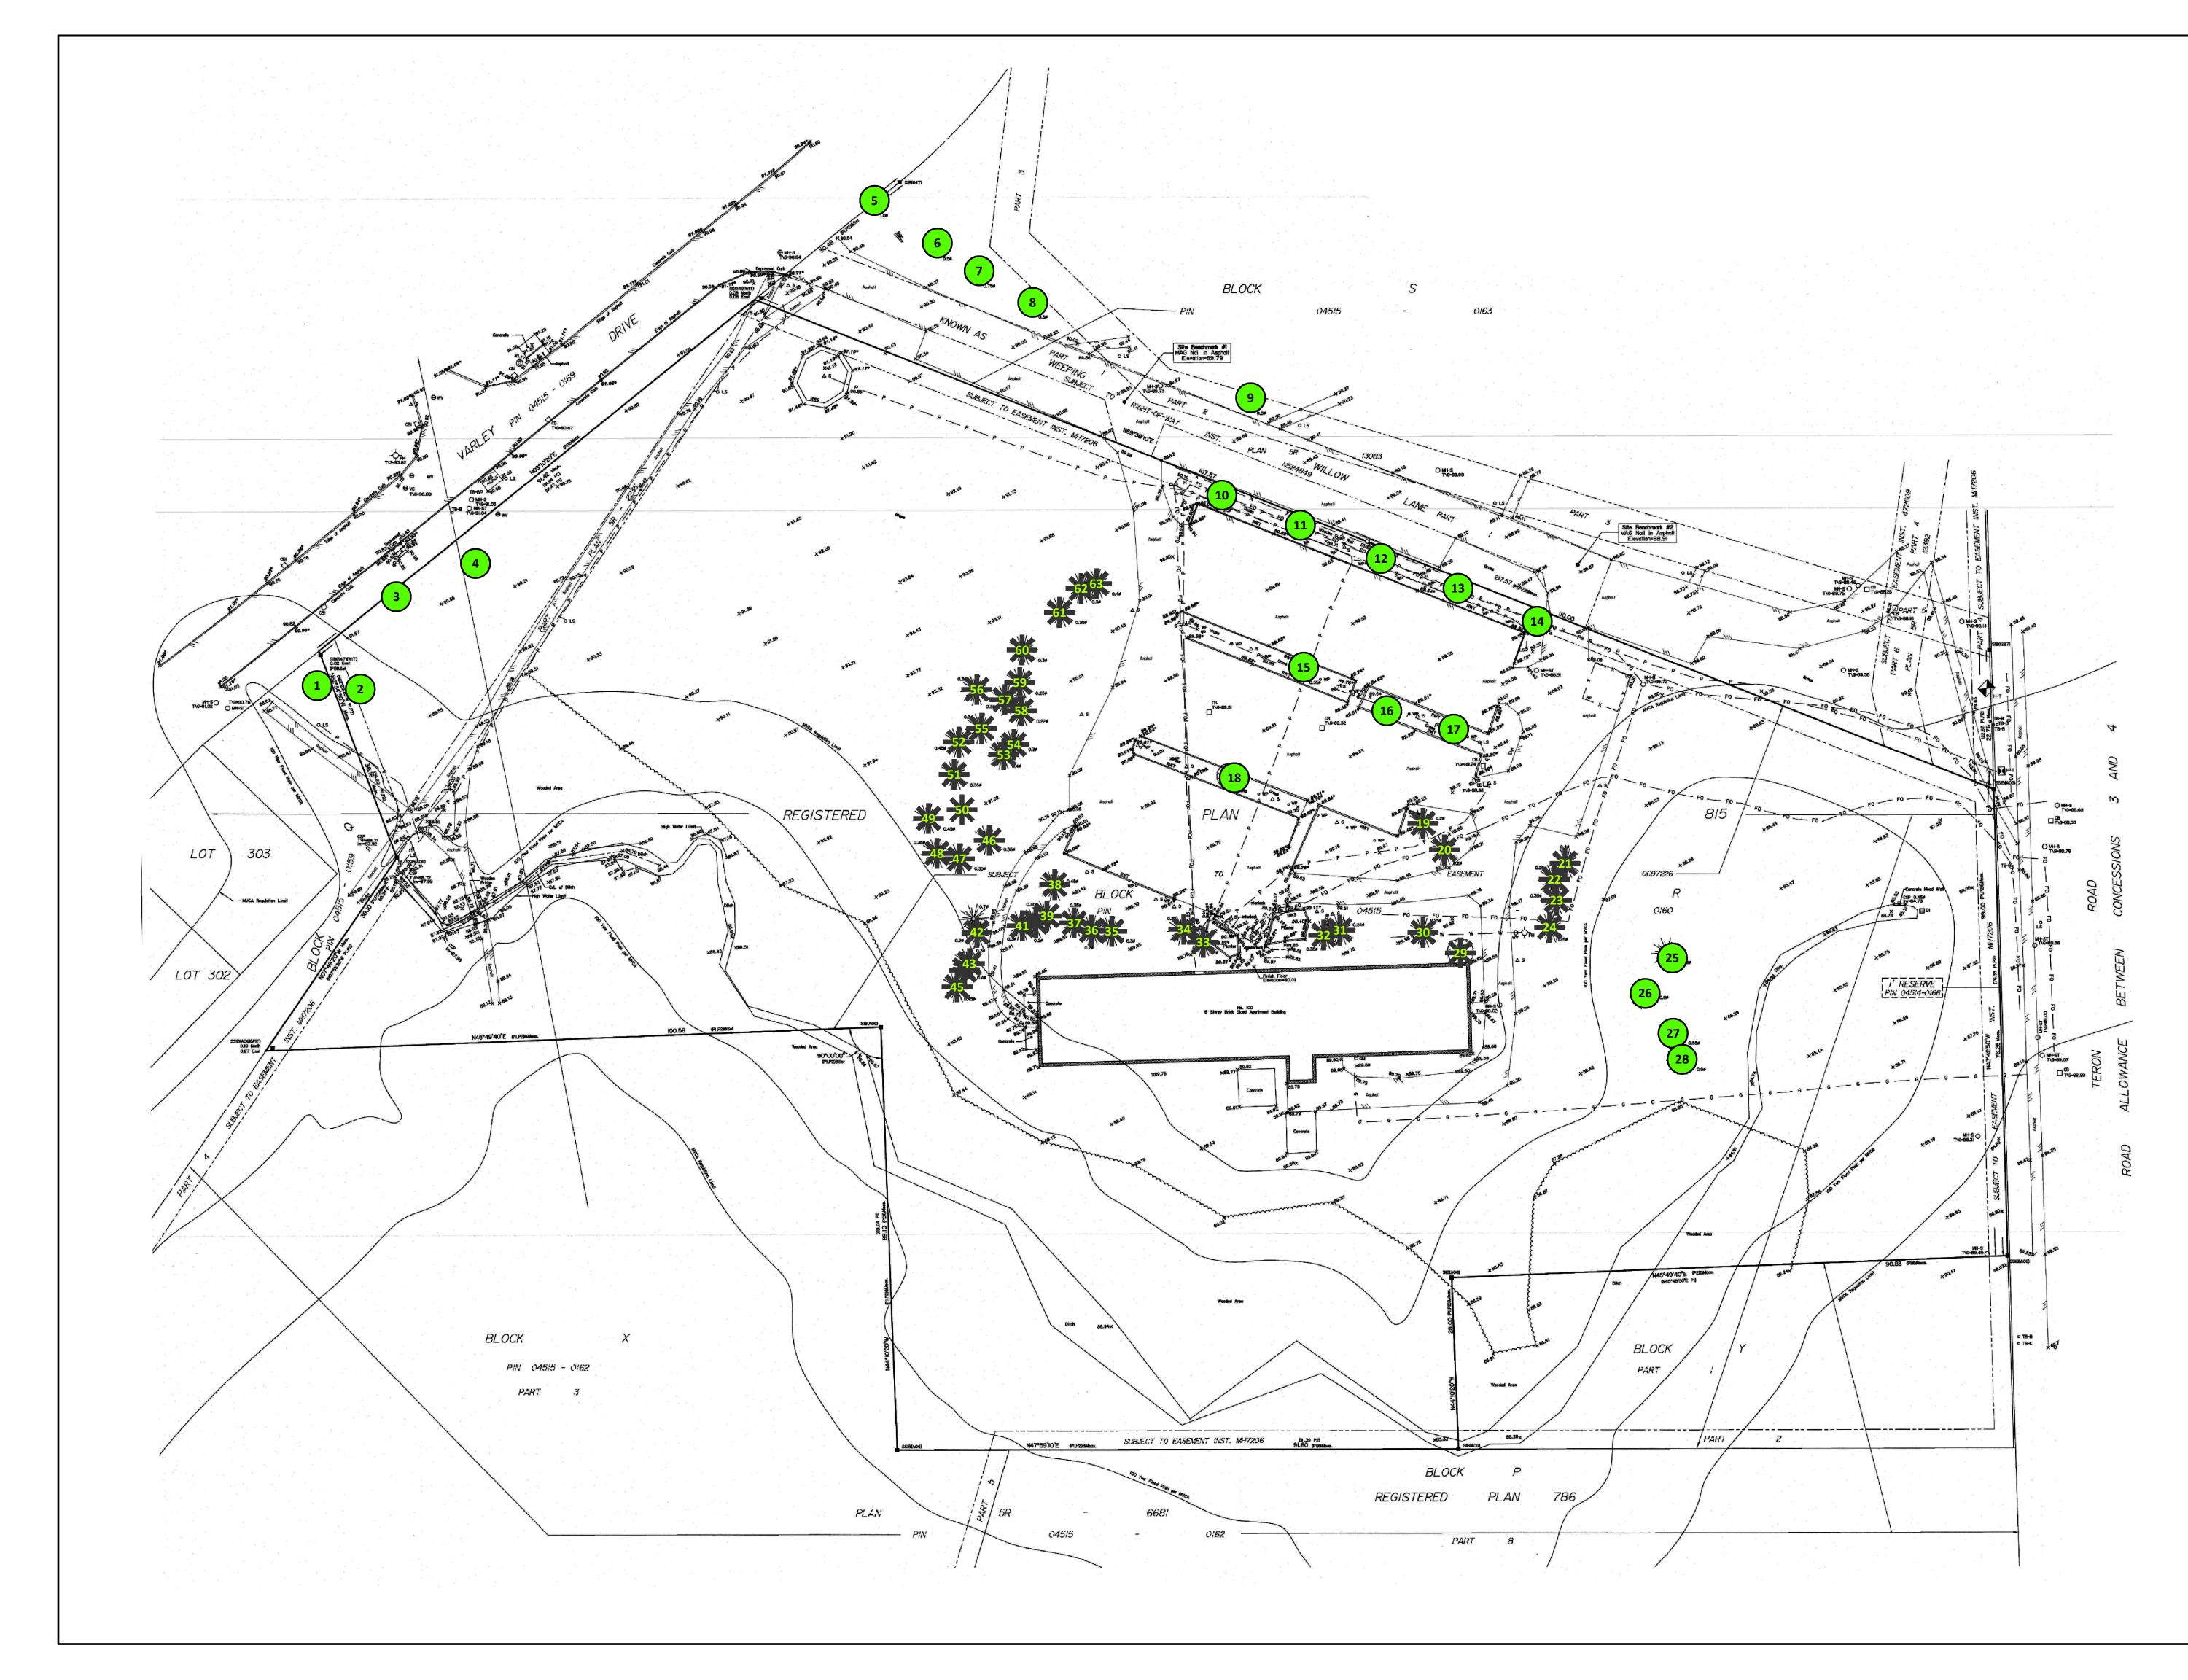
Table 1 on pages 2 through 7 details the species, condition, size (diameter), ownership and status of each individual tree on and adjacent to the subject property. Each of these trees are referenced by the numbers plotted on the tree conservation plan included on page 8 of this report.

Preservation and protection measures intended to mitigate damage during construction will be applied for the trees to be retained on and adjacent to the subject property. The following measures are the minimum required by the City of Ottawa to ensure tree survival during and following construction:

- 1. As per the City of Ottawa's tree protection barrier specification, erect a fence as close as possible to the CRZ of the tree(s);
- 2. Do not place any material or equipment within the CRZ of the tree(s);
- 3. Do not attach any signs, notices or posters to any tree;
- 4. Do not raise or lower the existing grade within the CRZ without approval;
- 5. Tunnel or bore instead of trenching within the CRZ of any tree;
- 6. Do not damage the root system, trunk or branches of any tree;
- 7. Ensure that exhaust fumes from all equipment are NOT directed towards any tree's canopy.

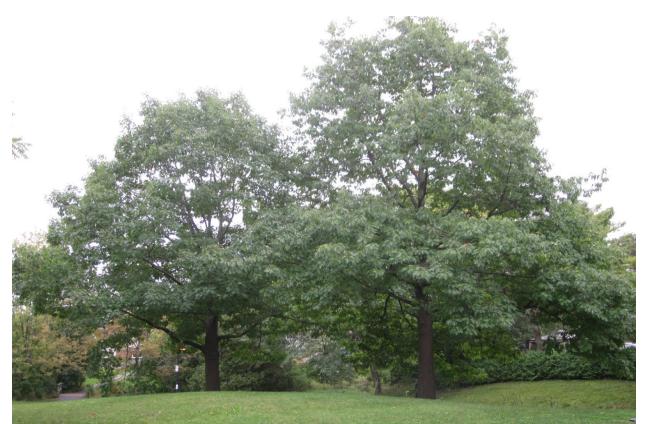
Tree	Tree species	Condition	DBH ¹	Owner	Age class, tree condition notes & preservation status (to be removed or
No.		$(VP \rightarrow E)$	(cm)	-ship	preserved and protected)
1	Red oak	Good	49.1	City	Mature; central dominant stem with co-dominant stems at 5.5m from grade
	(Quercus rubra)				- central with competing lateral; crown asymmetric due to influence of tree

#2; native species; to be preserved and protected
2	Red oak	Good	44.3	Private	Mature; central stem for most of height with co-dominant leaders at 7m;
					lower laterals suppressed, upper competing; crown very asymmetric due to
					influence of tree #1; native species; to be preserved and protected
3	Black walnut	Good	29.2	Shared	Mature; central dominant stem with major competing lateral at 2m on west;
	(Juglans nigra)			(with	native species; to be preserved and protected
				city)	
4	Butternut	Good	39.8	Private	Mature; four stems arising at 1.4m – central constricted and in decline; few
	(Juglans				signs of butternut canker (Ophiognomonia clavigignenti-juglandacearum) -
	cinerea)				full crown (little dieback), several sooty and callused cankers; native
					species – possibly a hybrid tree; to be preserved and protected
5	Red maple	Fair	73.0	Neigh-	Mature; double stemmed at grade – divergent with included bark to 1.5m;

Picture 1. Trees #1 and 2 (right to left) at 100 Varley Drive

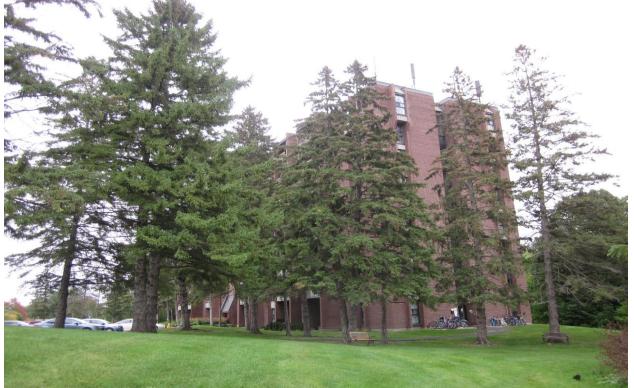
Picture 2. Trees #52 through 42 (left to right) at 100 Varley Drive

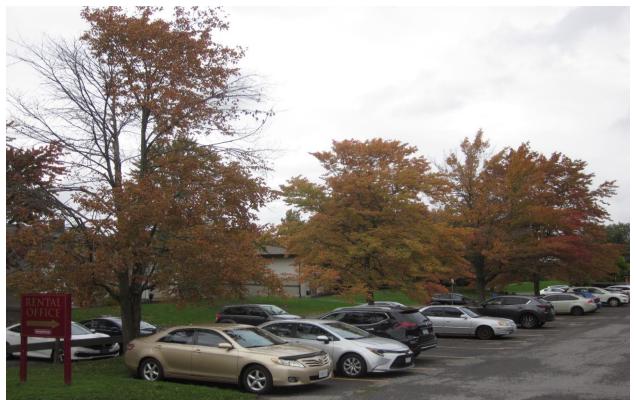
Picture 3. Trees #10-13 (left to right) at 100 Varley Drive

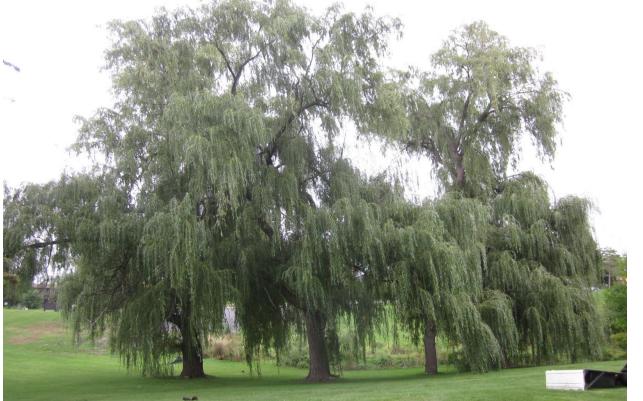
27	Golden weeping willow	Very Poor	54.9	Private	Mature; topped at 10m with decay in wound; major decay in main stem; cultivar; to be preserved and protected (though should be removed)
28	Golden weeping willow	Fair	102.2	Private	Very mature; central stem with tri-dominant leaders at 16m; suppressed laterals at 3, 6 and 9m – most broken due to storm damage, decay in wounds; cultivar; to be preserved and protected
29	White spruce	Fair	28.0	Private	Mature; fair crown density, growth increment and needle colour; many exposed and uplifted roots; native species; to be preserved and protected
30	White spruce	Fair	32.6	Private	Mature; fair crown density, growth increment and needle colour; sunscald injury to lower stem; native species; to be preserved and protected
31	White spruce	Good	41.4	Private	Mature; good crown density, growth increment and needle colour; crown asymmetric; native species; to be preserved and protected

Picture 4. Trees #25-28 (left to right) at 100 Varley Drive
