URBAN FORESTRY & FOREST MANAGEMENT CONSULTING

March 1, 2022

RE: TREE CONSERVATION REPORT FOR 1987 ROBERTSON ROAD

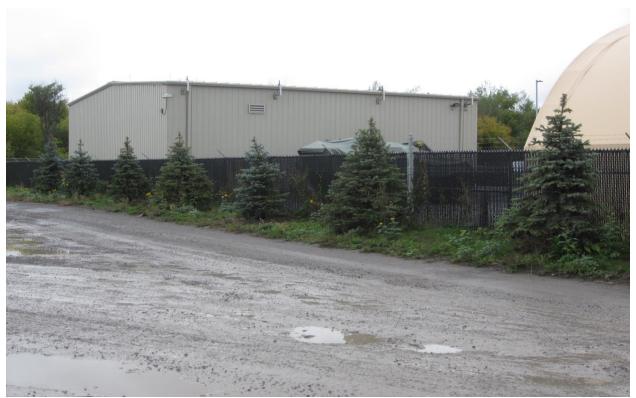
<u>Tree grouping A</u>: A line of nine planted Colorado spruce ranging in diameter from 5 to 9 cm which are in fair condition with the exception of one dead tree. Based on gaps in the line it appears other trees died and were removed in the past. This line of trees will be removed due to conflicts with construction. Transplanting elsewhere on the property may be an option for those trees in better health.

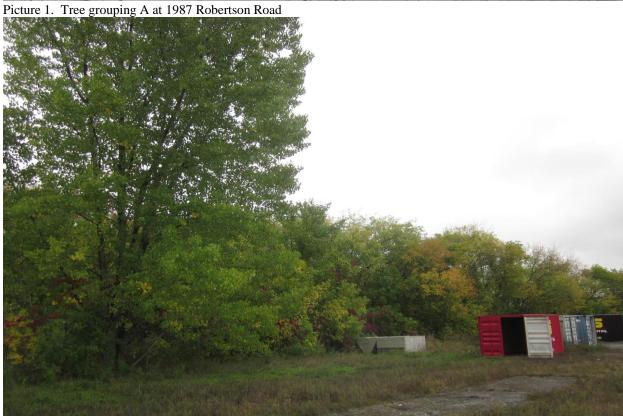
<u>Tree grouping B</u>: A group of Manitoba maples (*Acer negundo*) growing through the fence from the neighbouring property to the east. The largest tree is 19cm in diameter and in good condition. Being under the ownership of others these trees will be preserved and protected during construction (unless permission to remove is granted in writing by the adjacent landowner). However, the overhanging branches can be cut back to the property line.

Picture 2. Tree #1 (left) and grouping B at 1987 Robertson Road

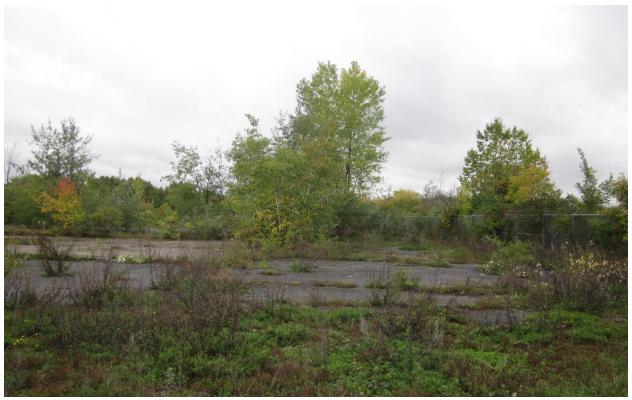
<u>Tree stand #1</u>: This stand is centered on a compacted area of stone, possibly a former parking lot. As with other areas on the property, all these trees arose from seed spread from elsewhere.

Tree Species	Average diameter (cm)	Percent occupancy
American elm	12	6
Ash species	12.5	2
Eastern cottonwood	15.1	28
Manitoba maple	12.1	28
Siberian elm		
(Ulmus pumila) ³	19.7	2
White poplar	16	2
Trembling aspen (Populus		
tremuloides)	15.1	32

Picture 3. Tree stand #1 at 1987 Robertson Road

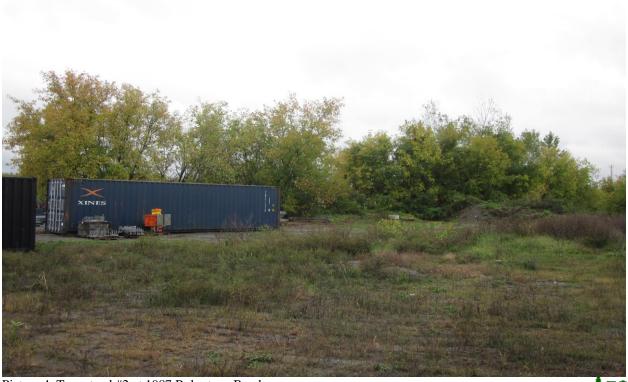
<u>Tree stand #2</u>: As with stand #1, this stand is centred on a heavily disturbed and compacted area.

Tree Species	Average diameter (cm)	Percent occupancy
Manitoba maple	16.3	43
White poplar	24.6	35
Trembling aspen	17.3	22

Picture 4. Tree stand #2 at 1987 Robertson Road

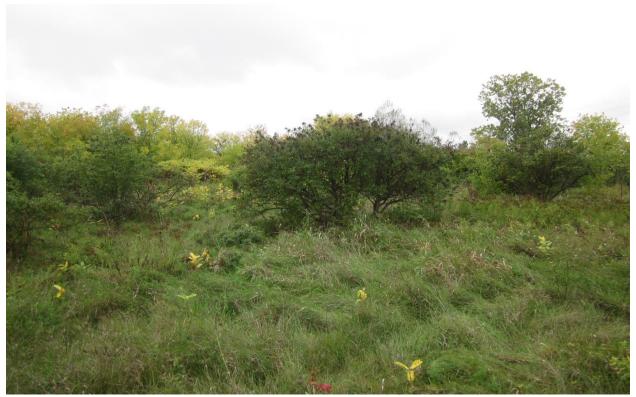
<u>Tree grouping C</u>: A series of sample plots were taken in this area to determine general tree composition – species, average diameters and percent occupancy by stem count:

Tree Species	Average diameter (cm)	Percent occupancy
American elm		
(Ulmus americana)	15.4	21
Ash species		
$(Fraxinus \text{ spp.})^1$	15.2	13
Balsam poplar		
(Populus balsamifera)	14.6	18
Crab apple		
(Malus spp.)	17	2
Green ash		
(Fraxinus pennsylvanica var.		
subintegerrima) ¹	13	5
Manitoba maple		
(Acer negundo)	14.1	39
Willow species		
(Salix spp.)	19	2

¹ all ash on the property are either dead or heavily infested with emerald ash borer (*Agrilus planipennis*)

Picture 5. Tree grouping C at 1987 Robertson Road

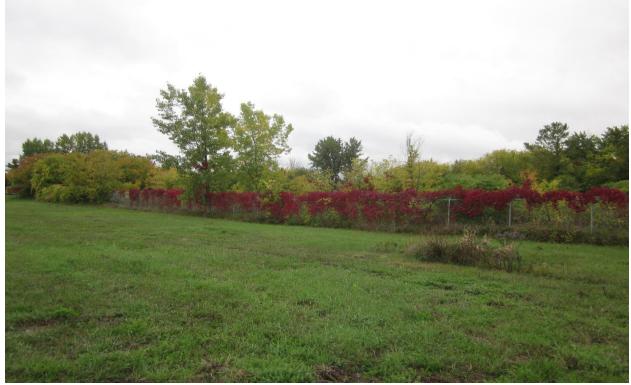
<u>Tree grouping D</u>: A series of sample plots were taken in this area to determine tree composition:

Tree Species	Average diameter (cm)	Percent occupancy
American elm	15	6
Eastern cottonwood (Populus deltoides)	27	6
Manitoba maple	15.8	82
Eastern redcedar (Juniperus virginiana)	6	6

Picture 6. Tree grouping D at 1987 Robertson Road

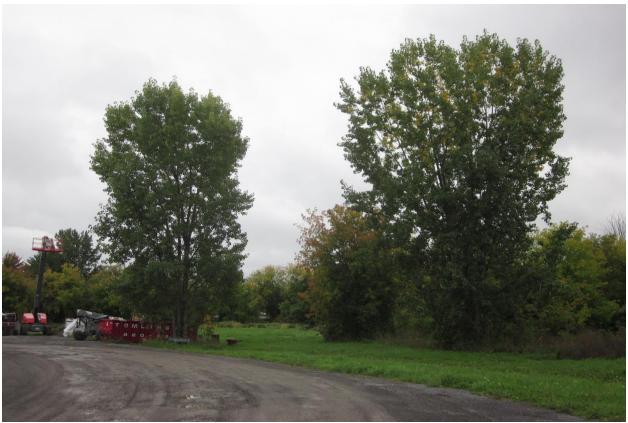
Tree	Tree	Diameter	Tree Condition,
No.	Species	(cm)	Condition Notes and Age
			Good; multi-stemmed (6) at grade; growing
1	Eastern cottonwood	27.5 avg.	through chain link fence; mature
			Good; basal wound; located on edge of hill,
2	Eastern cottonwood	60	near train tracks; mature
3	Eastern cottonwood	30 avg.	Good; multi-stemmed (3) at grade; maturing
	Crab apple		
4	(Malus spp.)	12.5 avg.	Good; multi-stemmed (7) at grade; maturing
			Good; multiple leaders at 1m from grade;
5	Eastern cottonwood	55	mature
			Good; double leader at 0.2m from grade with
6	Manitoba maple	27 avg.	inclusion ridge at union; maturing
7	Manitoba maple	21	Good condition; maturing
8	Balsam poplar	20	Fair; growing against building; maturing

Picture 7. Trees #3 and 5 at 1987 Robertson Road

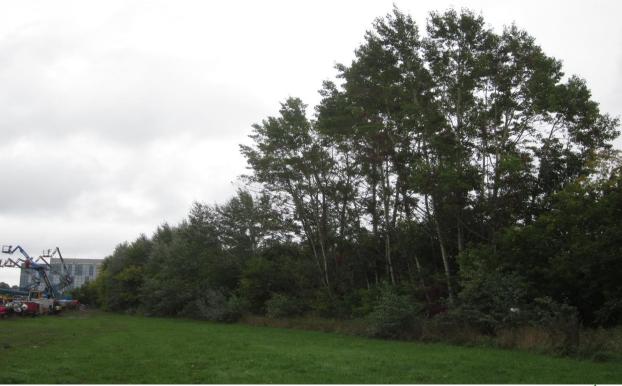
<u>Tree grouping E</u>: A series of sample plots were taken in this area to determine tree composition:

Tree Species	Average diameter (cm)	Percent occupancy
American elm	16	1
Manitoba maple	14	57
White poplar (<i>Populus alba</i>) ²	17.1	42

white poplar is an introduced and invasive species in Ontario

Picture 8. Tree grouping E at 1987 Robertson Road
