April 18, 2023

1900 and 2000 CITYPARK DRIVE TREE INVENTORY AND RETENTION REVIEW

project
1900 & 2000 CITY PARK DRIVE

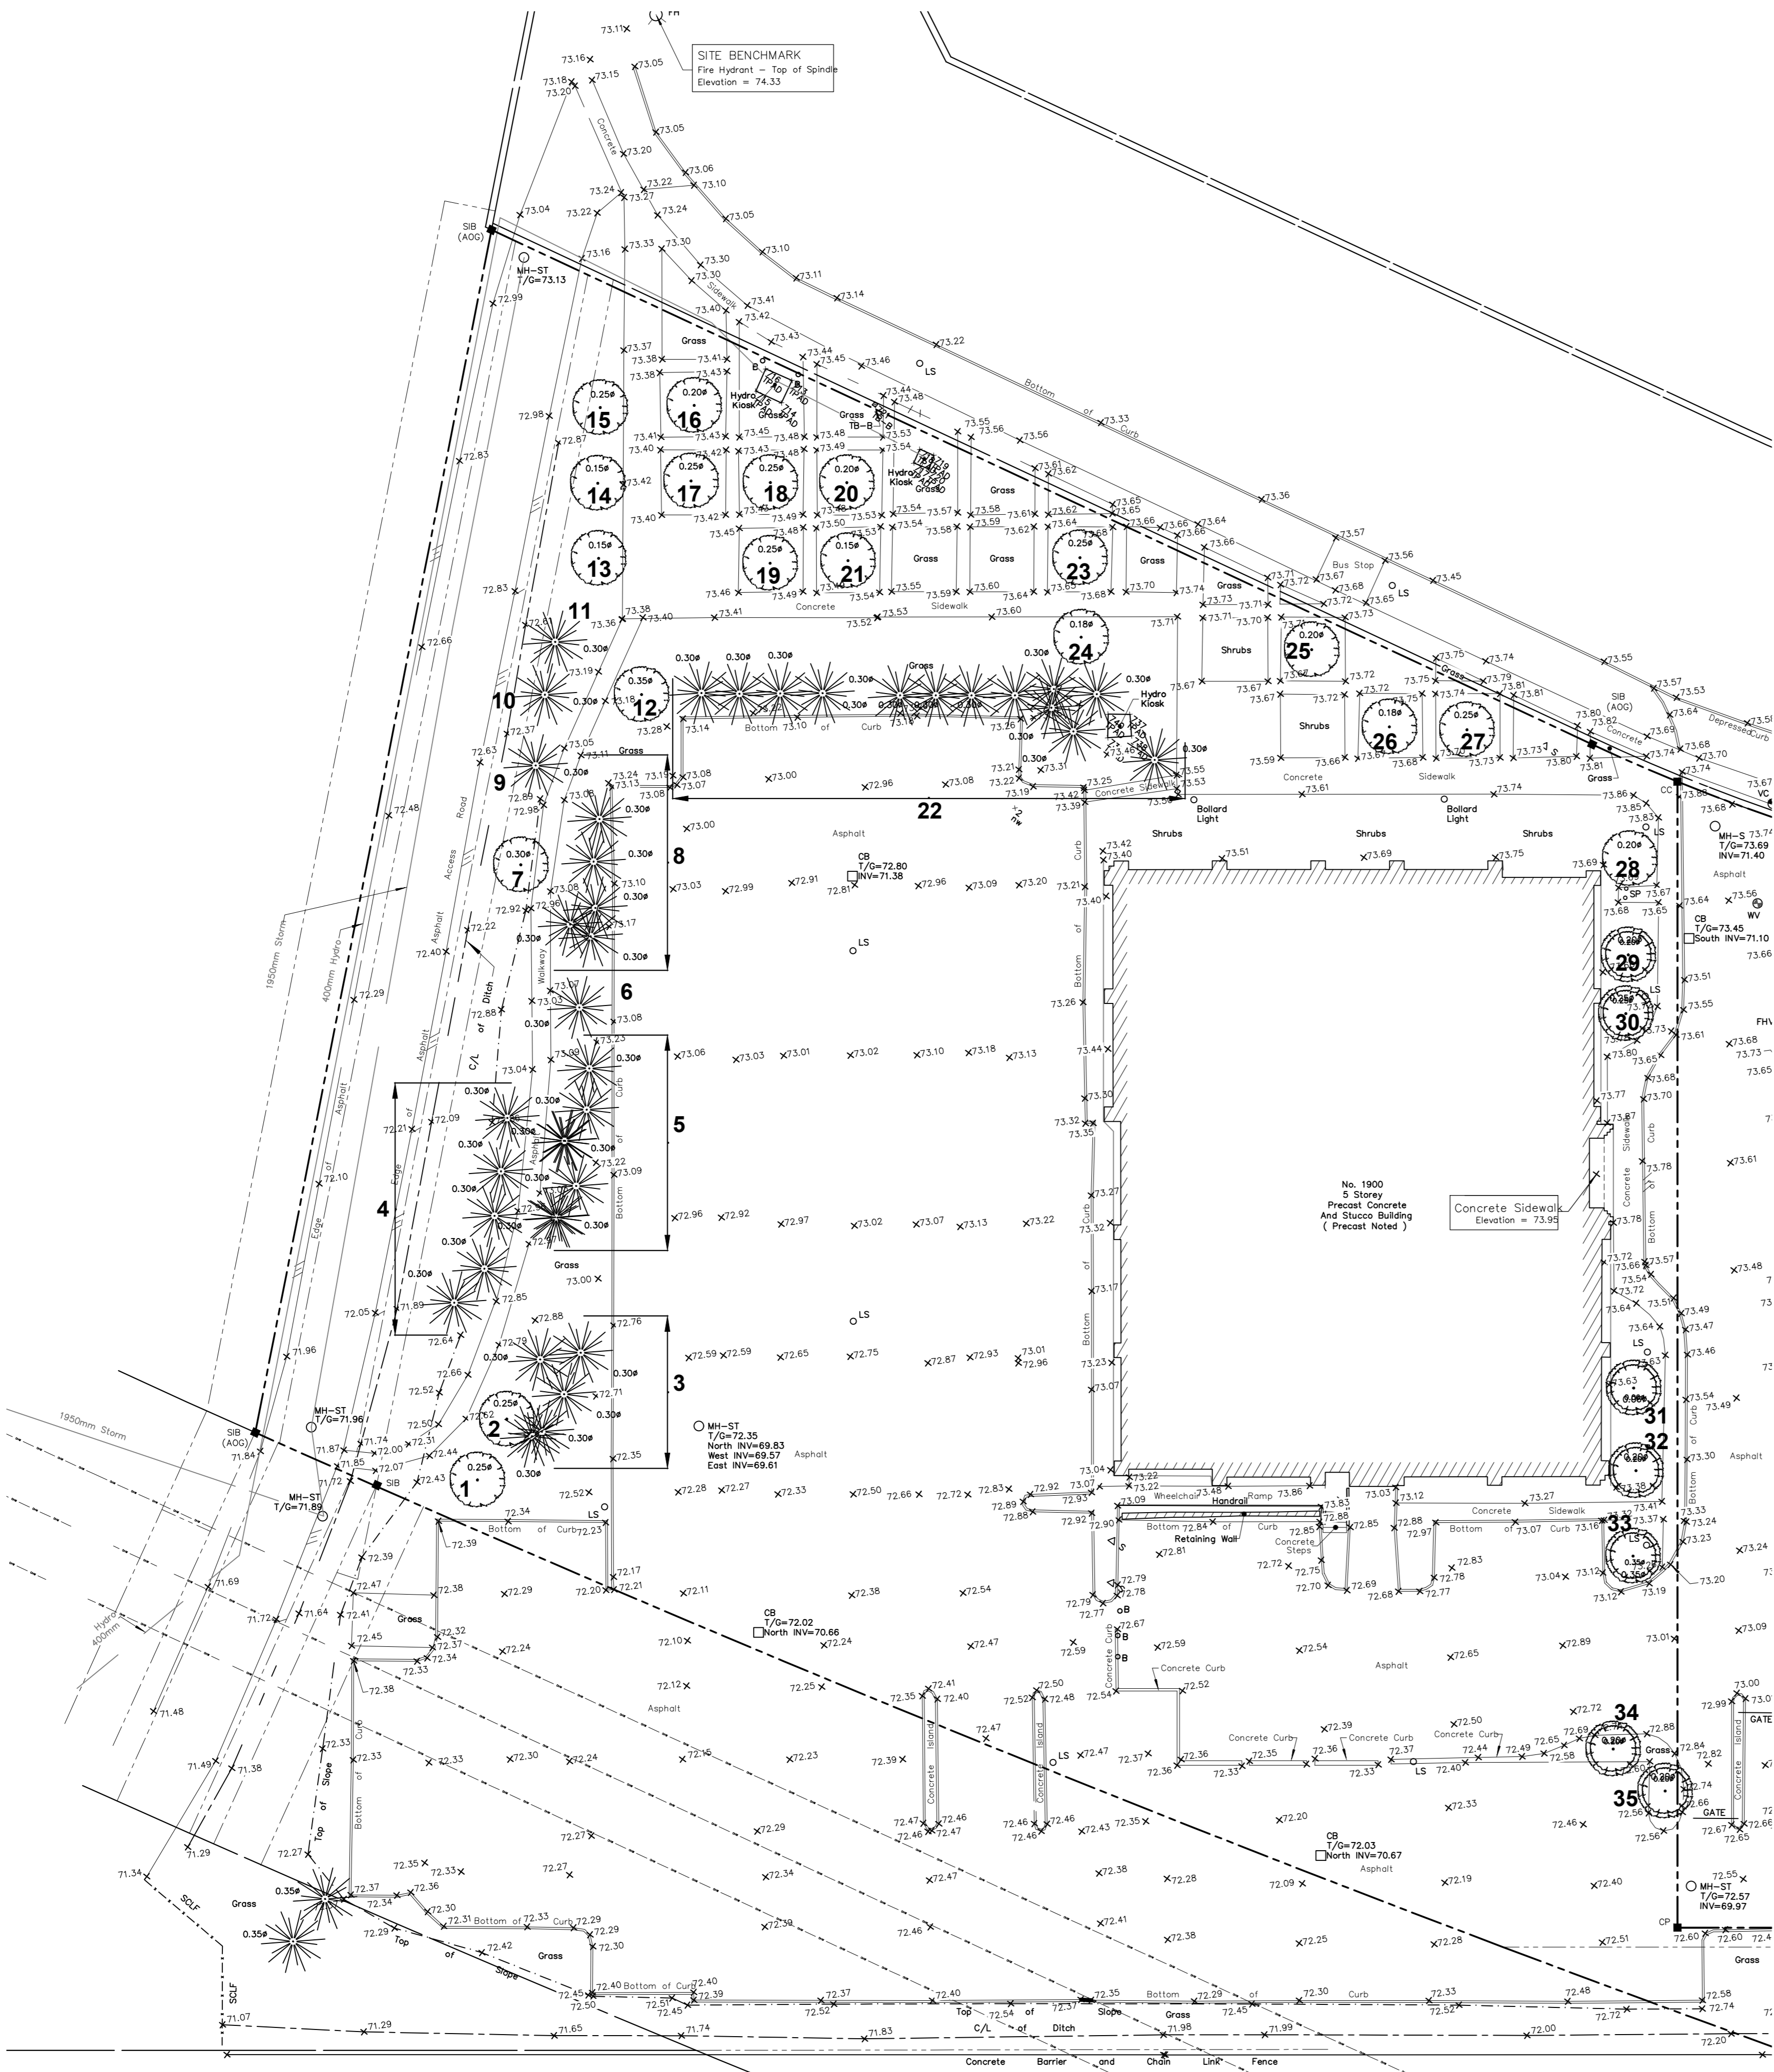
1 EXISTING VEGETATION
Scale: 1:500

This block consists of an existing 5 storey building, parking and built landscape with semi mature trees. The majority of the species here are Norway Maple, Colorado Spruce and Japanese Tree Lilac, semi-mature to mature size, from poor to good condition, refer to chart.

Tree Retention: Preservation opportunities exist in the north west corner (parkland dedication) (trees #8-21), depending on the future use. The remainder of the trees would be removed. A final review of retention possibilities will be undertaken during the site plan control process with a final site plan layout. Refer to attached tree retention areas.

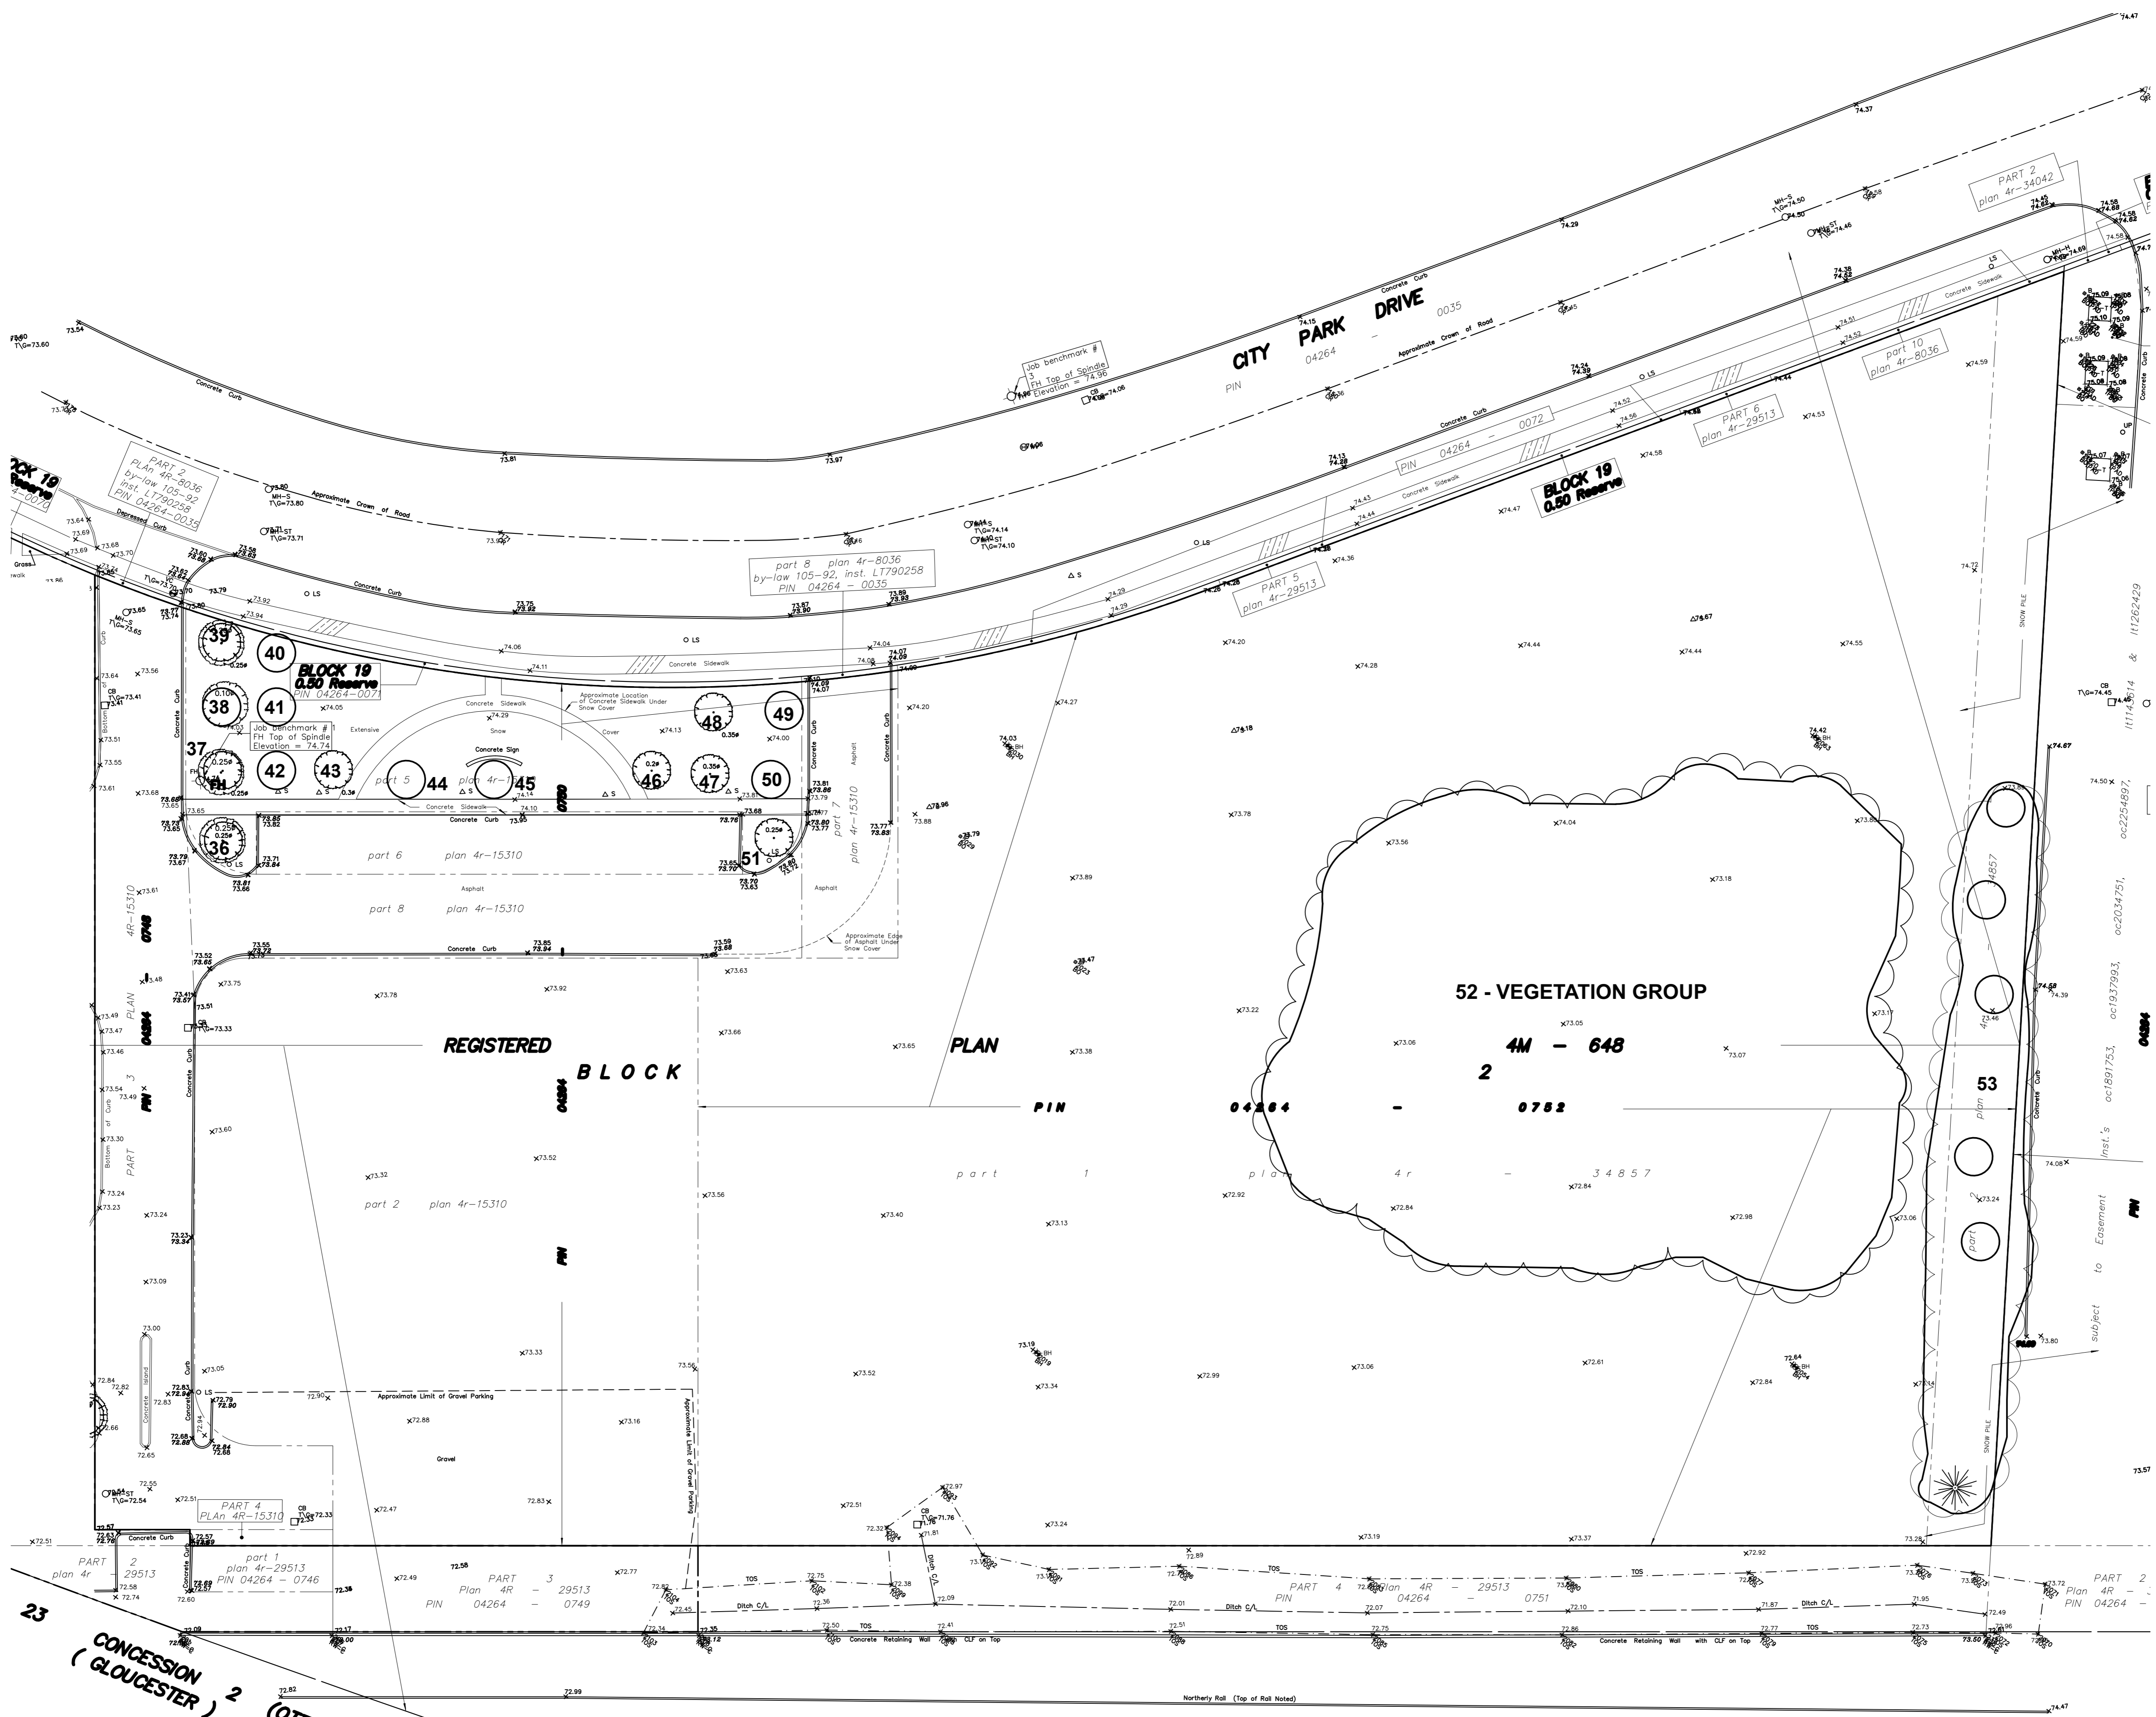
1 EXISTING VEGETATION
 Scale: 1:500

Majority of this block is vacant field. Existing planted trees are located in the north-western portion (young to maturing Norway Maple and Crab Apple) and along the eastern property line (young Norway Maple, Colorado Spruce and White Elm). A naturalized vegetation area is centrally located consisting mainly of young White Elm and Buckthorn. Condition is very poor to good, refer to chart.

Tree Retention: based on the current schematic site plan, preservation opportunities exist in the north west corner in the r.o.w. adjacent to the proposed entrance drive (trees #36-40, 48 & 49). The remainder of the trees would be removed. A final review of retention possibilities will be undertaken during the site plan control process with a final site plan layout. Refer to attached tree retention areas.
