CONSERVATION PLAN 359 Kent Street, 436 & 444 Maclaren Street, Ottawa

March 2023 Application File Number: D02-02-21-0095 [ZBLA] & D01-01- 21-0015 [OPA]

1.0 MATERIAL CONSERVATION PLAN

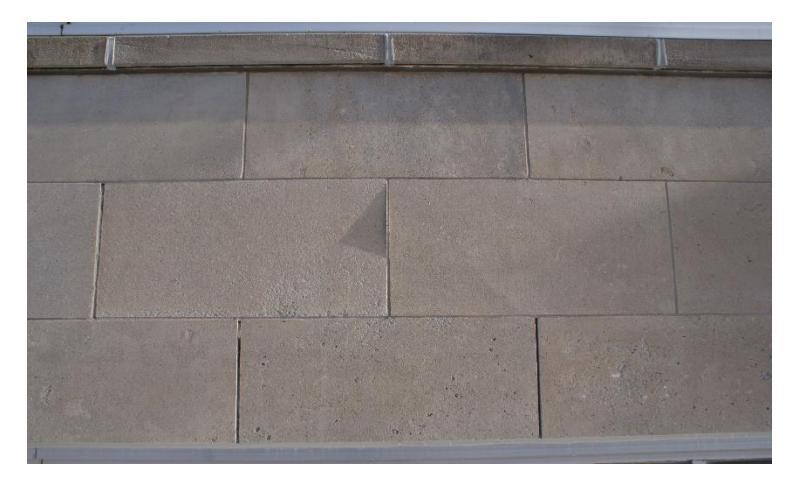
Condition: The limestone cladding is in good condition generally with a few stones at grade level that have been adversely affected by de-icing salts. A number of stones have surface defects or concretions that have not weathered well; however, they are limited in number. A detailed condition assessment of each stone panel will be completed as part of the dismantling process. There are a number of stone panels where the mortar is missing from the joints particularly in the area of the introduced Kent Street entrance providing a general sense of how difficult the removal of the mortar from the units may be during the salvage process.

Figures 7: View of the Niagara limestone cladding above the Kent Street entrance. Note the variations in the material, coursing and the window sill course band the length of units corresponding with the cladding coursing. Mortar is missing from a number of joints. Source: Commonwealth 2023.

Risks: The removal of any adhered Portland based pointing from the stones may be problematic, and a method should be developed to minimize damage that may result. Exposing the stones outdoors for a period of six-months including a winter is one option. (It will be important to follow up with Masonry Contractor, who carried out the test removal of a limestone panel from the façade of the building at 100 Argyle. This will give a sense of how the adhered Portland from the stone was removed. In the summary description it states that the Portland mortar was well adhered to the end grain of the stone.)

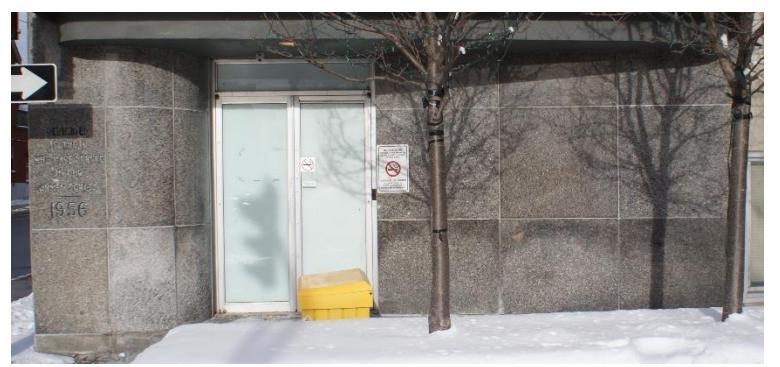
Figure 8: View of granite inset entrance with canopy

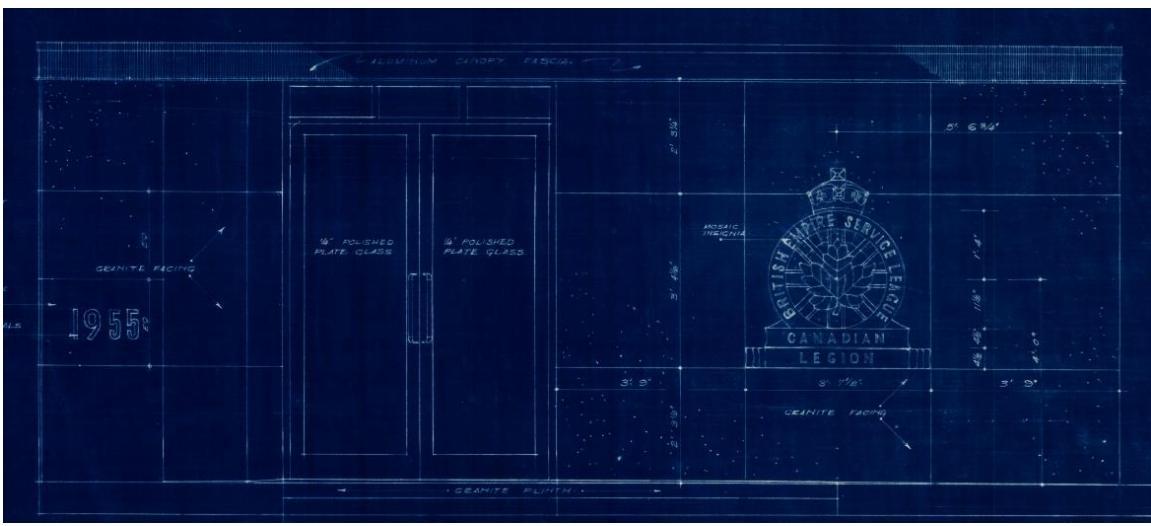
Figures 9: Elevation of the Gilmour Street entrance illustrating the arrangement of the granite cladding. The Royal Canadian Legion crest was removed in 2009 and the original granite panels removed and new material inserted possibly due to the poor condition of the material. Note the two radius cut granite panels to the left of the door and the panel arrangement to the right of the door. Source: 1955 Drawing Set A5

Condition: De-icing slats have had a major impact on the lower three stones set at floor level. The surfaces are disaggregated and crumble to the touch. The memorial stone with an incised date and inscription is in better condition although it is not clear when the inscription was incised.

Rehabilitation – The original granite cladding panels to the east of the entrance door were removed in 2009 when the coat of arms was removed. The entrance door width will be increased to meet the OBC. Remove the existing granite panels and insert a glazed curtain wall to the east of the new entrance door maintaining the existing entrance plan configuration and canopy.

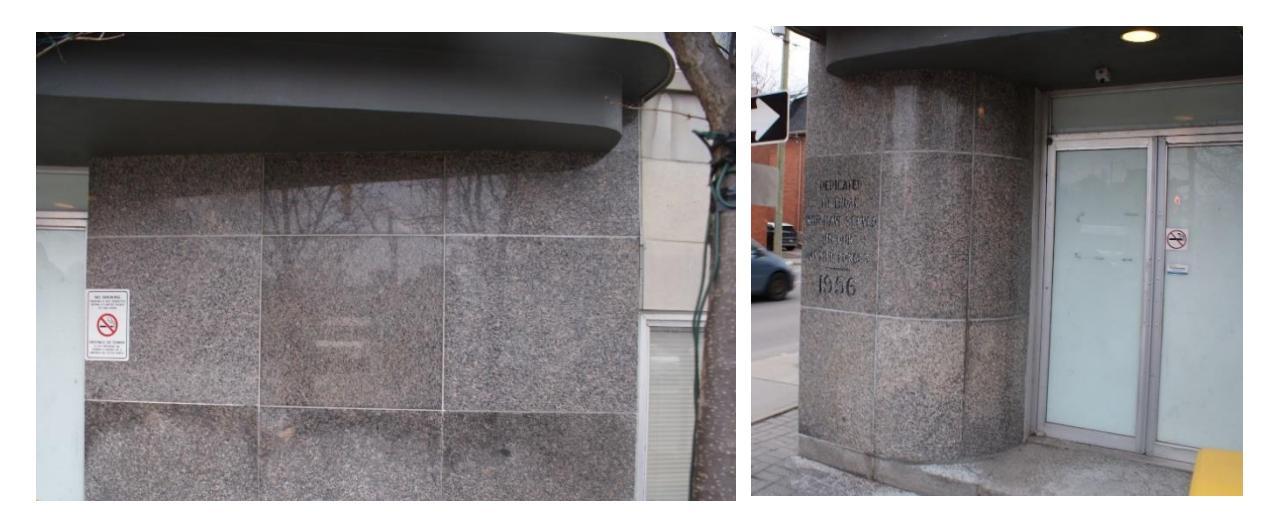
Figures 10 & 11: (6 -left) View of the introduced polished granite panels to the right of the Gilmour Street entrance. (7-right) View of the original polished granite panels. Source: Commonwealth 2023

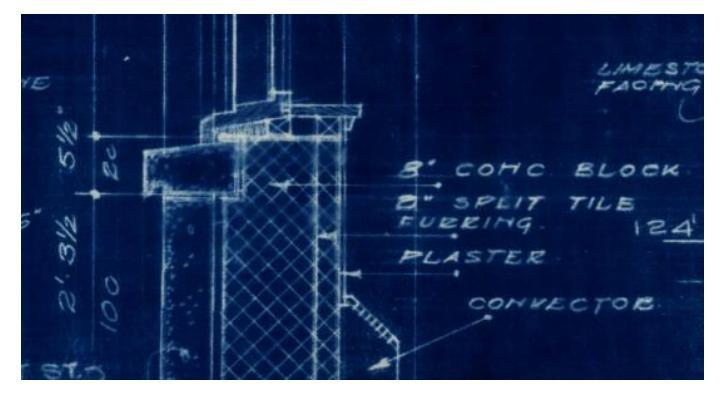
Figure 12; Detail section through the Kent and Gilmour facades illustrating the arrangement of the limestone sill course and limestone cladding. The sills are bonded to the limestone cladding and the concrete back-up wall making it difficult to salvage the window sill course material. The drip edge only adds to the difficulty of successfully salvaging the material for reuse. Source: 1955 Drawing Set A4

Condition: The limestone windowsills are relatively porous along cleavage planes, susceptible to de-icing salts, and freeze-thaw cycling to varying degrees dependent upon material defects within individual stones. Stones vary in quality as is evident on all elevations where sound stones are interspersed with poorer quality material that has failed. Typical failure patterns include delamination along cleavage planes after the surface has weathered and at the exposed surfaces where the material pops during freeze thaw cycling. Approximately 30% of the sill stones will need to be replaced, and further loss is expected during the dismantling, storage and reinstallation processes; however, between the four façades there should be enough good quality sill stones to complete the Gilmour and Kent street window sill courses.

Rehabilitation – The limestone sills will continue to weather and deteriorate over time. The limestone is not the highest quality material. Install new pre-cast concrete sills that are tinted to match the dimension, form and colour of the existing material. Replacing them all is the client's preference.

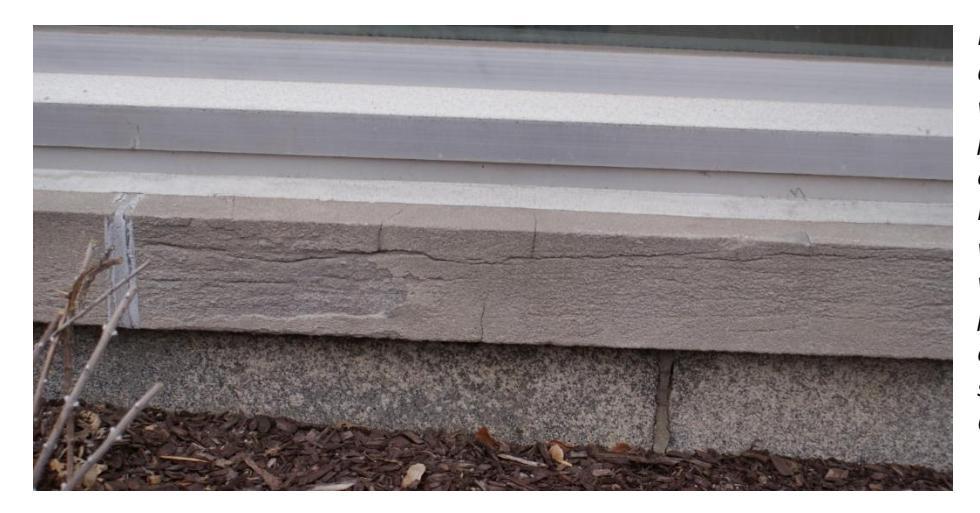
Figure 13: View of a deteriorated limestone windowsill and the granite plinth course below. The cleavage planes within the limestone sills are evident where the sawn surface has weathered. The cleavages planes follow the layers of deposition of the sedimentary rock. Source: Commonwealth 2022.

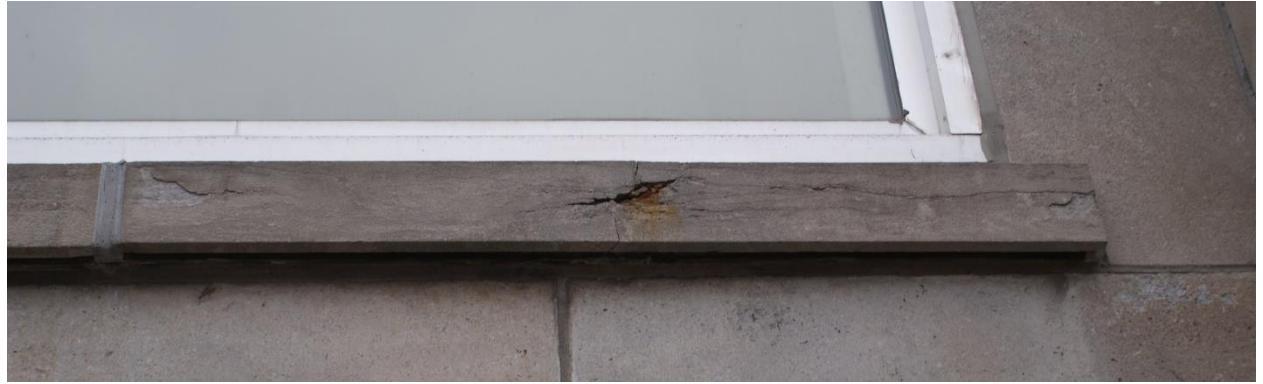
Figure 14: View of a deteriorated limestone windowsill. The cleavage planes within the limestone sills are evident where the sawn surface. The cleavages planes follow the layers of deposition of the sedimentary rock. Source: Commonwealth 2022.

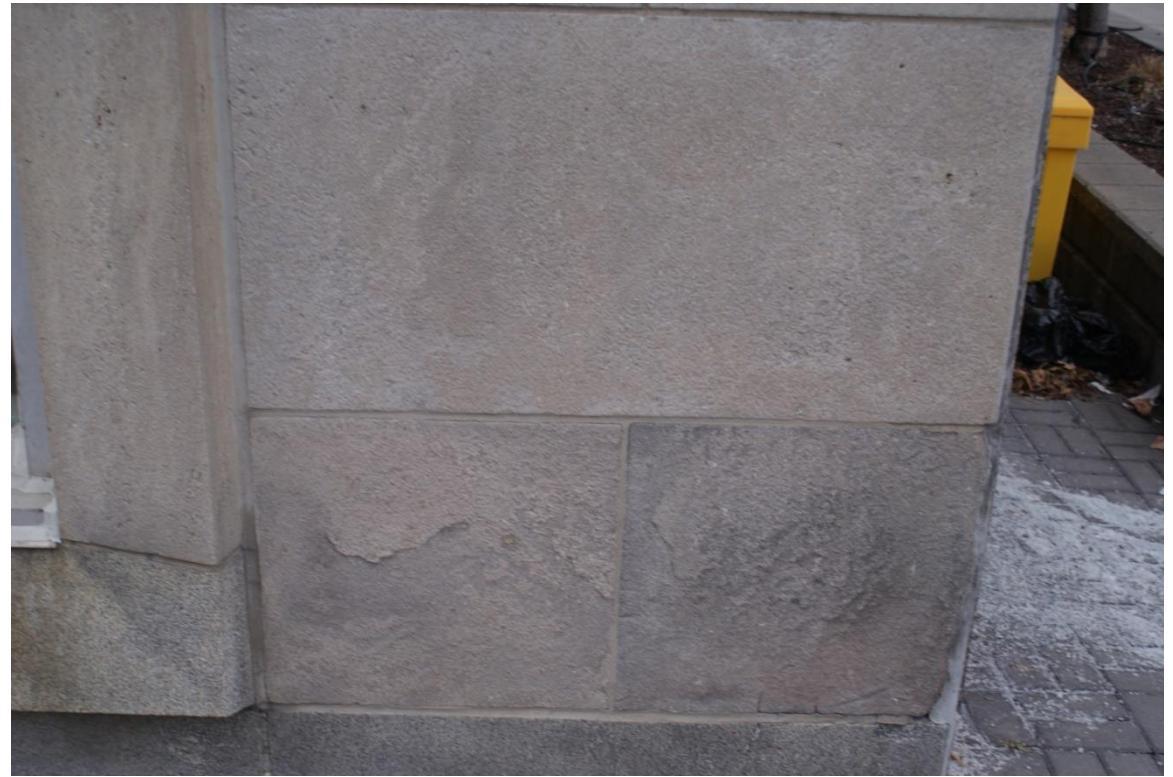
Condition: The limestone window surrounds on the multi-storey windows on Kent and Gilmour are generally in good condition. There is some deterioration of the surface due to de-icing salts where the units are in proximity to grade, some material defects, and rust staining of the material. The condition of the individual units will be assessed and noted during the dismantling phase.

Figure 15: Detail view at the base of the wall at the south-west corner. The surface of the two Niagara limestone panels at the base of the wall are scaling due to de-icing salts. The granite plinth course is evident at the bottom of the photo. The Niagara limestone window surround is the vertical element to the left and a granite window sill/ surround below. Source: Commonwealth 2022.

Preservation of the limestone window surrounds and reinstallation in the Kent and Gilmour Street façades.

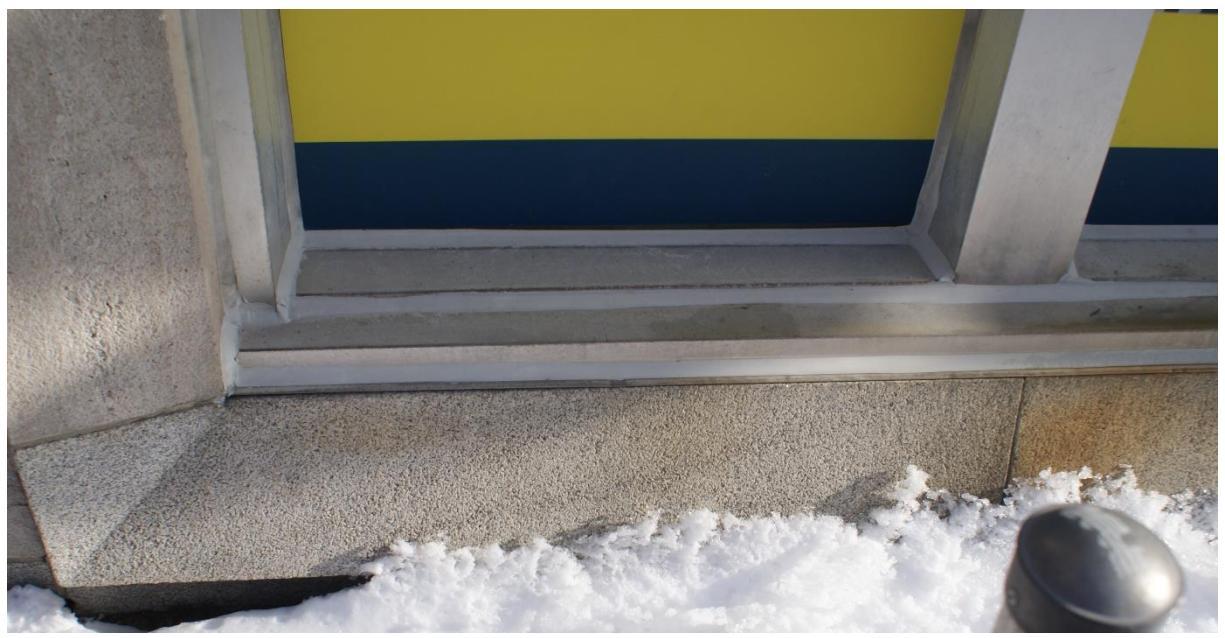
Figure 16: Detail view of the base of the Kent Street window. The horizontal units at the base of the window are formed of the same material as the granite plinth course. The vertical stone to the left is a limestone unit. Note the close match in colour and surface texture. Source: Commonwealth 2023

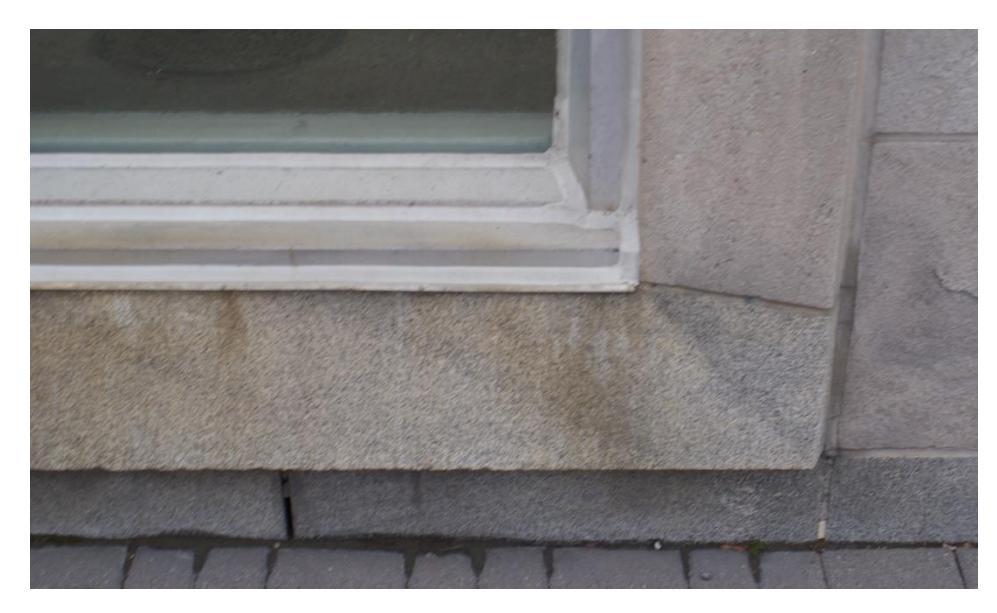
Condition: The granite sill on the Kent Street window is in good condition. The condition of the granite plinth course buried below grade has not been determined.

Figure 18: Detail of the granite plinth course and windowsill granite surround at the base of the three-storey Kent Street window. The colour of the granite sill is very close to the limestone cladding and window surrounds. Source: Commonwealth 2022.

Preservation of the intact granite sill and plinth course panels and reinstallation in the Kent and Gilmour Street façades forming an upstand wall supporting curtain wall glazing. The condition of the material buried below grade has not been determined.

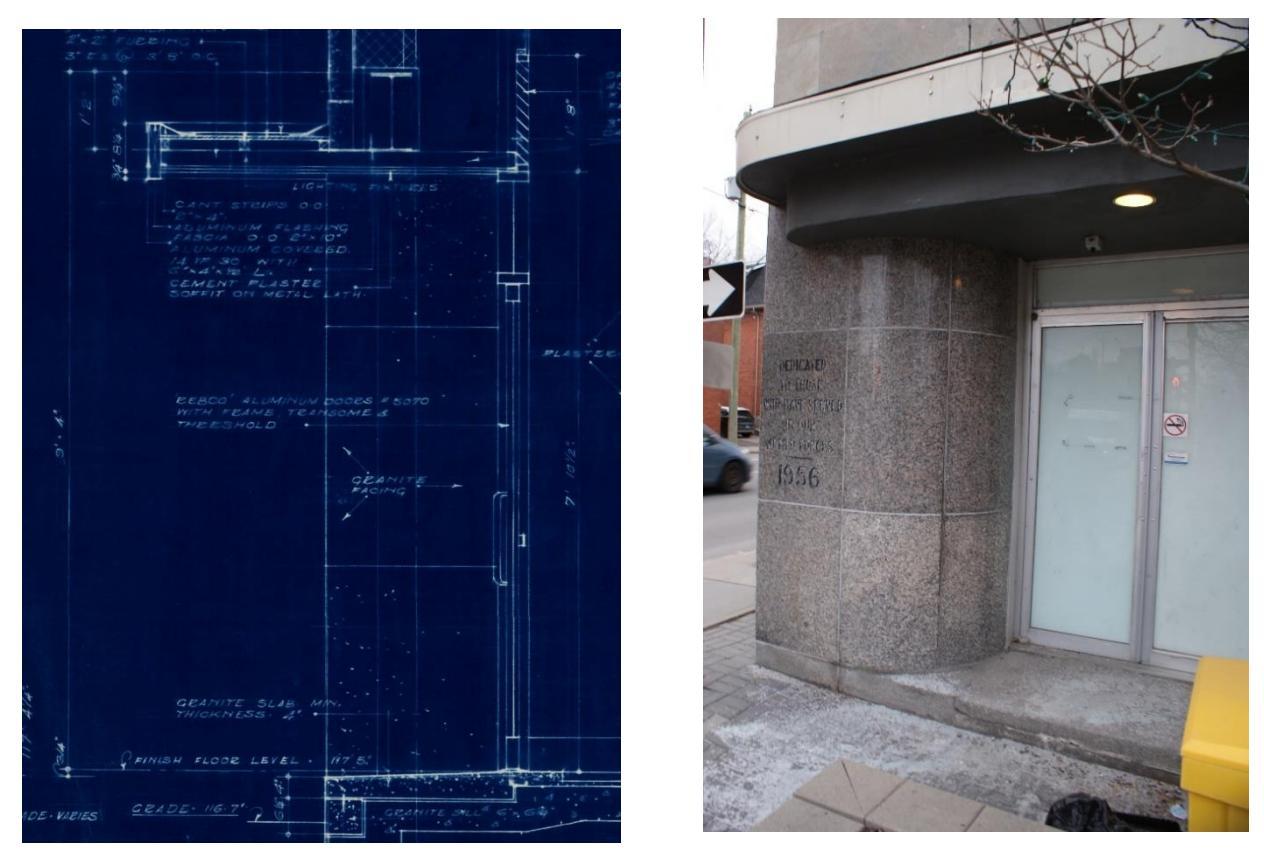
Condition: The canopy has been modified with a dropped modern enclosure with recessed lighting.

Figures 19 & 20: Detail section of the Gilmour Street Entrance illustrating the form and materials and the relationship to the entrance doors. Existing view of the canopy illustrating alterations to the canopy and entrance doors. Source: Original 1955 Drawing Set A5 & Commonwealth 2022.

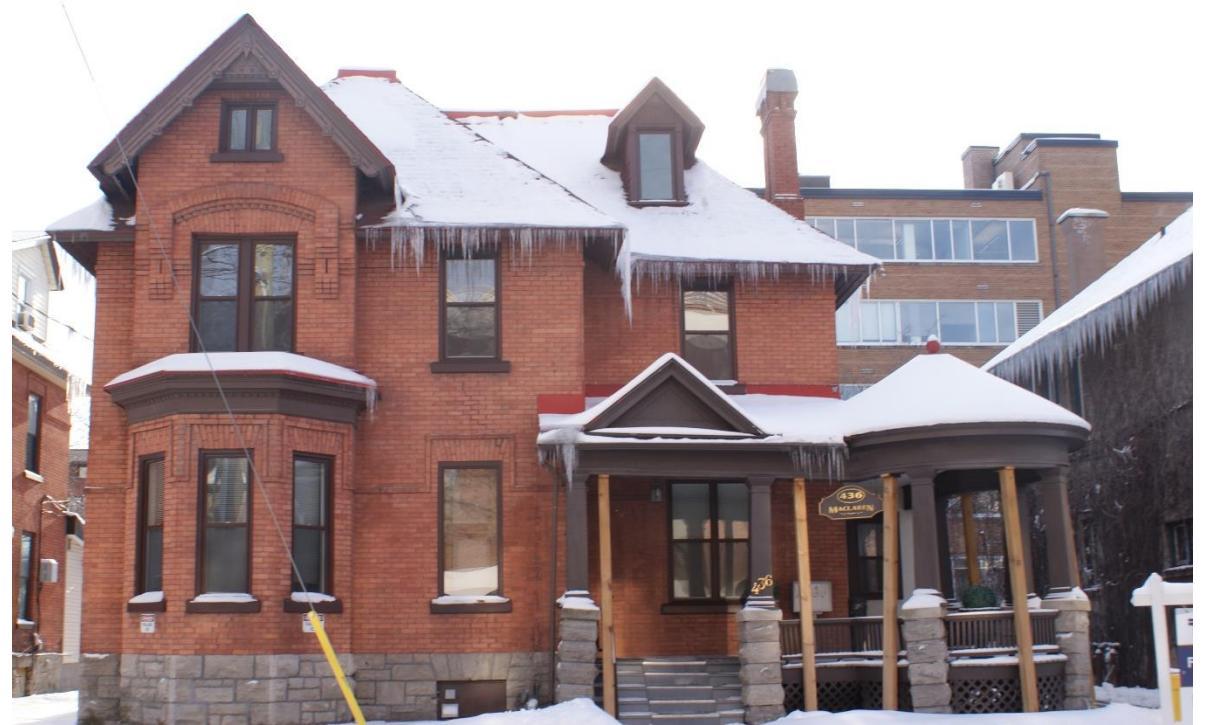
The building at 436 MacLaren is in good condition overall with the exception of the one-storey porch. The coursed limestone pillars supporting the deck structure need to be dismantled and rebuilt with a new foundation. The deck structure which is supported on the masonry piers will also need some attention.

Figure 25: View of 436 MacLaren Street. The masonry piers supporting the porch have settled due to inadequate foundation depth. A detailed assessment of the condition of the porch is required. Guidelines from the CHCDP provide guidance for the conservation approach to the materials and assemblies. Source: Commonwealth 2023.

e) Where a porch or balcony is badly deteriorated, it should be conserved, not replaced. Where components are beyond reasonable repair, new components should match the originals in terms of design and detail, with the same materials, style and size, as closely as possible.

i) Masonry piers that support historic porches should be conserved. Repairs should be made in kind.

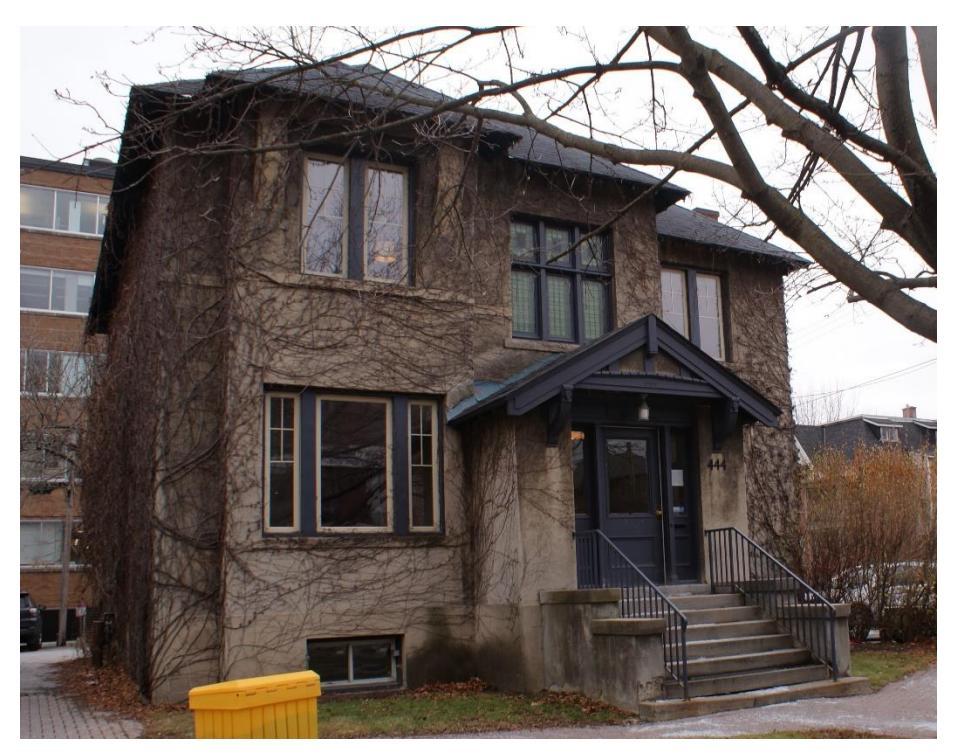
The building at 444 MacLaren is covered in vines that should be removed. The guidelines contained in the 2022 Centretown Heritage Conservation District Plan (CHCDP) are provided to guide the conservation work.

Figure 26: View of 444 MacLaren Street. The stuccoed exterior wall is covered in vines that should be removed before they have an adverse impact on the stucco finishes. Source: Commonwealth 2022

1. Conserve, maintain and repair historic masonry, stucco, and wood exterior cladding.
