March 31, 2023

## RE: TREE CONSERVATION REPORT FOR 1987 ROBERTSON ROAD

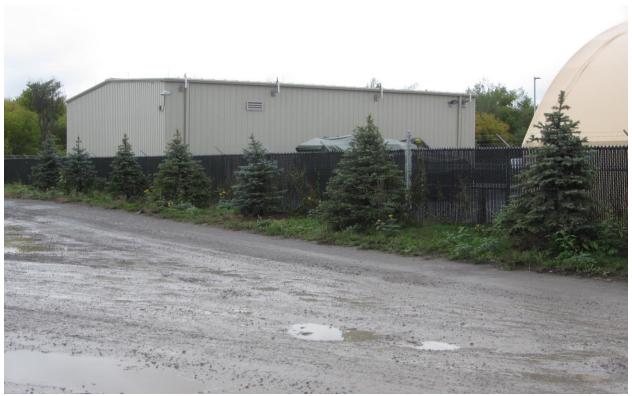
<u>Tree grouping A</u>: A line of nine planted Colorado spruce ranging in diameter from 5 to 9 cm which are in fair condition with the exception of one dead tree. Based on gaps in the line it appears other trees died and were removed in the past. This line of trees will be removed due to conflicts with construction. Transplanting elsewhere on the property may be an option for those trees in better health.

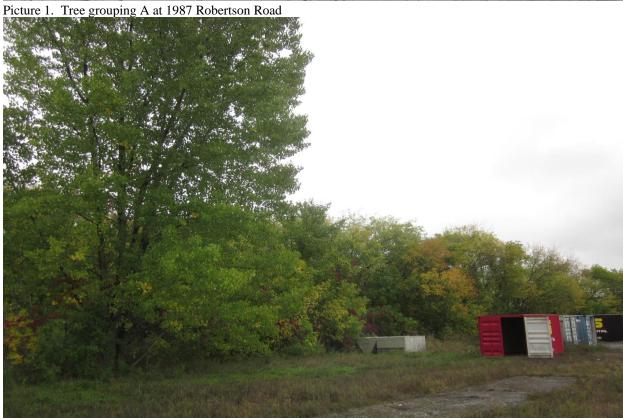
Picture 2. Tree #1 (left) and grouping B at 1987 Robertson Road

<u>Tree grouping B</u>: A group of Manitoba maples (*Acer negundo*) growing through the fence from the neighbouring property to the east. The largest tree is 19cm in diameter and in good condition. Being under the ownership of others these trees will be preserved and protected during construction (unless permission to remove is granted in writing by the adjacent landowner). However, the overhanging branches can be cut back to the property line.

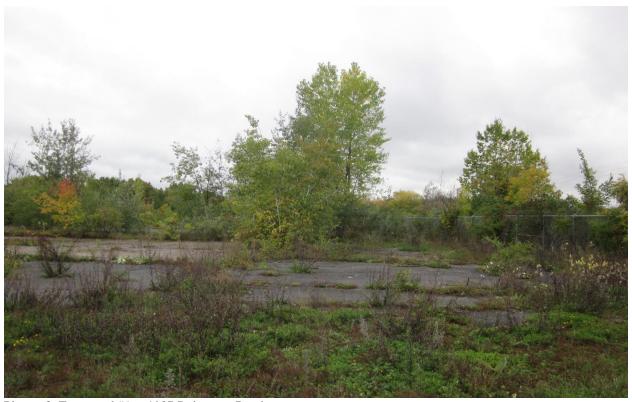
Picture 3. Tree stand #1 at 1987 Robertson Road

<u>Tree stand #1</u>: This stand is centered on a compacted area of stone, possibly a former parking lot. As with other areas on the property, all these trees arose from seed spread from elsewhere.

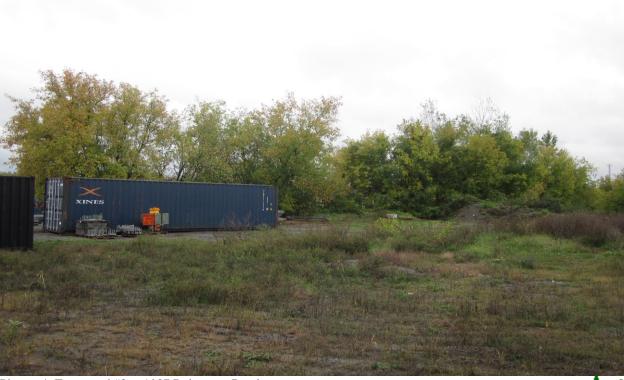
Picture 4. Tree stand #2 at 1987 Robertson Road

<u>Tree stand #2</u>: As with stand #1, this stand is centred on a heavily disturbed and compacted area.

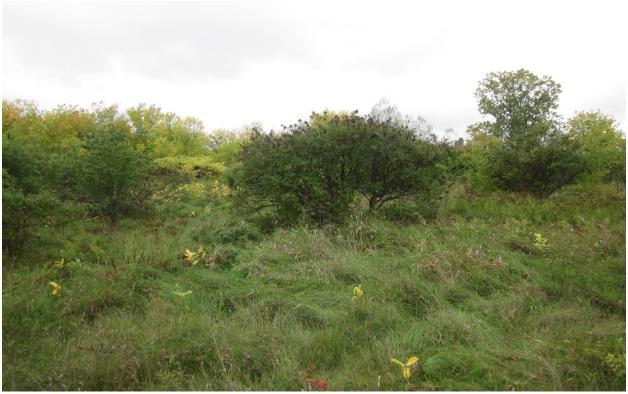
Picture 5. Tree grouping C at 1987 Robertson Road

<u>Tree grouping C</u>: A series of sample plots were taken in this area to determine general tree composition – species, average diameters and percent occupancy by stem count:

<sup>&</sup>lt;sup>1</sup> all ash on the property are either dead or heavily infested with emerald ash borer (*Agrilus planipennis*)

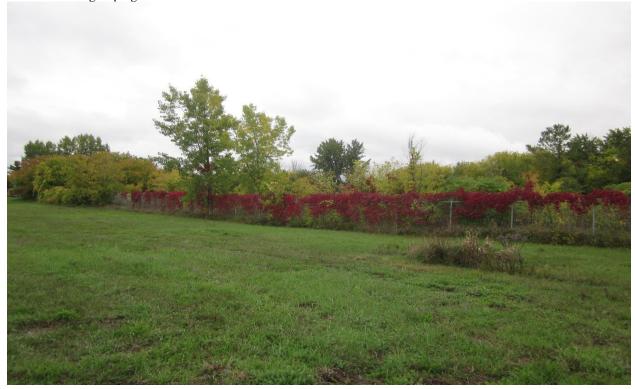
Picture 6. Tree grouping D at 1987 Robertson Road

<u>Tree grouping D</u>: A series of sample plots were taken in this area to determine tree composition:

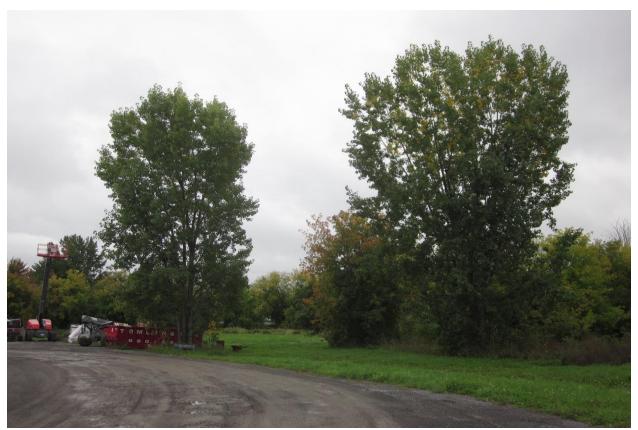
Picture 7. Trees #3 and 5 at 1987 Robertson Road

Tree	Tree	Diameter	Tree Condition,
No.	Species	(cm)	Condition Notes and Age
			Good; multi-stemmed (6) at grade; growing
1	Eastern cottonwood	27.5 avg.	through chain link fence; mature
			Good; basal wound; located on edge of hill,
2	Eastern cottonwood	60	near train tracks; mature
3	Eastern cottonwood	30 avg.	Good; multi-stemmed (3) at grade; maturing
	Crab apple		
4	(Malus spp.)	12.5 avg.	Good; multi-stemmed (7) at grade; maturing
			Good; multiple leaders at 1m from grade;
5	Eastern cottonwood	55	mature
			Good; double leader at 0.2m from grade with
6	Manitoba maple	27 avg.	inclusion ridge at union; maturing
7	Manitoba maple	21	Good condition; maturing
8	Balsam poplar	20	Fair; growing against building; maturing

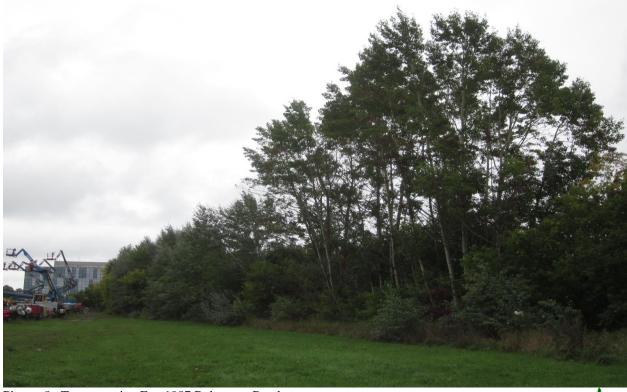
Picture 8. Tree grouping E at 1987 Robertson Road

<u>Tree grouping E</u>: A series of sample plots were taken in this area to determine tree composition:

<sup>&</sup>lt;sup>2</sup> white poplar is an introduced and invasive species in Ontario
