Tree Conservation Report 424 Churchill Avenue North Ottawa, Ontario

Prepared for GSI Properties
By Arcadis IBI Group
August 12, 2024

CLIENT:	GSI Properties
PROJECT NAME:	Tree Conservation Report 424 Churchill Avenue North Ottawa, Ontario
REPORT TITLE:	Tree Conservation Report 424 Churchill Avenue North Ottawa, Ontario
IBI REFERENCE:	139413
VERSION:	1.0
DIGITAL MASTER:	https://ibigroup.sharepoint.com/sites/Projects2/139413/Internal Documents/6.0_Technical/6.05_Landscape/03_Reports/LTR_424_Churchill_2022-10-07_DRAFT.docx 2022-10-14IMG
ORIGINATOR:	Tim McCormick
REVIEWER:	Erin Hellinga
AUTHORIZATION:	Tim McCormick
CIRCULATION LIST:	Jemmy Taing (GSI Properties), Kris Benes (Open Plan Architects Inc.)
HISTORY:

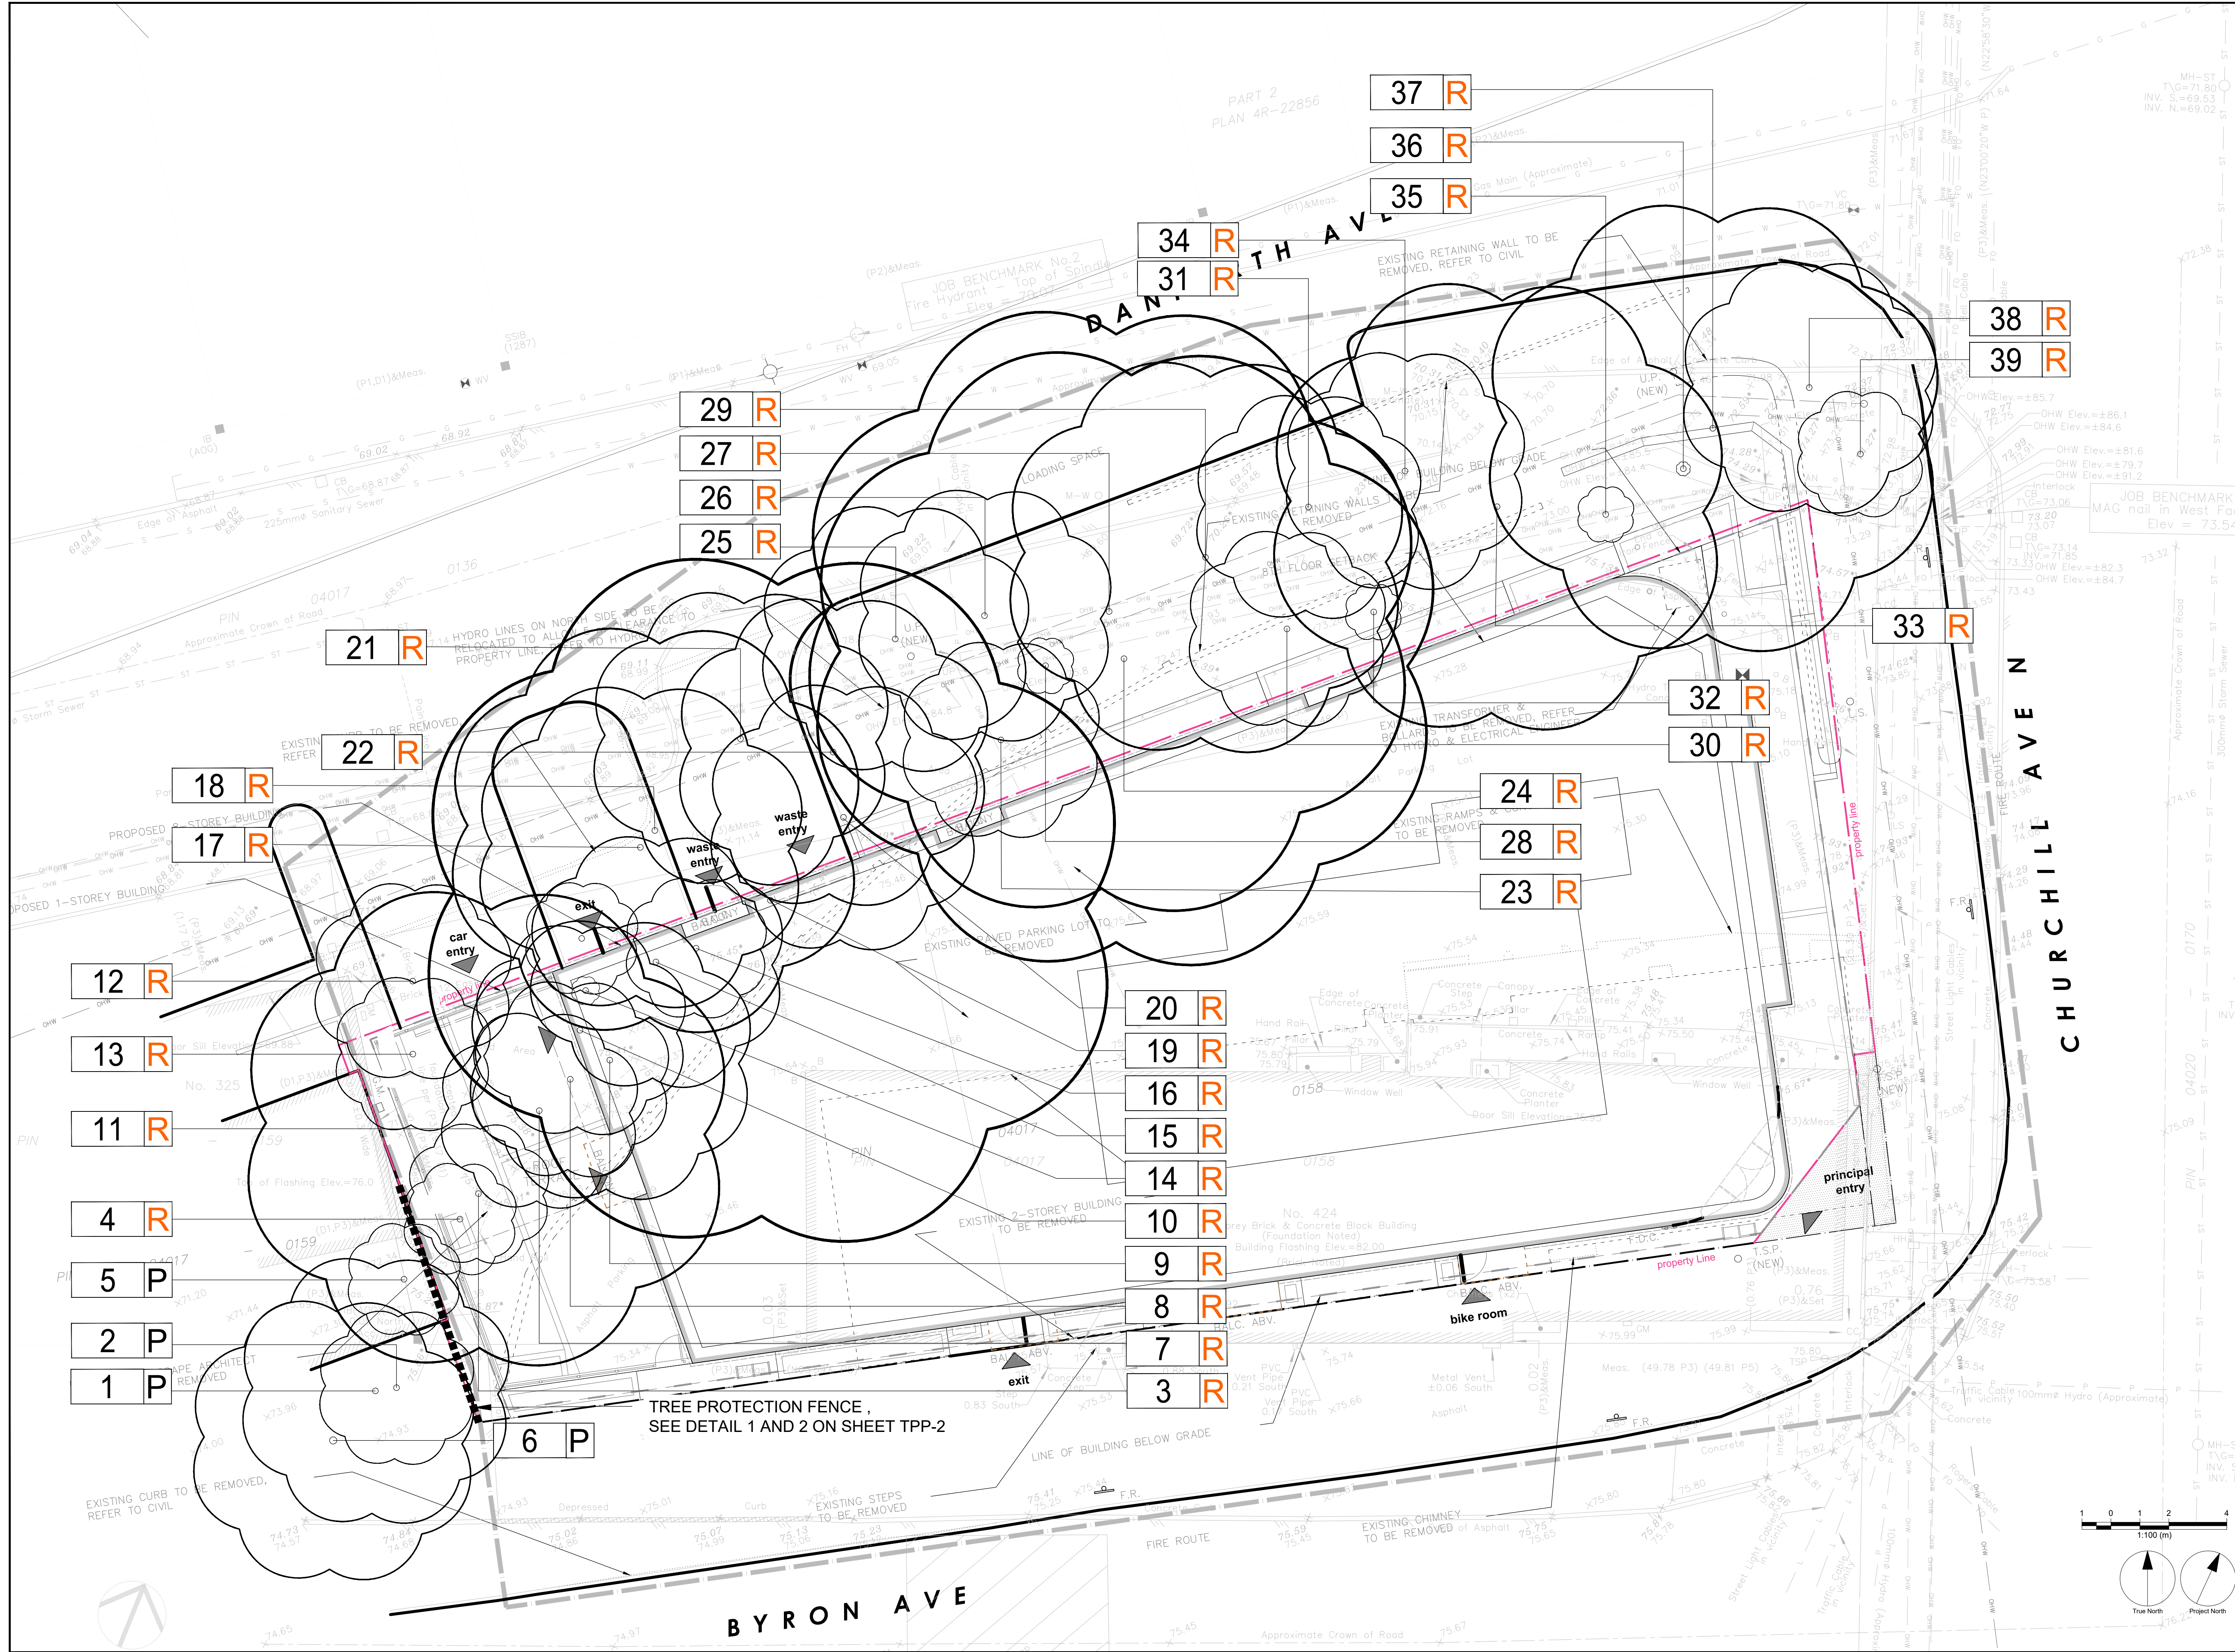
SHEET NUMBER TPP-1 **ISSUE** 3

Based on the layout of the subject property, location of the trees, and necessary site work to facilitate the construction onsite, there will be no trees preserved or protected on the subject site. Tree 1, Tree 2, Tree 5, and Tree 6 will be preserved and protected on the adjacent property. Tree preservation fencing will be erected at the property limit to protect these trees during construction.

There are thirty-four (34) trees that will need to be removed to facilitate the construction of the proposed building and development. There is one (1) dead tree within property that will also be removed within the proposed building area.

Tree Protection Fencing (TPF) is to be installed on site along the western property line to protect four (4) trees on the adjacent property (Appendix A). The limits of TPF have been indicated on the Tree Conservation Plan sheet TPP-1 and shall be considered to delineate the limits of work. All TPF shall conform to the City of Ottawa's current standards and Tree Protection Specification as shown on Detail 1-TPP2.

1. Tree Protection Fencing (TPF) should be installed to protect all trees identified for preservation. TPF should conform to City of Ottawa standards and the locations indicated on the TPP (Appendix A). Upon installation of the TPF, the Contractor should contact the Project Arborist to review and approve the fencing and its location prior to commencement of any site work. This should be coordinated with City staff for approval. The TPF should remain intact throughout the entire construction period, as specified on the plans. The TPF should be inspected monthly and repaired as required and should be removed at the completion of all site works.
