131, 139 PARKDALE AVE & 122 FORWARD AVE

Tree Conservation Report

CIMA+ file number: A0001295
17 December 2025 - Review 000

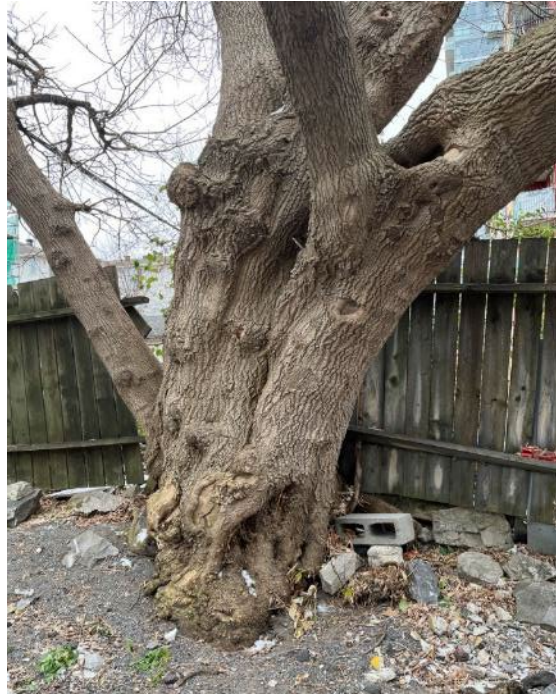
The largest tree on the Property was Tree 3, a Manitoba Maple with a dbh of 121 cm. Its condition was poor. This individual had poor form, with swelling at the base of the trunk, burls and woundwood along its stems, and an unbalanced crown (Photo 1). These symptoms are reflective of its poor growing conditions, with litter, bricks, and compacted, gravelly soil.

Photo 1: Poor structure and growing conditions of Tree 3 (November 18, 2025)

All six (6) individuals surveyed are proposed for removal. Five of them fall within the limits of excavation. Tree 4, which is outside the excavation limits, is proposed for removal because of its poor condition and damage. Four of these are owned by the Proponent and two (Trees 4, 6) by the City.

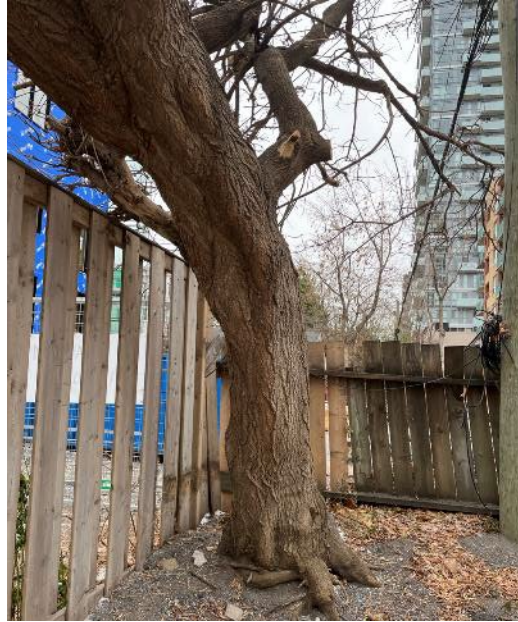
- Tree 1 was growing in concrete within a parking lot and leaning.
- Tree 2 had a **significant** lean over the adjacent fence, and was growing in poor conditions (compacted soil, presence of litter and gravel, and unstable growing surface) (Photo 3).
- Tree 5 was growing against fencing, and its trunk was girdled just below it split into codominant stems (Photo 4).

Photo 2: Tree 2's growing conditions and heavy lean (November 18, 2025)

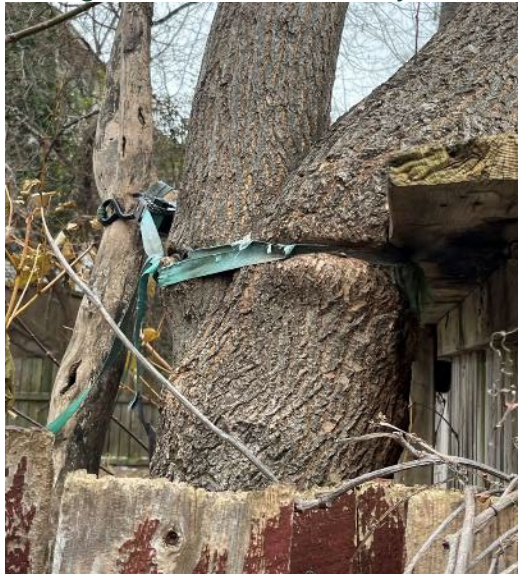
Photo 3: Tree 5's girdled trunk and growth against fence (November 18, 2025)

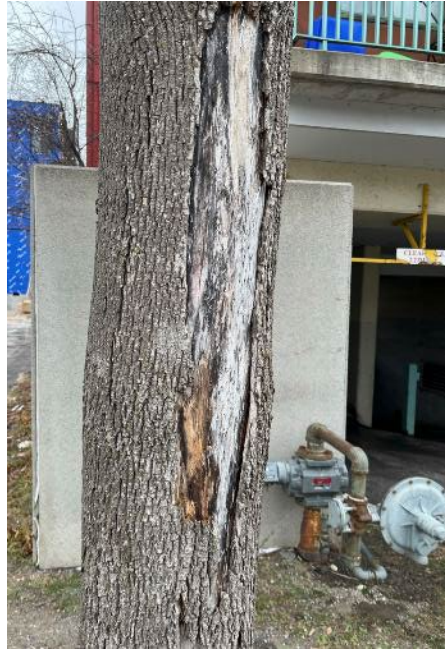
The singular red maple, Tree 4, showed signs of mechanical and frost damage (Photo 5). It had exposed roots along the ground, also indicative of stress due to poor growing conditions.

Photo 4: Damage on Tree 4 (November 18, 2025)
